## Template Method Statement to be used within a Bat Development Licence Application

| <b>Method Statement Title:</b> | Althrey Woodhouse, Overton Road, Bangor-on-Dee |
| <b>Site Address:</b> | Althrey Woodhouse, Overton Road, Bangor-on-Dee, LL13 0DA |

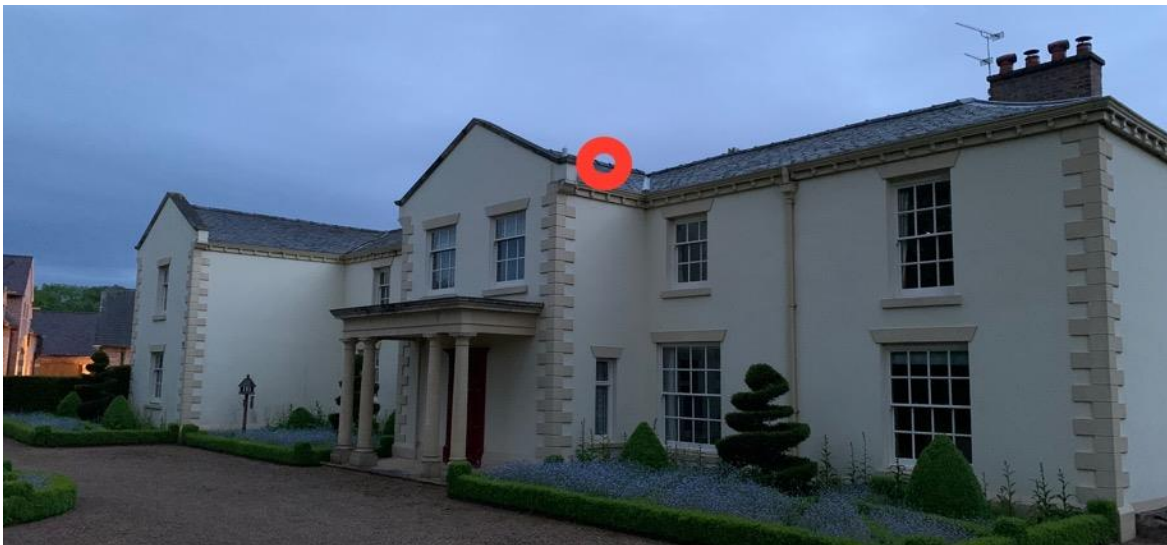
### Roost Access Point 1

One Common Pipistrelle exited a day roost at the verge of the ridge on the northern side of the building (Roost Access Point (RAP) 1 at 21:28. The roost location of this bat is not known, although it is likely between the slates and roof lining near the location of the RAP.

One Common Pipistrelle exited a day roost at the verge of the ridge on the northern side of the building (RAP 1) at 21:20. The roost location of this bat is not known, although it is likely between the slates and roof lining near the location of the RAP.

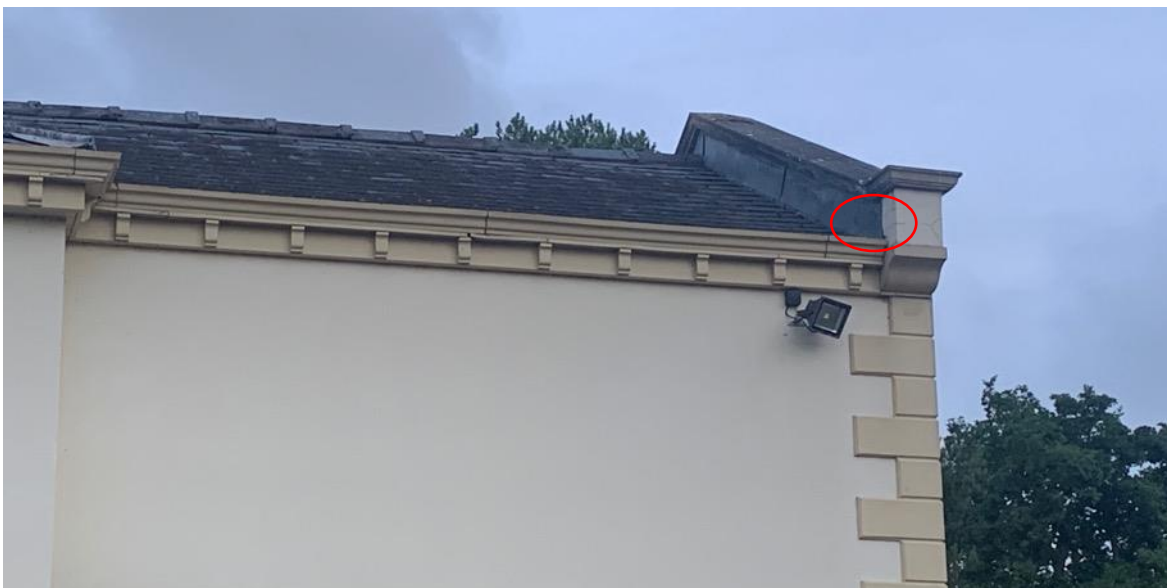
### Roost Access Point 2

One Soprano Pipistrelle exited a day roost near the eaves on the eastern side of the house, adjacent to the north-eastern gable (RAP 2) at 21:32.

Three Soprano Pipistrelles entered a day roost via RAP2 at 04:26, 04:31 and 04:45.
