Norish Foodcare, Ash Road South, Wrexham Industrial Estate, WREXHAM, LL13 9UG

| Project No | G24001 | Level | 32.11 mAOD | Termination Reason | Base of foundation pad exposed | |

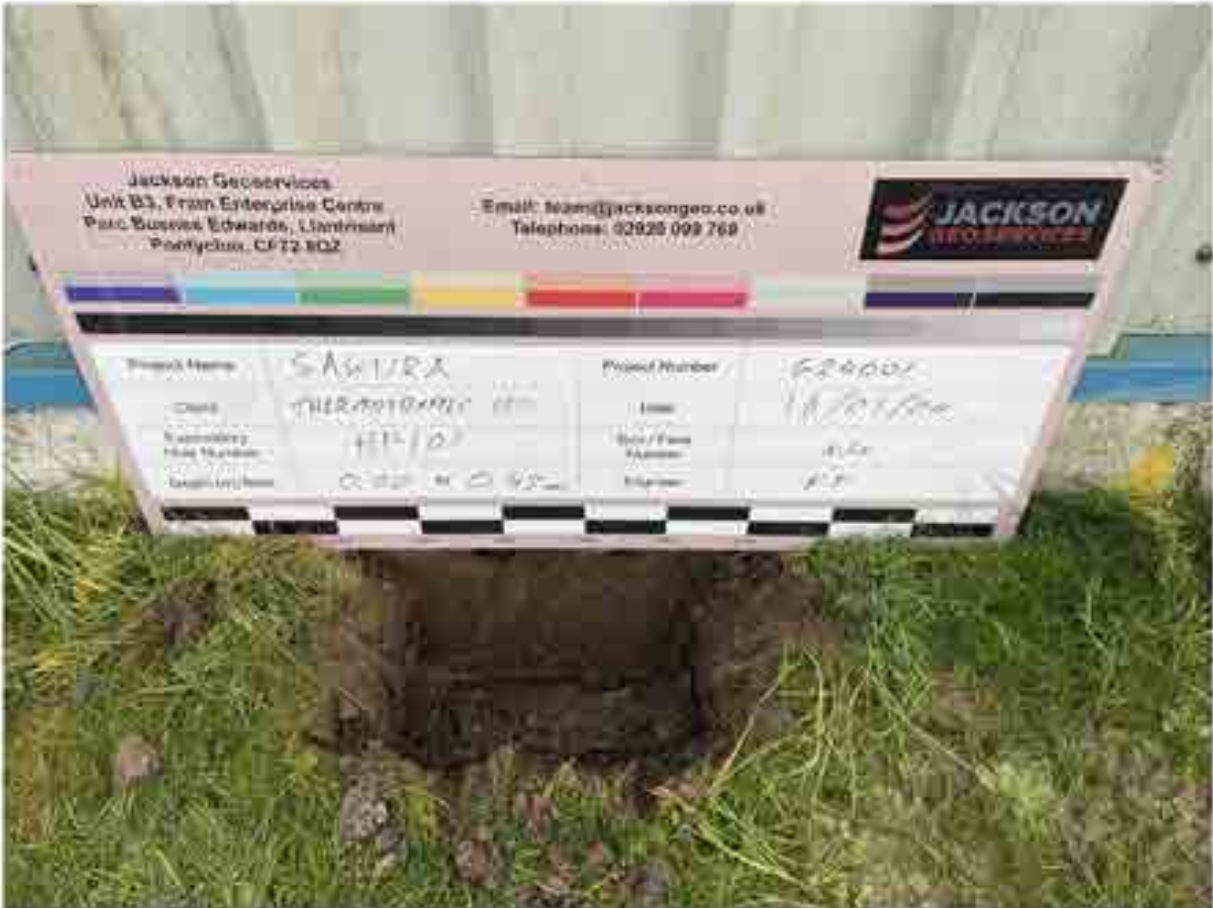
HP101

| Termination Reason | Base of foundation pad exposed | | | Width | 0.40 | | | | | | | |
| Remarks<br>hand excavated foundation inspection pit from GL to 0.26m. | | | | | | | | | | | | |

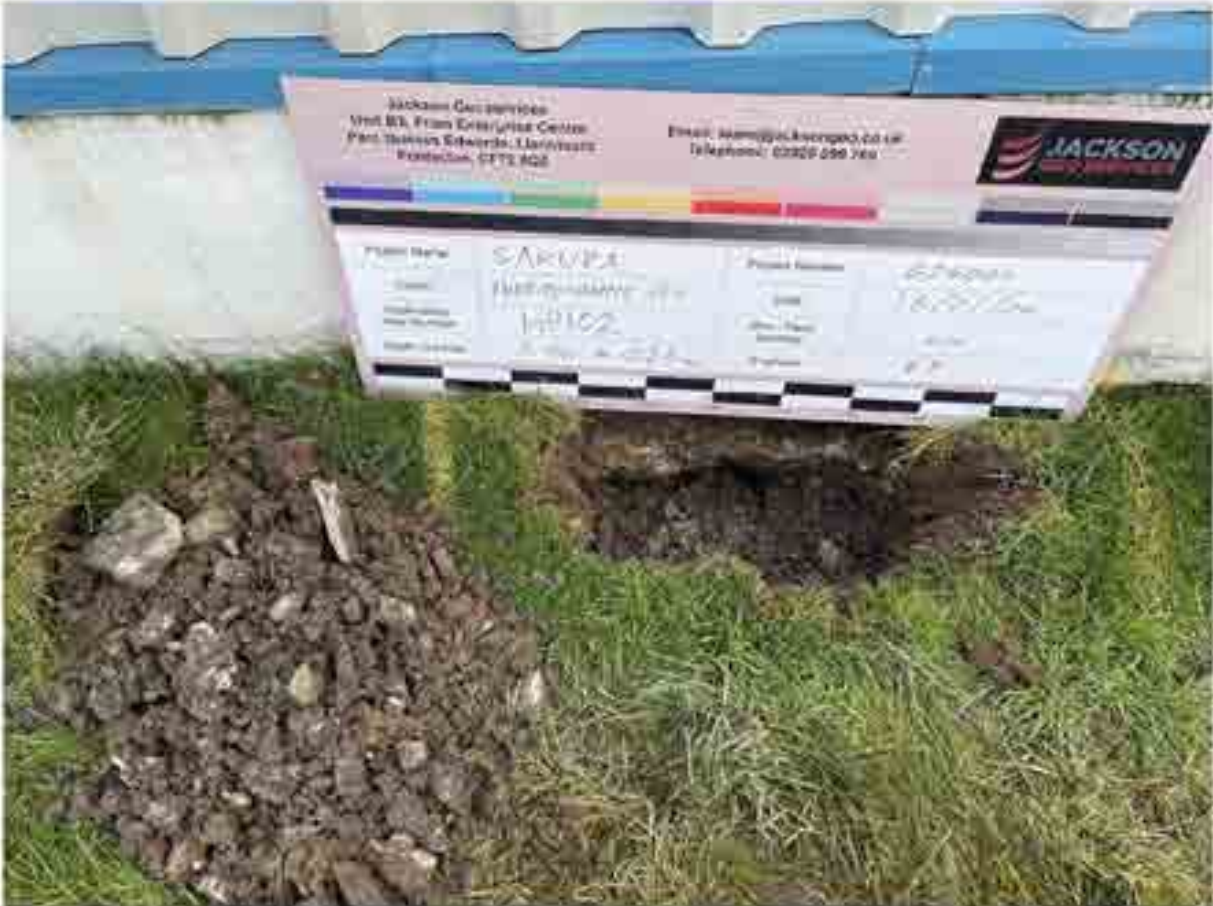
HP102

| Project No | G24001 | Level | 31.56 mAOD | Termination Reason | Base of foundation pad exposed |

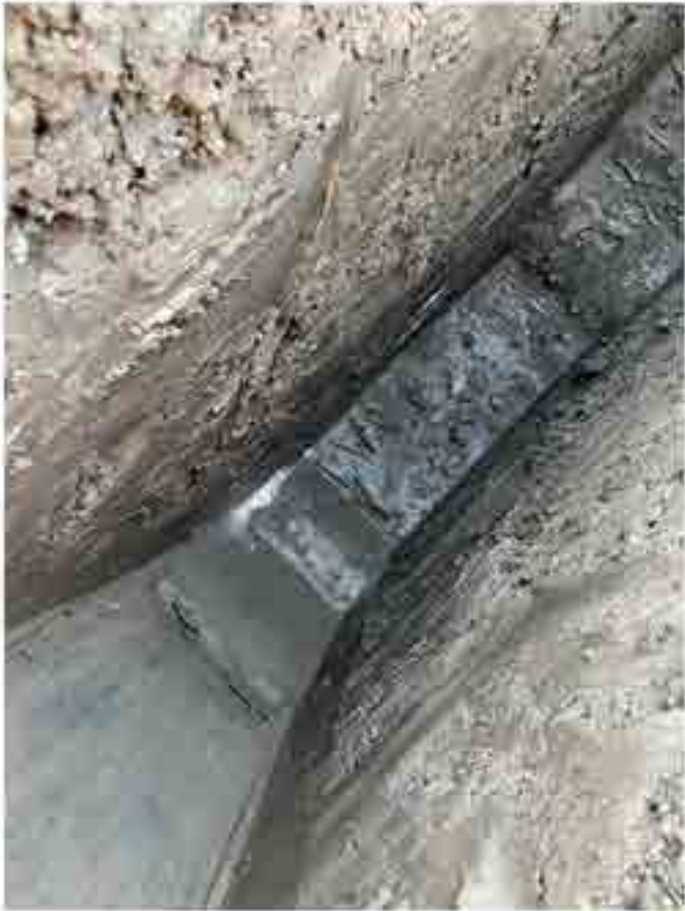
| Project No | G24001 | Level | 31.29 mAOD | Termination Reason | Potential service encountered (concrete pipe). | |

Concrete utility at base
