*Site – Plas Fron Lodge*

*Reference – 20240064*

*Location – Cross Lanes, Wrexham*

## ***Bat Survey***

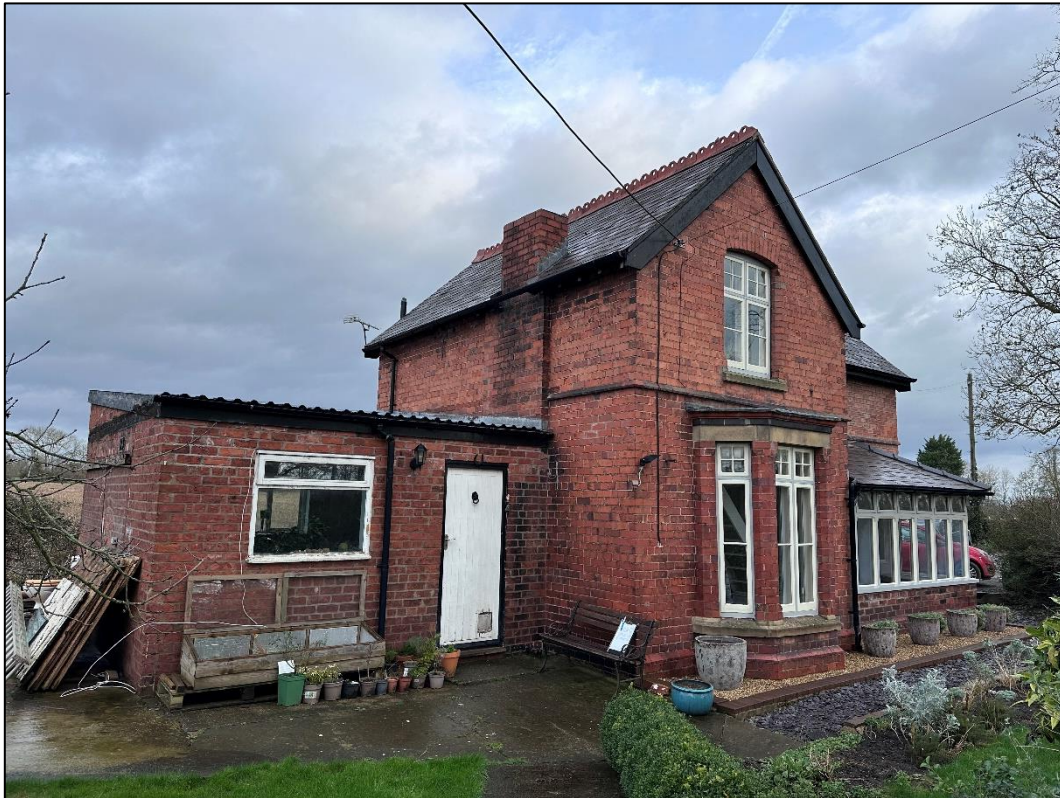
Figure 2: The southeast elevation of the building.

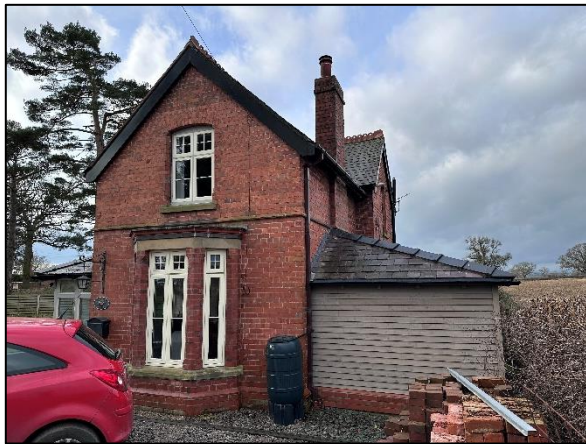
Figure 3: The northeast elevation of the building.

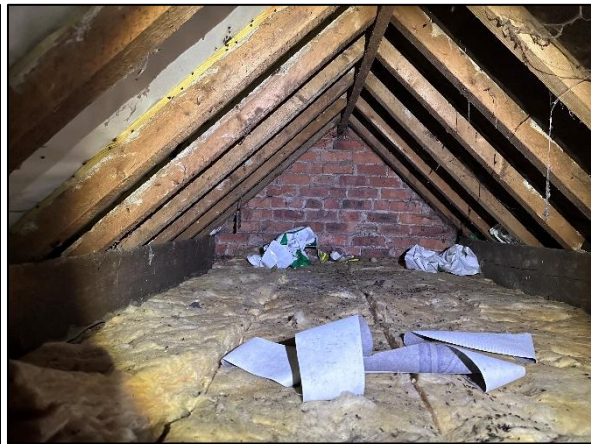
Figure 4: The roof void within the building.

4.2.7. The roof void of the building was found to display purlin and rafter timbers and an internal lining of partial bitumen felt and partial Breathable Roofing Membrane (BRM).

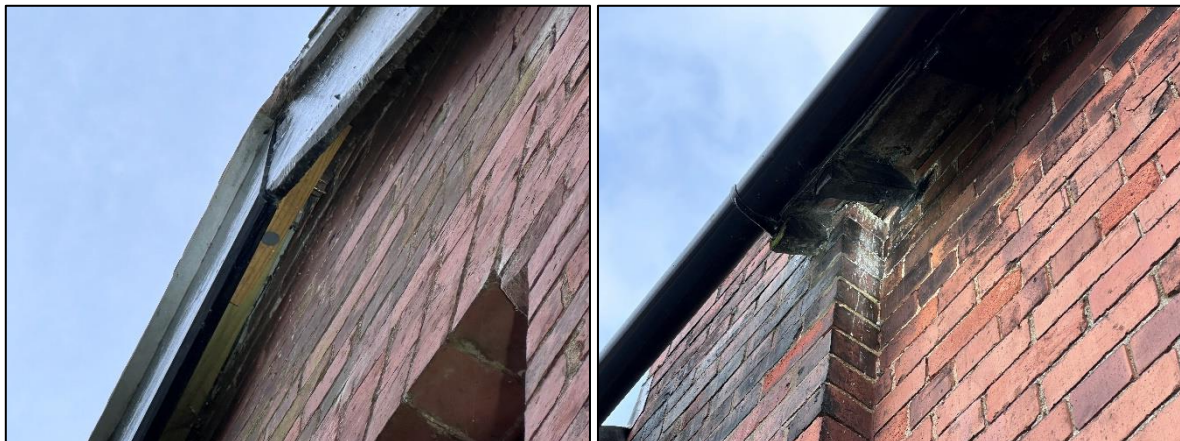
4.2.2. The eaves around the main building were found to be open providing opportunities for bats and birds to access the walls tops on all sides of the building. No bat field signs were identified although occasional areas of bird droppings were visible around the eaves of the main building, implying previous nesting activity.

Figure 6: Voids at the gable end of the building. Figure 7: Bird droppings around voids in the eaves of the building.

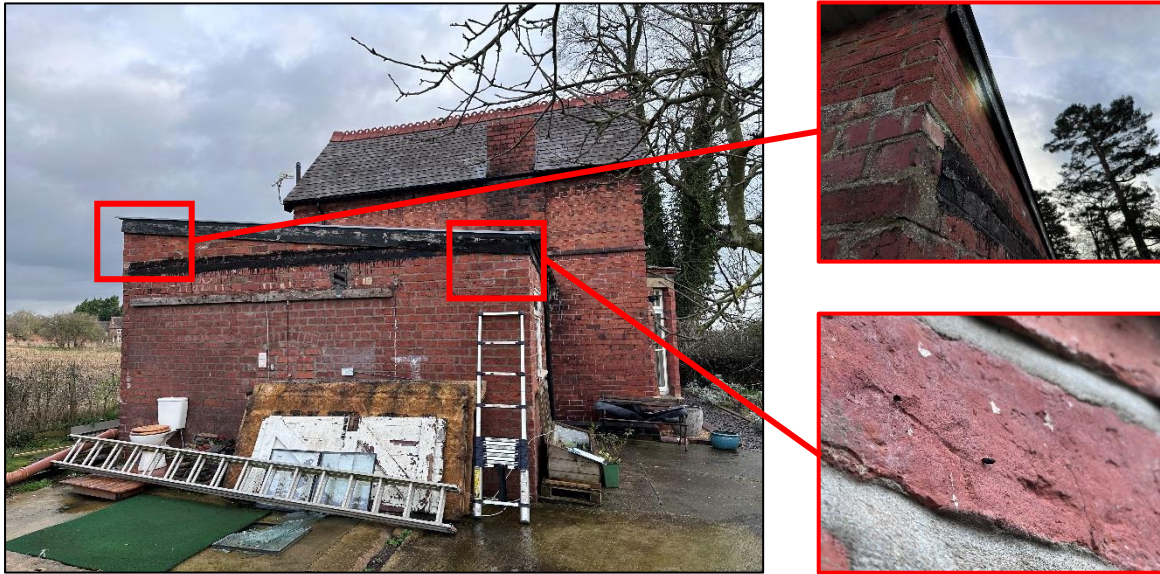
4.2.3. The fascia boards on the extension displayed occasional voids, particularly on the southwest elevation of the building. A single bat dropping was identified underneath gaps in the fascia board in two locations on the southwest elevation of the extension.

4.2.4. The bat droppings were individual droppings present on the brickwork with no signs of additional bat droppings on the floor below. An accurate species identification could not be carried out and the samples were too small to collect for eDNA analysis, although the droppings were indicative of pipistrelle species (*Pipistrellus sp.*).

Figure 8: Showing the location of droppings identified under the fascia board.

5.3.6. Prior to the works commencing on the demolition of the single storey extension a soft strip of the fascia board will be carried out under direct supervision of the named ecologist. Any bats encountered will be immediately moved to the bat boxes erected on the site.

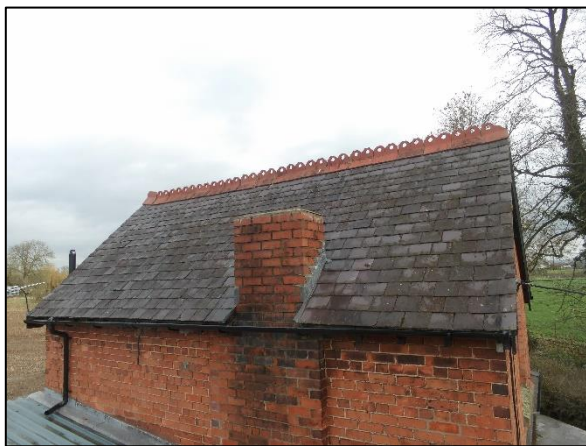
4.2.5. The roof of the building was found to be in a generally good condition with tight fitting slates and the ridge tiles in place and relatively well sealed. The leadwork around the chimney stacks was in good condition with no obvious voids.

Figure 9: The roof and leadwork to the southwest.

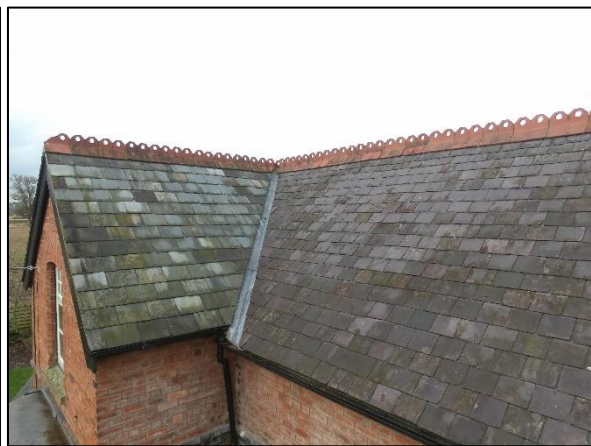
Figure 10: The tight-fitting slates and ridge tiles.

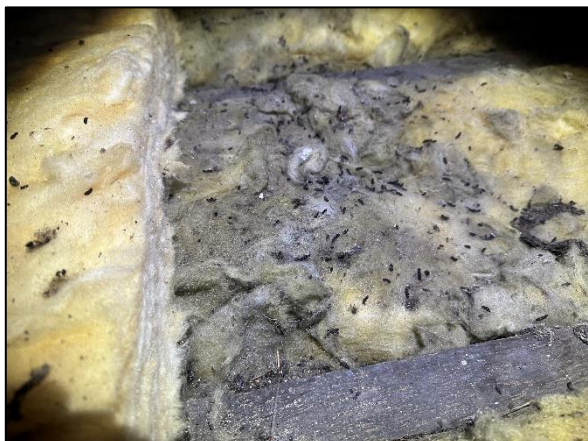
4.2.8. Several hundred bat droppings, fresh and old, were identified scattered throughout the roof void with occasional concentrations under the ridge and on the gable end on the northwest elevation of the building, including droppings on the brickwork and the loft floor below. No bats were visible in the roof void at the time of the survey.

Figure 11 Bat droppings on the loft floor.

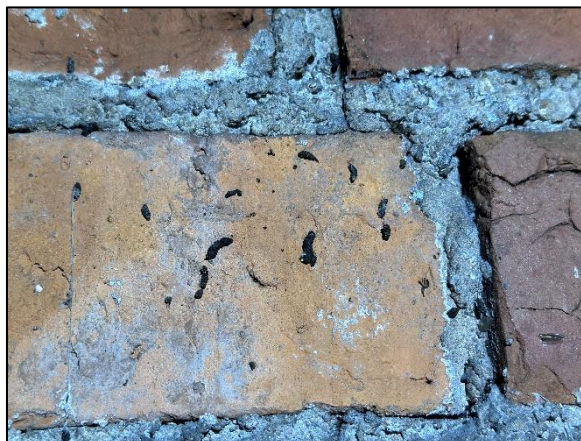
Figure 12: Bat droppings on the gable end wall.

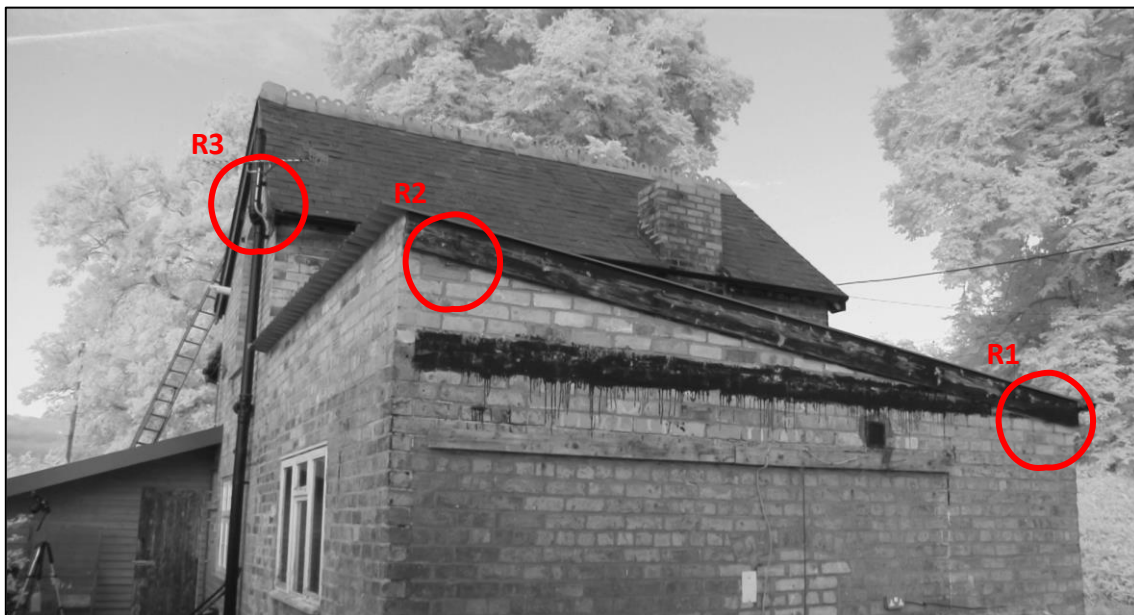
4.4.3. During the survey three bats were identified to emerge from the building. The emergence locations are shown in Figure 14.

Figure 14: Showing the emergence locations identified during the survey, including references.

4.4.4. At 21:23 a bat, identified from echolocation calls at the time of emergence to be a common pipistrelle emerged from behind the fascia board to the south of the single storey extension of the building (R1) and flew off site to the southeast.

4.4.5. At 21:45 a bat, identified from echolocation calls at the time of emergence to also be a common pipistrelle, emerged from behind the fascia board to the north of the single storey extension of the building (R2) and flew off site to the south.

4.4.6. At 21:49 a bat emerged from the eaves on the northern gable end of the building (R3) and flew to the west. The bat was not recorded at the time of emergence but was considered likely to be the whiskered bat identified in the roof void prior to the survey.

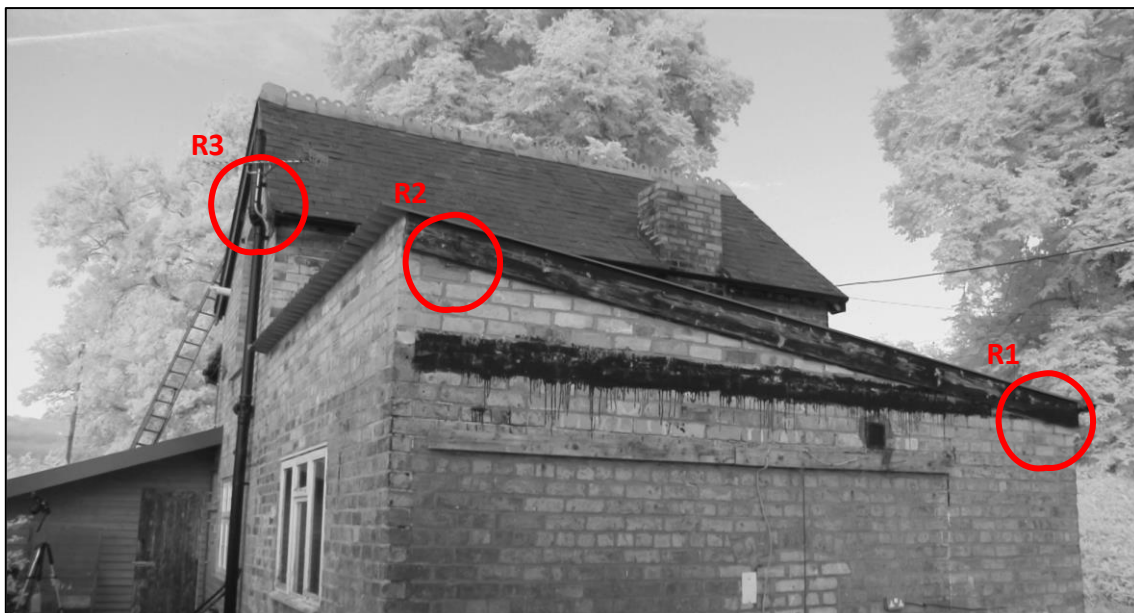
4.5.2. Bat droppings present under the fascia board on the single storey extension of the building implied the presence of bat roosts in this area, with the droppings considered likely to be pipistrelle species droppings. The activity surveys confirmed the presence of common pipistrelle roosting behind the fascia board in two places, to the south of the fascia (R1) and to the north of the fascia (R2).

4.5.3. The low numbers of bat droppings and presence of a single bat emerging from both locations indicates that both roosts comprise common pipistrelle day roosts.

Figure 15: Showing the emergence locations identified during the survey, including references.

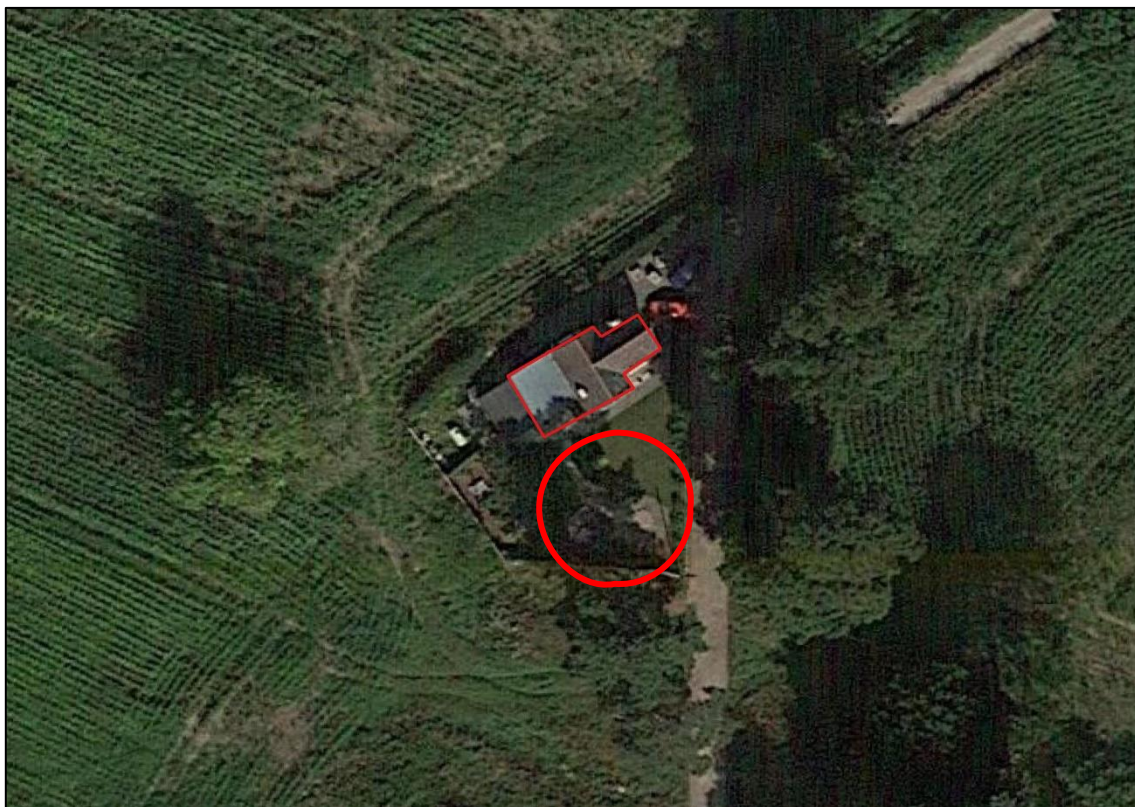
5.3.2. The bat boxes will be mounted together and will be placed at least 3.5-4m in height facing southeast, south or southwest. Figure 17 shows the approximate location the bat boxes will be mounted.

*Figure 17: Showing the approximate location for the bat boxes.*

5.3.1. Prior to the works commencing on site two bat boxes will be erected on a tree or pole within the garden of the property. The bat boxes will comprise 'Vivaro Pro – large multi chamber woodstone bat boxes' (Figure 16) or equivalent.

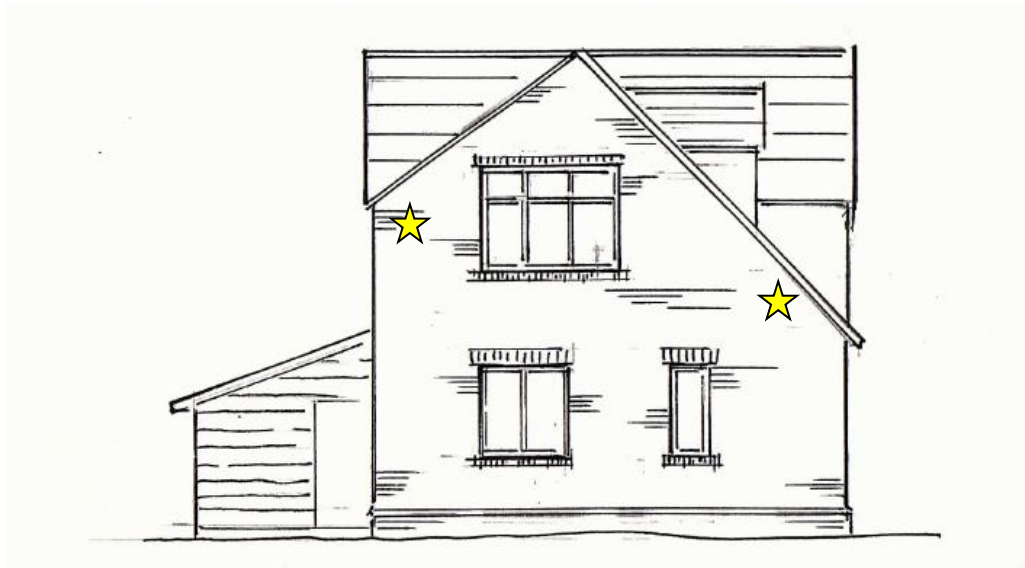
Figure 20: Approximate bat brick locations.

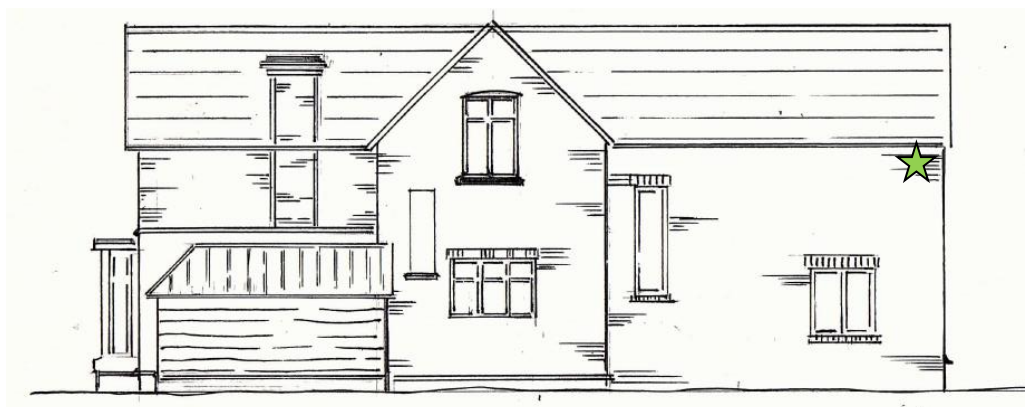
Figure 21: Approximately sparrow terrace location.

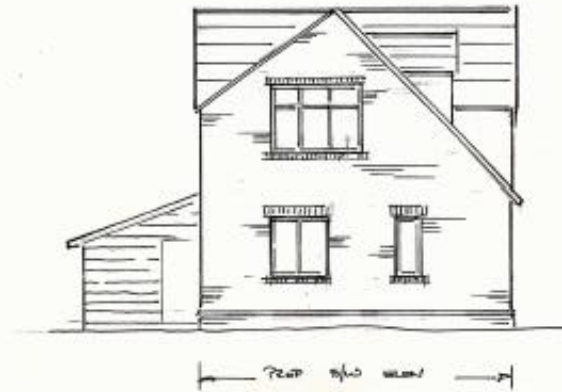
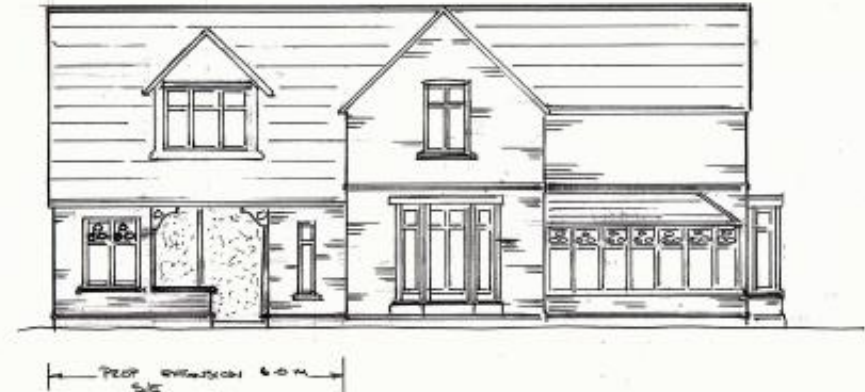
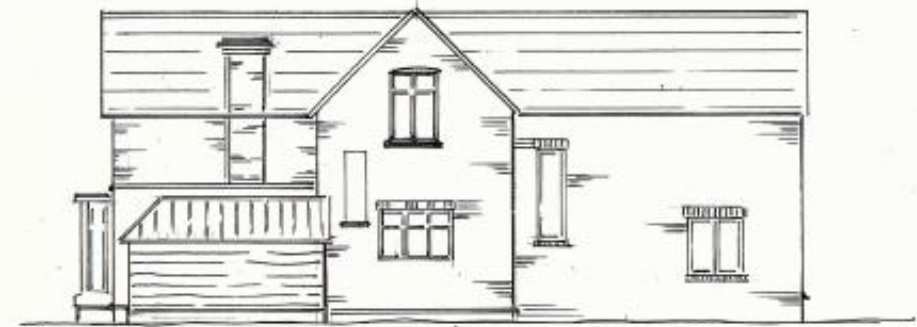
PROPOSED ELEVATIONS + ROOF

2.3.1. The proposals are to demolish an existing single storey extension to the rear of the property and to construct a two-storey extension on a larger footprint. The extension will tie into the existing roof void on the southwest elevation of the building.

BRICKWORK TO MATCH EXIST  
STONE CILLS TO S.E. ELEVATION  
TO MATCH EXIST  
SLATE ROOF  
DORMER GABLE + CHIMNEY IN LEAD  
PORCH RENDERS ROUGH CAST + PAINT FIN  
THREE H.W. LONGER PAINT FIN
