# Broad Oak Farm, Rossett

## Infiltration Test Report

May 2024

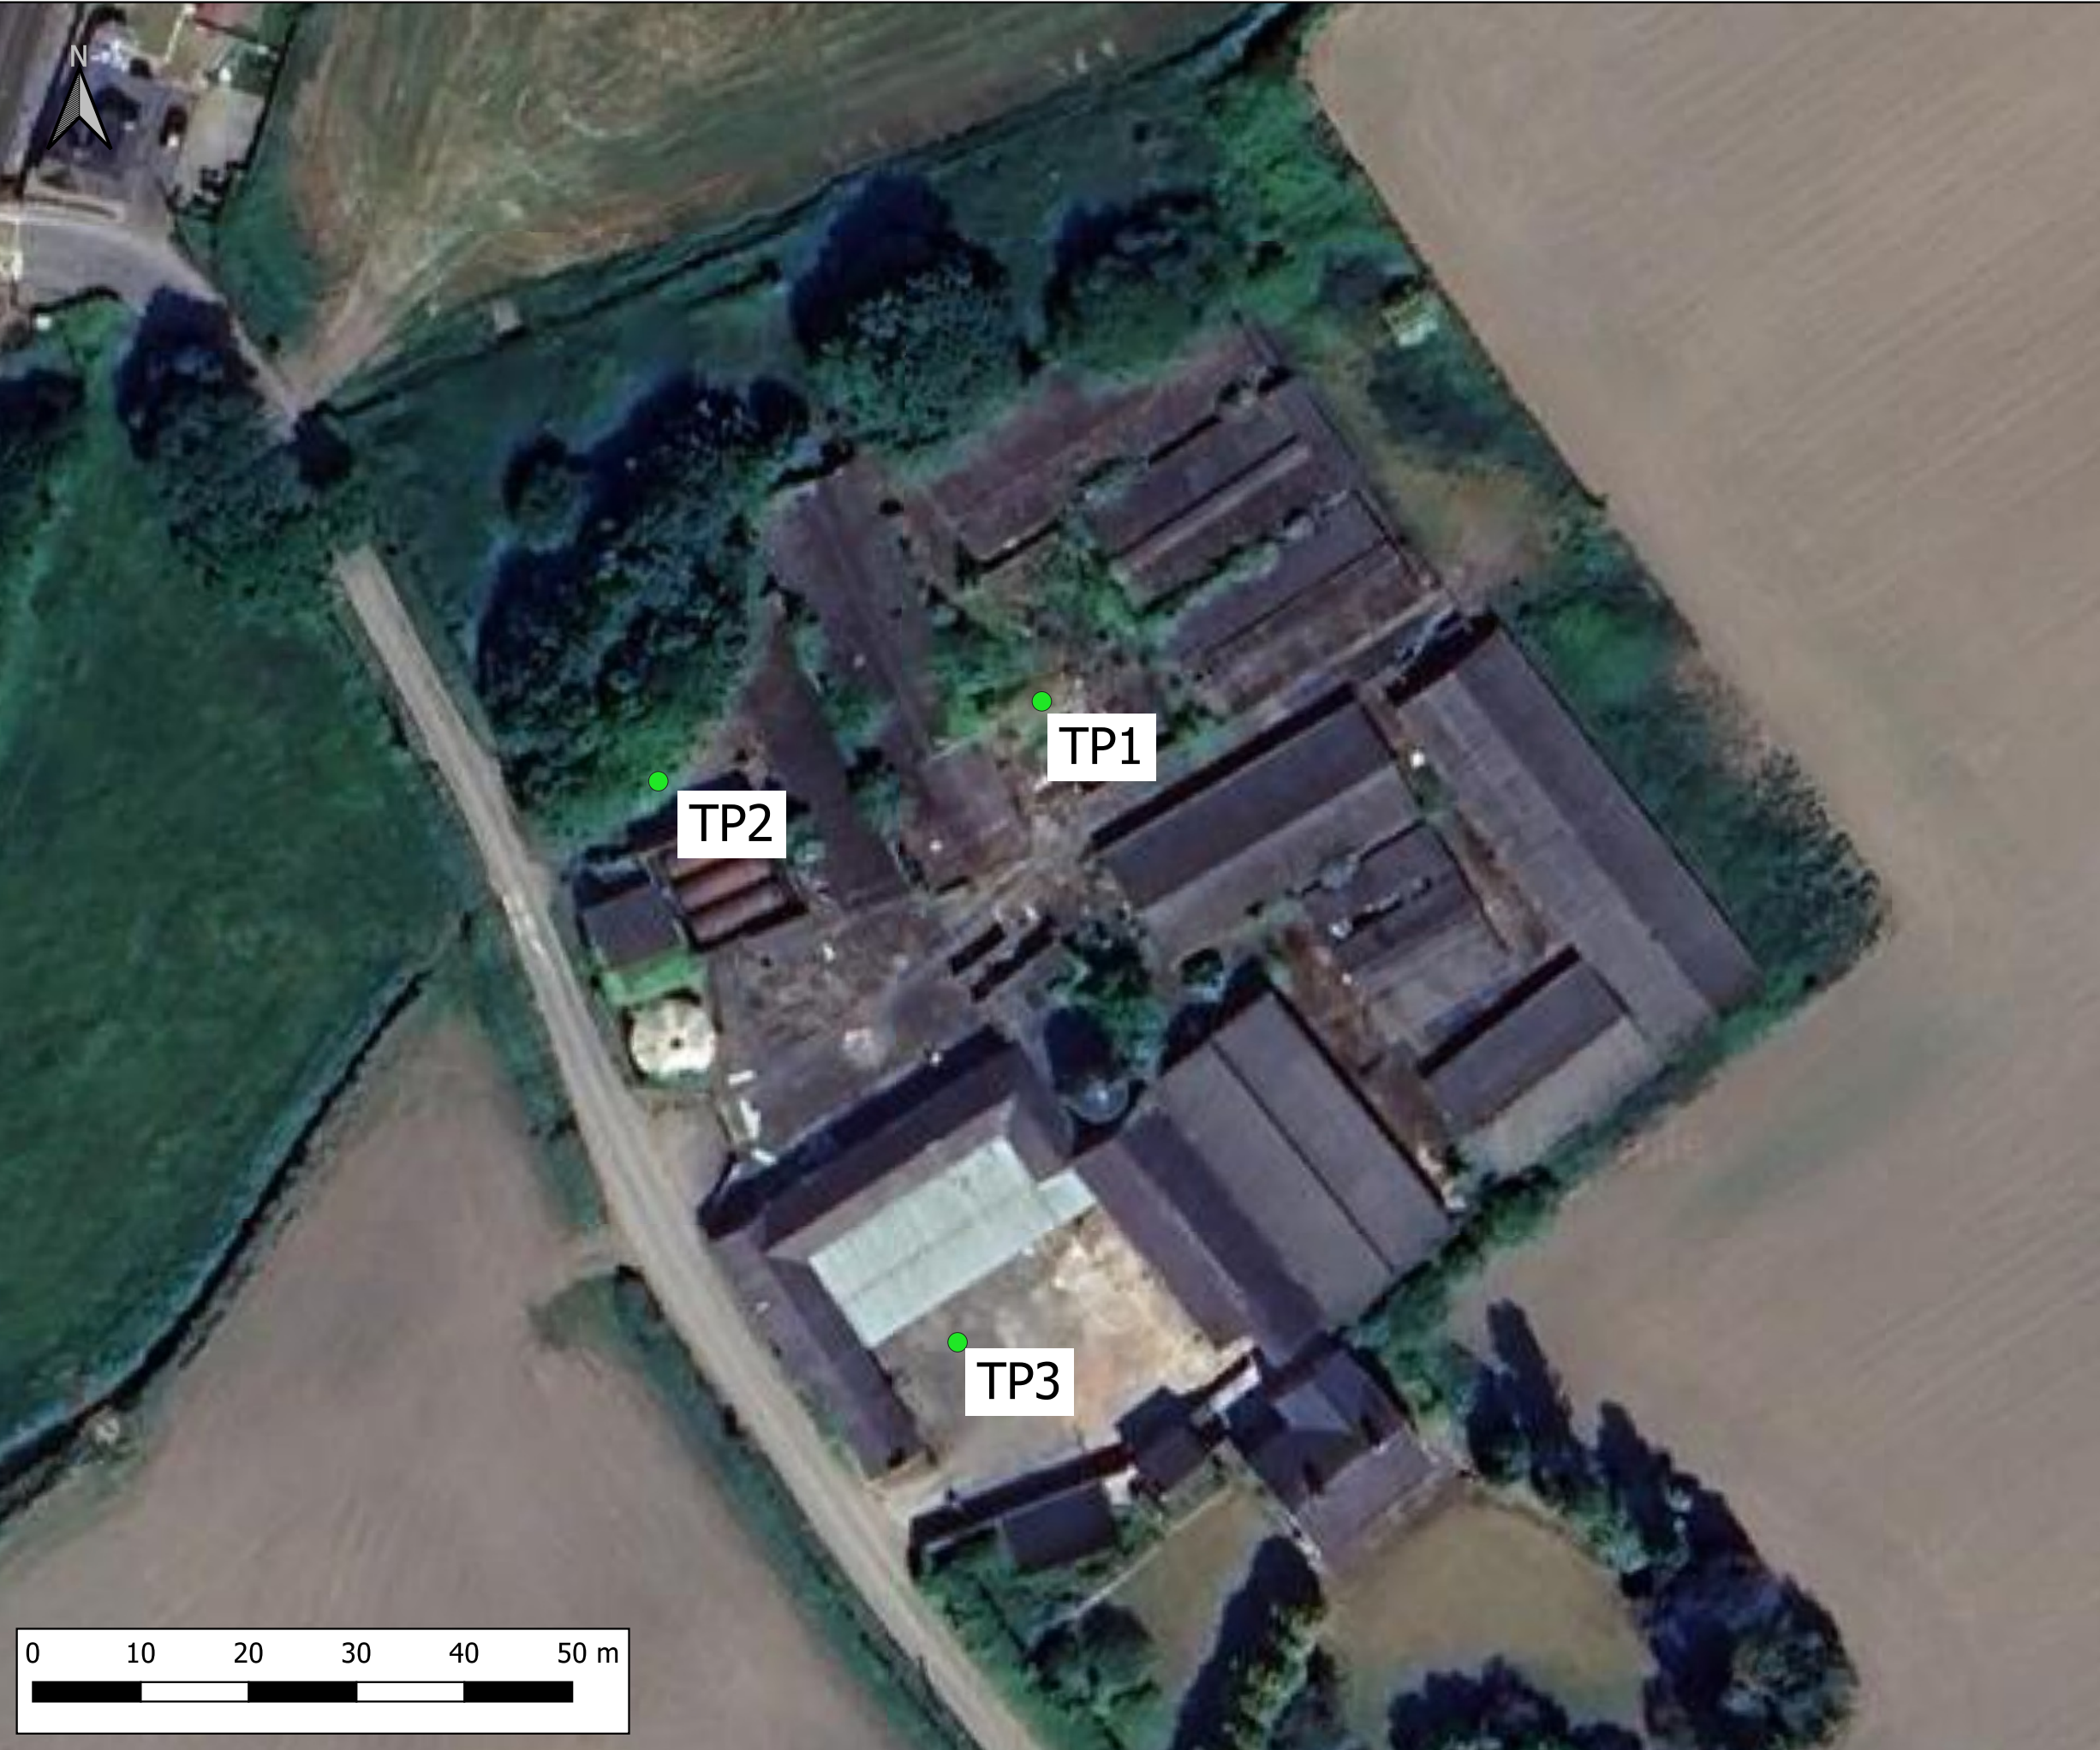
Trial Pit Location Plan

● Trial Pit Locations

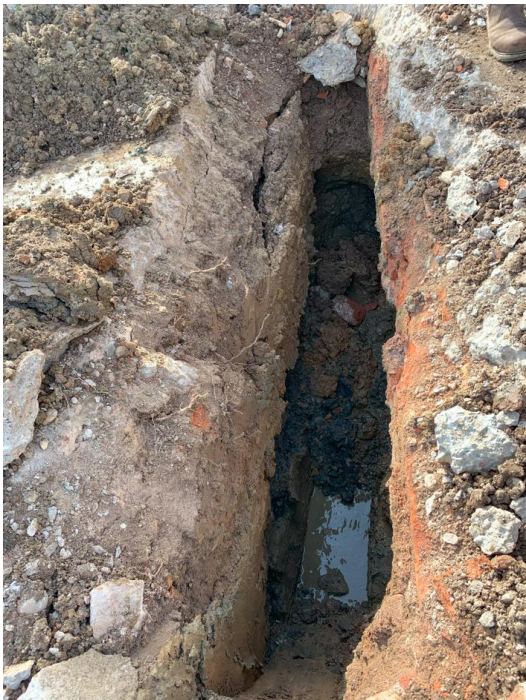
| <b>Photo No.1</b> | <b>15923 – Broad Oak Farm, Rossett</b> |

| <b>Date: 23/04/2024</b><br><br><b>Description:</b><br><br>TP1 (groundwater present). | |

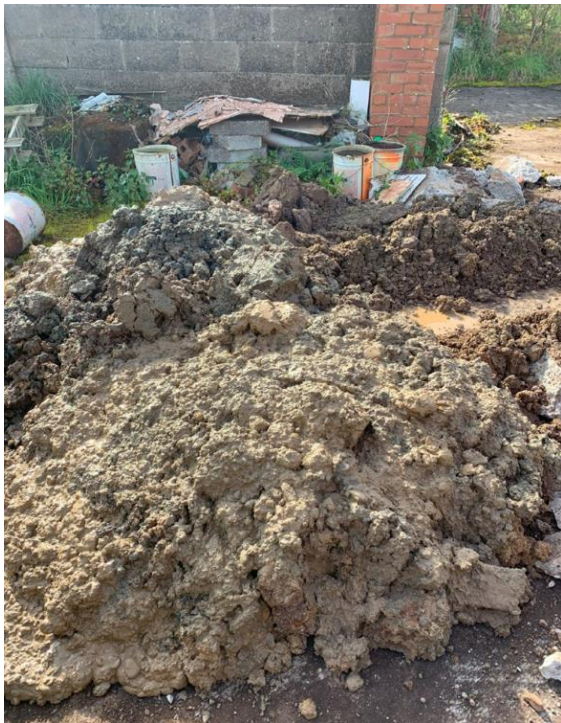
| <b>Photo No. 2</b> | <b>15923 – Broad Oak Farm, Rossett</b> |

| <b>Date: 23/04/2024</b><br><br><b>Description:</b><br><br>The excavated materials / arising from TP1. | |

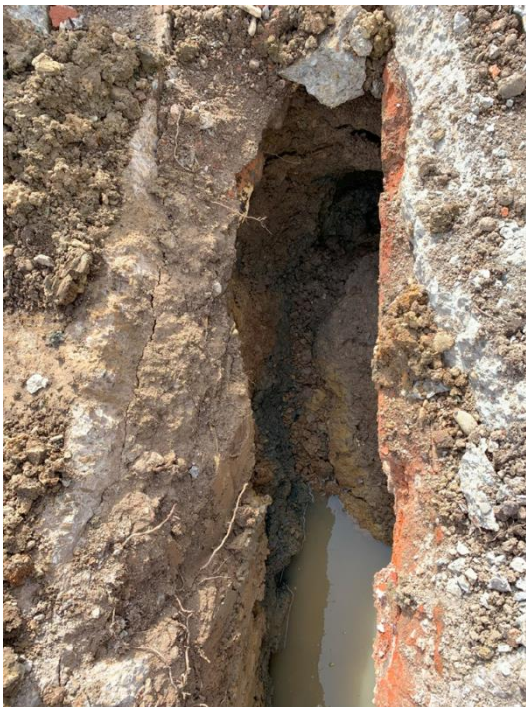
| Photo No.3 | 15923 – Broad Oak Farm, Rossett |

| Trial Pit | Description | Slowest Infiltration Rate |
|---|---|---|
| 1 | <p>The trial pit was excavated to a depth of 1.8m.bgl. Groundwater was recorded at 1.72m.bgl.</p> <p>No tests were undertaken in TP1 as the pit was unstable and sides were collapsing.</p> <p>The groundwater level in TP1 rose from 1.72m.bgl to 1.17m.bgl in 4 hours.</p> | N/A – Rising groundwater and pit collapse. |

| <p>Date: 23/04/2024</p> <p>Description:</p> <p>Collapsed end of TP1 (abandoned).</p> | |

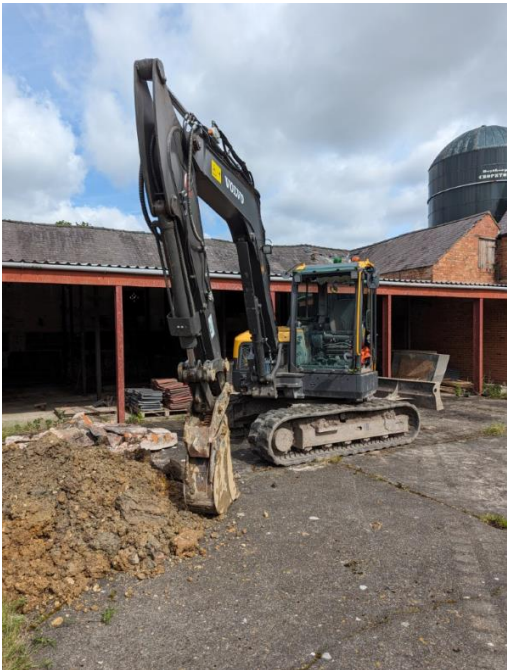
| Photo No. 4 | 15923 – Broad Oak Farm, Rossett |

| <p>Date: 23/04/2024</p> <p>Description:</p> <p>Excavator used to dig TP1-TP3.</p> | |

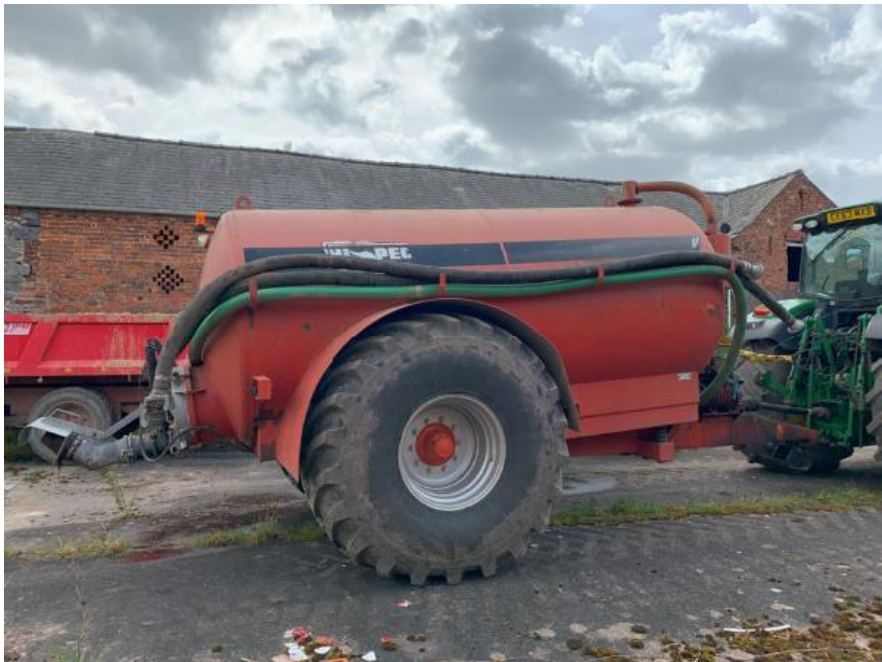
| <b>Photo No.5</b> | <b>15923 – Broad Oak Farm, Rossett</b> |

| <b>Description:</b><br><br>Water bowser used to fill TP 2 & 3. | |

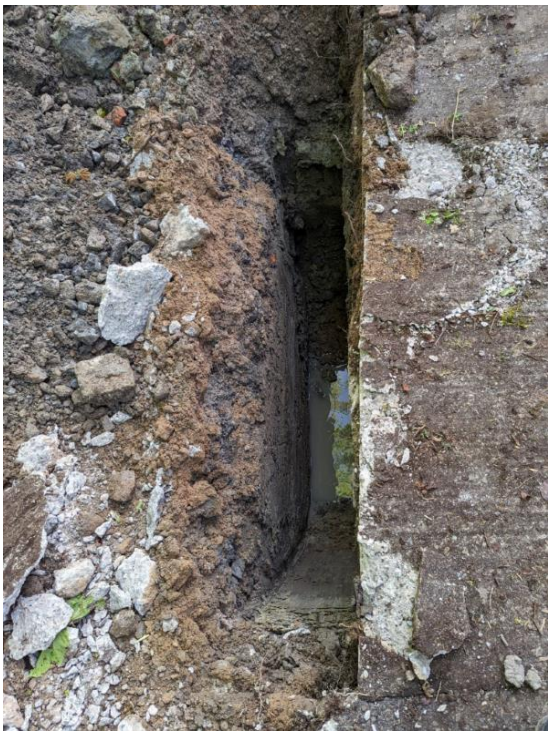
| <b>Photo No. 6</b> | <b>15923 – Broad Oak Farm, Rossett</b> |

| <b>Description:</b><br><br>TP2 (groundwater present). | |

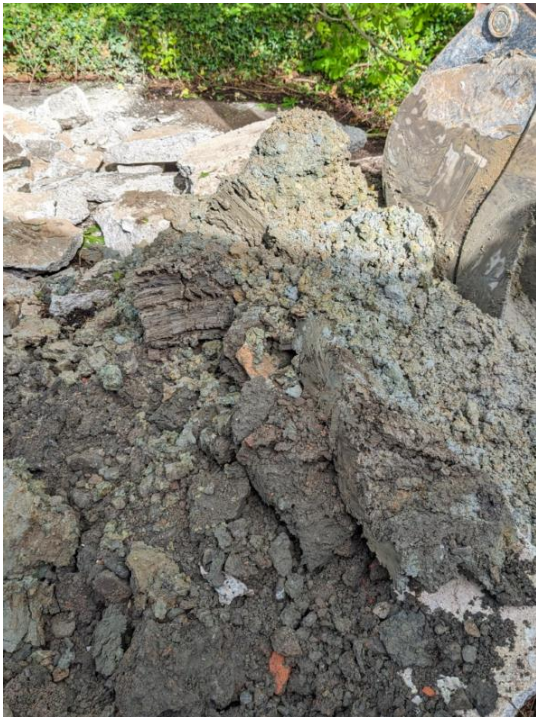
| <b>Photo No.7</b> | <b>15923 – Broad Oak Farm, Rossett</b> |

| <b>Date: 23/04/2024</b><br><br><b>Description:</b><br><br>The excavated materials / arising from TP2. | |

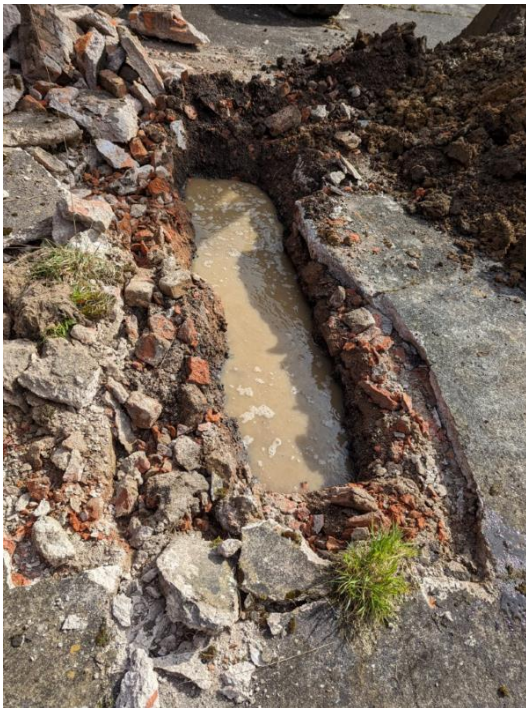
| Photo No.9 | 15923 – Broad Oak Farm, Rossett |

| <p>Date: 23/04/2024</p> <p>Description:</p> <p>TP3 filled with water.</p> | |

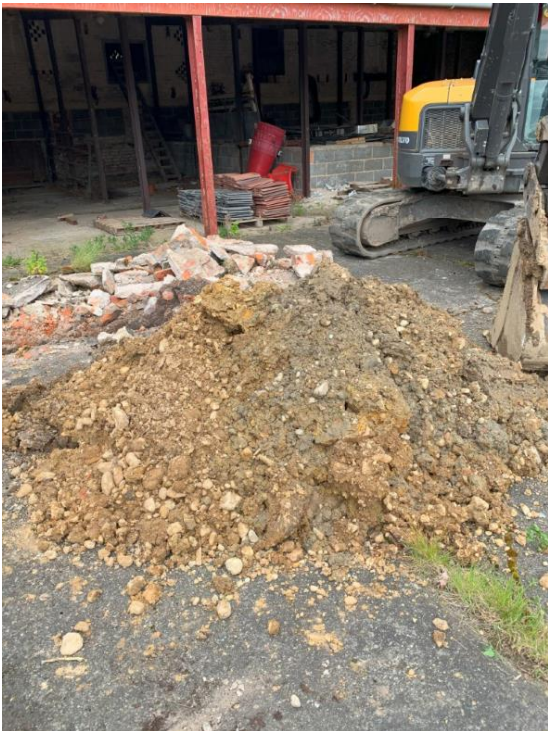
| Photo No. 10 | 15923 – Broad Oak Farm, Rossett |

| <p>Date: 23/04/2024</p> <p>Description:</p> <p>The excavated materials / arising from TP3.</p> | |

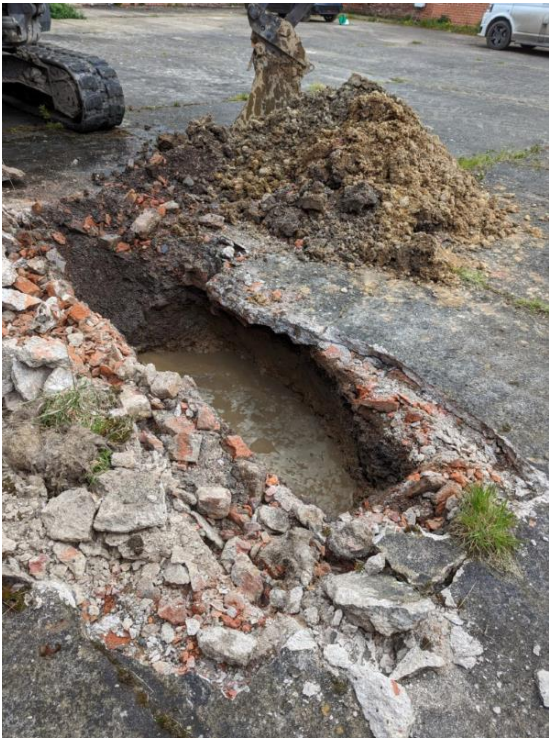
| <b>Photo No.11</b> | <b>15923 – Broad Oak Farm, Rossett</b> |

| <b>Description:</b><br><br>TP3 immediately after collapse. | |

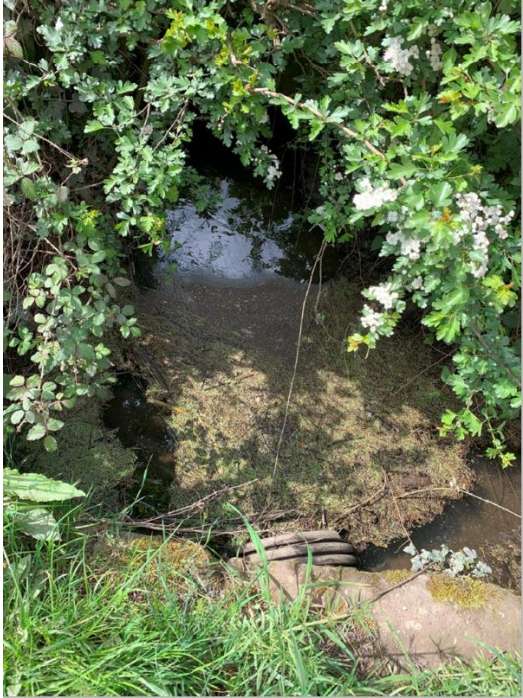
| <b>Photo No. 12</b> | <b>15923 – Broad Oak Farm, Rossett</b> |

| <b>Description:</b><br><br>Llyndir Lane Culvert Inlet. | |

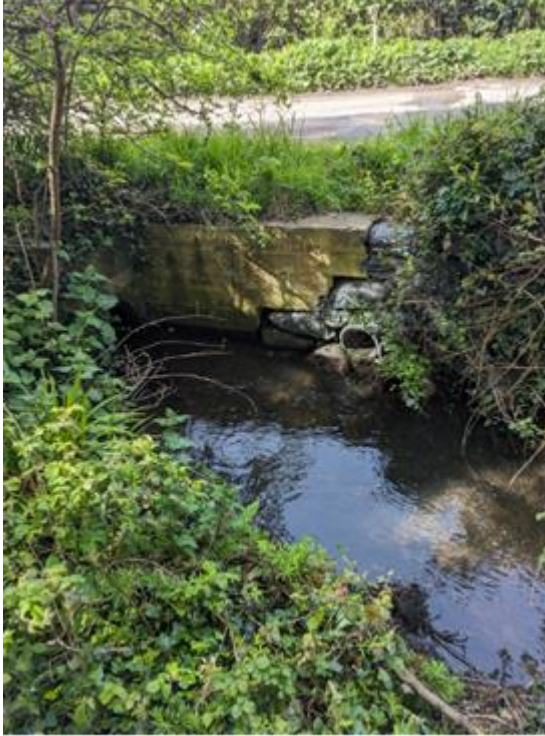
| Photo No.13 | 15923 – Broad Oak Farm, Rossett | |

| Description:<br><br>Watercourse and Llyndir Lane culvert outlet. | | |

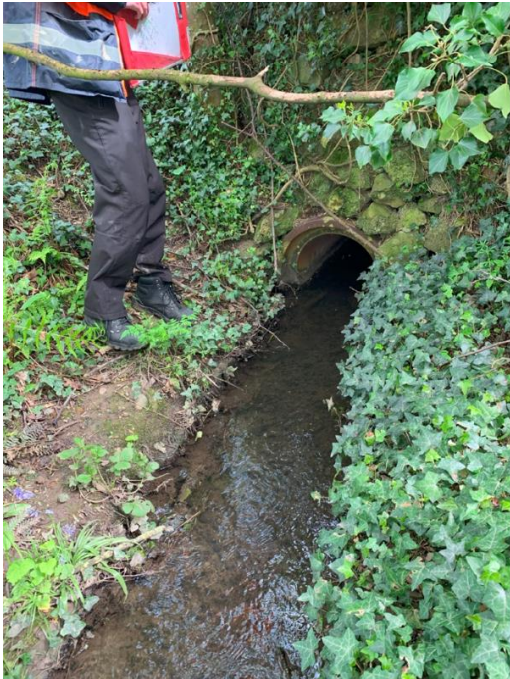
| Photo No. 14 | 15923 – Broad Oak Farm, Rossett | |

| Description:<br><br>Culvert inlet on the unnamed watercourse flowing adjacent to the site at approx NGR: 336706 , 358536. | | |

It is recommended that an alternative discharge method is used, such as discharge to the unnamed watercourse along the northern boundary of the site.
