## Chirk Railing Replacement – Heritage Impact Assessment

This assessment has been prepared to support an application for planning permission and demolition in a conservation area in relation to replacing the existing steel railings on the brow of Chirk Tunnel and along path towards Chirk Aqueduct within the Chirk Conservation Area.

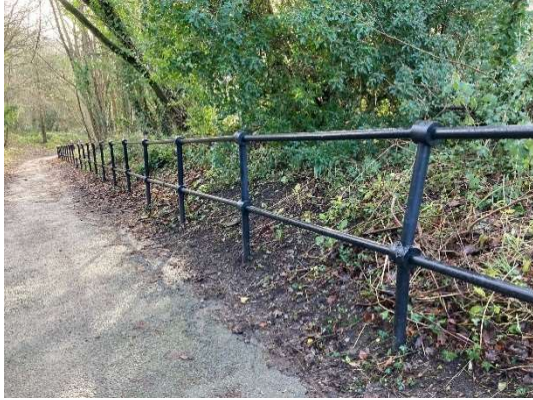
*Figure 1: Example of the existing railing*

The proposed replacement railings have been designed to improve the existing railings (see Figure 1), which have deteriorated over time and are failing in some areas (see Figure 2), as well as the wider public realm. The railings were originally installed in 2007 (by the Canal & River Trust in partnership with Wrexham County Borough Council) before the development of the World Heritage Site, following inscription in 2009.

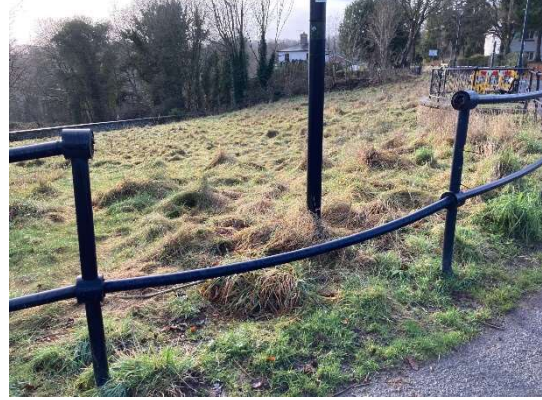
*Figure 2: Example of failed elements*

Vertical railings will be installed to the viewing area, similar in height and appearance to those which they replace. A new vehicular access gate will be installed where there is currently a failed section of railing.

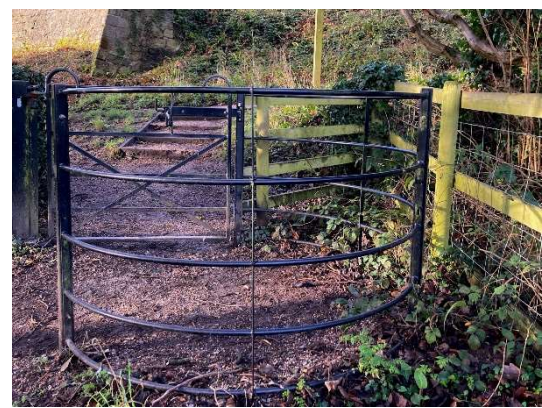
*Figure 4: Example of proposed estate type railing.*

The majority of the new railings will reflect other 'estate style' railing installations within the broader World Heritage Site, such as at Trevor and Llantysilio (see kissing gate example in Figure 4).
