# ARBORICULTURAL METHOD STATEMENT

Bersham Colliery,  
Wrexham

[1650-AMS-V1]

Bersham (Glenside) Ltd.

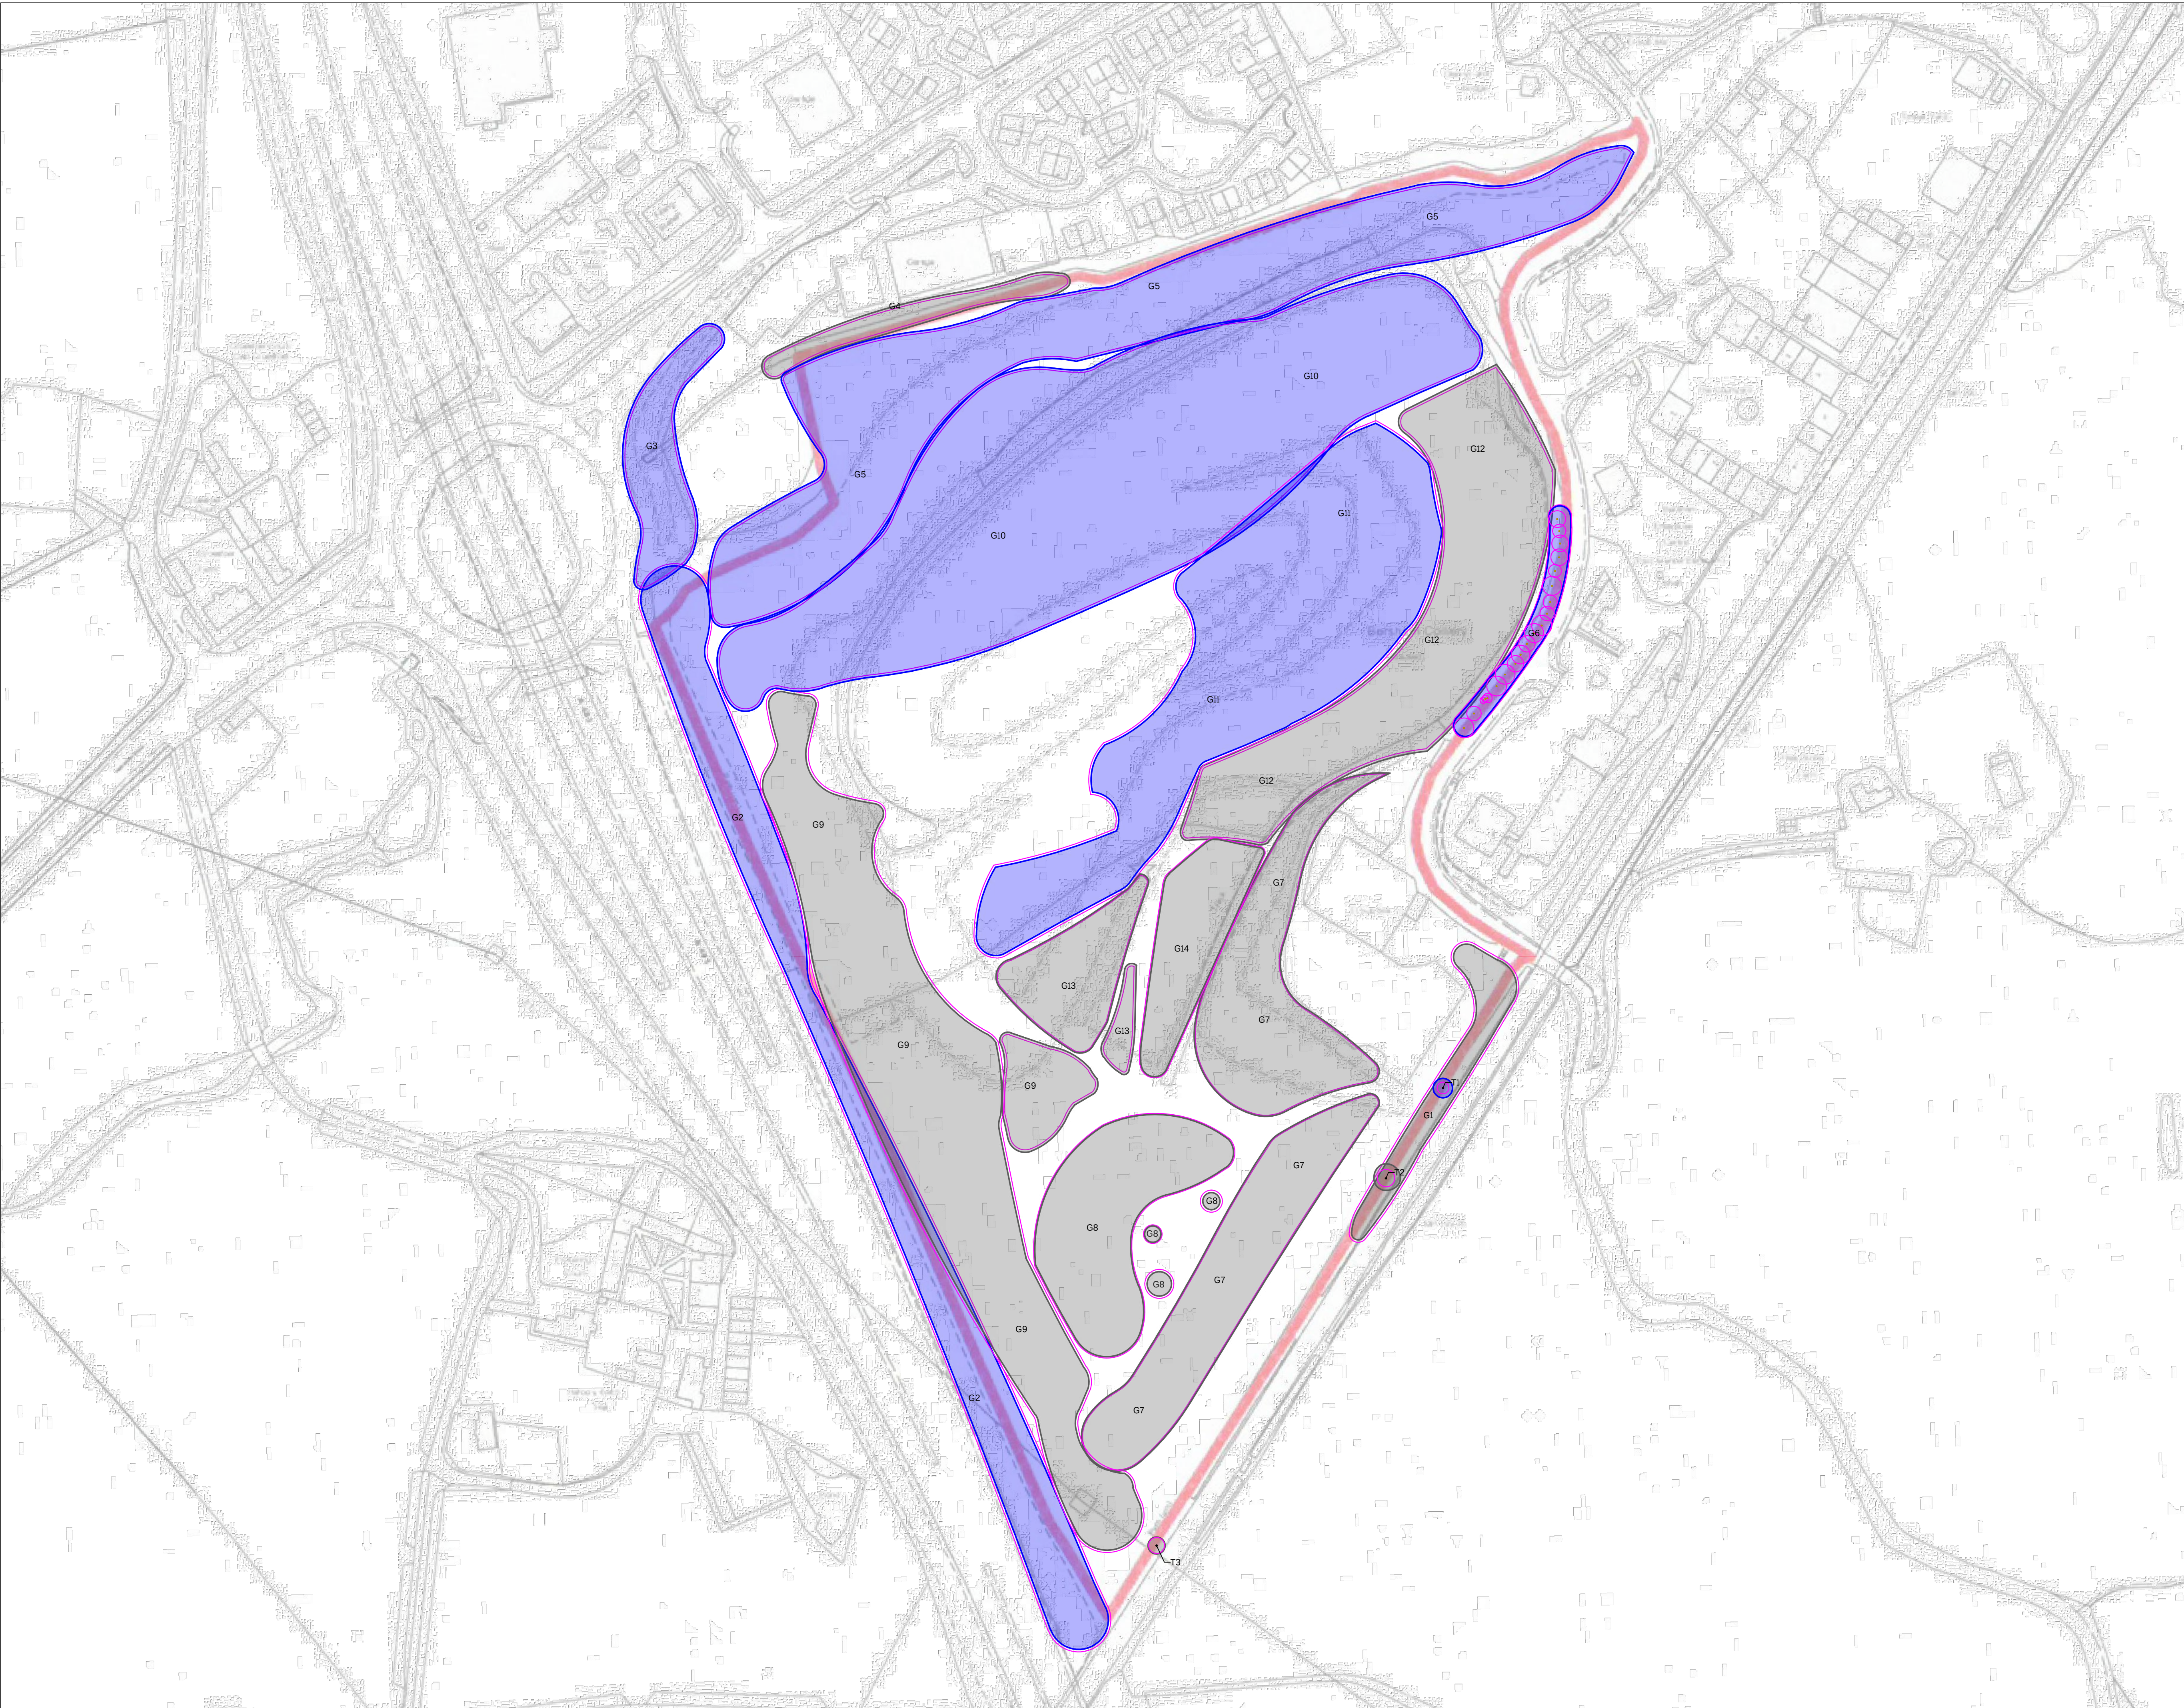
TITLE  
Tree Constraints Plan

NOTES:  
Tree locations are estimated from measurements on-site. No  
topographical survey available at the time of tree survey.

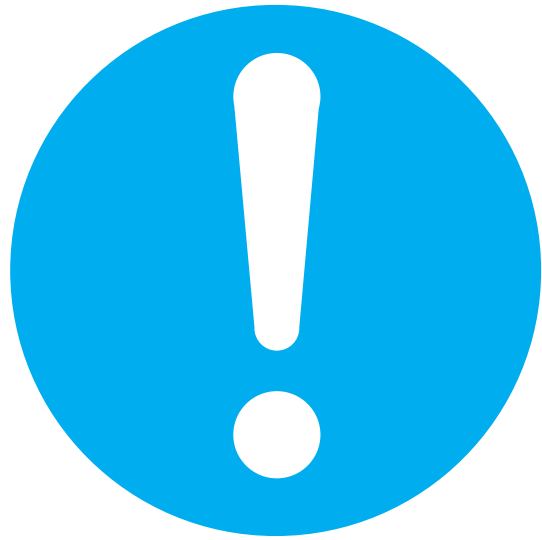
# TREE PROTECTION AREA

## NO ACCESS - TREE PROTECTION AREA

- NO MATERIALS, MACHINERY, TEMPORARY STRUCTURES OR CHEMICALS SHALL ENTER OR BE STORED WITHIN THIS AREA
- FENCING WILL NOT BE ALTERED OR MOVED WITHOUT PRIOR AGREEMENT OF THE PROJECT ARBORICULTURIST.

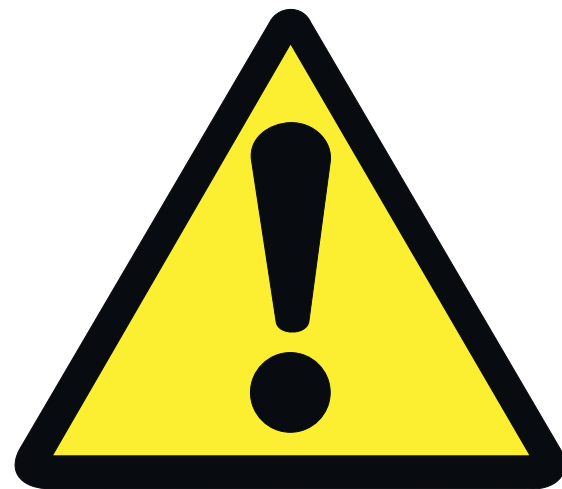
## TREE PROTECTION FENCING

- TREES ENCLOSED BY THIS FENCE ARE PROTECTED BY PLANNING CONDITIONS AND/OR ARE THE SUBJECTS OF A TREE PRESERVATION ORDER.
- UNAUTHORISED DAMAGE TO PROTECTED TREES IS A CRIMINAL OFFENCE AND COULD LEAD TO ENFORCEMENT ACTION.
