# PLAS GRONO, ERDDIG:

## BAT MITIGATION AND CONSERVATION PLAN

Report Ref EE.756.22.1.KW

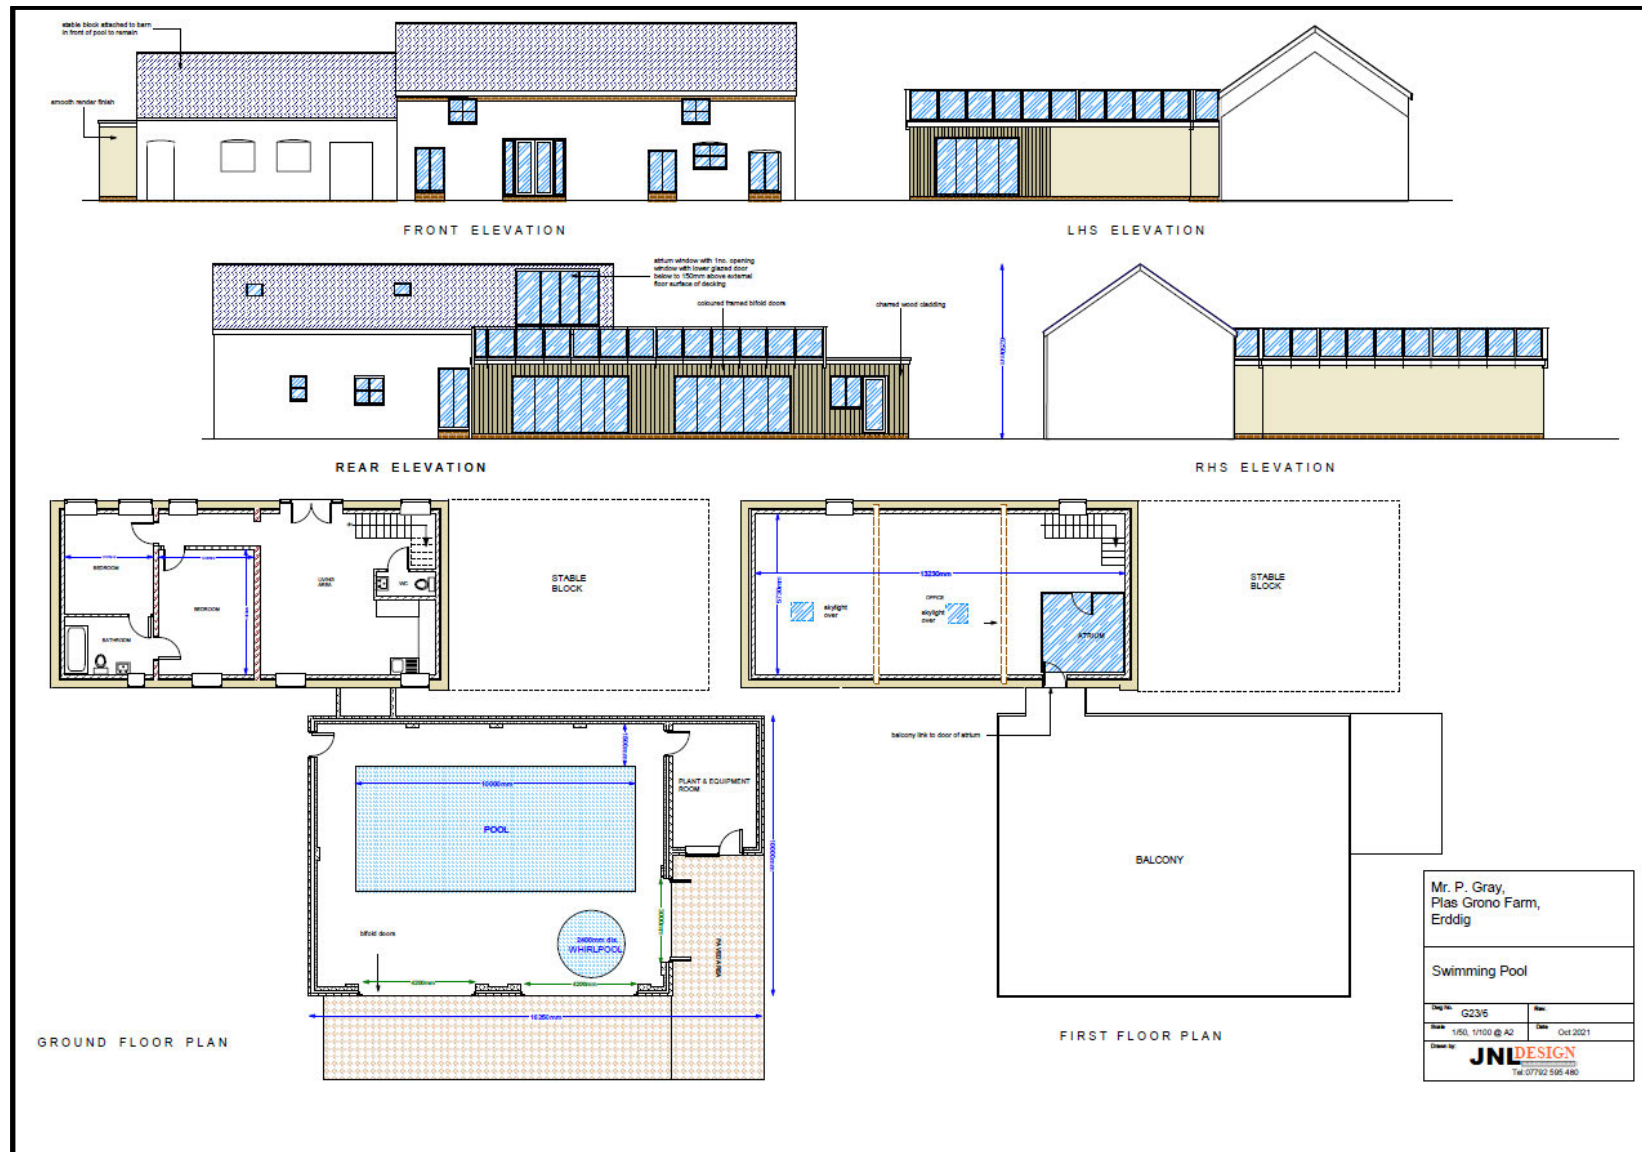
FIGURE 1.2: PROPOSED ELEVATIONS AND FLOOR PLANS OF SWIMMING POOL BUILDING. BASE IMAGE ©JNL DESIGN

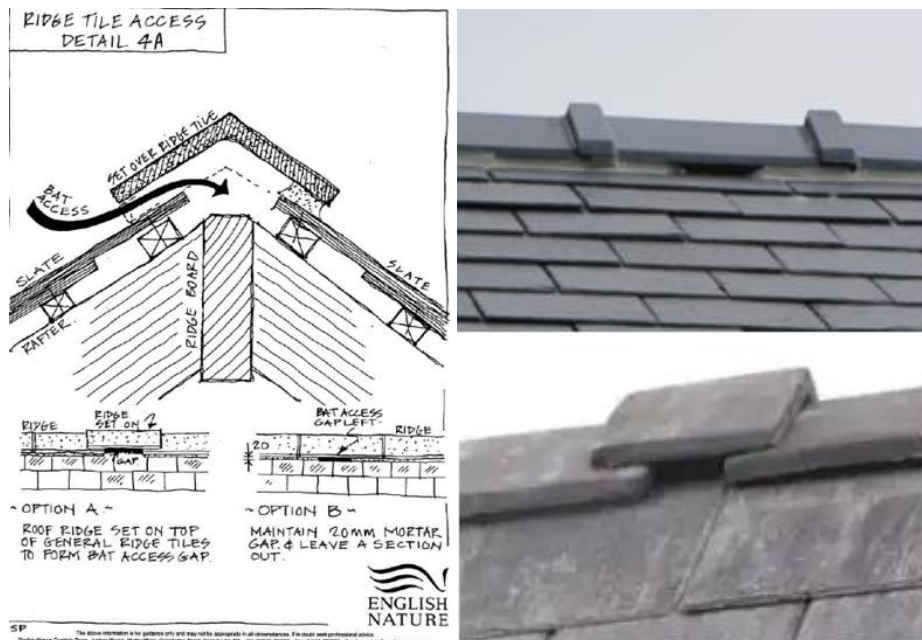
**FIGURE 2.4: EXAMPLE OF RAISED RIDGE TILE ACCESS**

- The roof of the converted barn building will be lined with a non-breathable membrane and three access slates (Figure 2.3) and two raised ridge tiles (Figure 2.4) will be installed to provide roosting opportunities for crevice dwelling bats between the tiles and the felt.
- Two woodstone bat boxes; one Beaumaris bat box and one multi-cavity bat box; will be erected onto the western gable end of the converted barn, as close to the apex as possible, approx. 1m apart.

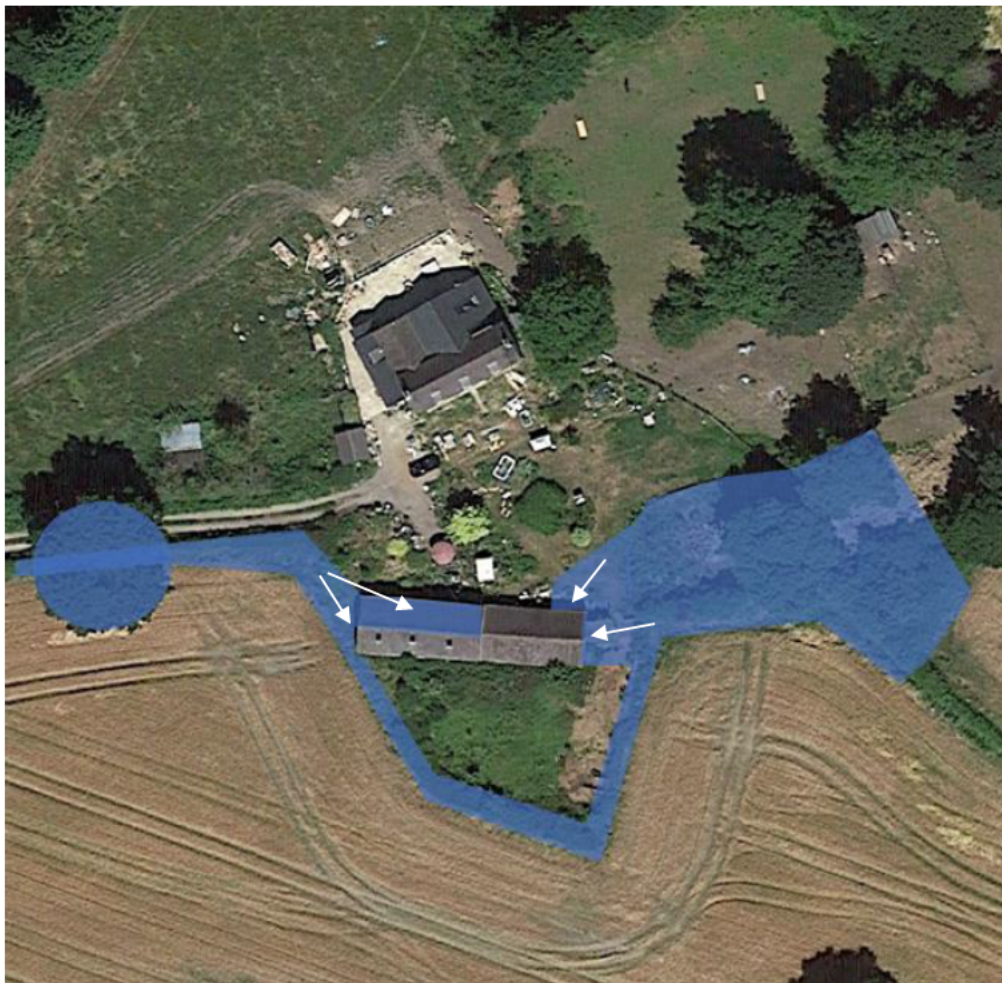
**FIGURE 2.6 – PROPOSED SITE PLAN SHOWING DARK BUFFER ZONE (BLUE) FROM THE MITIGATION ACCESS POINTS (WHITE ARROWS) AND THE SURROUNDING FORAGING HABITAT (NOT TO SCALE)**

- There must be no lights focused on the pond or any of the surrounding hedgerows (including the proposed planting) and mature trees within the site, during or after the works. There will be a dark 'buffer zone' from the western and eastern gable ends of converted barn and stable block respectively, following the boundary vegetation, that will not be subject to light spillage (Figure 2.6). There will be no illumination of the recommended bat mitigation, bat access points and bat boxes once the works are complete.
