## **Preliminary Roost Assessment and Survey for Evidence of Nesting Wild Birds**

**at Tower View, Alma Road, Froncysyllte, LL20 7PY**

**March 2024**

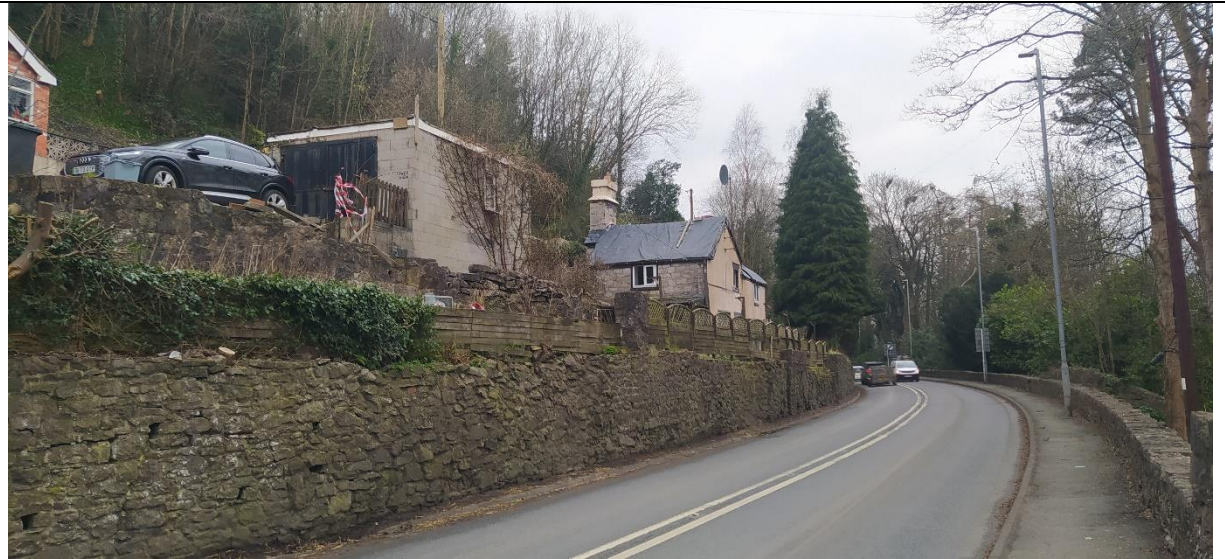
This is built of blocks with large timber doors. The roof is flat and felted. There are negligible opportunities for roosting on the outside of the garage and no evidence of bats was seen on its outside at the time of survey. See photos 1 and 9.

Photo 1 – shows the east and north-facing elevation of the garage and the dwelling

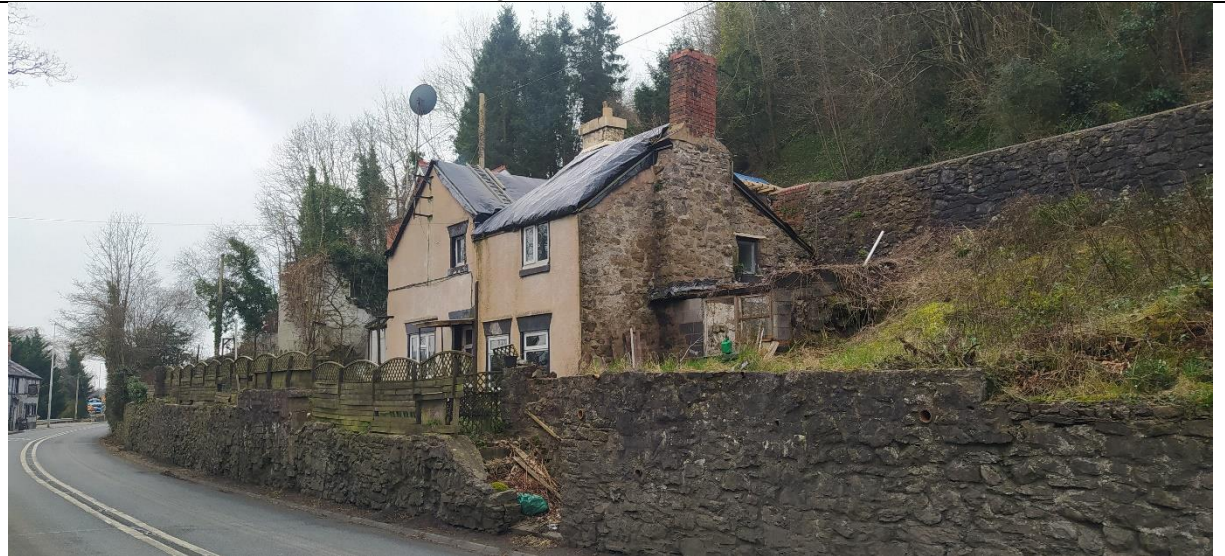
The two-storey detached dwelling is primarily built of stone with some aspects fully rendered. It has two double pitched rooves, one with an east-west aspect, the other with a north-south aspect. Both are slated, but both have also been covered in plastic tarpaulins, tightly sealed with batons to the walls. It is understood that these tarpaulins have been in place for some time, estimated as since 2010. Two chimneys are also present, one brick, one stone - some of which is rendered. See photos 1 to 4.

Photo 2 – shows the west and north-facing elevations of the dwelling

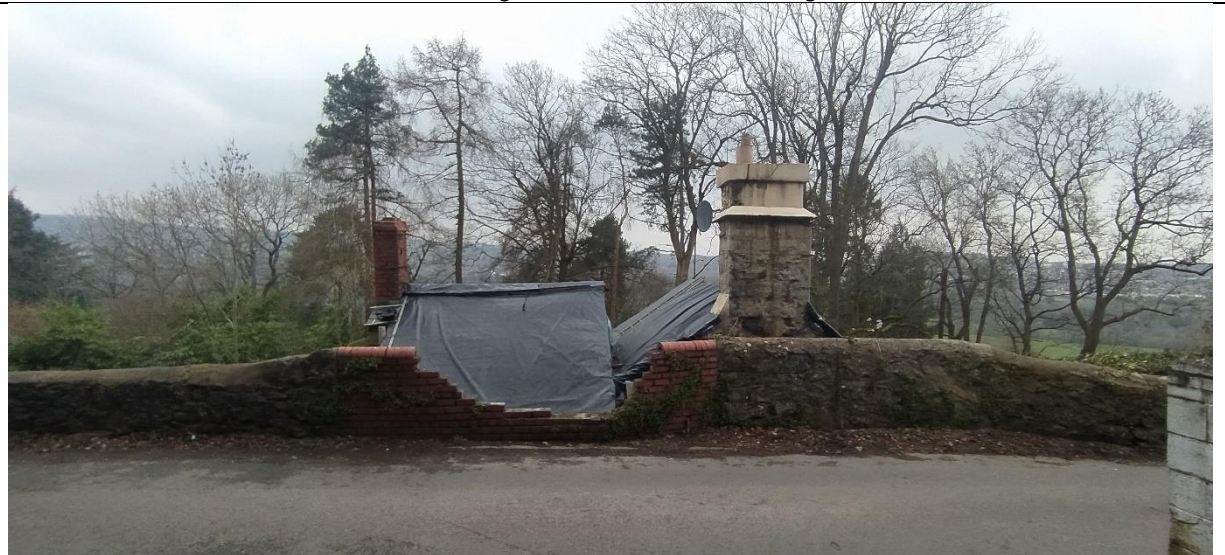
Photo 3 – shows south-facing roof of the dwelling

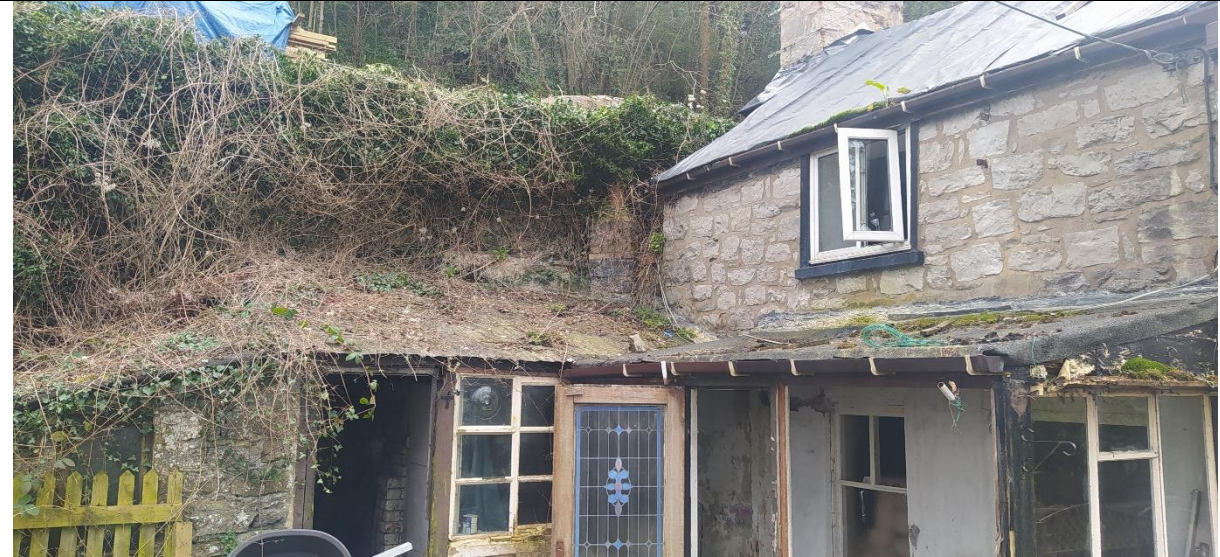
The east-facing aspect has an L shaped single storey lean to that is built of stone, brick, timber and glazing with single pitch corrugated onduline type material and corrugated galvanised steel roofing, some of which has also been felted. See photos 4, 7 and 8.

Photo 4 – shows the east-facing elevation of the dwelling with the lean-tos

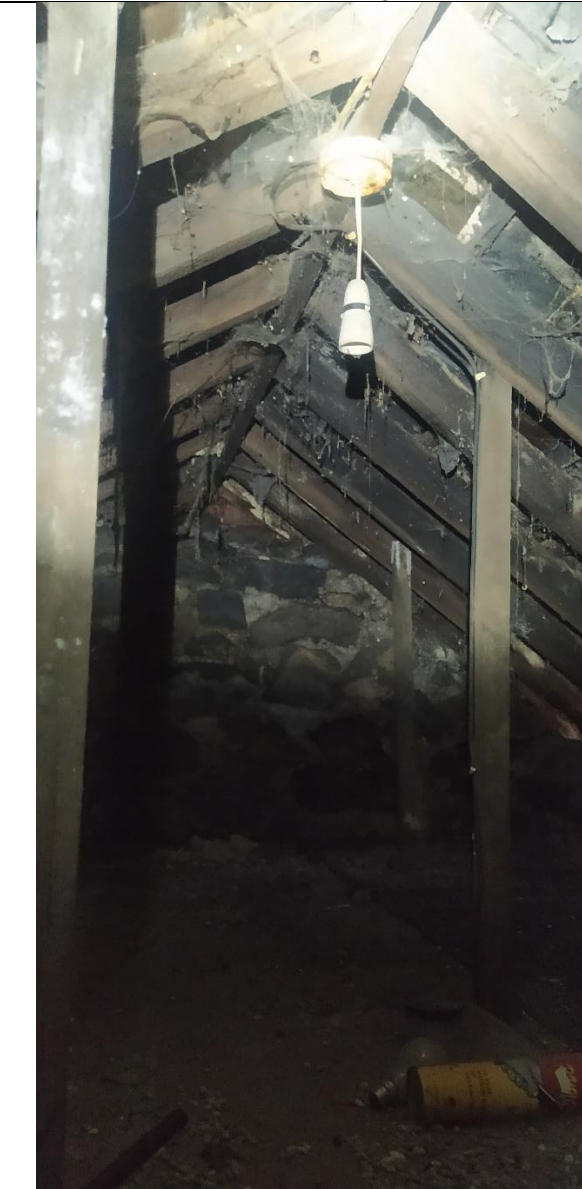
Internally, the two loft spaces are 'cobwebby', showing no recent passage by flying bats has occurred. Below the slates there is no membrane. There was no visible light ingress. No evidence of bats was seen in the roof void at the time of survey. Given the good access for survey, lack of membrane, and the clear views of the ceiling tops, any bat droppings would have been very visible, had they been present. See photos 5 and 6.

Photo 5 – shows one of the two 'cobwebby' roof voids

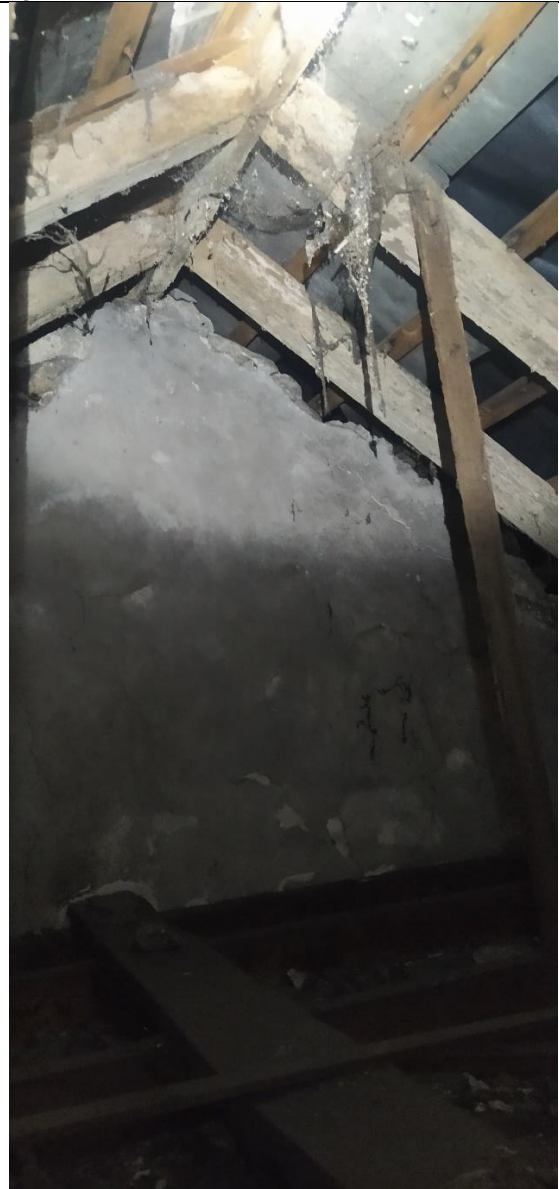
Photo 6 – shows the second 'cobwebby' roof void

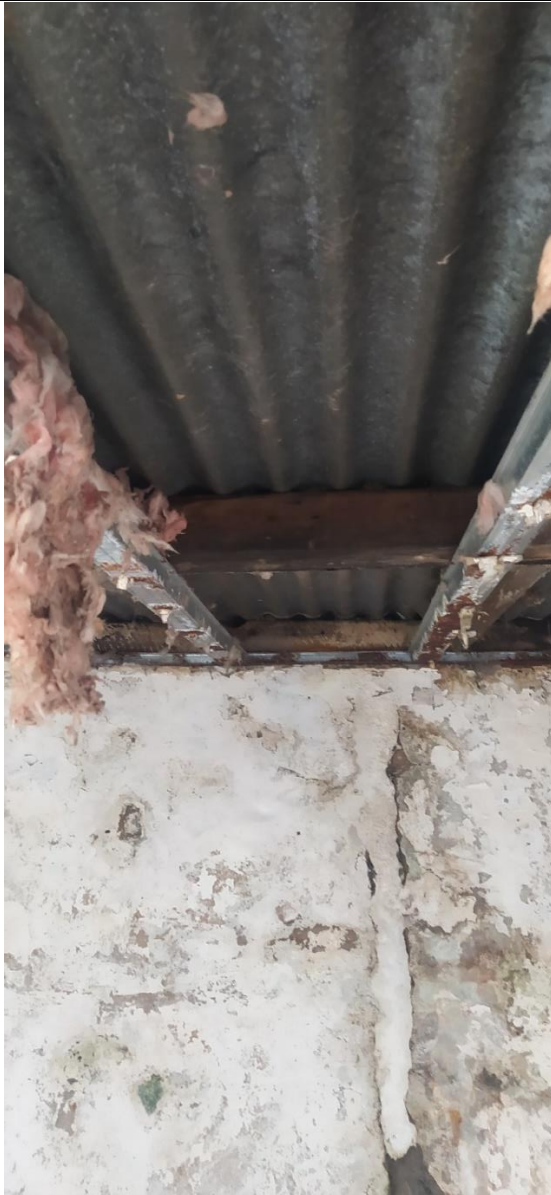
Photo 7 – shows the corrugated 'onduline' like material roof of part of the lean to

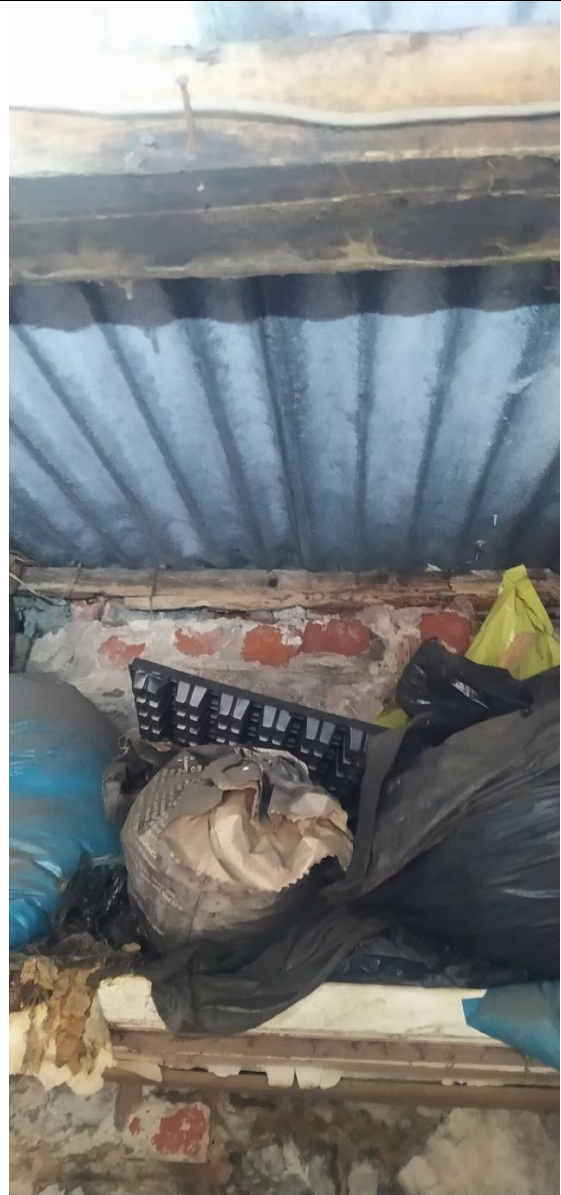
Photo 8 – shows the corrugated galvanised steel roof of part of the lean to

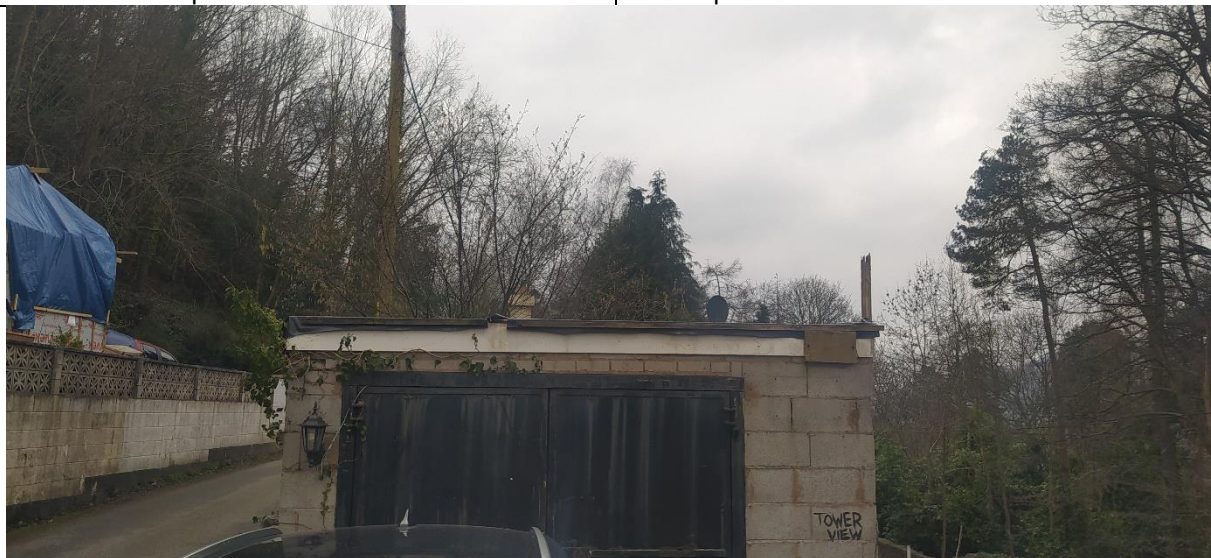
Internally, there is no loft space. The only possible ingress was a gap that was so tightly filled with vegetation that ingress was considered highly unlikely. No evidence of bats was seen inside the garage at the time of survey. Given the good access for survey any bat droppings would have been very visible, had they been present.

Photo 9 shows the detached garage
