## **Template Method Statement to be used within a Bat Development Licence Application**

| <b>Method Statement Title:</b> | EE.4446.LMS.24.JF - Silverdale Method Statement |
| <b>Site Address:</b> | Silverdale, Tainant, Penycae, Wrexham, LL14 1UG |

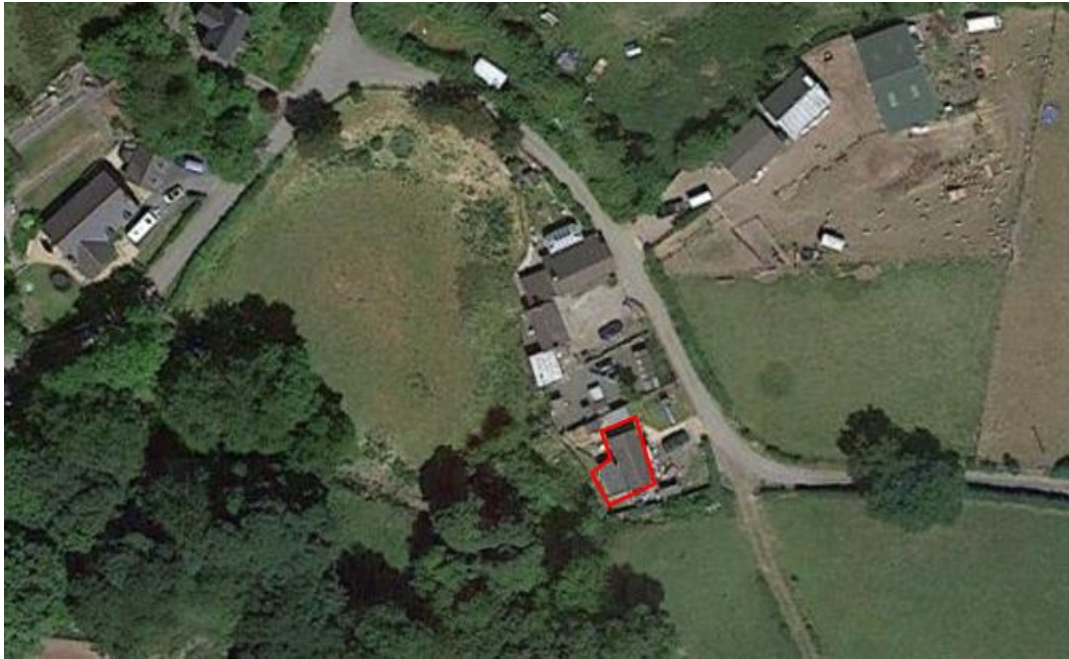
**Figure C.5.1: The site and surveyed building (red)**

The site was located within a rural area, approximately 1.7km to the south west of Rhosllanerchrugog, Wrexham. The wider area comprised pastoral fields and hedgerows and a wooded valley with Nant Crogfryn running through, this was adjacent to the property and ran a total of 2km from the north west to Stryt Issa to the south east. The survey area is shown in Figure C.5.1.

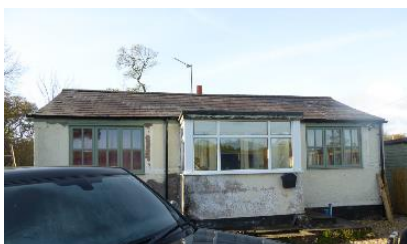
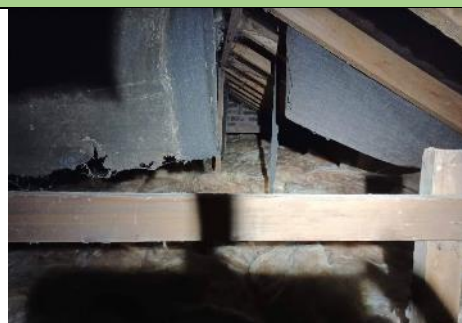
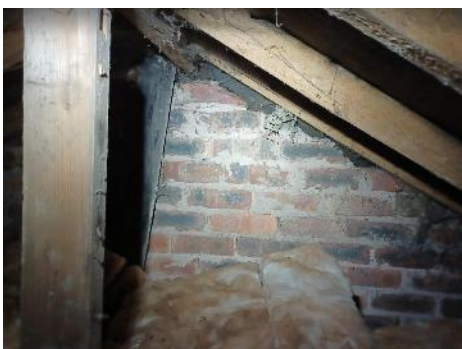
| Bungalow | | | |
|---|---|---|---|
| <p>The building was approximately 8 x 5 m (main section) and 3 x 5 m for the western flat roofed section.</p> <p>The walls of the building are brick and rendered. There are wooden fascias running along all sections of the building, apart from the gable ends (no bargeboards).</p> <p>The roof of the main section was a pitched slate roof.</p> | <p><b>Eastern Elevation</b></p> | <p>Internally there was a small loft space running the length of the main section of the building, this was insulated with rockwool. The loft was approximately 1.2 m in height.</p> <p>The roof was lined with bitumen felt, there were exposed brick walls at both gable ends.</p> <p>The loft space was subject to some air flow due to gaps present in the slates and torn bitumen felt.</p> | <br> |

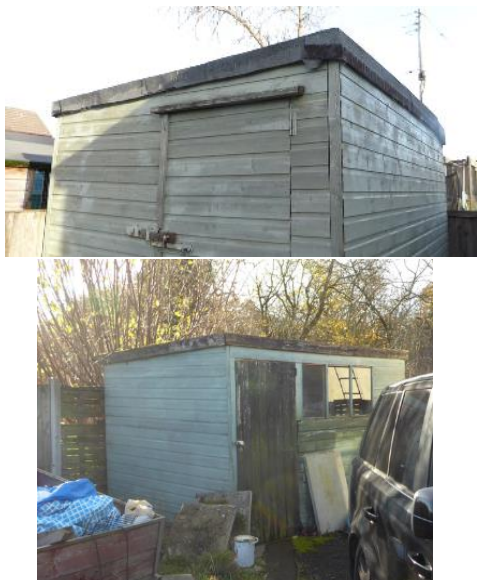
| Bungalow | | | |
|---|---|---|---|
| <p>Two sheds were present on site, these were traditional timber sheds with flat bitumen felt roofs. The shed to the east of the property had windows present and was used for storage; the shed to the north had no windows present.</p> | | <p>N/A – The sheds were locked and not accessible</p> | <p>N/A</p> |

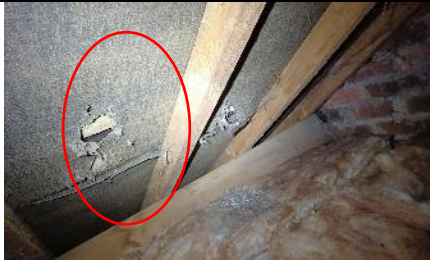
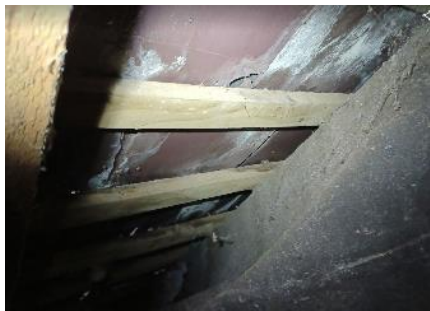
| Location | Feature Description | Example Photos |
|---|---|---|
| Loft - Internal | Ripped bitumen felt with exposed slates behind | |

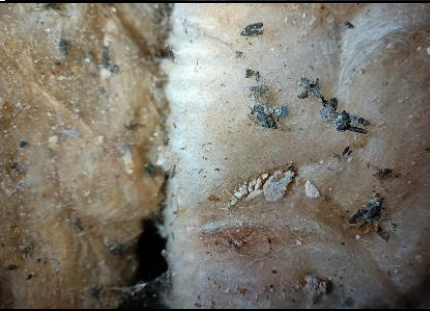
| Location | Feature Description | Example Photos |
|---|---|---|
| Loft Internal | Droppings | |

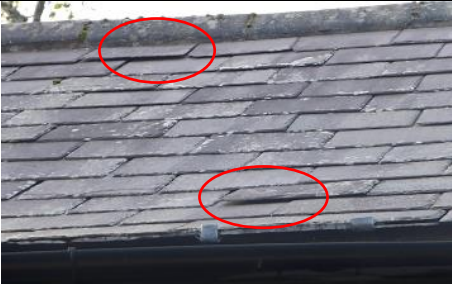
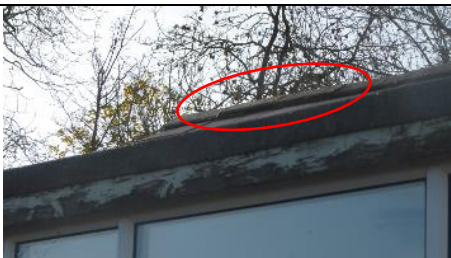
| Location | Feature Description | Example Photos |
|---|---|---|
| A | Small gaps present under ridge tiles and some raised slates | |

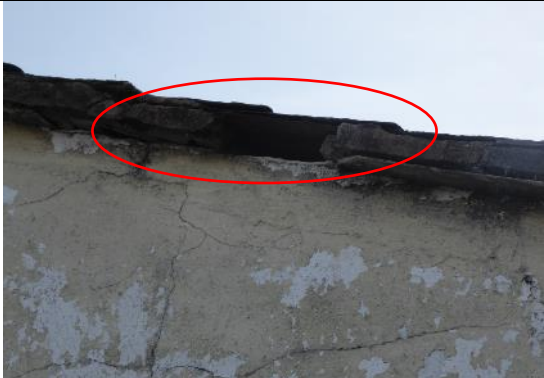
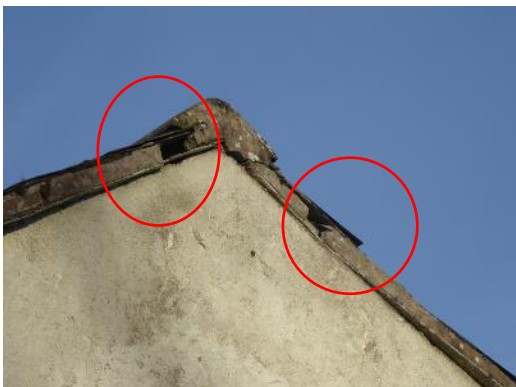
| B | Missing mortar from end of the gable | |

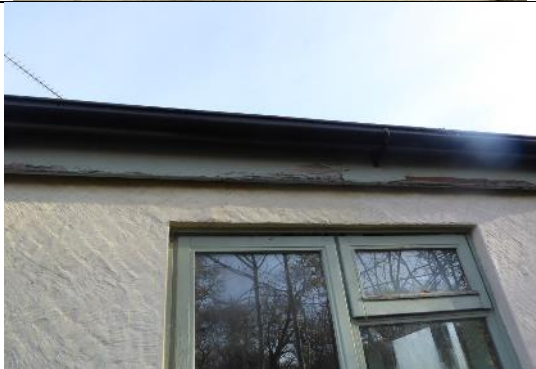
| C | Gaps behind the fascias | |

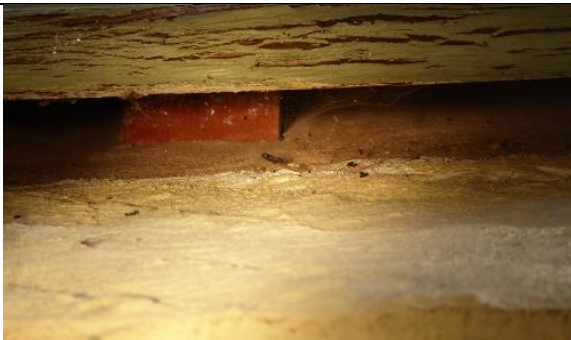
| C | Behind the fascia | |

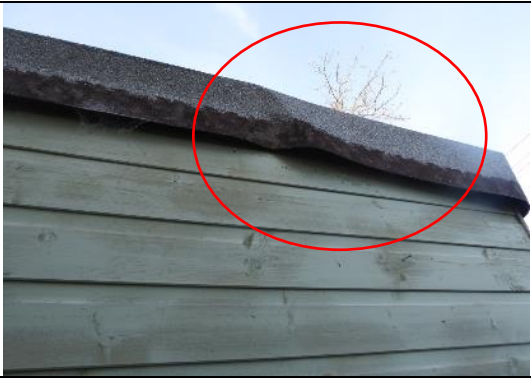
| Sheds | Gaps behind felt | |

The sheds were not accessible during the PRA, and as they had low potential to support bats they have been included on the licence.

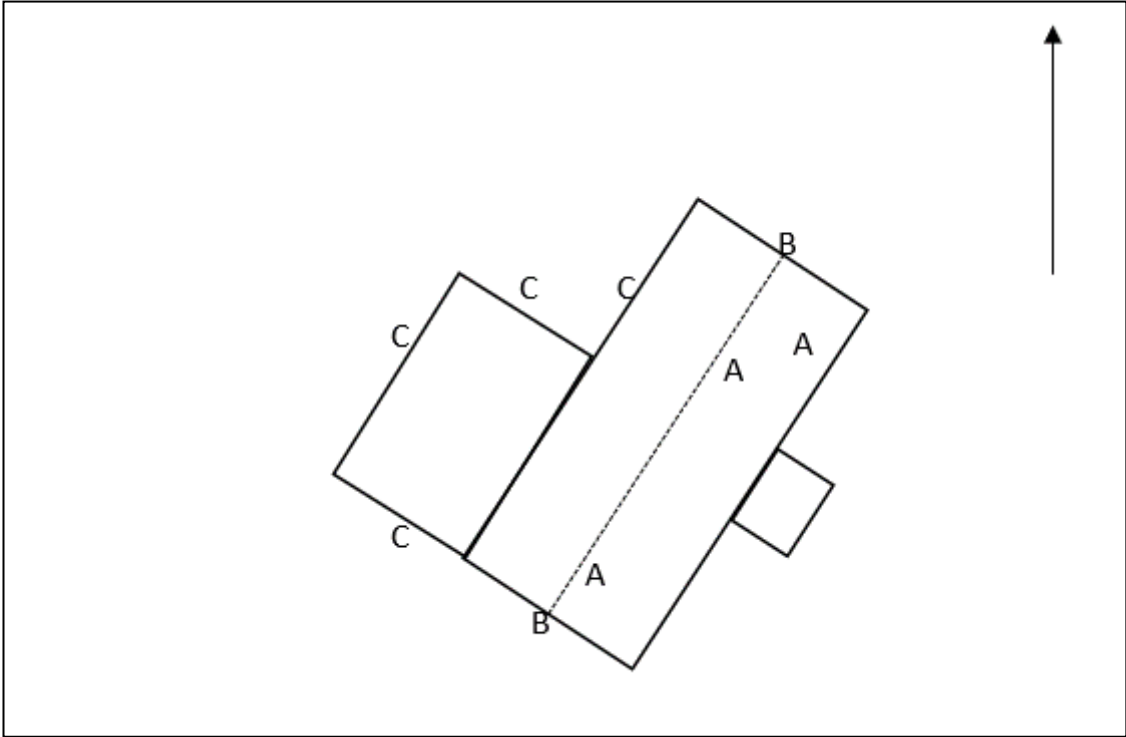
Figure C.7.1 – Location of features identified in Table C.7.1 above.

The PRA identified a number of potential roosting features (PRFs) which would provide bats with roosting areas and access into building. In addition to the PRFs, bat droppings were found beneath the south-western fascia and in the loft space. From the evidence found, and the number of bat droppings present, it is considered that the building is in use by a small number of bats. The bat droppings were sent away for DNA analysis and the results show that they were soprano pipistrelle (*Pipistrellus pygmaeus*) – this was the case for both the samples from within the loft and behind the fascia. The sheds on site offered limited roosting opportunities for bats. These are described in Table C.7.1 and the location in relation to the site are shown in Figure C.7.1. Additionally, the updated PRA found the situation on site was basically the same, with the addition of another bat dropping beneath the fascia on the south-western elevation. The results are described in Table C.7.2.

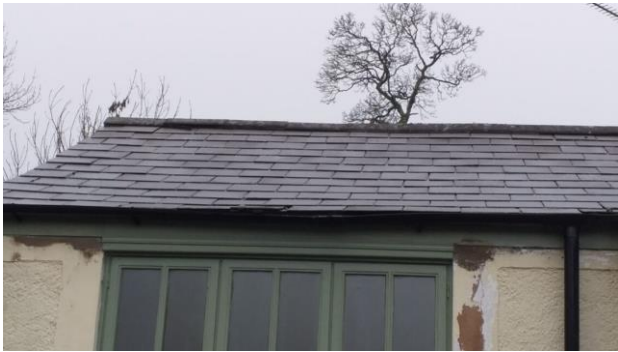
| Location | Feature Description | Example photos |
|---|---|---|
| A | Small gaps present under ridge tiles and some raised slates. | |

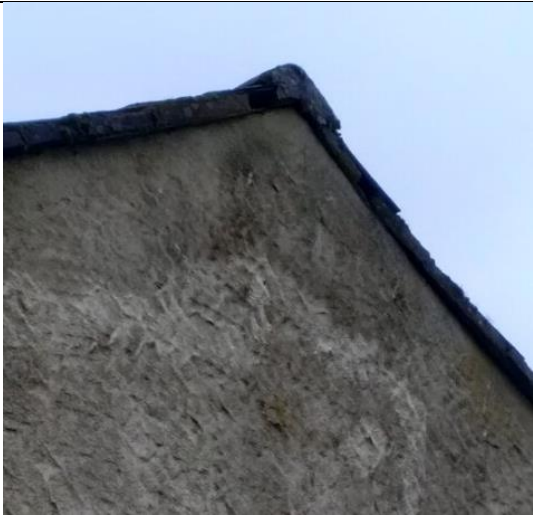
| B | Missing mortar from end of the gable | |

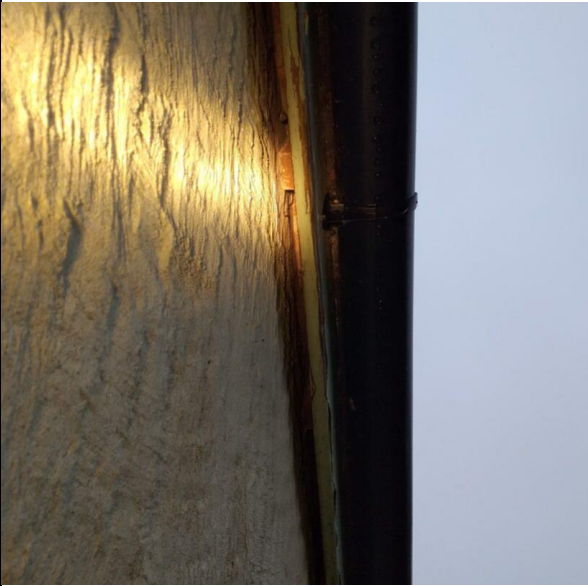
| C | Gaps behind the fascias. | |

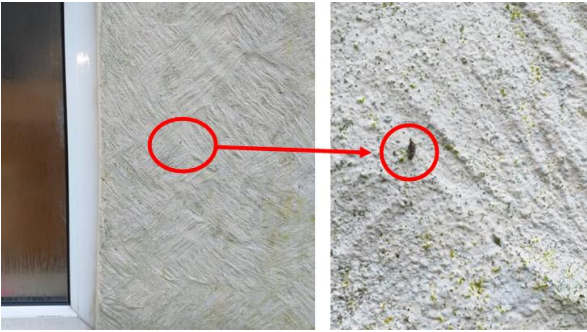
| C | Dropping underneath the south-western fascia. | |

The updated PRA found droppings in a new location to the previous PRA. The dropping was characteristic of pipistrelle bat, so either species should be presumed to be using the site. This suggests that bats are using numerous potential roosting features and access points around the building on an occasional basis.

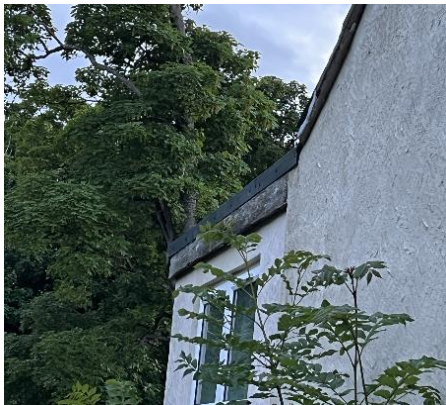
| Time | Species | Activity | Emerge? | Location |
|---|---|---|---|---|
| 21:25 | Soprano pipistrelle | <p>Emergued from under the fascia board of the flat roofed section on the south west elevation where droppings had previously been found.</p> <p>An Anabat placed close by confirmed it was a soprano pipistrelle. It flew directly into the woodland to the south west.</p> | Yes | |

Soprano pipistrelle droppings had previously been found under the fascia board and inside the loft space. Closer inspection under the fascia board where the bat emerged show a small gap at the top of the wall where the bat was most likely gaining access under the flat roof. Silverdale was therefore used by at least one soprano pipistrelle as a day roost and the main loft space has been used by soprano pipistrelle bats in the past, based on the droppings present.

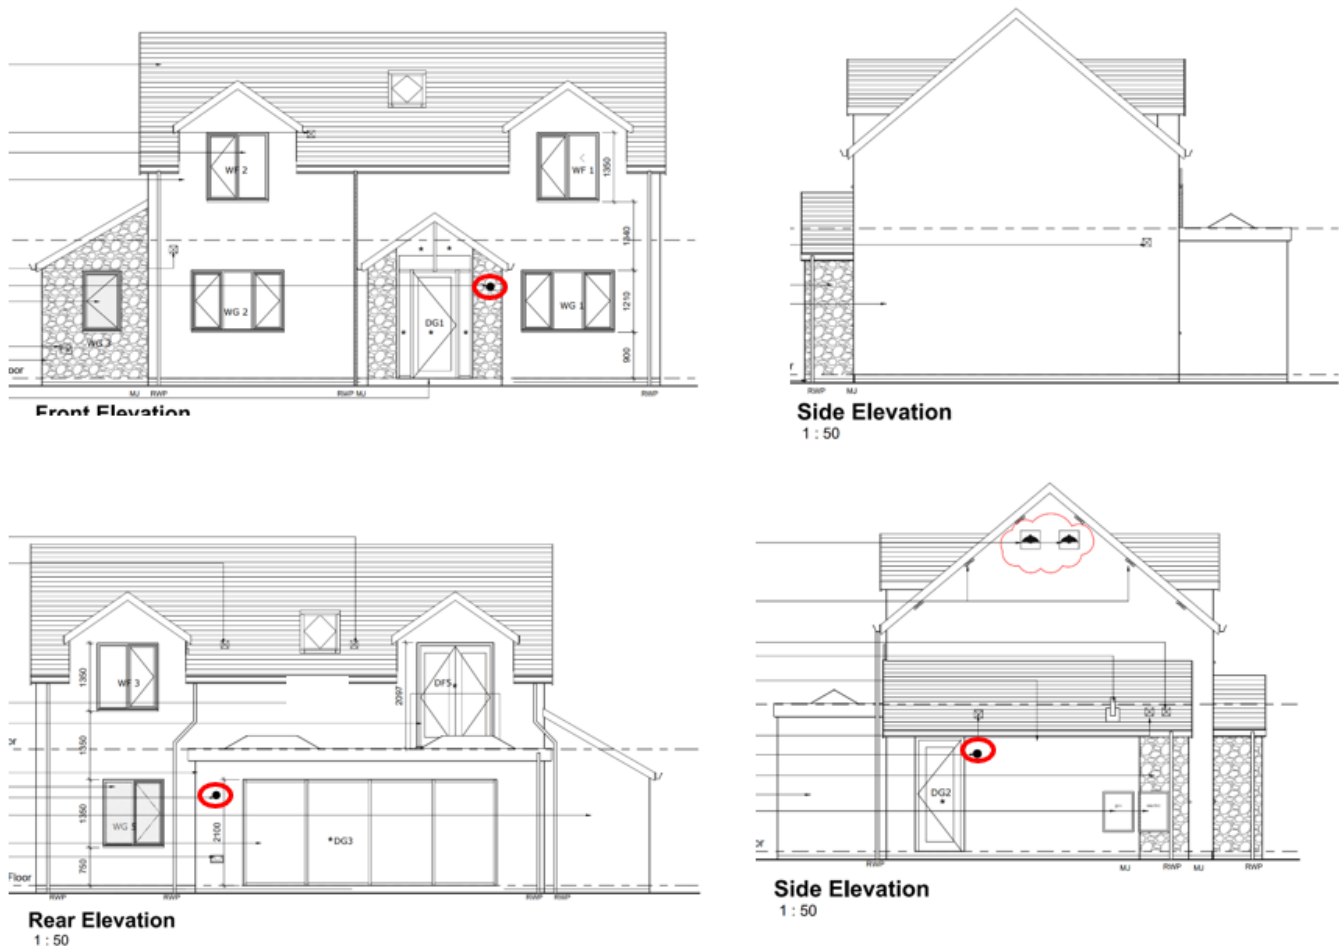
**Figure D.5.1: Locations of the external lights (red circles), and the proposed bat compensation and enhancements (red cloud and barge boards)**

- There will be no lights focused on any surrounding trees or hedgerows, or the mitigation bat roosting areas. There will be a dark 'buffer zone' to south and south west of the site that will not be subject to light spillage. There will be no illumination of the recommended bat mitigation once the works are complete.

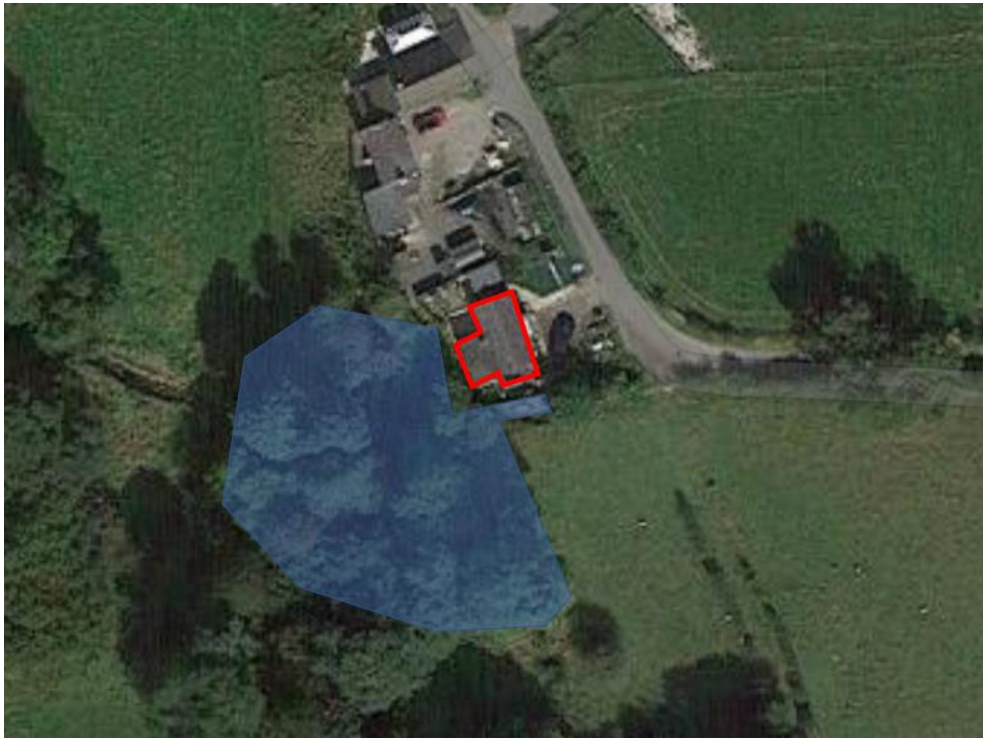
**Figure D.5.2: Habitat that will not be illuminated (blue area)**

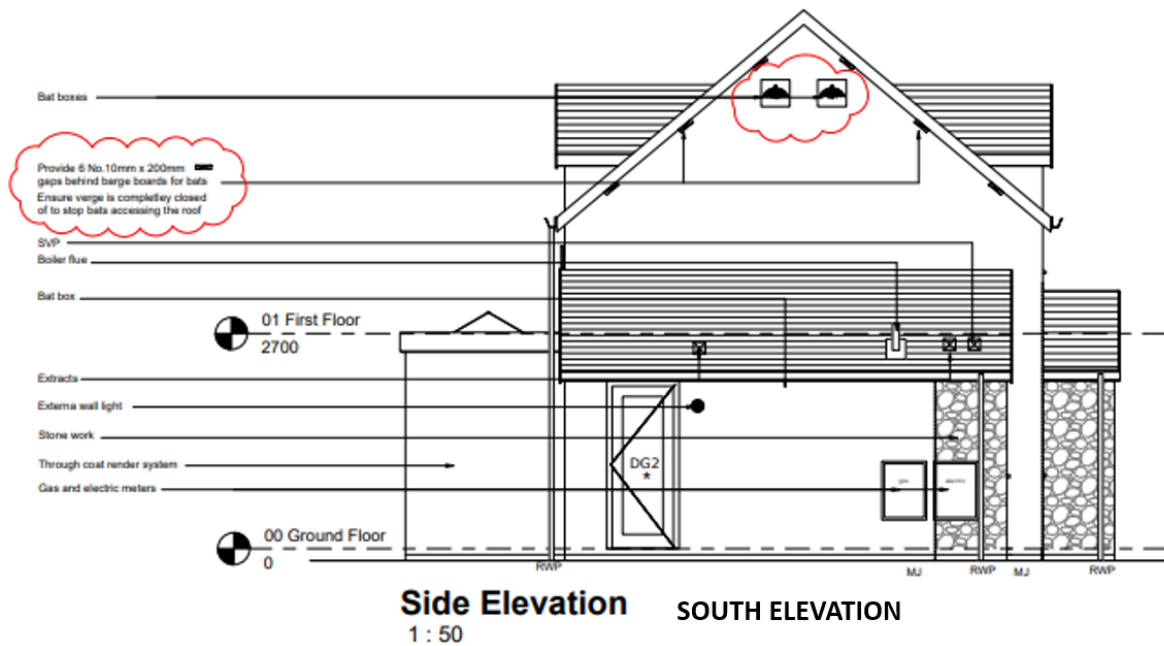
**Figure E.2.1: Locations of the bat boxes (red clouds) and the barge board gaps (black rectangles) upon completion of the works**

Three bat boxes have been incorporated into the design of the site. The boxes utilised in the building's design will comprise two built-in bat boxes, similar in form to Vivara Pro Build-in Woodstone Bat Tube, and one external bat box such as a Beaumaris style bat box. Many bat boxes are out of stock online at the time of writing, therefore, an ecologist will recommend suitable bat boxes to the client when they are required. Two of the boxes will be incorporated into the south facing elevation of the new building, and one will be sited on the western elevation/in the grounds of the site. This will provide bats with multiple roosting options depending on the conditions.

In addition to the bat boxes, crevices will be left between the bargeboards and the building on the southern elevation. Figure E.2.1 below shows the location of the bat boxes and the bargeboard roosting areas.
