## Template Method Statement to be used within a Bat Development Licence Application

| <b>Method Statement Title:</b> | Mulberry House, Burton |
| <b>Site Address:</b> | Mulberry House, Burton, Wrexham, Wrexham County Borough, LL12 0HU |

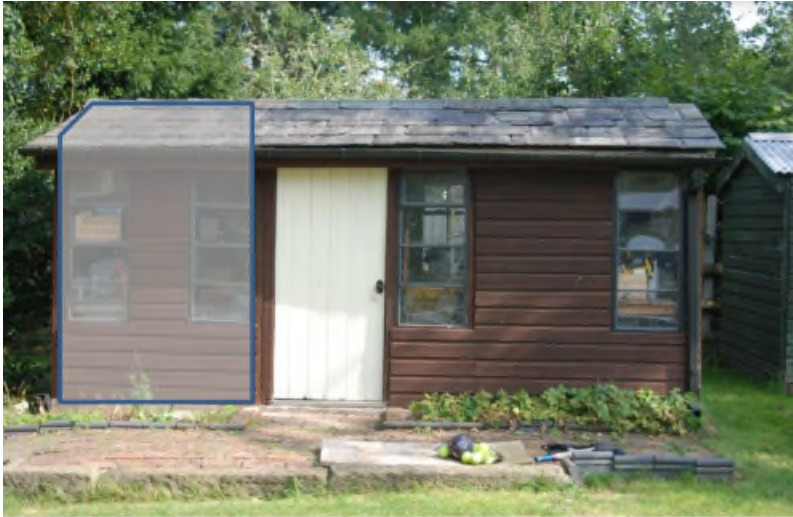
Fig. 4: Shed to be modified to provide roost

A section of the slate roofed shed in the garden (not included within the survey) can be designated and converted into a bat roost suitable for day roosting crevice dwelling bats and a BLE night roost/ feeding perch.

- An area will be partitioned from the rest of the shed (with a stud wall for example). This area should be at least 1.5m long, and the width and height of the shed.

- The windows will be blocked with black paint and then bordered with plywood.
- Batons and timbers removed from the roof removal of the building proposed for works will be installed into the bat loft as additional ridge beams and purlins to provide recognisable and familiar roosting features.

- The bat loft will further be enhanced with a panel box that will be inserted onto the northern gable end within the bat loft. This will comprise a plywood board fitted to 1inch x 1inch timbers with a gap on the underside only so bats can access the space from underneath.

- A rough sawn, untreated timber, double ridge beam should be installed, with rough timber planks placed along the ridge beam to provide roosting opportunities.

- The shed space should be left empty and not used as storage so as to allow free movement and flights of bats inside.
- Two bat access points will be created, these will be 100mm x 20mm slots cut as high as possible at the apex of the northern gable.

- An access hatch will be provided on the stud wall, at the opposite side to the panel box, measuring no more than 0.7m x 0.5m to allow access for monitoring purposes by licenced persons only

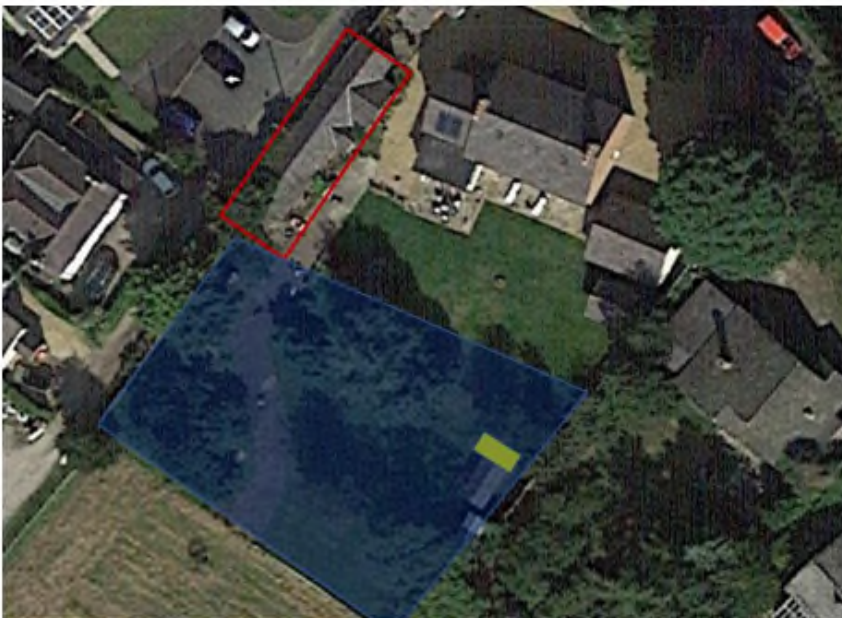
Fig.5: Shed proposed for mitigation roost (yellow) with dark buffer zone (blue) and building proposed for conversion (red)

- There must be no lights focused on the trees to the south of the site during or after the works. There will be no illumination of the recommended bat mitigation and bird boxes (see below) once the works are complete. There should be dark buffer zone across the southern section of the garden where the designated bat area will be created (Figure 5).
