## **PROTECTED SPECIES SURVEY**

**LAND OFF 21 HIGH STREET**

**JOHNSTOWN, WREXHAM**

**5<sup>th</sup> February 2024**

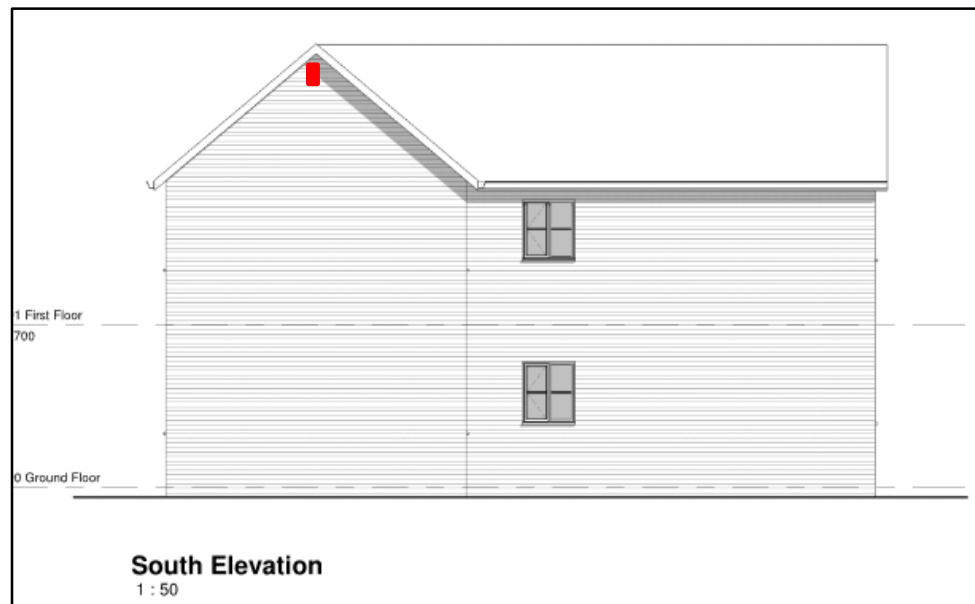
- A Vivara Pro build in woodstone bat tube will be built into the brickwork/render on the new, south facing elevation wall as shown below.

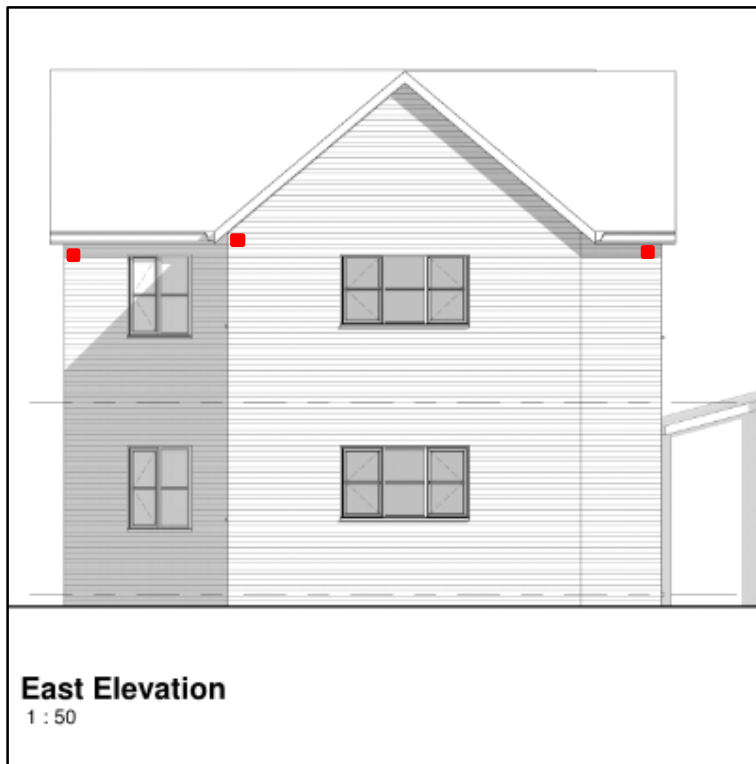
Three Schwegler Type 24 swift/multi-species boxes will be built into the brickwork/render on the east facing elevation as shown below.

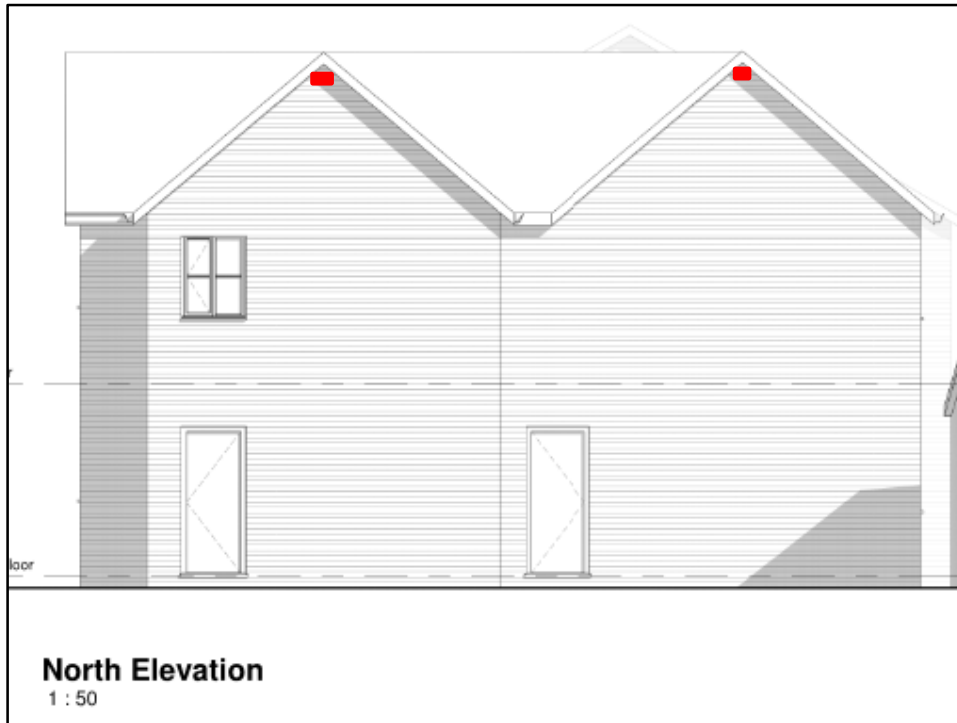
**Two Woodstone Madrid swift nest boxes (bottom entry) will be installed on the north facing elevation as shown below.**

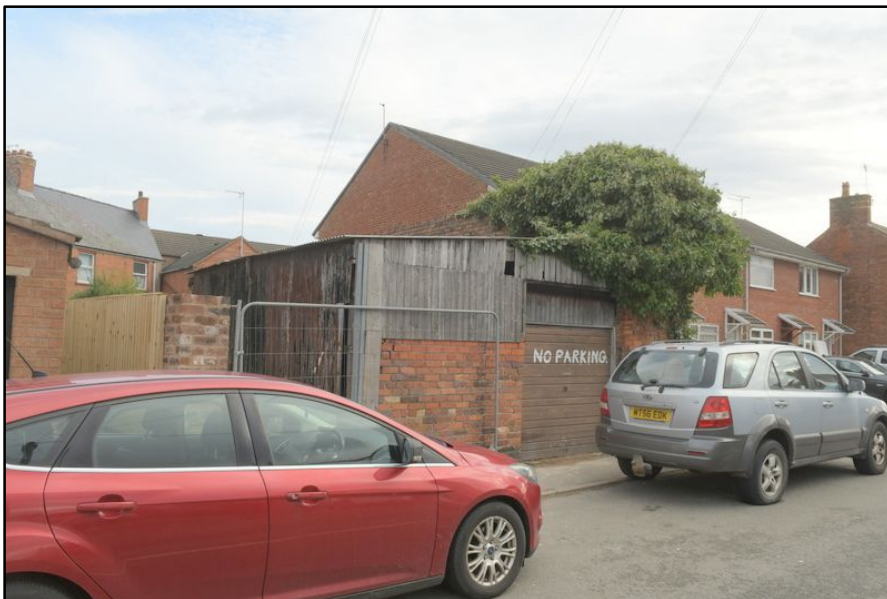
### View from the road to the front and side of the garage

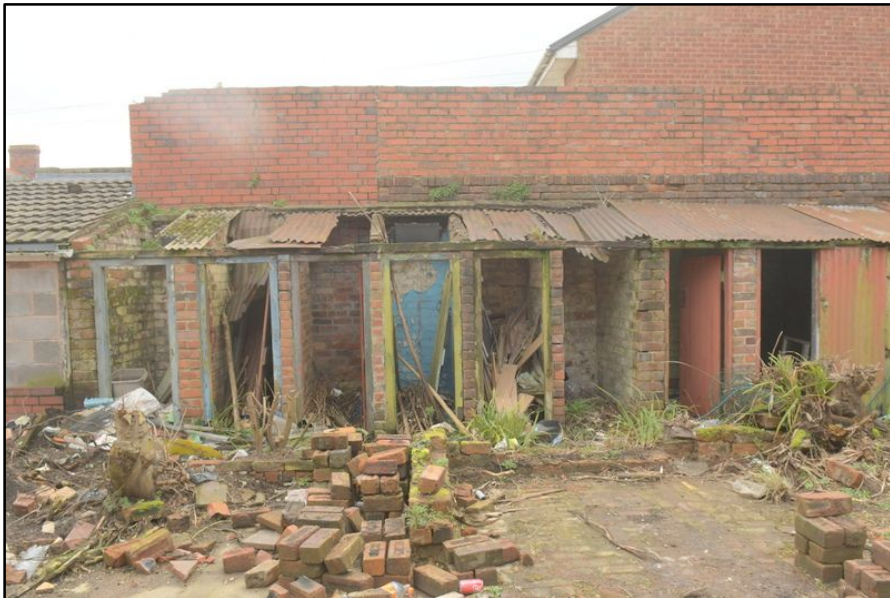
The row of single toilets at the rear were inspected and nothing was found, they are mostly derelict. Two of them still have a roof covering with an intact cistern but all areas are open and exposed to the wind and rain.

**Old derelict toilet block**

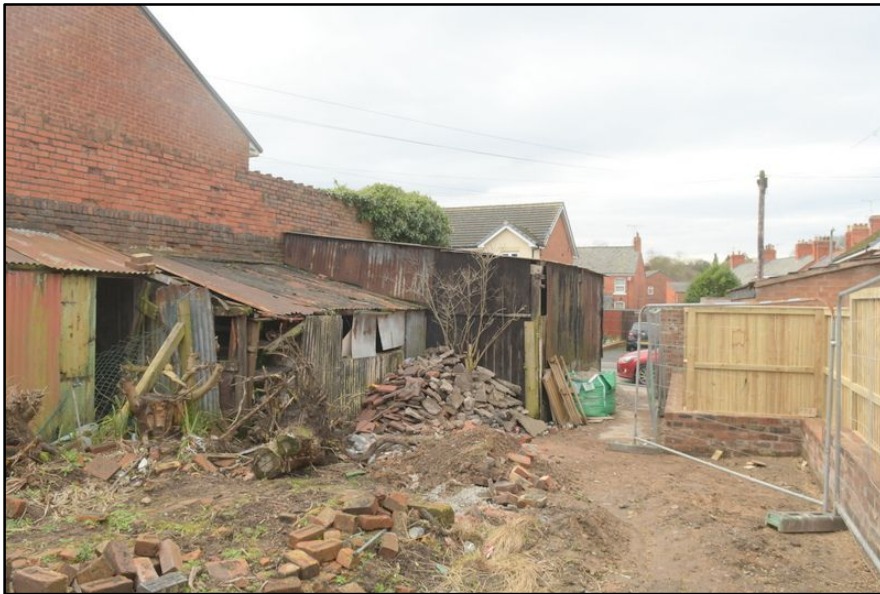
**From the rear of the site looking to the rear of the garage**

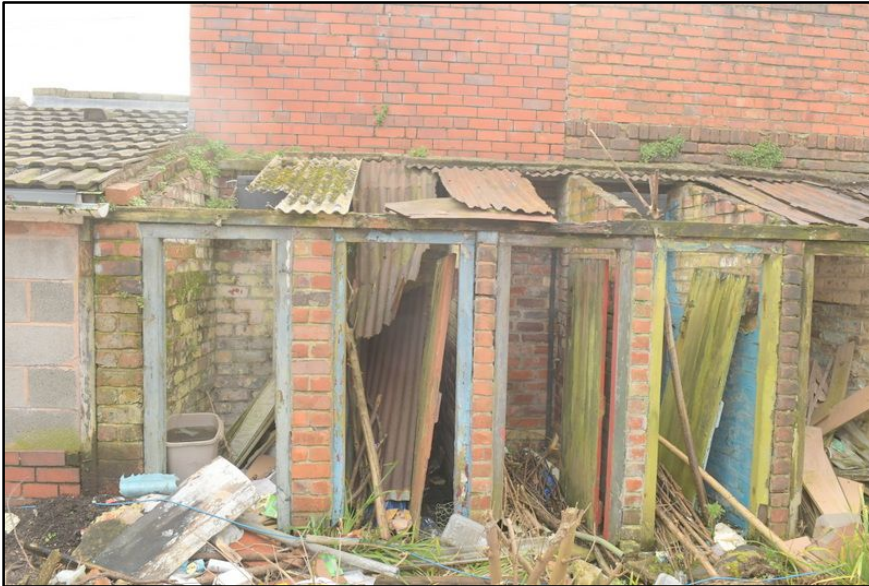
**The roofs of the toilets have mostly collapsed**

**All removal of ivy/vegetation, demolition of the garage/lean-to and the toilets will only be undertaken between October and February inclusive. The reason for this is to avoid any potential nest disturbance to nesting birds during the breeding season.**

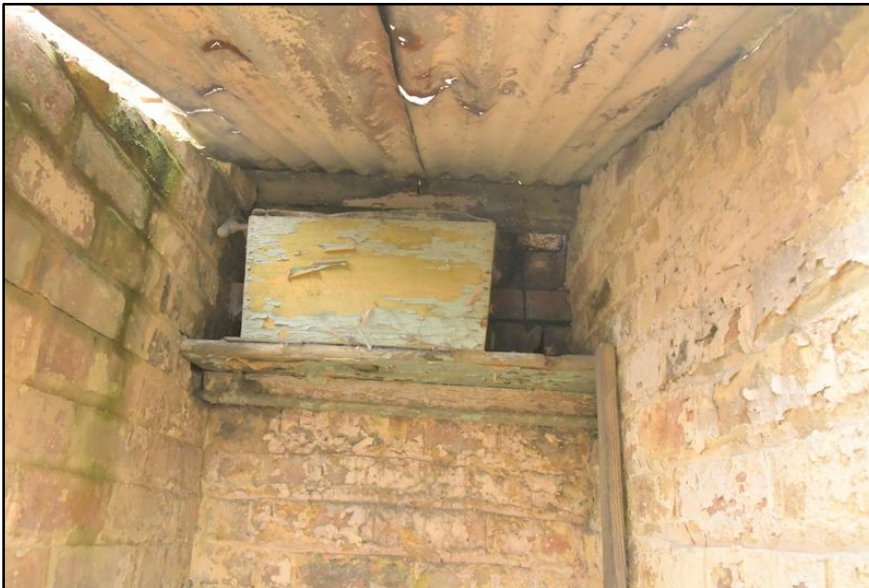
There was no obvious evidence of nesting birds in the toilets but there are areas that are likely to be used, some of which may be hidden such as the space at the rear of the cisterns or behind remnant roof panels.

**Potential nest site around the cistern**

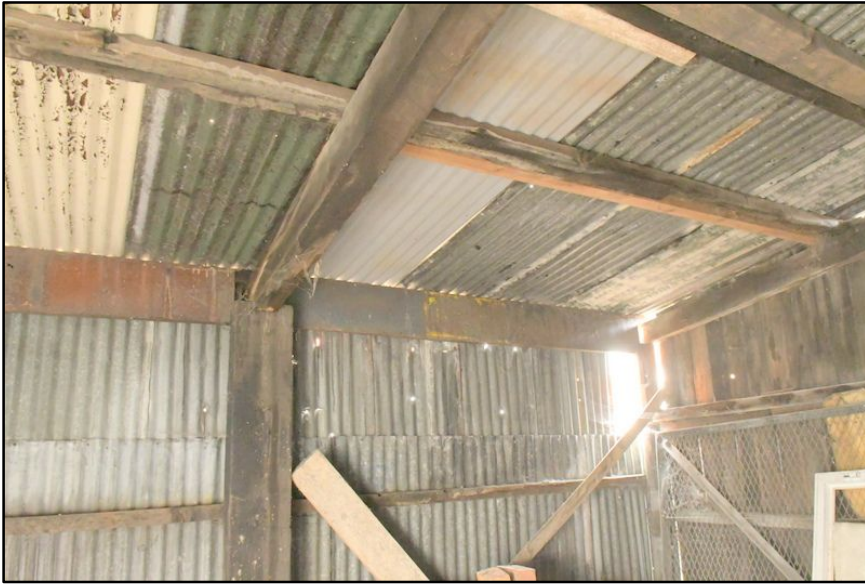
The lean-to garage has been constructed from a wooden frame covered with sheets of corrugated iron, the structure leans against a brick wall. The toilets are constructed from brick with corrugated sheet roof sections, most have collapsed.

**Wooden frame garage with tin sheet wall and roof**

- **All roof coverings should be carefully removed by hand to ensure that no roosting, torpid or hibernating bats are injured during the proposed works.**
- **Door and window frames should be removed with care to ensure that no roosting, torpid or hibernating bats are injured during the proposed works.**

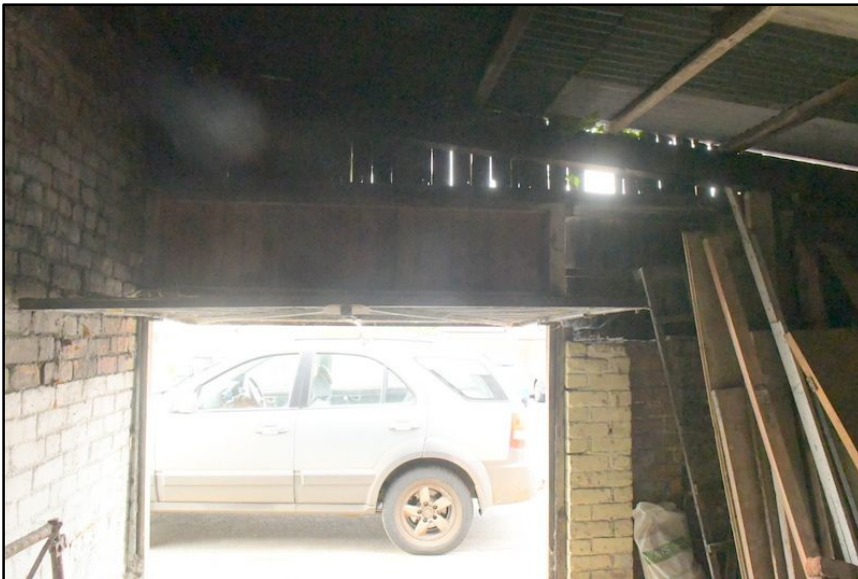
At the time of the survey there was no evidence of nesting birds anywhere in or around the structure of the garage. It is open access from the rear and there are holes on the front gable so it may be used by certain species during the main breeding season.

**Garage door facing the road**
