**ADDITIONAL PHASE 2 GROUND  
INVESTIGATION: WYNNSTAY  
TECHNOLOGY PARK, RUABON**

**GSL3060R01**

**06 MARCH 2024**

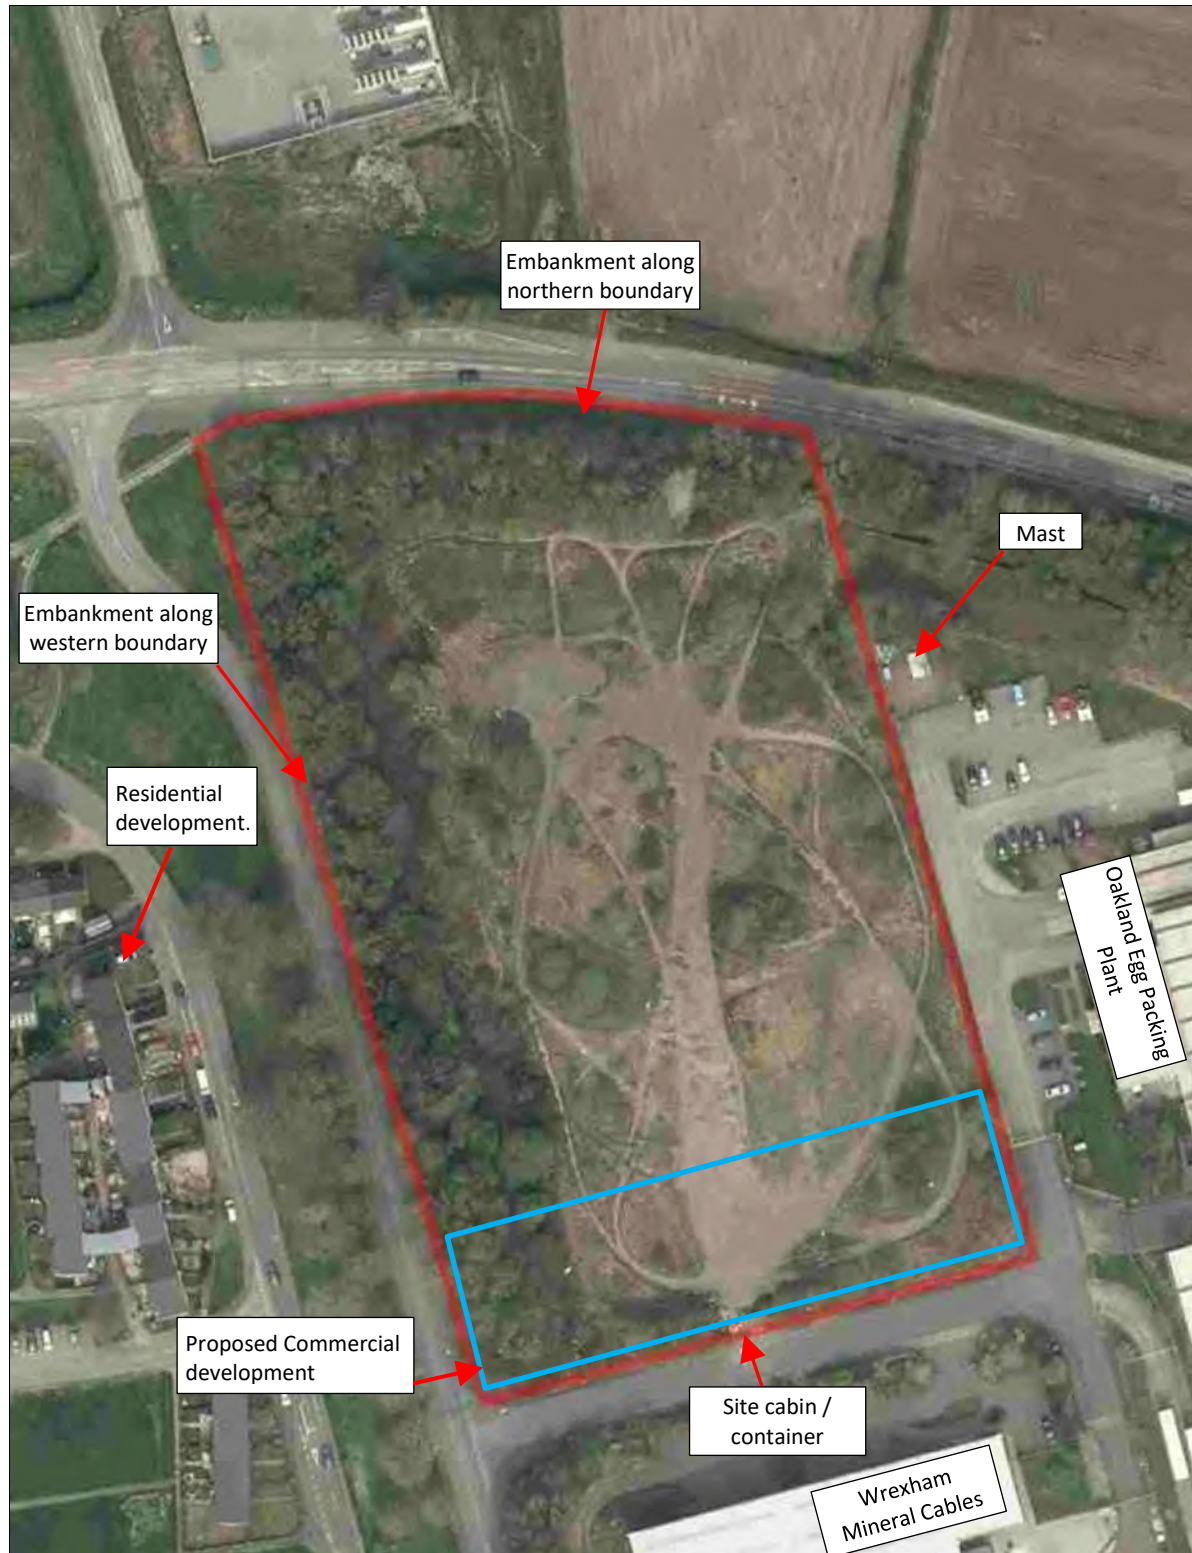
**Figure 2 - Extract from Aerial photography from Groundsure Report**

| Surrounding Area | Two commercial sites border to the east (Oakland Egg Packing Plant) and south (Wrexham Mineral Cables). Residential properties are present to the west and an electricity substation is present to the north. The site is bordered by Llangollen Road to the north and Wynnstay Lane to the west. See <b>Figure 2</b> |

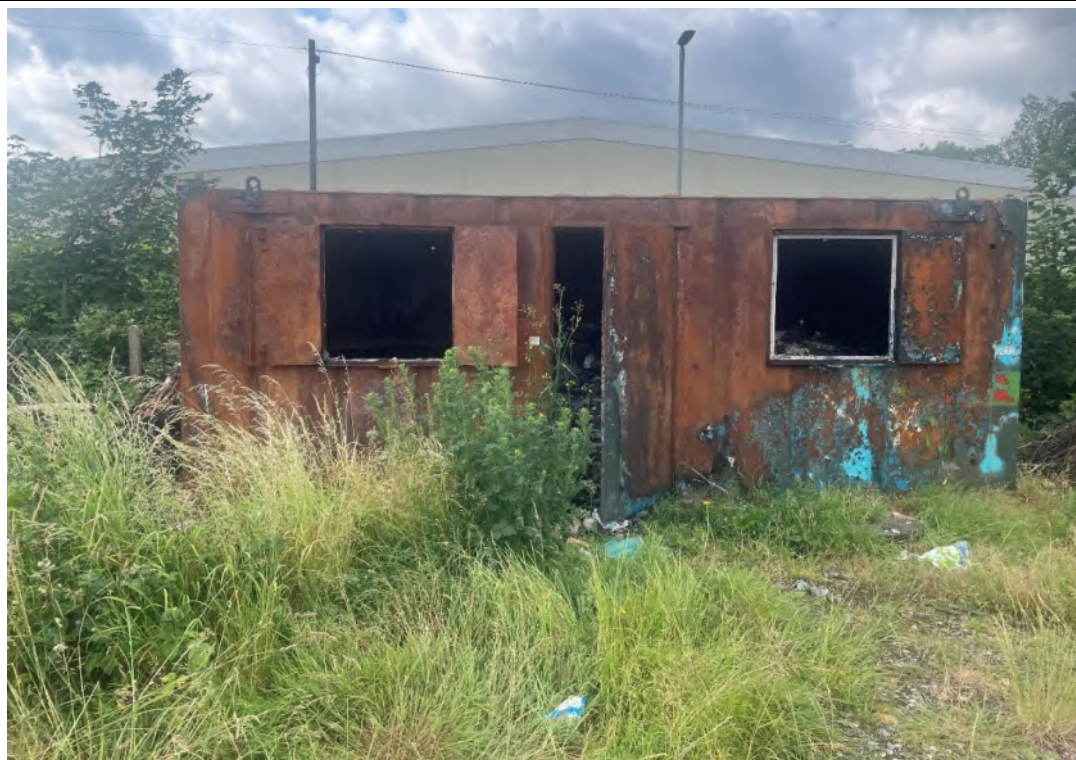
| Existing Buildings& Structures | No permanent structures present on site. There is disused site office / steel container, which shows evidence of fire damage inside. |
| Waste Disposal/<br>Materials Storage | No significant areas of waste storage or fly tipping present on site. There is some evidence of fire damage and burnt material present within the container located on the southern boundary.<br><br>There are two relatively small stockpiles of vegetation present which is understood to originate from recent vegetation clearance. |

Photo 14 – Old container present along southern boundary. Evidence of fire damage. Burnt ash material present inside container. No evidence of any impact outside the container.

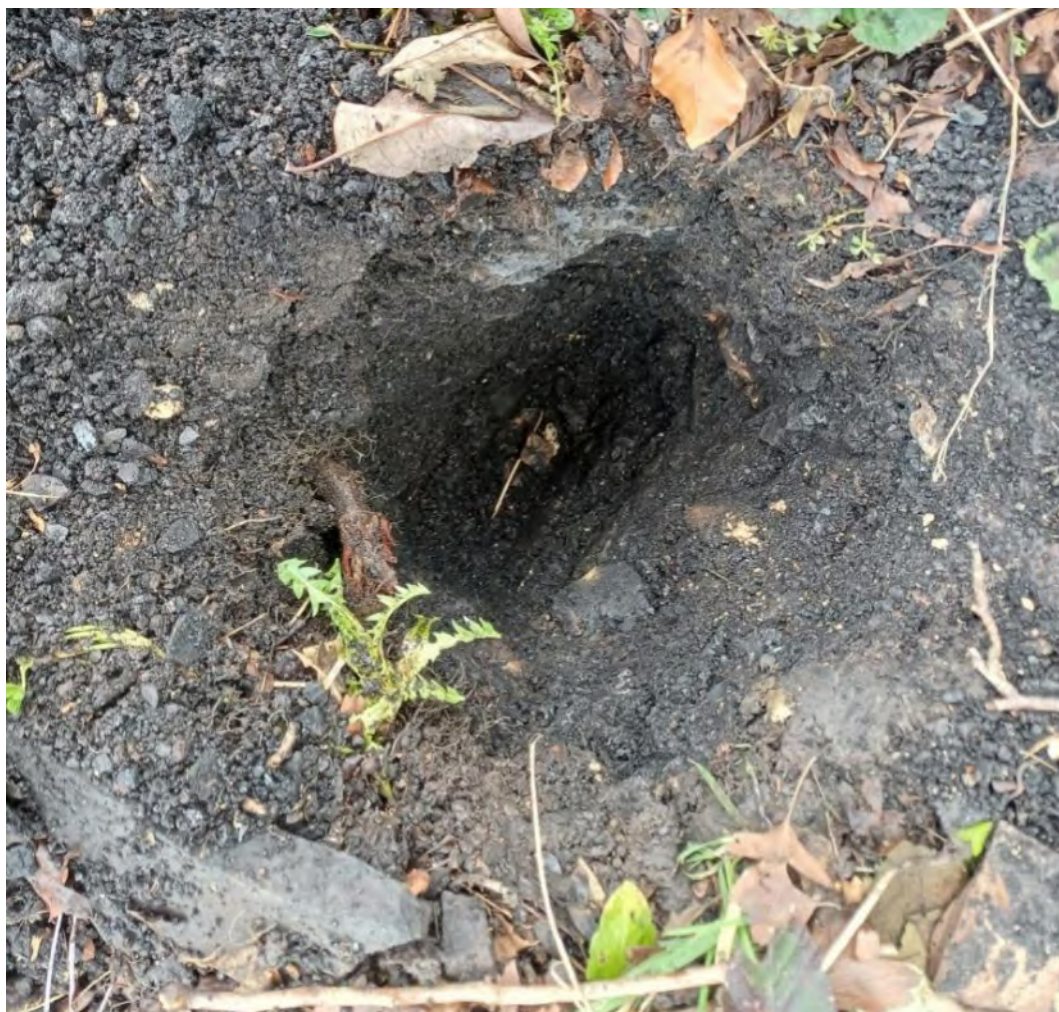
HP1 – 0.50m bgl

| Well | Water Strikes | Sample and In Situ Testing | | | Depth (m) | Level (m) | Legend | Stratum Description | |
|---|---|---|---|---|---|---|---|---|---|
| | | 0.50 | ES | | 0.50 | 126.50 | | Loose dark grey fine to coarse sub angular GRAVEL of clinker, red brick and mudstone with ash. (MADE GROUND) | |

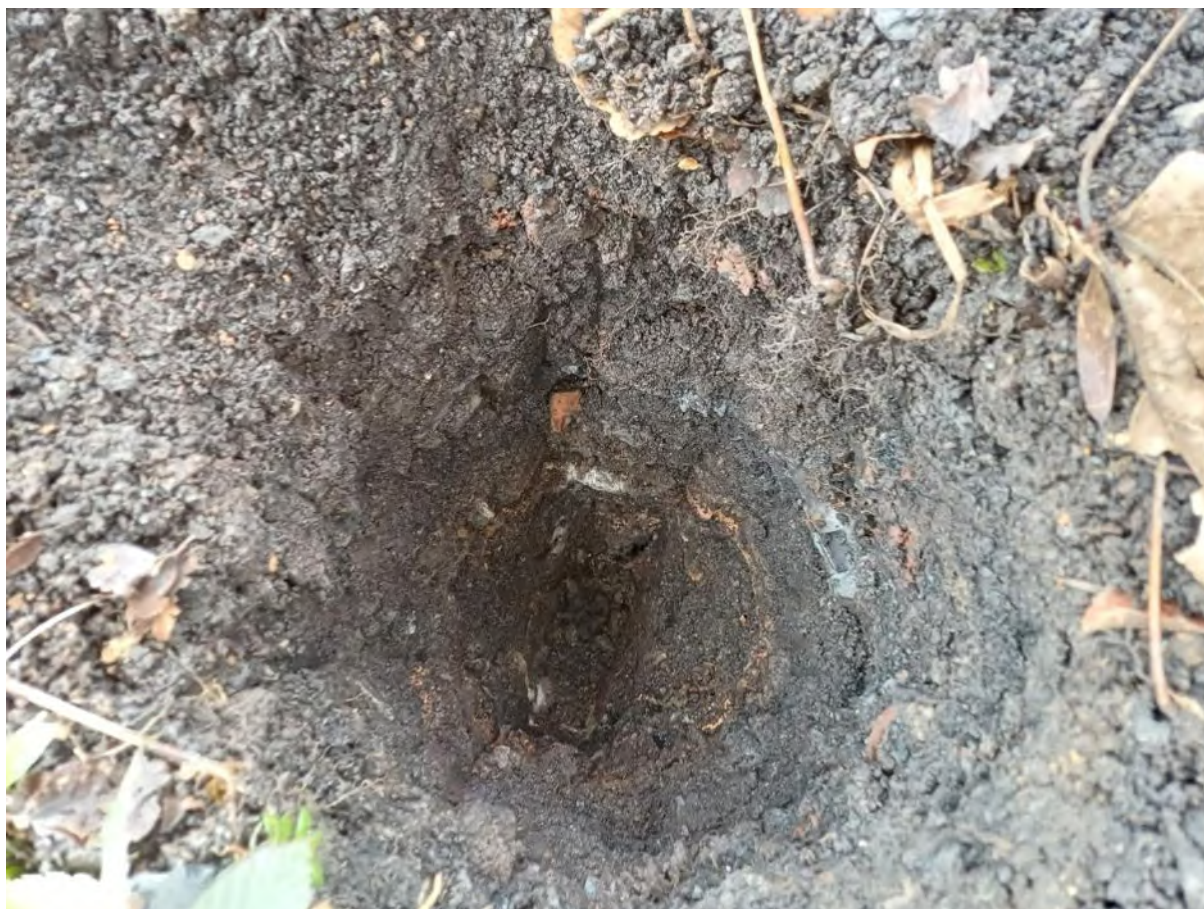
HP3 – 0.70m bgl

| Well | Water Strikes | Sample and In Situ Testing | | | Depth (m) | Level (m) | Legend | Stratum Description | |
|---|---|---|---|---|---|---|---|---|---|
| | | 0.70 | ES | | 0.70 | 126.30 | | Loose dark grey fine to coarse sub angular GRAVEL of clinker and mudstone with ash. (MADE GROUND) | |

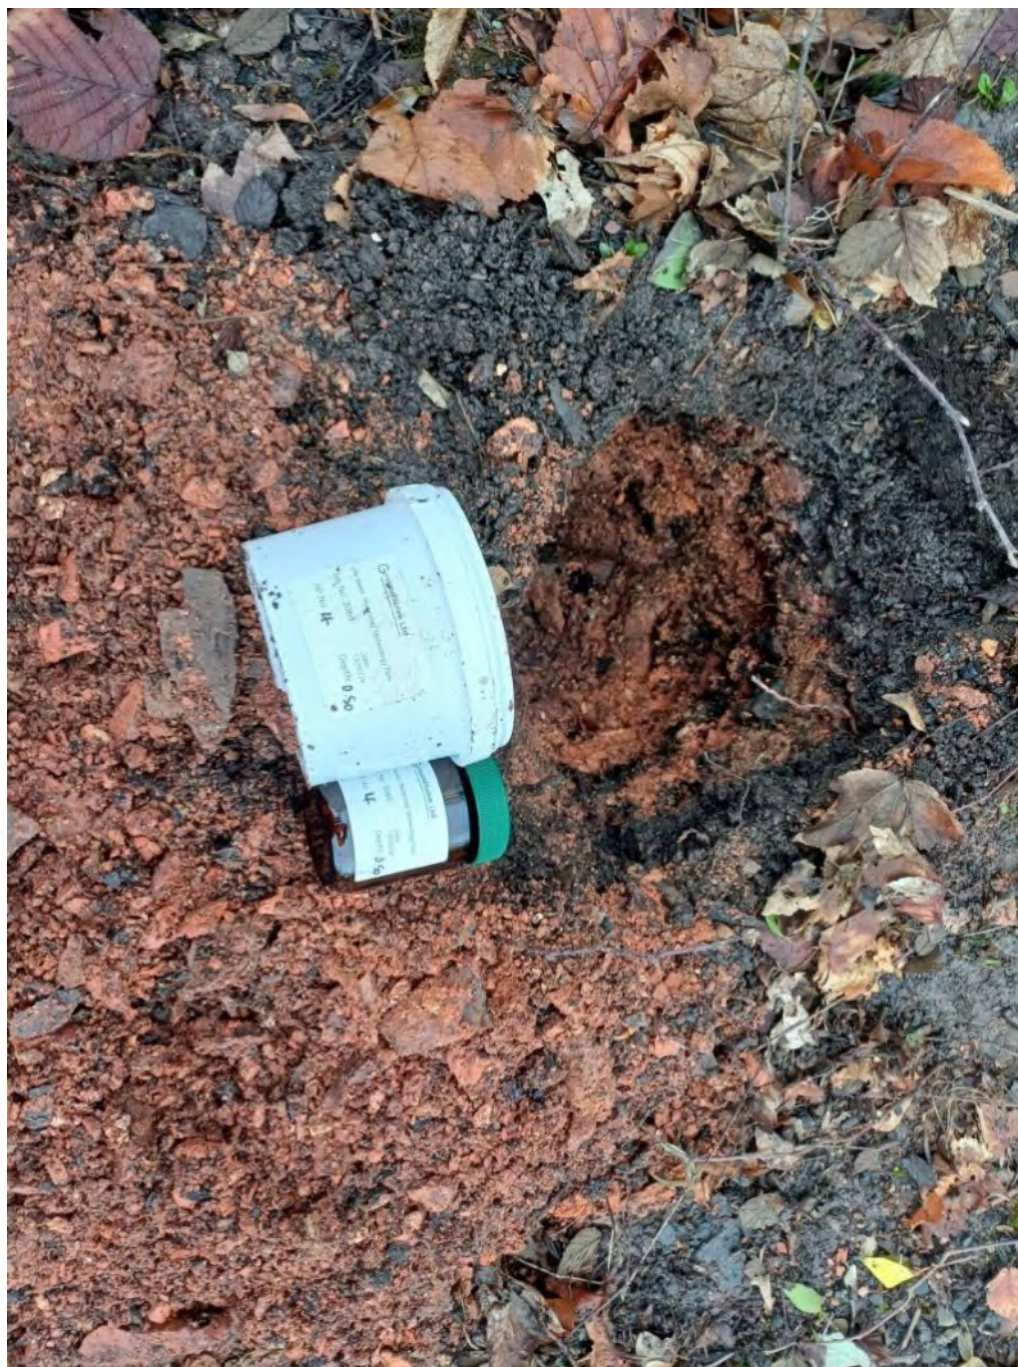
HP4 – 0.50m bgl

| Well | Water Strikes | Sample and In Situ Testing | | | Depth (m) | Level (m) | Legend | Stratum Description | |
|---|---|---|---|---|---|---|---|---|---|
| | | 0.50 | ES | | 0.50 | 126.50 | | Loose orange brown fine to coarse sub angular GRAVEL of clinker and mudstone with ash. (MADE GROUND) | |

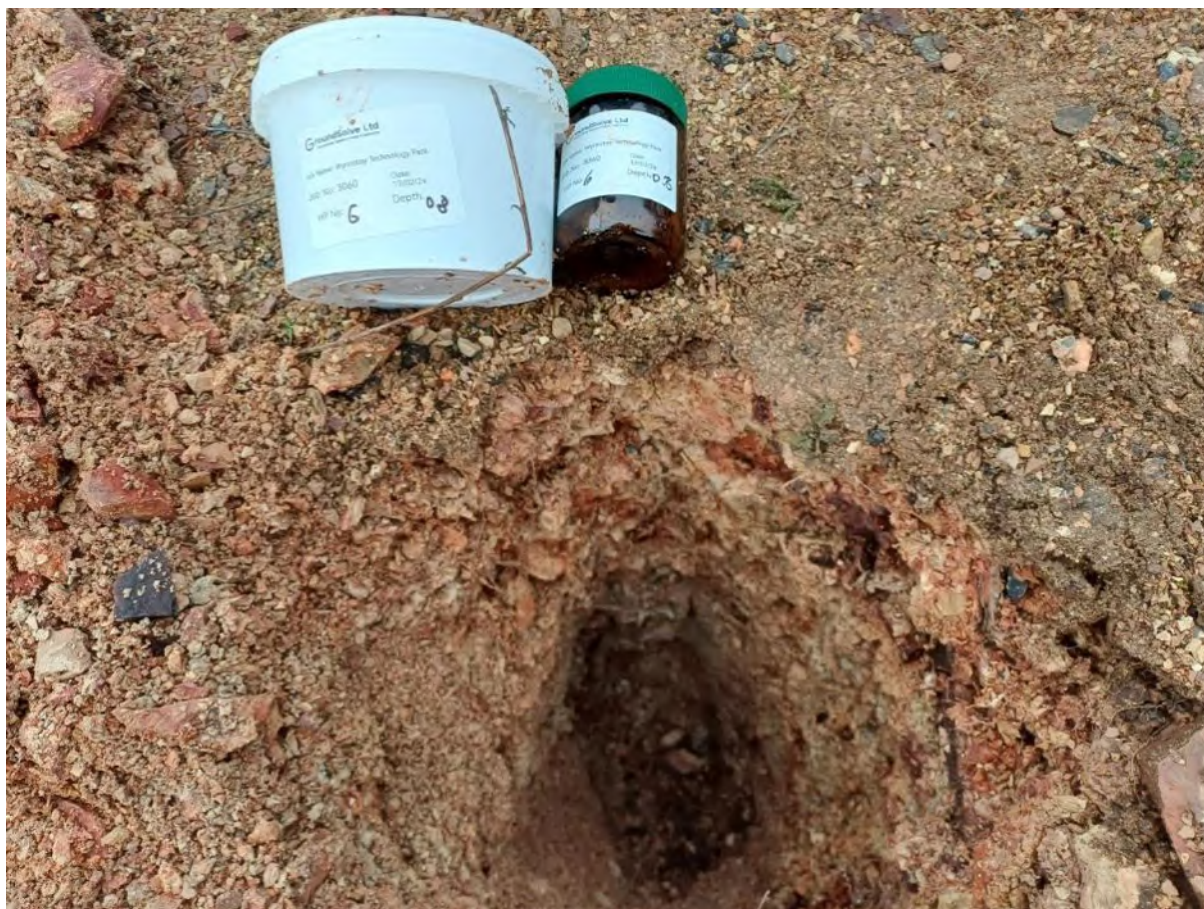
HP6 – 0.80m bgl

| Well | Water Strikes | Sample and In Situ Testing | | | Depth (m) | Level (m) | Legend | Stratum Description | |
|---|---|---|---|---|---|---|---|---|---|
| | | 0.80 | ES | | 0.80 | 128.20 | | Loose light reddish cream slightly sandy fine to coarse sub angular GRAVEL of mudstone with occasional cobbles.<br>(MADE GROUND) | |

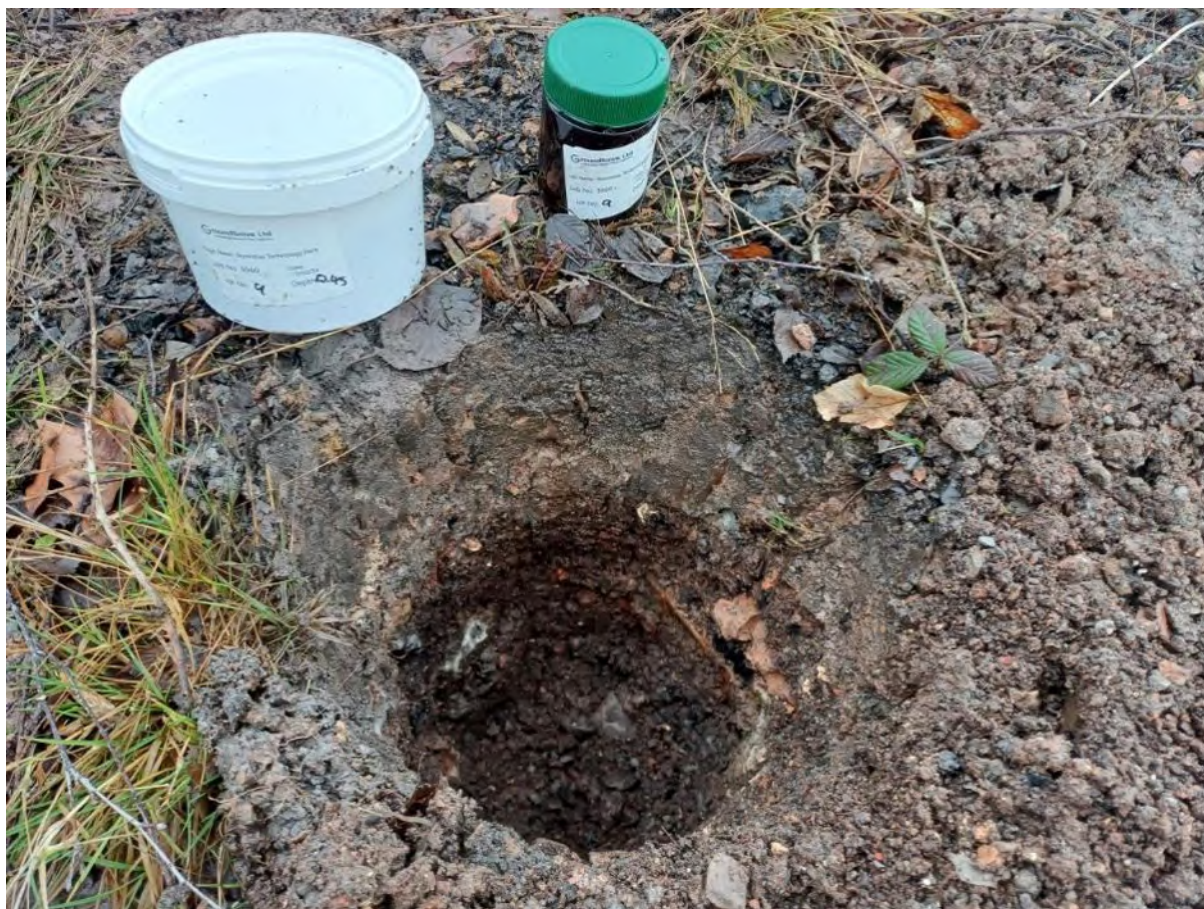
HP9 – 0.45m bgl

| Well | Water Strikes | Sample and In Situ Testing | | | Depth (m) | Level (m) | Legend | Stratum Description | |
|---|---|---|---|---|---|---|---|---|---|
| | | 0.45 | ES | | 0.45 | 123.24 | | Loose light reddish cream slightly sandy fine to coarse sub angular GRAVEL of mudstone, redbrick, clinker with ash with occasional cobbles. (MADE GROUND) | |

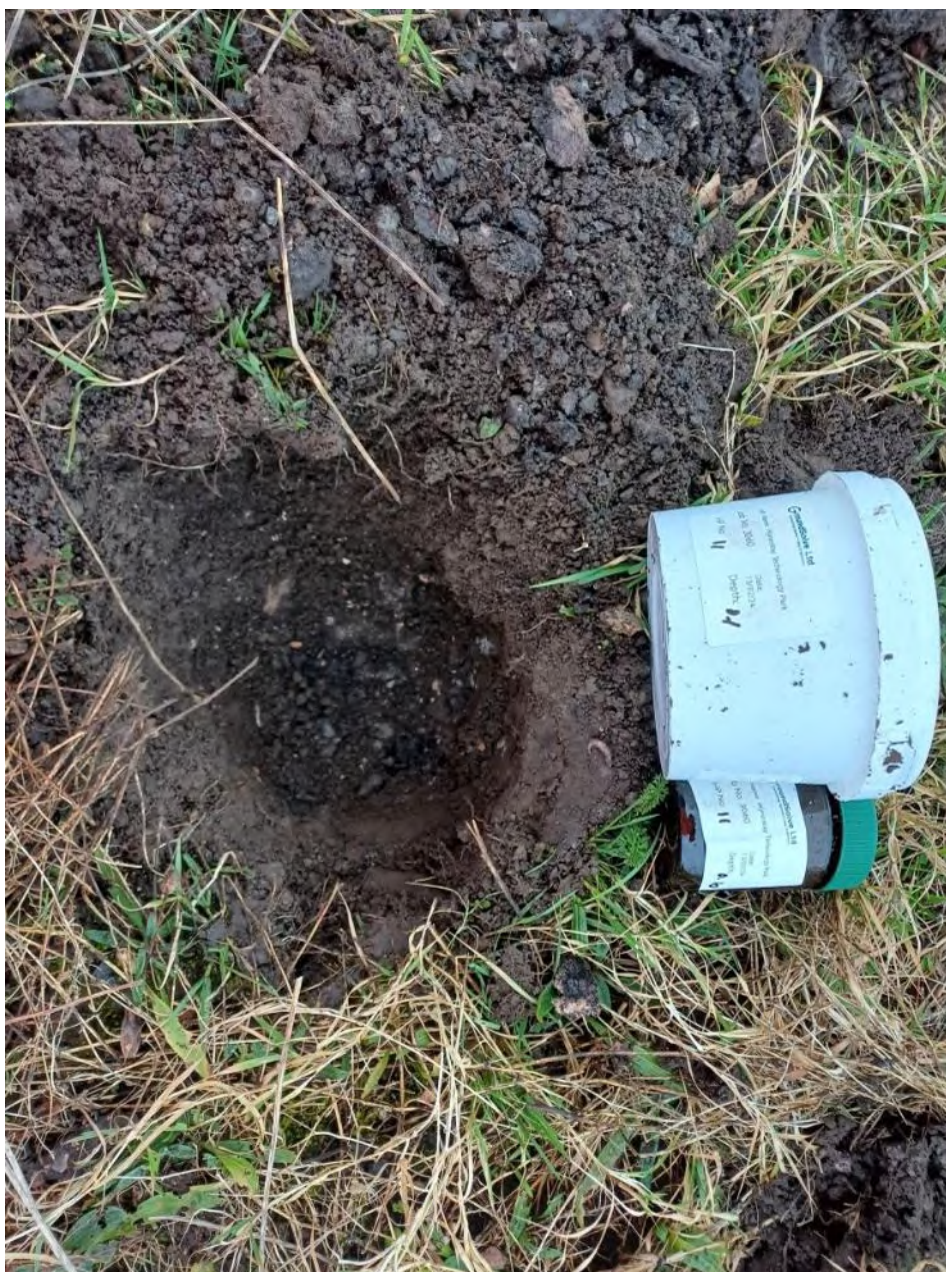
HP11 – 0.10m bgl

| Well | Water Strikes | Sample and In Situ Testing | | | Depth (m) | Level (m) | Legend | Stratum Description | |
|---|---|---|---|---|---|---|---|---|---|
| | | 0.10 | ES | | 0.10 | 124.40 | | Loose light reddish cream slightly sandy fine to coarse sub angular GRAVEL of mudstone with occasional cobbles.<br>(MADE GROUND)<br>End of Borehole at 0.100m | 1 |
