## Demolition Survey

Unit 15/16 Bridgeway Centre  
Bridge Road  
Wrexham  
LL13 9QS

| Type of survey: | Demolition Survey (with MA only) | | |

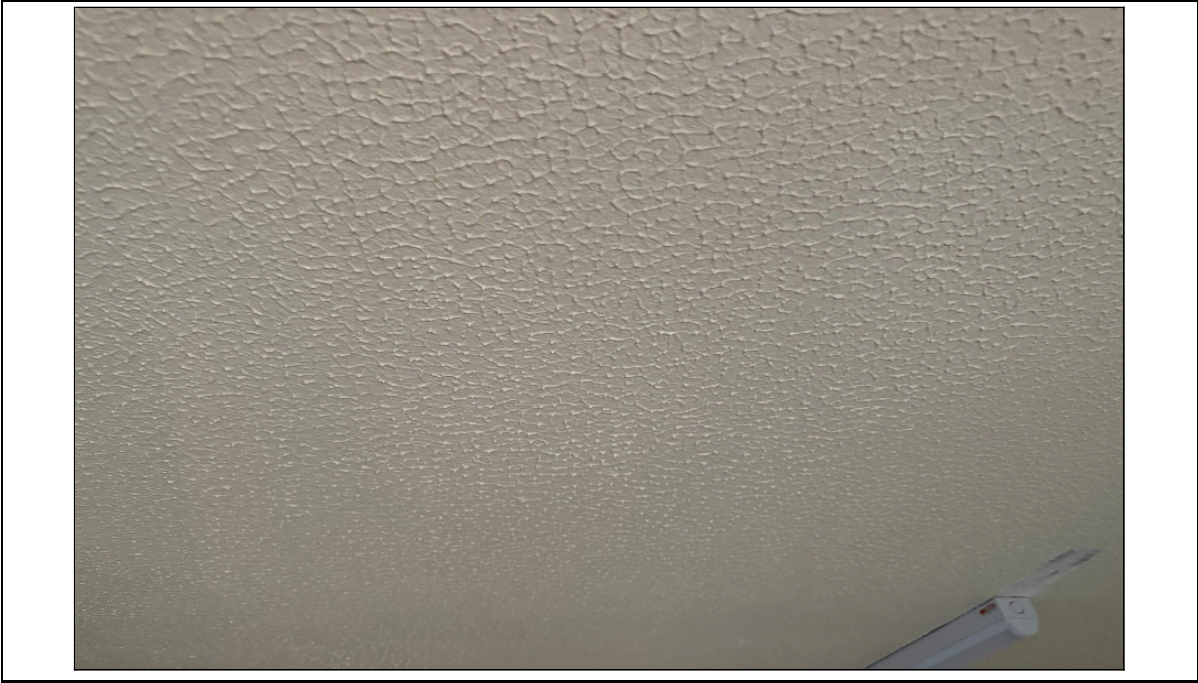
| Item Number / Sample No (S,SP,P,As) |
|---|
| 1 / Visual (P) |

| Item | Quantity |
|---|---|
| Textured Coating to ceiling/walls previously identified positive | 30m² |

| Analysis | Product Type | Surface Treatment | Condition | Accessibility |
|---|---|---|---|---|
| Chrysotile (1) | Well-bound Material (1) | 0 | Good Condition (0) | Usually inaccessible or unlikely to be disturbed |
| 2 | | | | |

| Material Risk Score | |
|---|---|
| Comment | none licensed acm |

| Material Risk Score | |
|---|---|
| Recommendation | Remove in accordance with CAR 2012 |

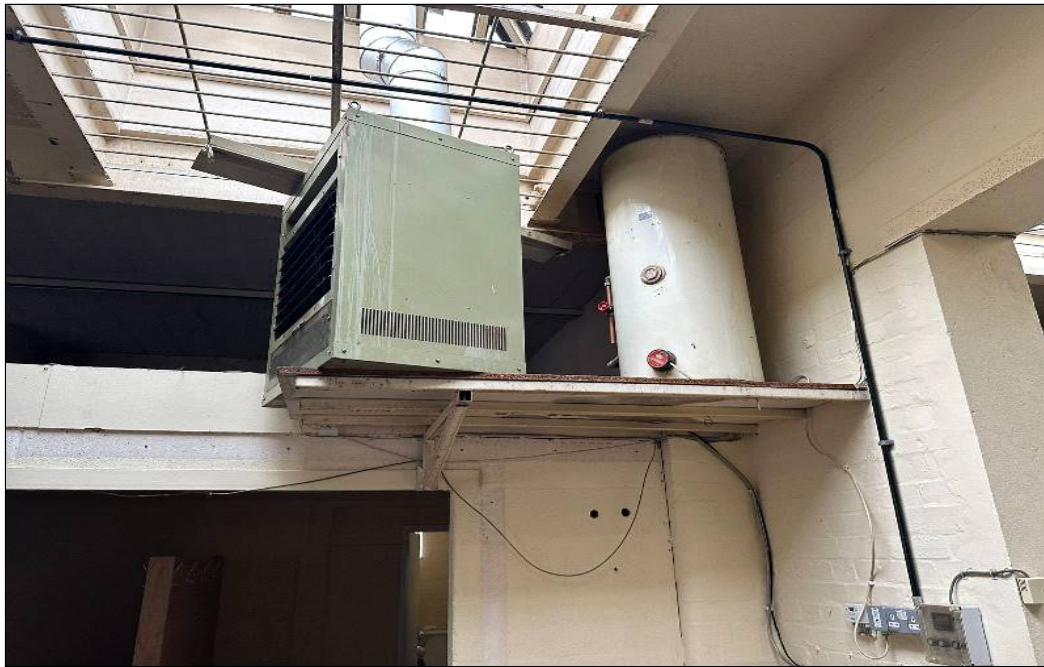
| Item Number / Sample No (S,SP,P,As) |
|---|
| 2 / Visual (P) |

| Item | Quantity |
|---|---|
| No access into live heater due to no isolation certificate | 1no. |

| Analysis | Product Type | Surface Treatment | Condition | Accessibility |
|---|---|---|---|---|
| Chrysotile (1) | Asbestos Textiles/Paper (2) | 1 | Good Condition (0) | Usually inaccessible or unlikely to be disturbed |
| 4 | | | | |

| Material Risk Score | |
|---|---|
| Recommendation | Remove in accordance with CAR 2012 |
