# PERCOLATION TEST RESULTS

Hillside  
Erbistock  
Wrexham  
LL13 0DW

Date of tests: 24<sup>th</sup> September 2024

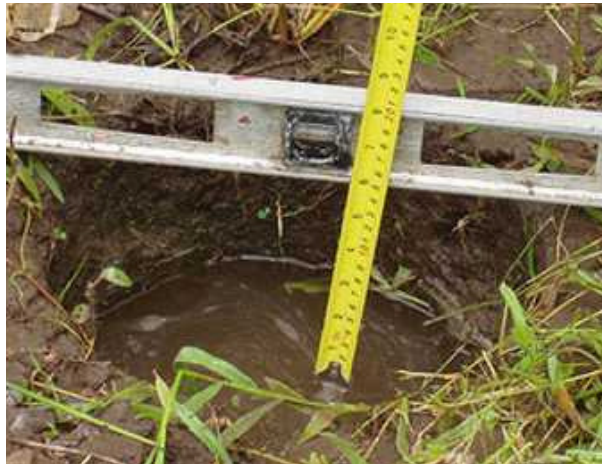
3 separate test holes were provided on site to the following dimensions: 300mm x 300mm x 300mm deep. Three separate tests were undertaken. Those test results are recorded below.
