**BAT SURVEY AND  
PRECAUTIONARY WORKING  
METHOD STATEMENT**

**WOODLANDS FARM, WREXHAM**

**SEPTEMBER 2024**

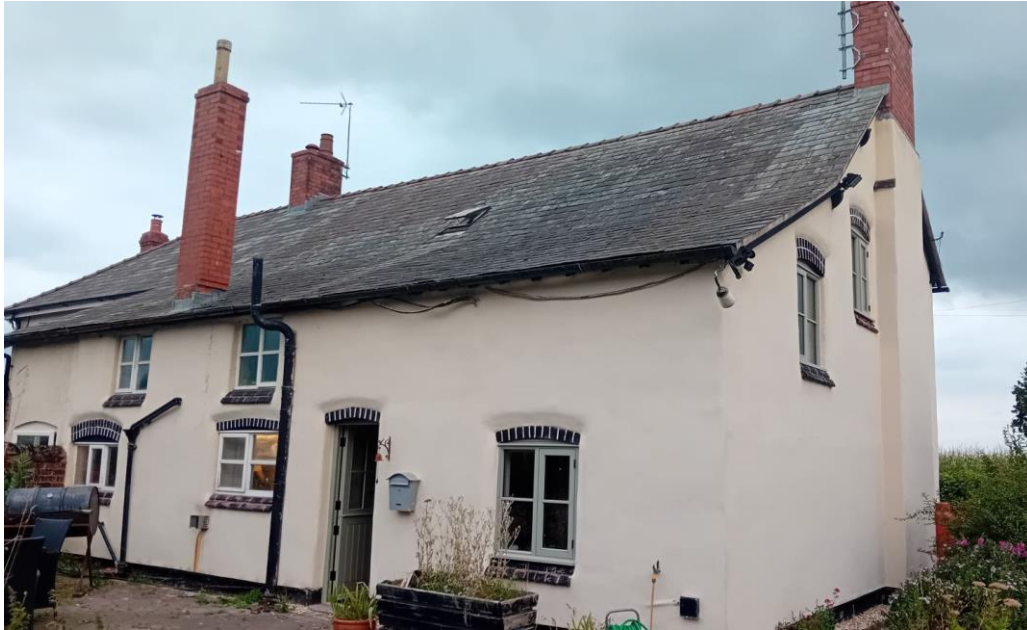
The site comprised a semi-detached two-storey traditional farmhouse, with a double-pitched slate roof and rendered brick walls. On the rear (north) side of the roof, the lower half of the roof was a shallower pitch and had a vaulted ceiling inside. The front (south) side of the roof had solar panels.

Externally in the proposed area of works the slates were generally well fitting with no missing or slipped slates. There were occasional gaps under the eaves which allowed potential access to the wall plate. No evidence of bats was found in this area and given the limited areas for bats to roost it was assessed to be of 'low' potential for roosting bats.

Plate 1: Woodlands Farm showing north (rear) elevation where work is planned

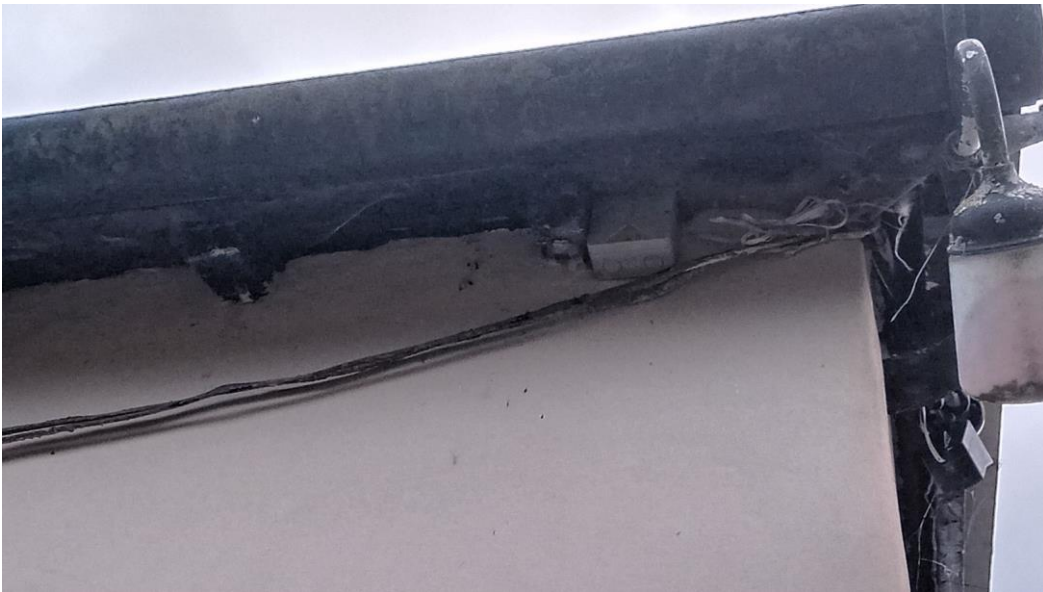
There were several areas with bird droppings stuck to the wall under gaps in the eaves, indicating the likely presence of nesting house sparrows *Passer domesticus* during the breeding season.

Plate 2: Bird droppings under eaves indicating likely house sparrow nest site

House sparrows are a 'Red List' species (Stanbury et al, 2021), and one of the reasons for significant population declines of this species is the loss of nesting habitat in buildings. It is therefore recommended that provision is made for this species to continue nesting under the eaves.

It is understood that the gaps at the eaves are due to be retained during re-roofing for ventilation. Old nesting material can be removed as long as it is not an active nest, i.e. with eggs, chicks or fledglings (N.B. if works are being undertaken outside of the nesting season i.e. September to February, sparrow nests are unlikely to be active).

Access gaps need to be 32mm wide and at least 28mm high for house sparrows, and ideally would recreate the existing gap sizes and locations being used by birds.

If recreating bird access into the eaves is not possible, at least three woodcrete house sparrow boxes should be mounted 1 – 2m apart under the eaves on the wall of the property (north facing is ideal so that they do not receive too much heat in the summer). However, it is preferable and cheaper to recreate access to permanent nesting locations in the eaves.
