# Project Sakura, Wrexham

Title Ground Conditions Assessment Report

Jubb have been commissioned by TSL on behalf of SmartParc to provide a geotechnical and geo-environmental assessment of the site, combining both a Phase 1 Desk Study and a Phase 2 Interpretative Ground Investigation (GI) Report. This report provides a review of the historic desk study information (as provided by the client), general site context and historical mapping, as well as advice for the geotechnical and geo-environmental design of the development and associated ground contamination and geotechnical hazards.

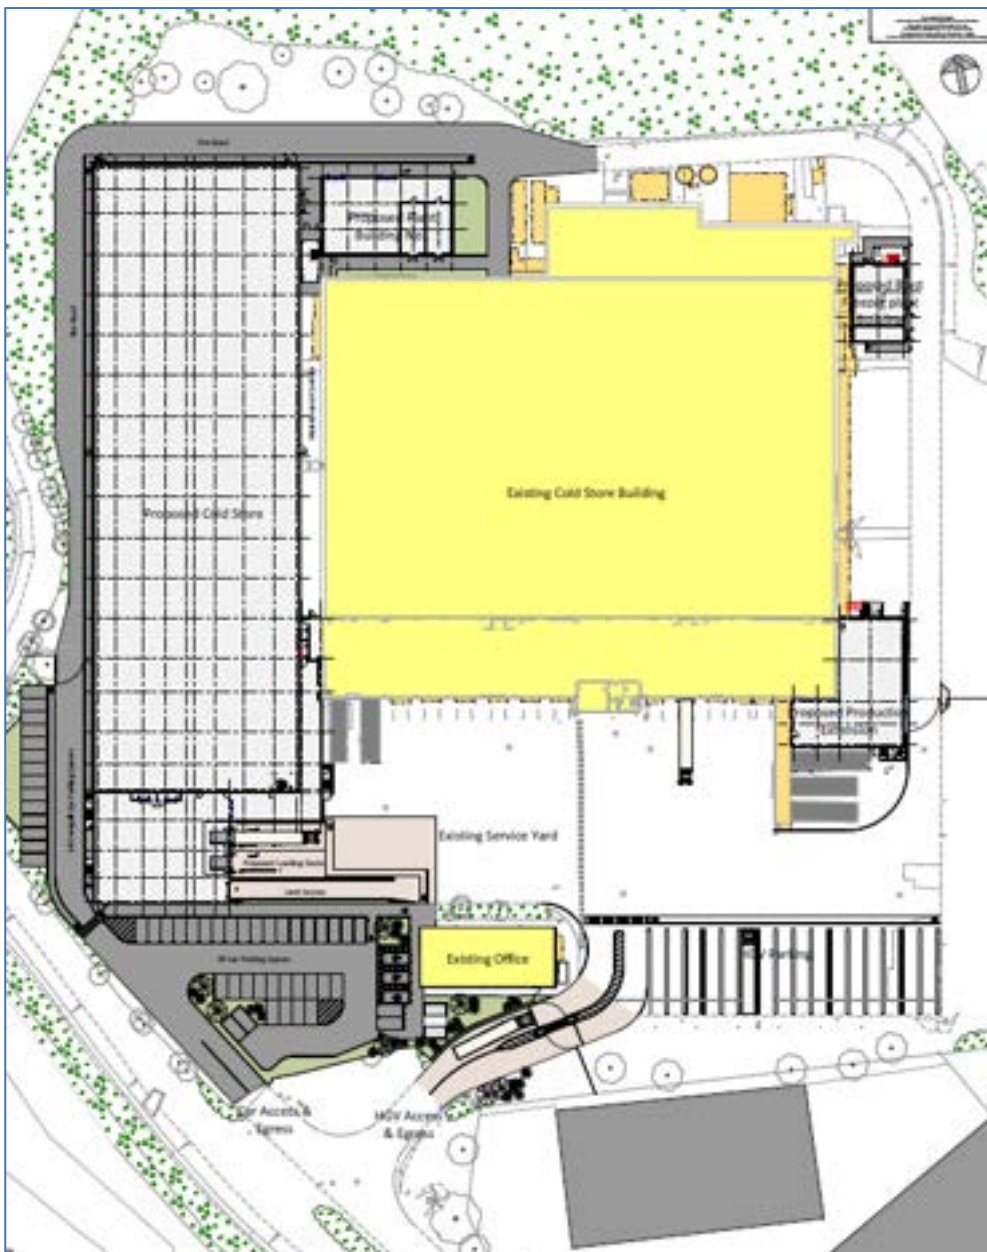
A new production building is also proposed on the southeast corner of the existing building.

Figure 2: Proposed General Arrangement Plan (from Ashton Smith drawing, GA Site Plan, TCSW-ASA-90-VS.ZZ-D-A-9003 S2 P08)

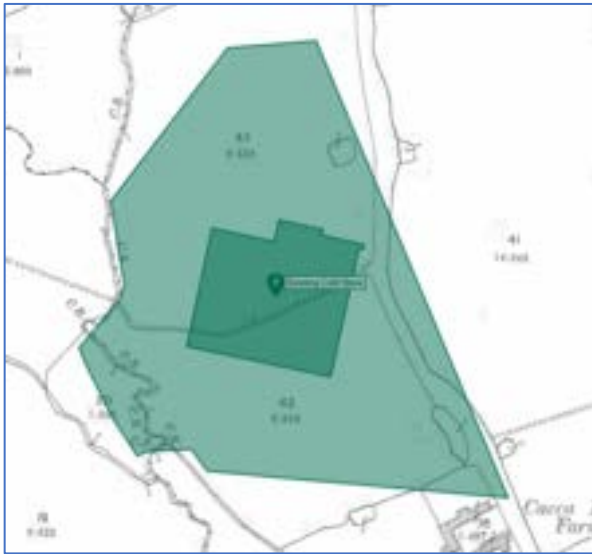
Figure 3: OS Mapping 1899

The site originally comprised open fields split centrally with a hedgerow and footpath (pre-1900), two ponds were present on the site, and a stream ran across the western edge of the site.

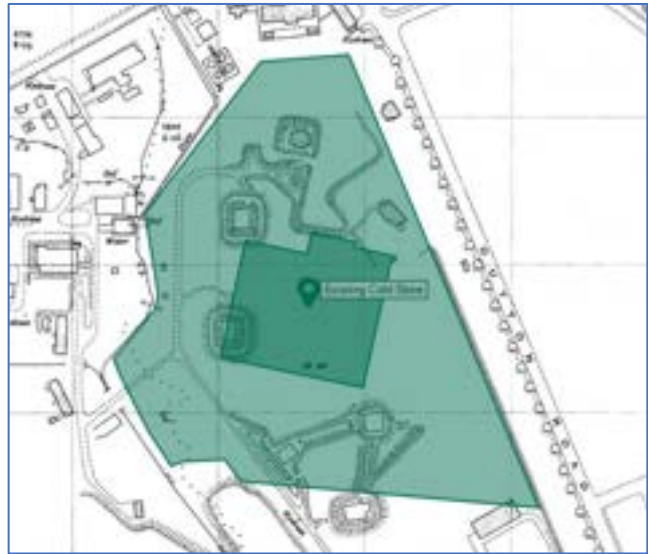
Figure 4: OS Mapping 1964

Online sources indicate that the wider area was occupied by Royal Ordnance Factory (ROF) Wrexham, which was constructed shortly after the start of WWII. The factory was responsible for the production of cordite, an explosive propellant for munition shells. The bunded store buildings noted on the subject site are likely to have been used to store explosives. A previous report (*Richards Moorehead & Laing Ltd 1993 – reviewed in Section 4.0*) indicated that former foundations of onsite structures were fully removed during redevelopment and earthworks in the 1980's.

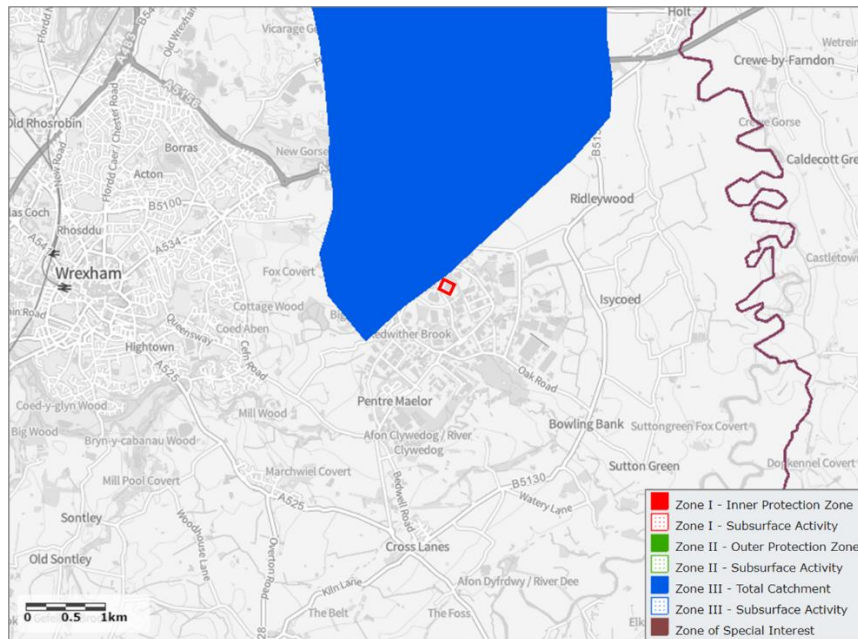
The site is not within a groundwater Source Protection Zone (SPZ). However a Total Catchment (Zone 3) is located approximately 100m to the northwest, associated with the principle aquifer of the Kinnerton Sandstone Formation.

Figure 5: SPZ (Site location in red)

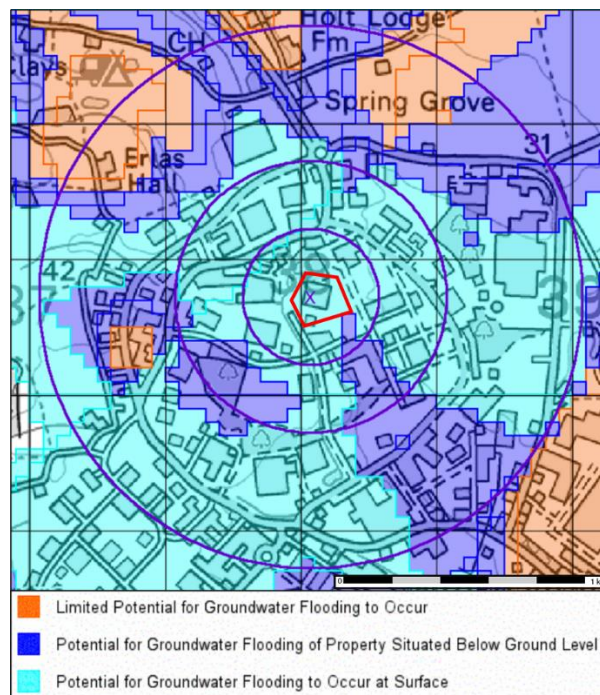
The Envirocheck report indicates a potential for groundwater flooding to occur at surface at the site. However, we typically consider that the groundwater will consummate with the adjacent watercourse, and in reality the risk of groundwater flooding is likely to be low.

Figure 6: BGS Groundwater Flooding Susceptibility Map (Site location in red)

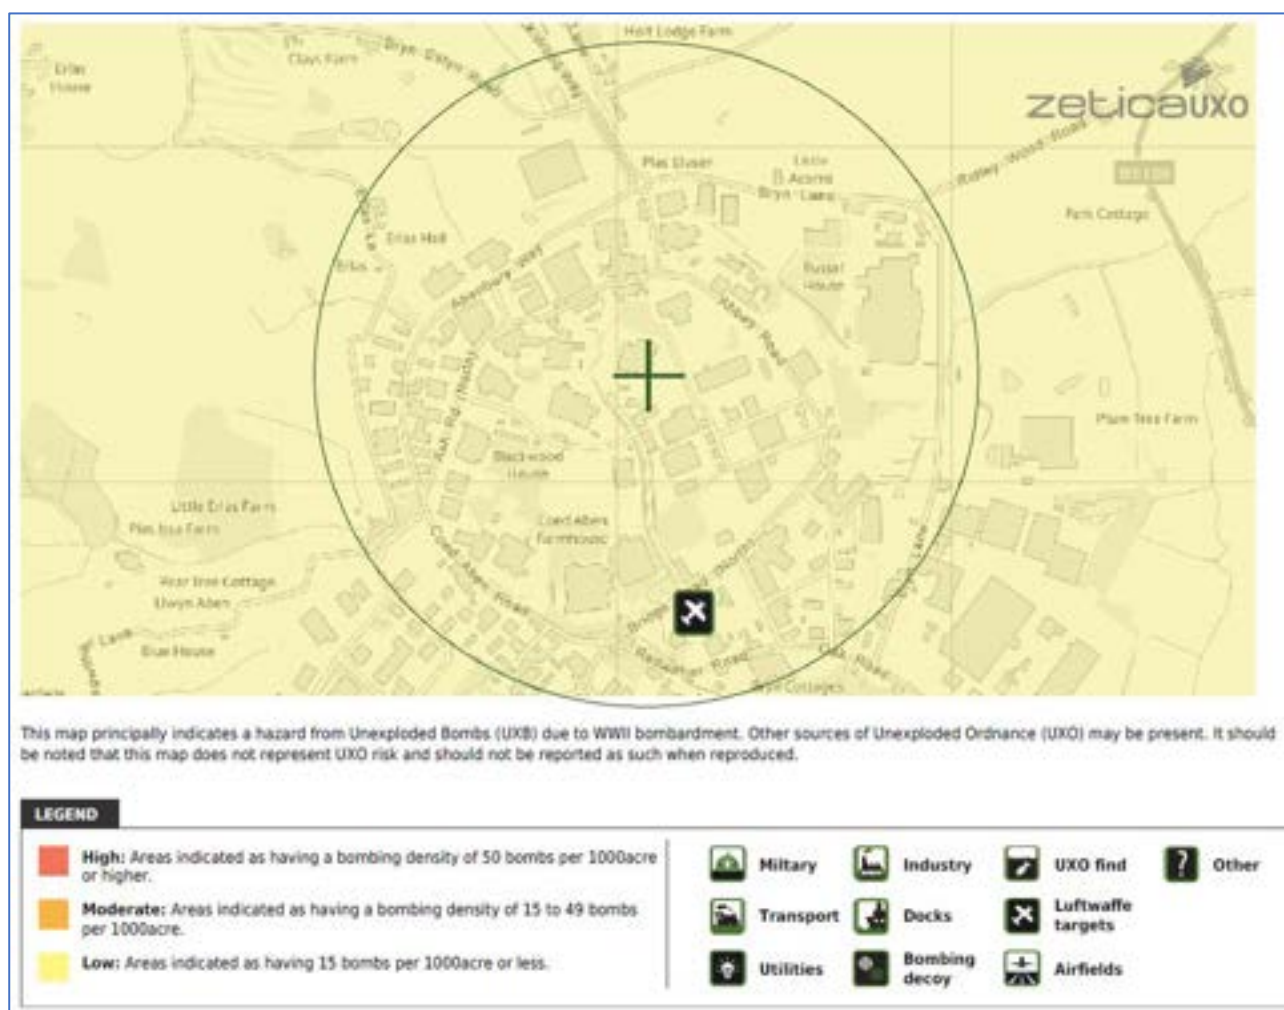
A preliminary assessment of the site risks of UXO has been undertaken using freely available maps from Zetica UXO indicate the site to be located within a low-risk area (bombing density of 15 bombs per 1000 acres or less). The figure below presents the Zetica mapping.

Figure 7: Zetica UXO Risk Mapping

Although the site has historically comprised a munitions factory, as it is recorded to be decommissioned and former foundations fully removed, therefore further UXO considerations are not necessary.

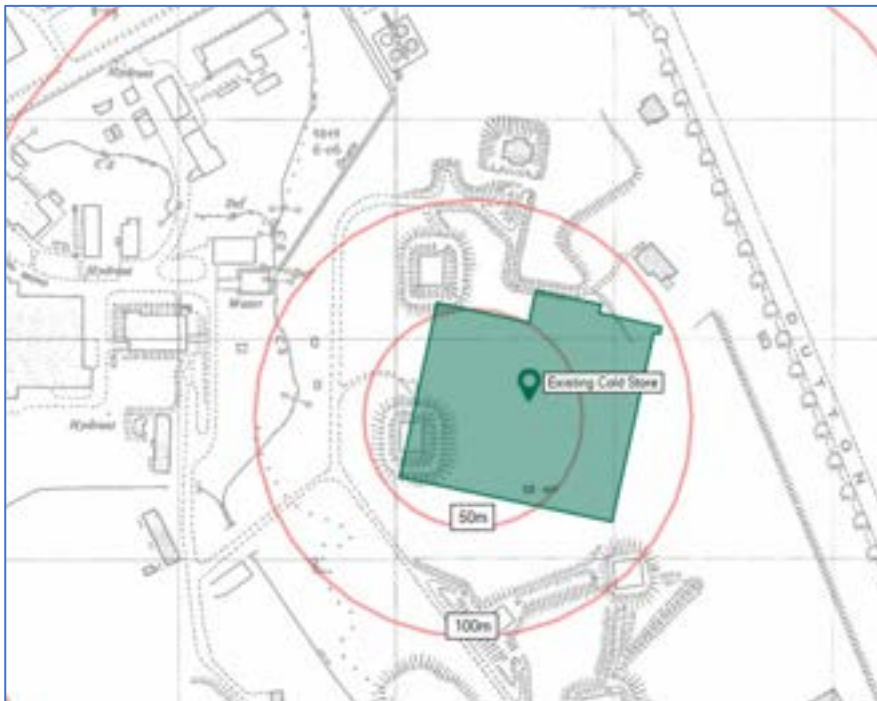
The report identified the Royal Ordnance Factory that occupied the wider site area, and referred to a number of historic structures on the site, and their removal in the 1980's, which comprised the grubbing out of foundations (which were up to 3m deep). These earthworks generated the soils currently forming the embankment to the north of the site. The voids were back filled with natural clay soils and a layer of topsoil placed at surface, the site area was also levelled at this time. The report identified 2 no. drainage ditches up to 1.5m deep on/ around site although their location is not clear from review of historic mapping.

The approximate location of the former ROF structures in relation to the existing development is shown on plan below.

Figure 8: Existing Building in Relation to Former ROF Structures (grubbed out)

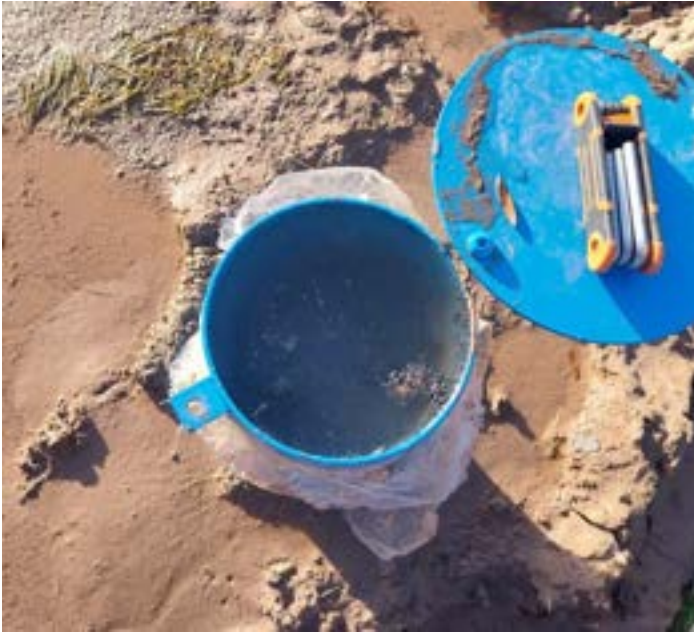
The flooded upstanding cover is indicated on the photograph below.

*Photograph 1 - Flooded upstanding cover on BH102*

The reason for the rising groundwater in BH102 has yet to be determined, and further monitoring of this hole is recommended.

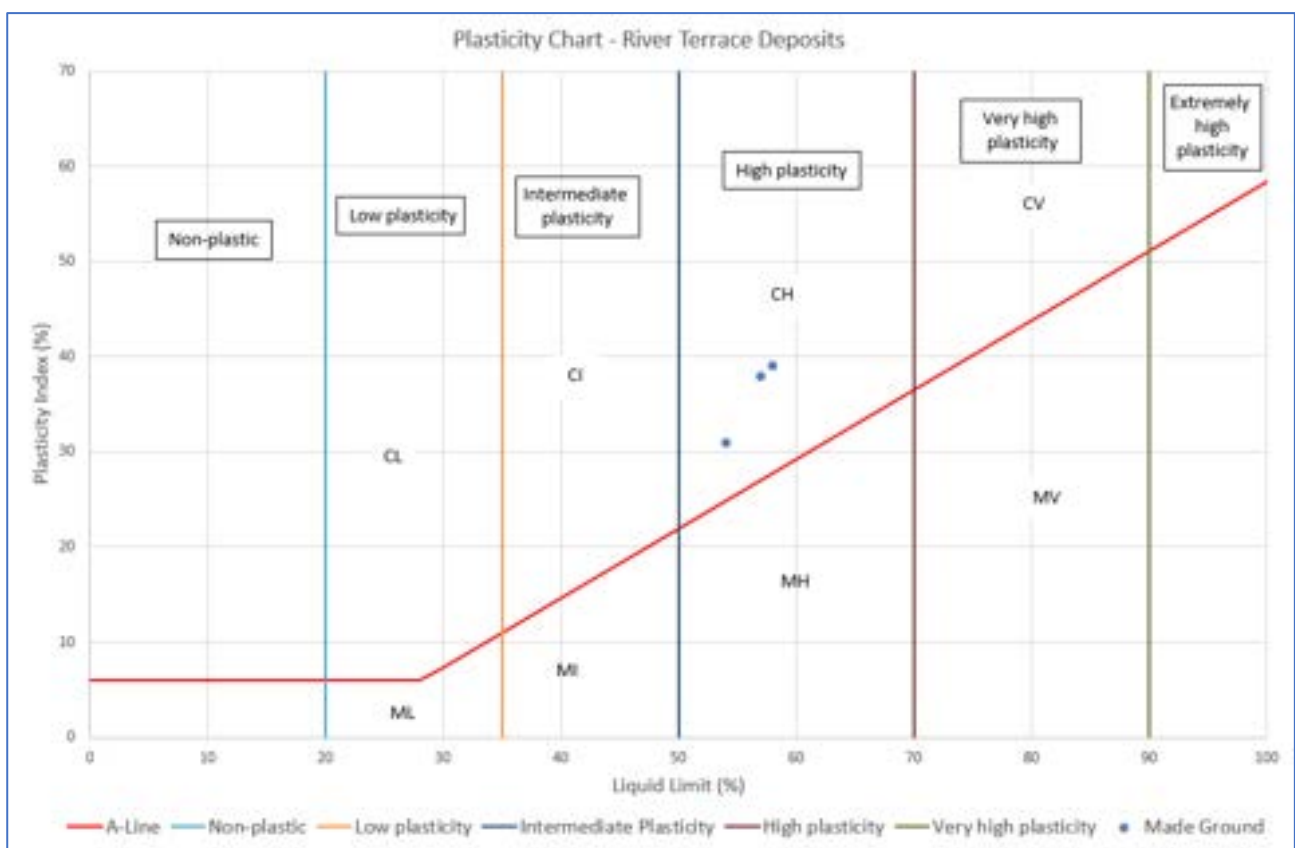
Figure 9. Made Ground - Atterberg Chart

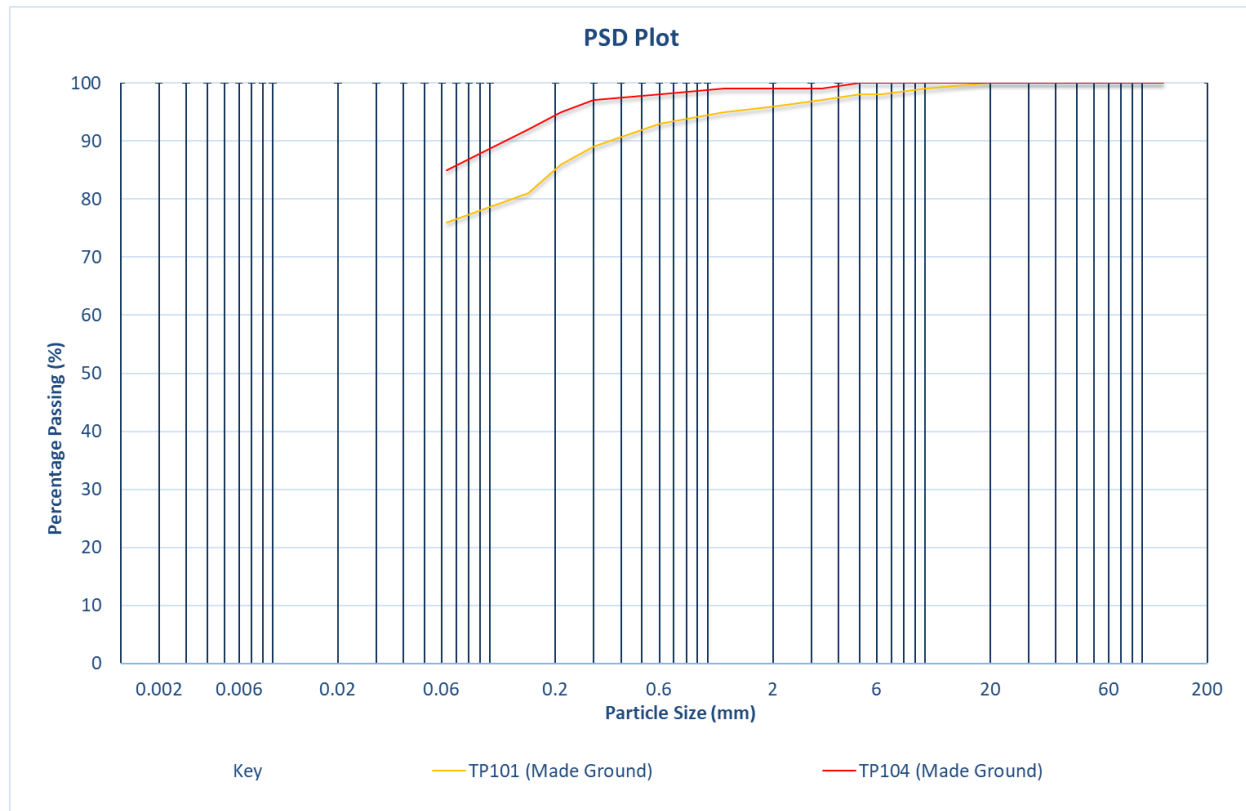
Figure 10: Particle size distribution chart of Made Ground

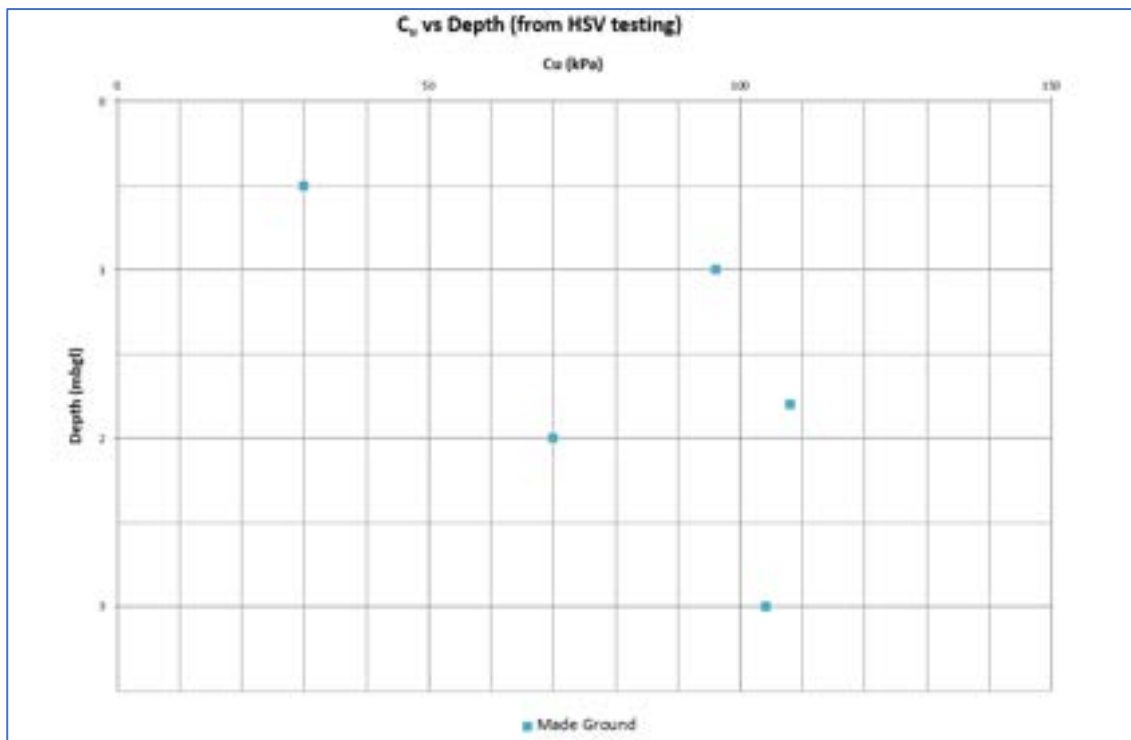
Figure 11. Made Ground - Hand Shear Vane results.

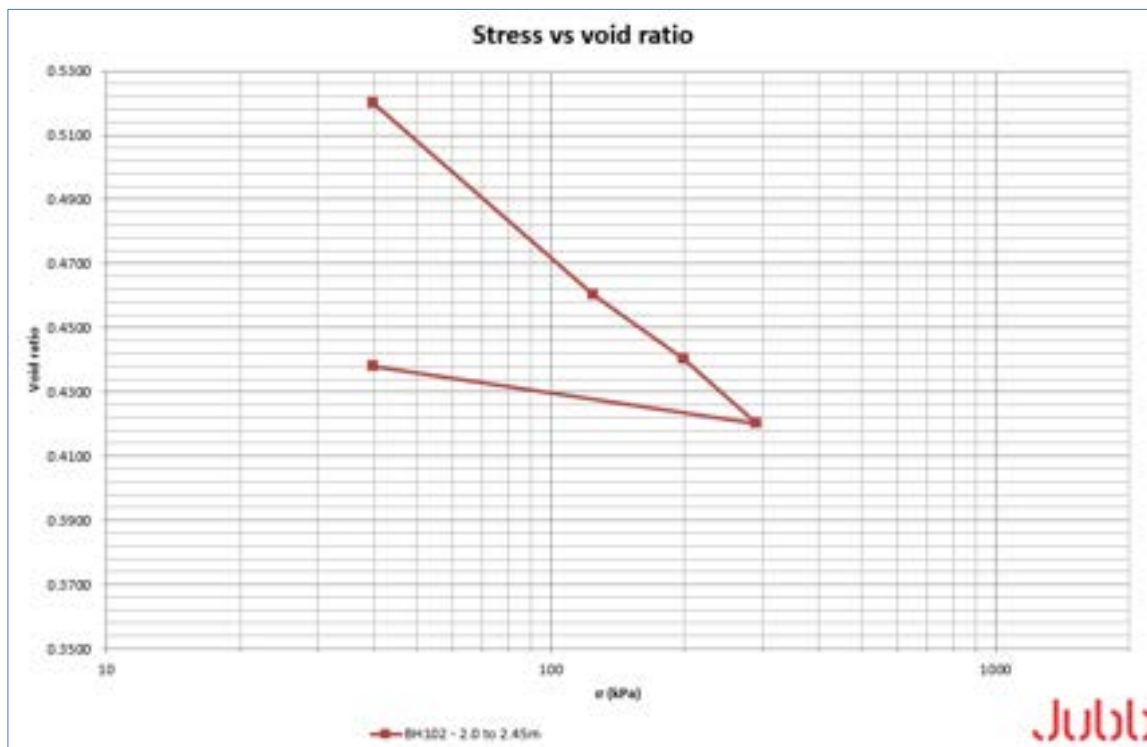
In addition, 1 no. one-dimensional consolidation tests was undertaken on an undisturbed sample from the Made Ground (2.00 - 2.45m bgl in BH102). Mv values of between 0.046 – 1.22 were recorded.

Figure 12: Made Ground Oedometer results

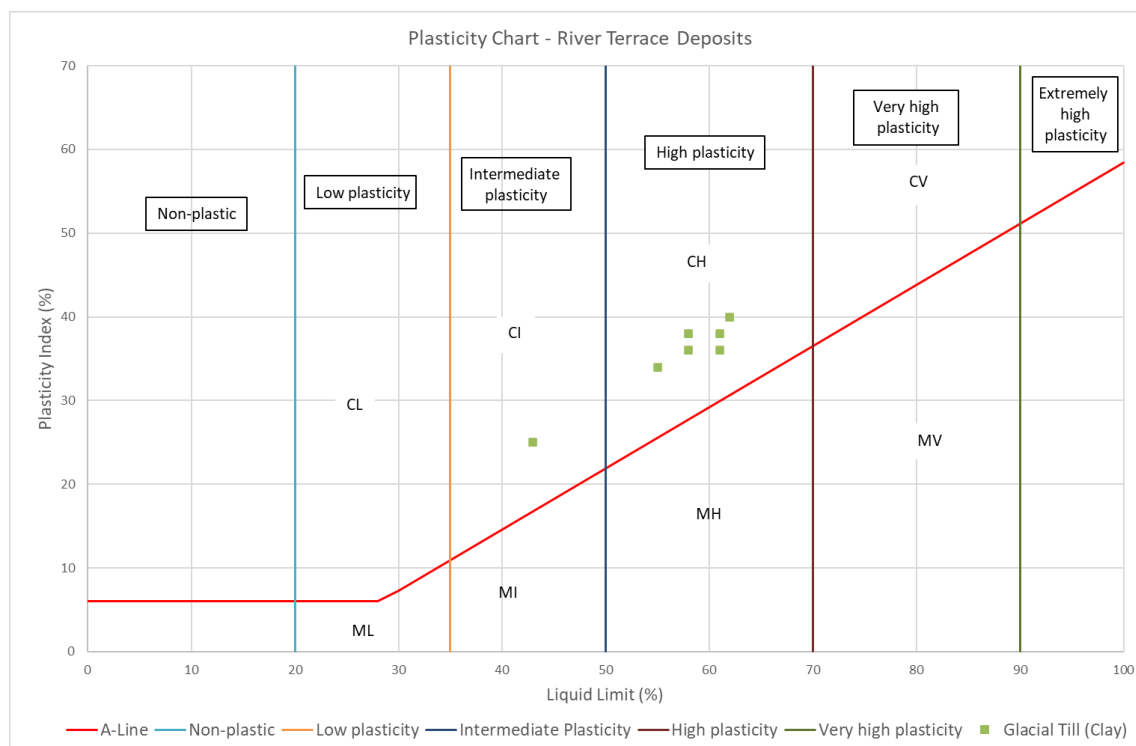
Figure 13: Glacial Deposits Atterberg Testing

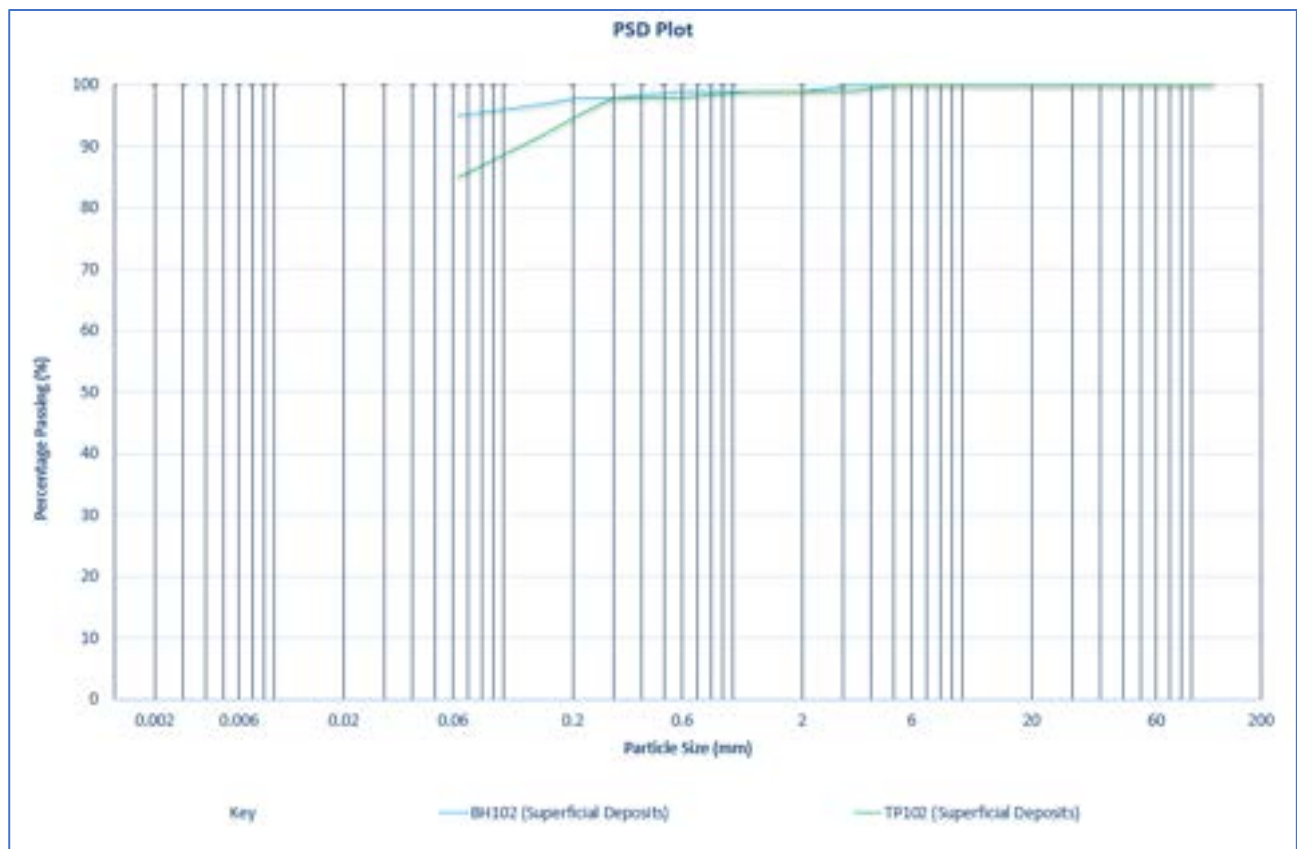
Figure 14: Particle size distribution chart of Glacial Deposits

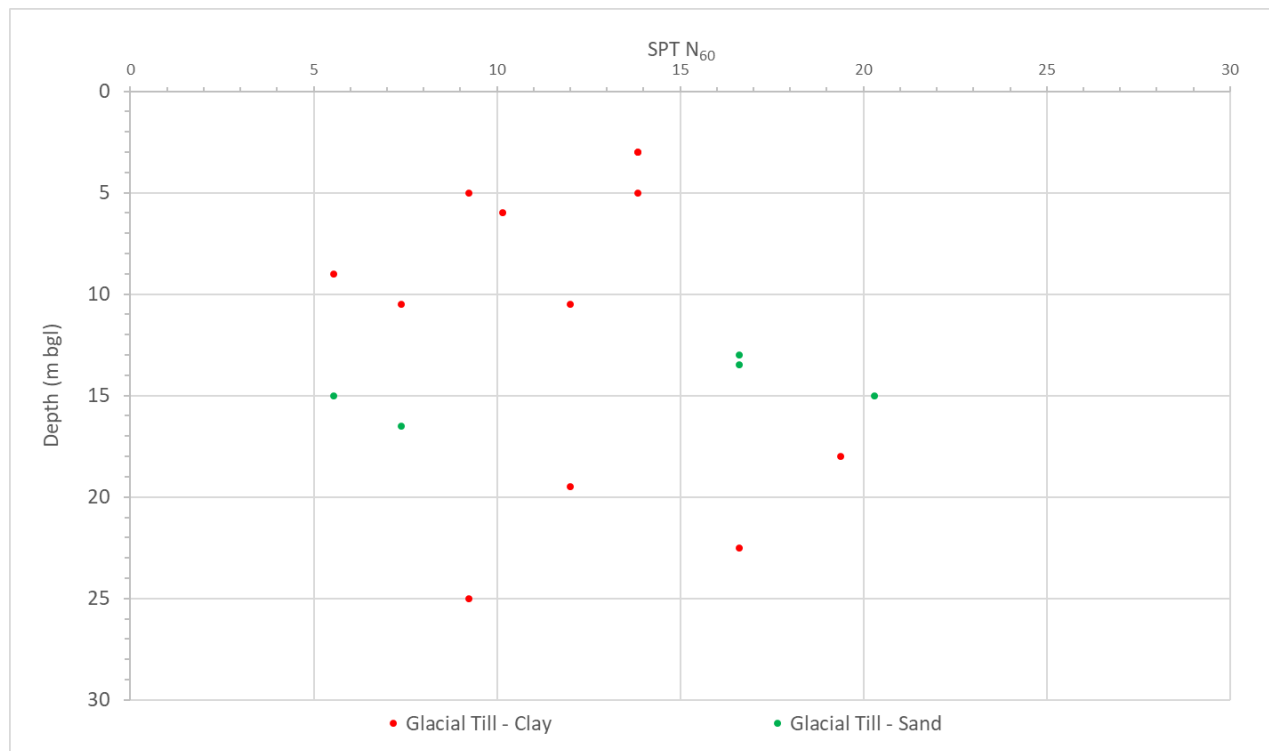
A total of 17 no. standard penetration tests (SPT) were carried out within the Glacial Till superficial deposits, 12 no. within variably sandy cohesive deposits and 5 no. within the more significant granular sand bands. The testing was carried out between 3m and 25m bgl depth and the SPT  $N_{60}$  results have been split into granular and cohesive units. No significant correlation between N value with depth was identified.

Figure 15. SPT Results – Glacial Deposits

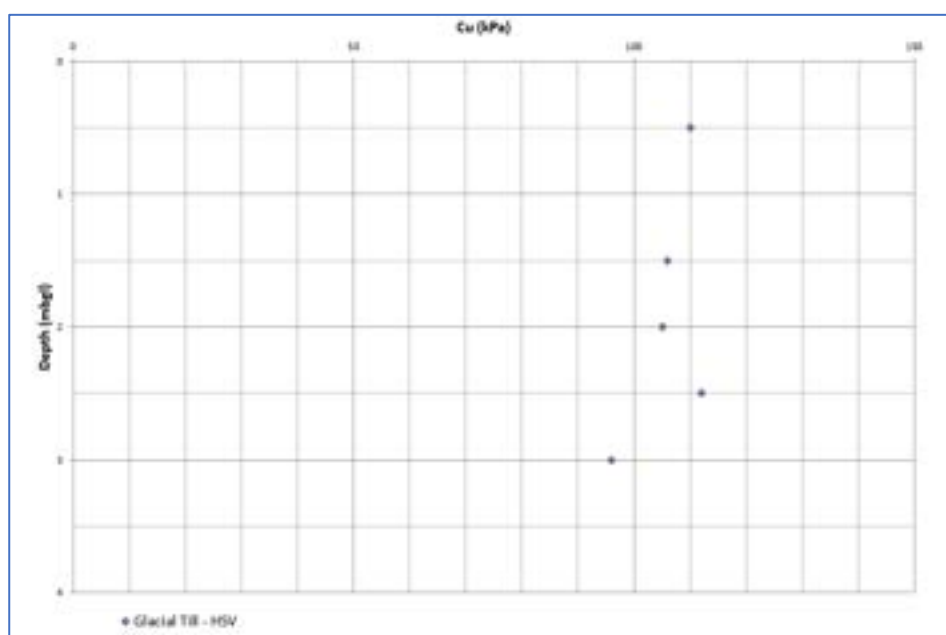
5 no. hand shear vane tests were carried out across the site within the cohesive superficial deposit soils, undertaken within TP102 between depths of 0.5m and 3.0mbgl. The results indicated an undrained shear strength ranging between 96kPa and 110kPa, with an average of 106kPa and a lower quartile of 105kPa.

Figure 16: HSV Values for Glacial Till

In addition, a 6 no. unconsolidated undrained triaxial (QUT) test were carried out on undisturbed samples from BH101 and BH102 within the cohesive superficial deposit soils between 4.00m and 24.45m depth bgl, which returned variable average undrained shear strengths, between 7kPa and 50kPa.

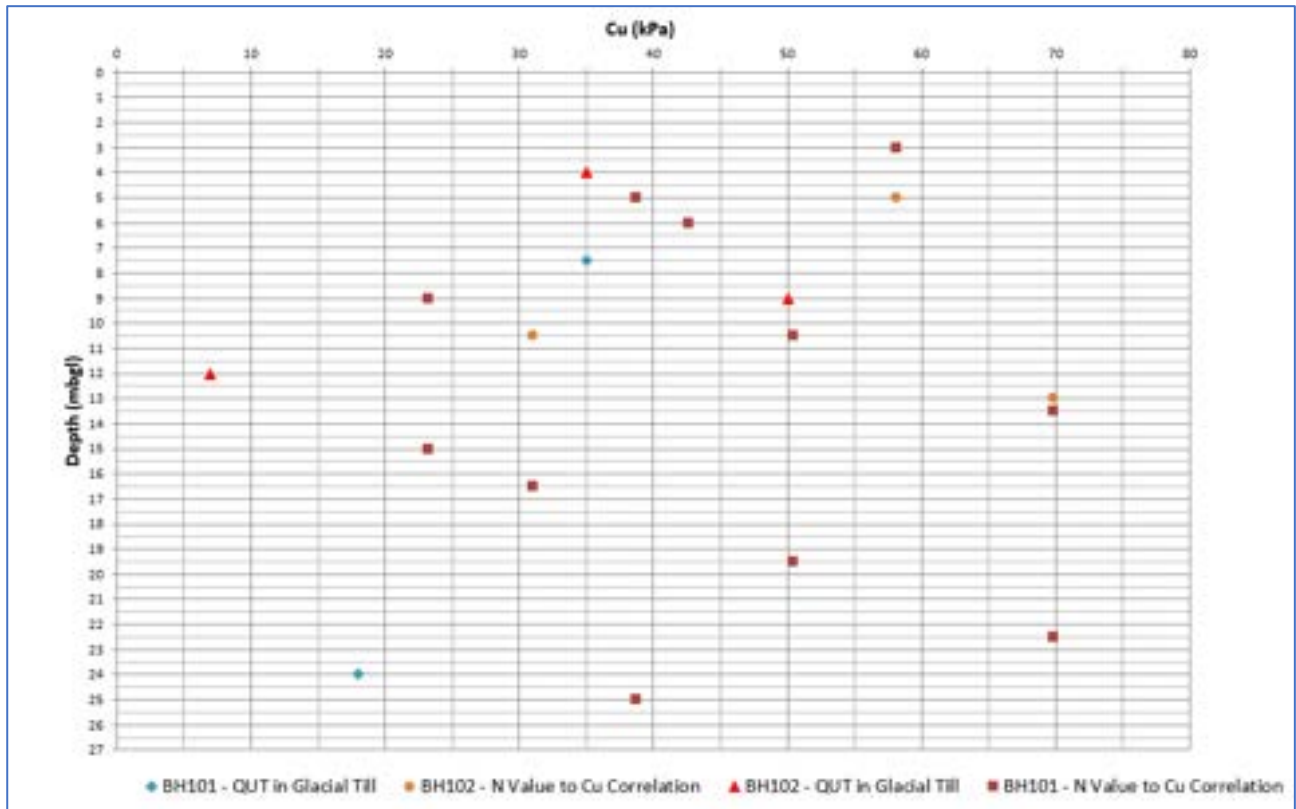
Figure 17. Glacial Till –  $C_u$  from QUT and SPT N Value Correlations

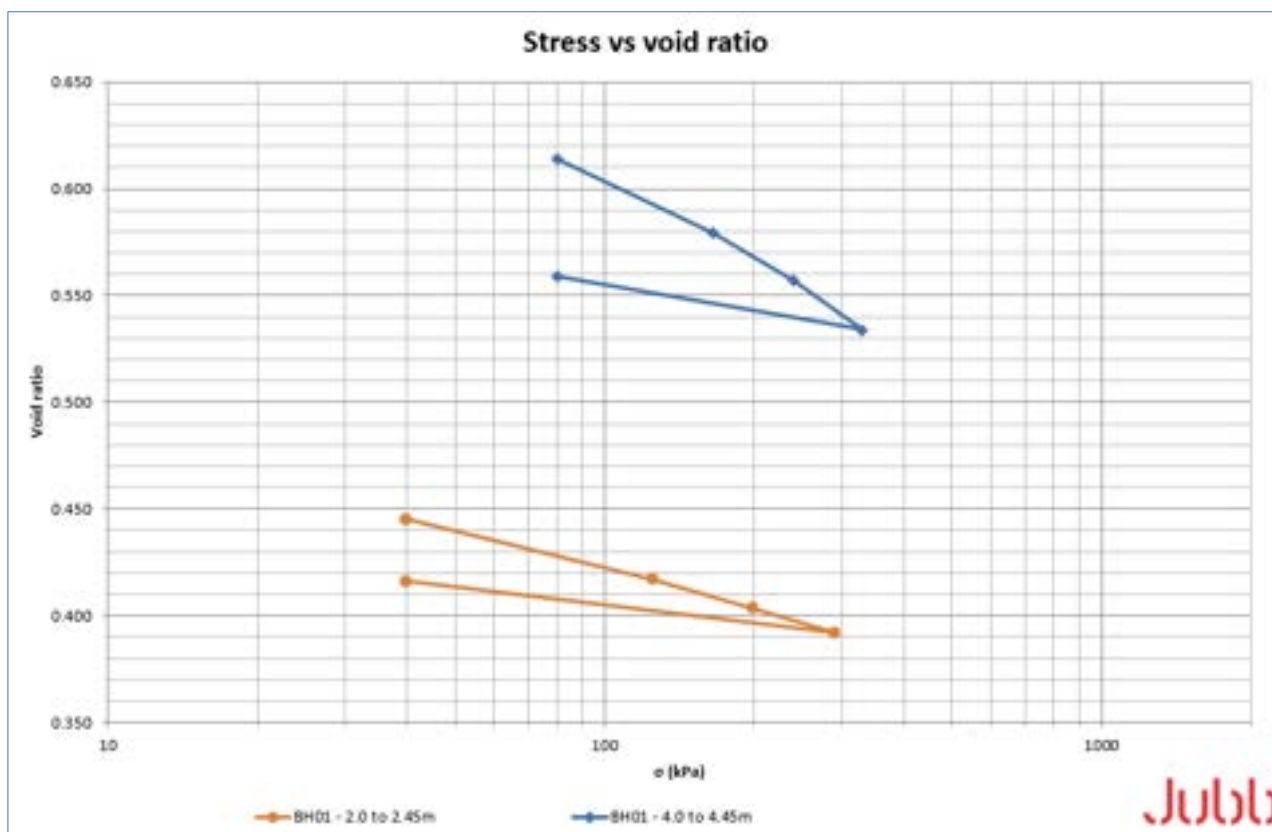
In addition, 2 no. one-dimensional consolidation tests were undertaken on an undisturbed sample from the Glacial Till materials, as indicated below.

Figure 18: Oedometer Test Results - Glacial Till

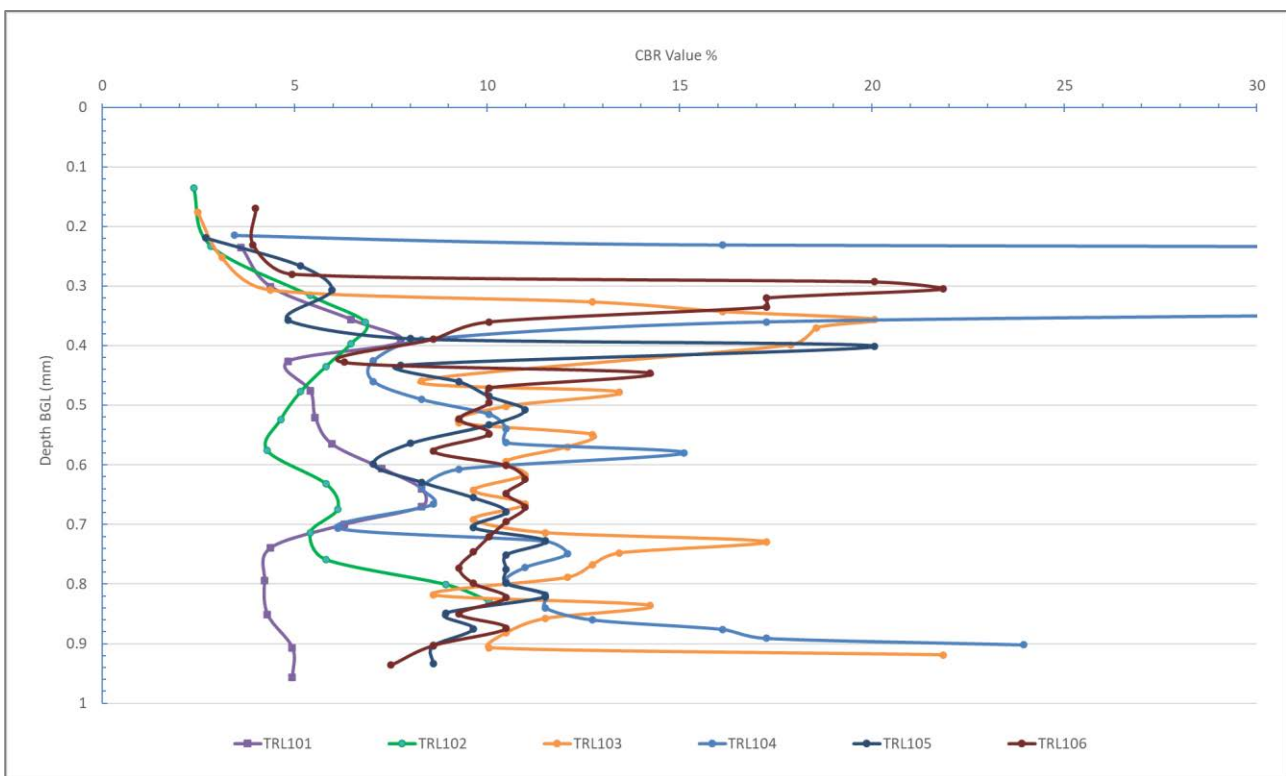
Figure 19: CBR vs Depth correlated from DCP testing

Between ground level and 0.2 m depth bgl the test probe typically penetrated the soils under the weight of the equipment, this represents the topsoil material, from 0.20m bgl CBR values were observed to range between 2% and in excess of 30%, with an average value of 14%.

Below 0.4 m depth, CBR values are observed to cluster between 5 - 10%.

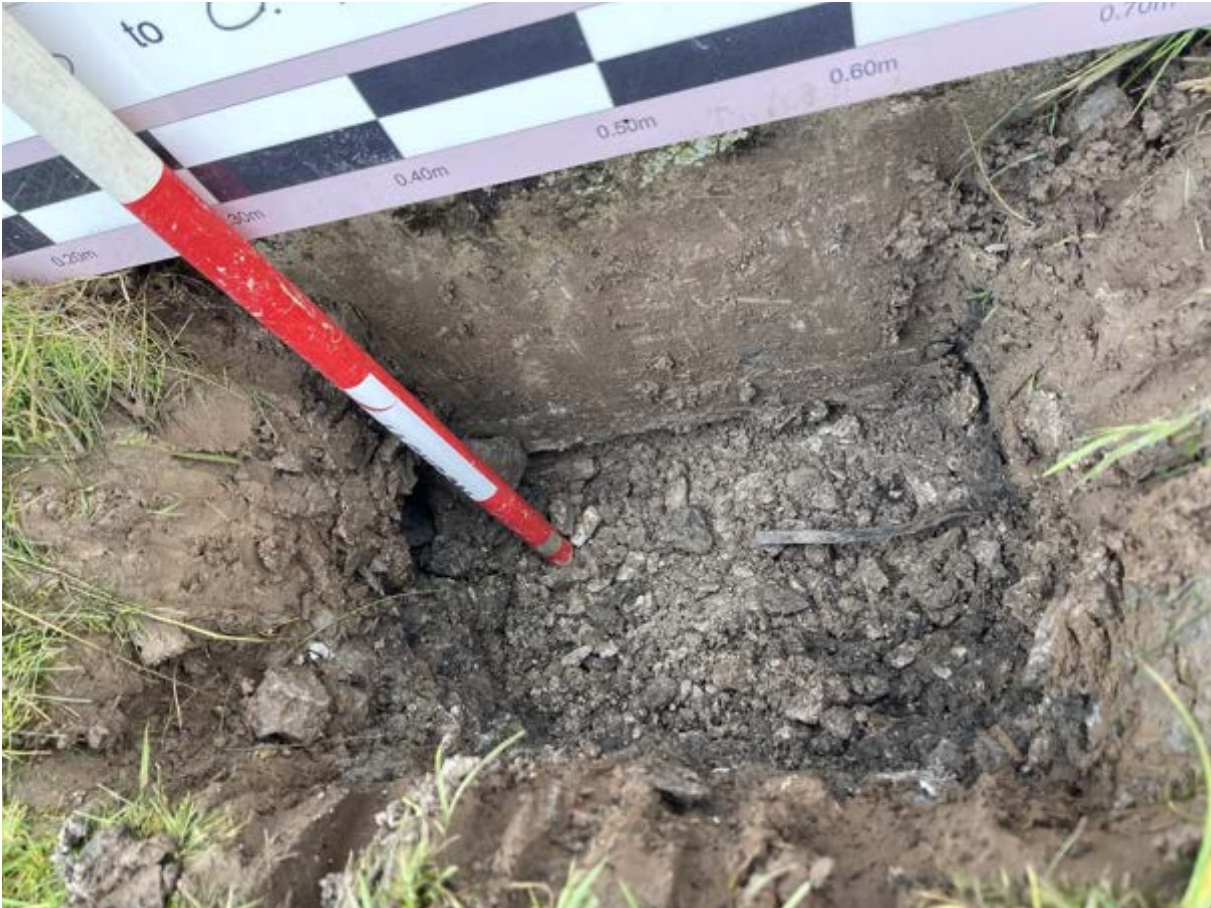
HP101 Detail

| Project No | G24001 | Level | 32.11 mAOD | Termination Reason | Base of foundation pad exposed | |

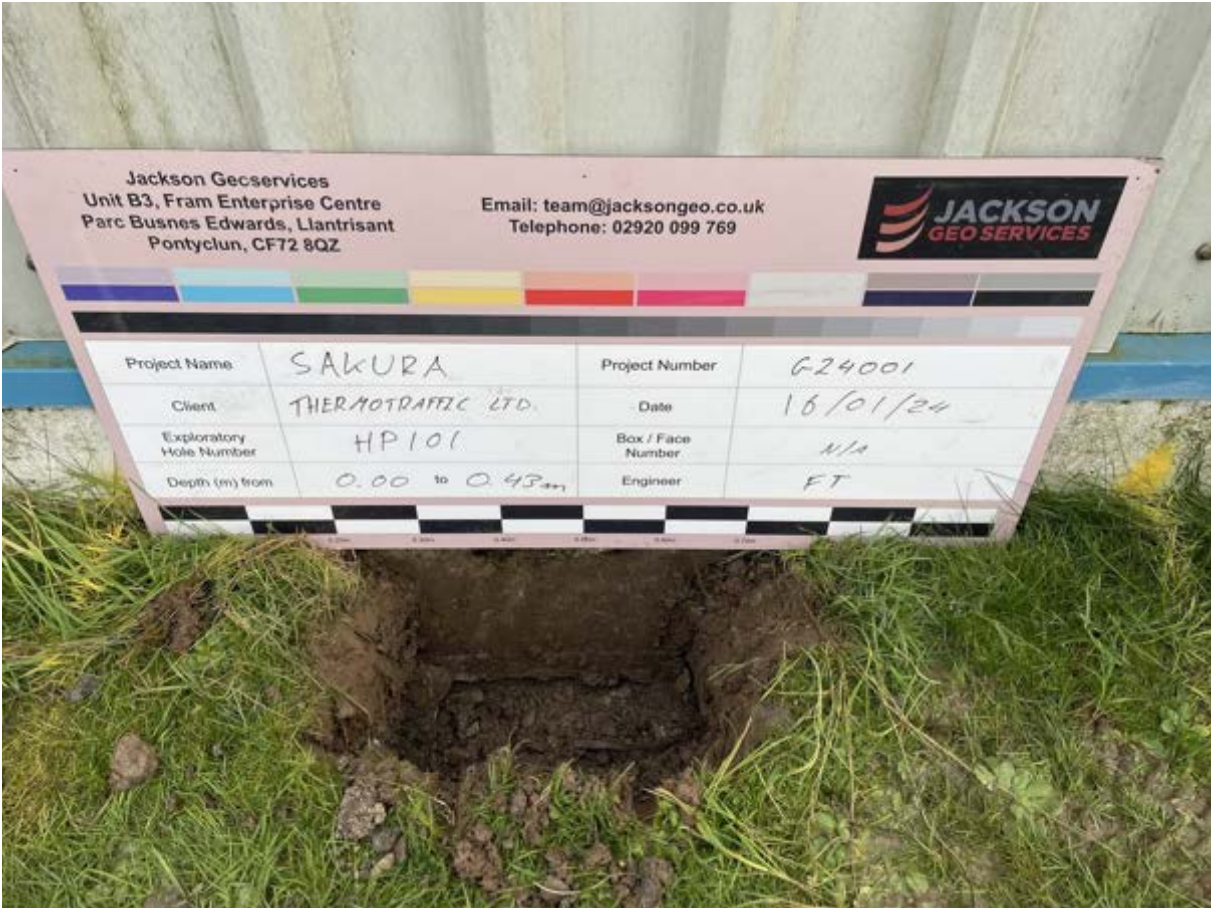
HP101

| Remarks<br>hand excavated foundation inspection pit from GL to 0.26m. | | | | | | | | | | | | | |

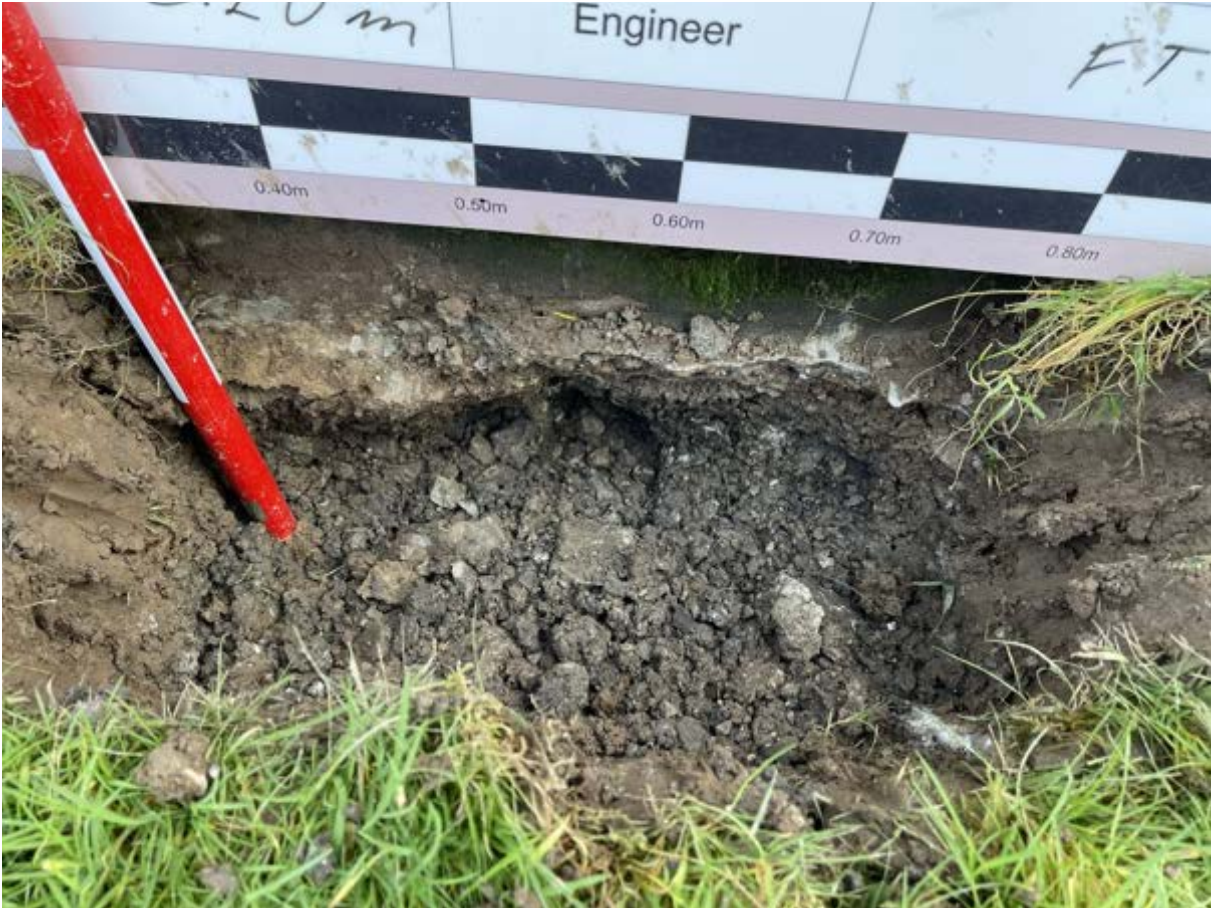
HP102 Detail

| Project No | G24001 | Level | 31.56 mAOD | Termination Reason | Base of foundation pad exposed | |

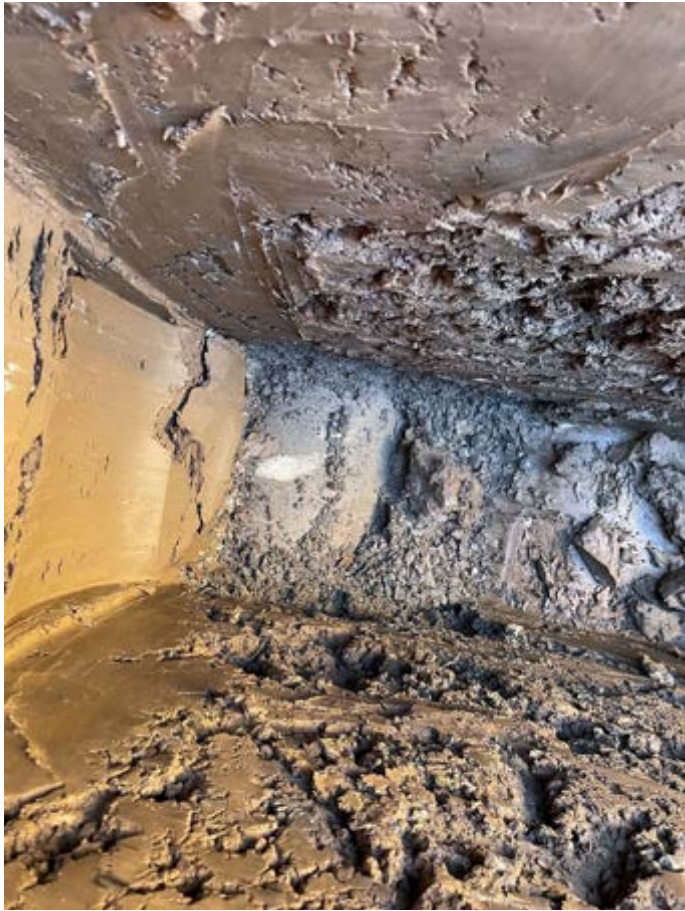
Concrete utility at base 1

TP101 and TP101 were terminated shy of target depths due to concrete culverts being encountered at 1.80m and 2.2m respectfully. TP103 was terminated shy of target depths due to the encountering of a water main at a depth of 0.7m bgl. No damage of these buried services was noted. TP105 was terminated shy of target depths due to the encountering of a metal wire/ cable at 1.8m bgl, presumed to be redundant and/ or as historic anthropogenic debris. All trial pit locations were photographed and backfilled upon completion, as per the other trial pit locations.

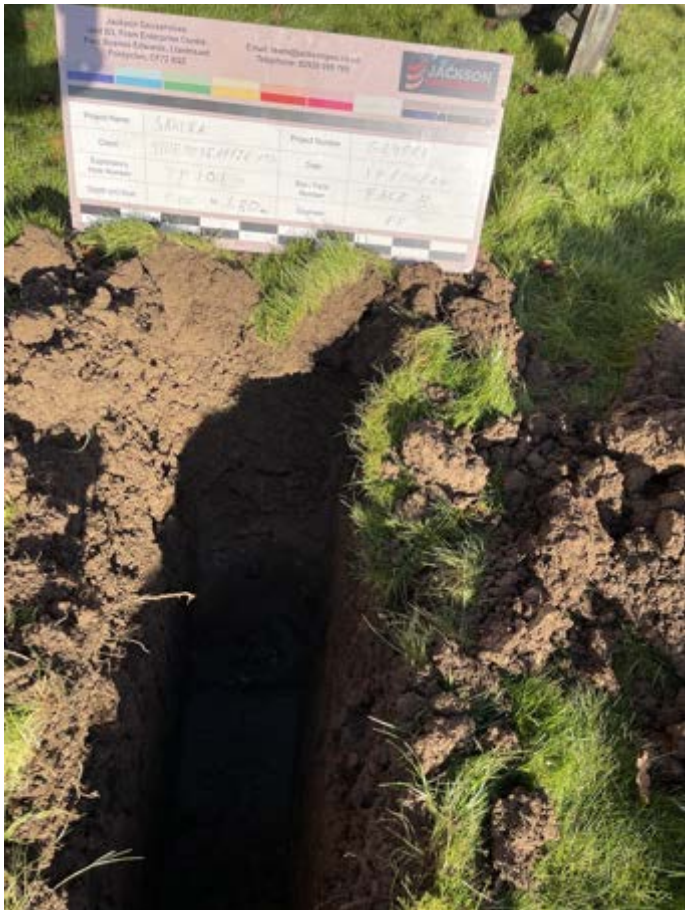
TP101 B

| Project No | G24001 | Level | 31.01 mAOD | Termination Reason | Service encountered (concrete pipe). | |

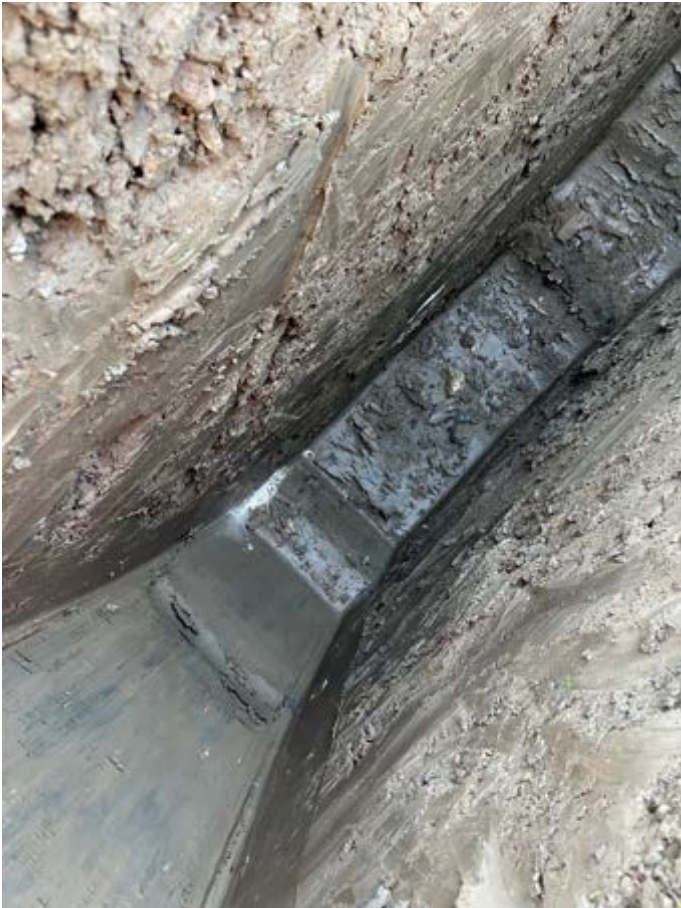
| Project No | G24001 | Level | 31.29 mAOD | Termination Reason | Potential service encountered (concrete pipe). | |

Concrete utility at base
