# Project Sakura, Wrexham

Title Ground Conditions Assessment Report

Jubb have been commissioned by TSL on behalf of SmartParc to provide a geotechnical and geo-environmental assessment of the site, combining both a Phase 1 Desk Study and a Phase 2 Interpretative Ground Investigation (GI) Report. This report provides a review of the historic desk study information (as provided by the client), general site context and historical mapping, as well as advice for the geotechnical and geo-environmental design of the development and associated ground contamination and geotechnical hazards.

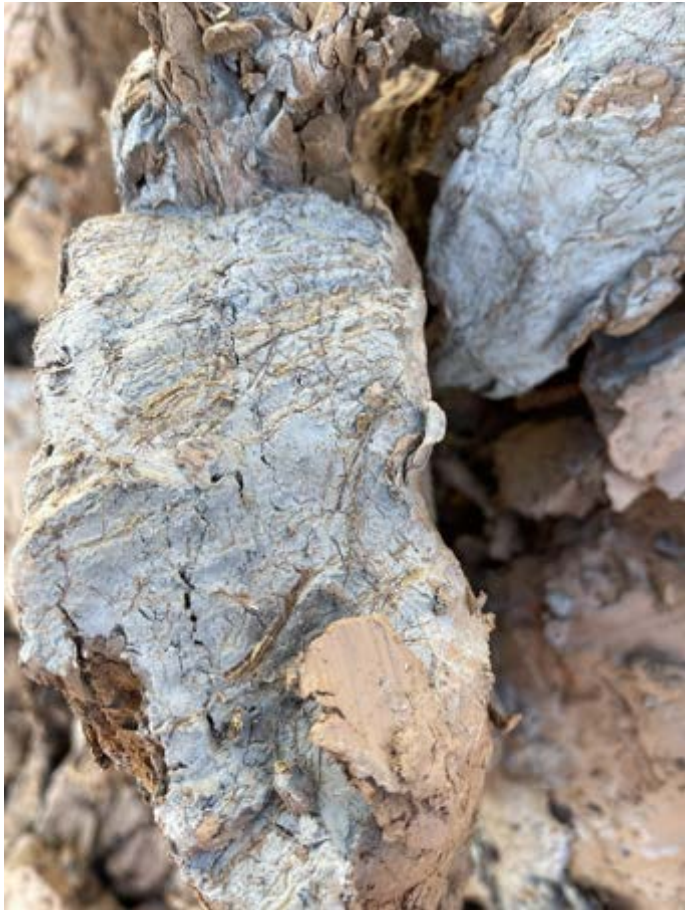
TP102 rootlets at 3.0m

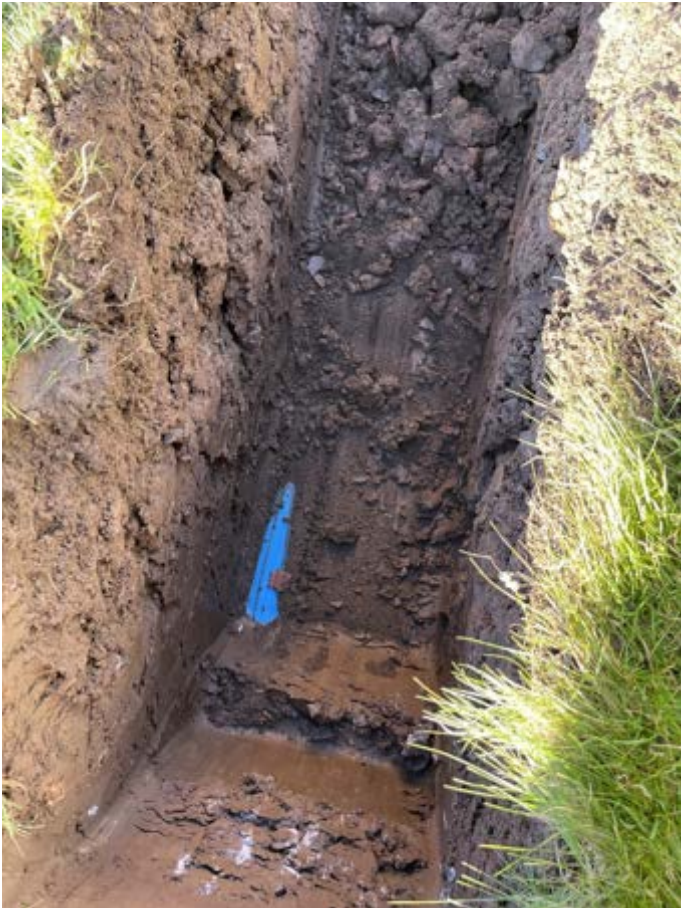
| Project No | G24001 | Level | 31.70 mAOD | Termination Reason | Water utility uncovered within pit. | |

TP103 utility and pit

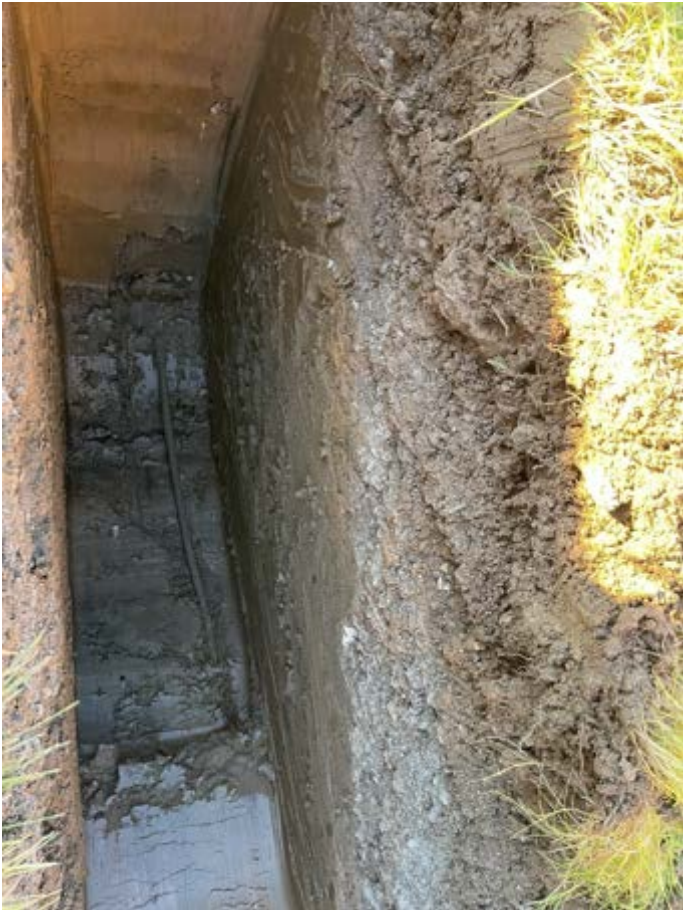
TP105 Face A

| Project No | G24001 | Level | 32.52 mAOD | Termination Reason | Potential service encountered (metal wire / cable). | |

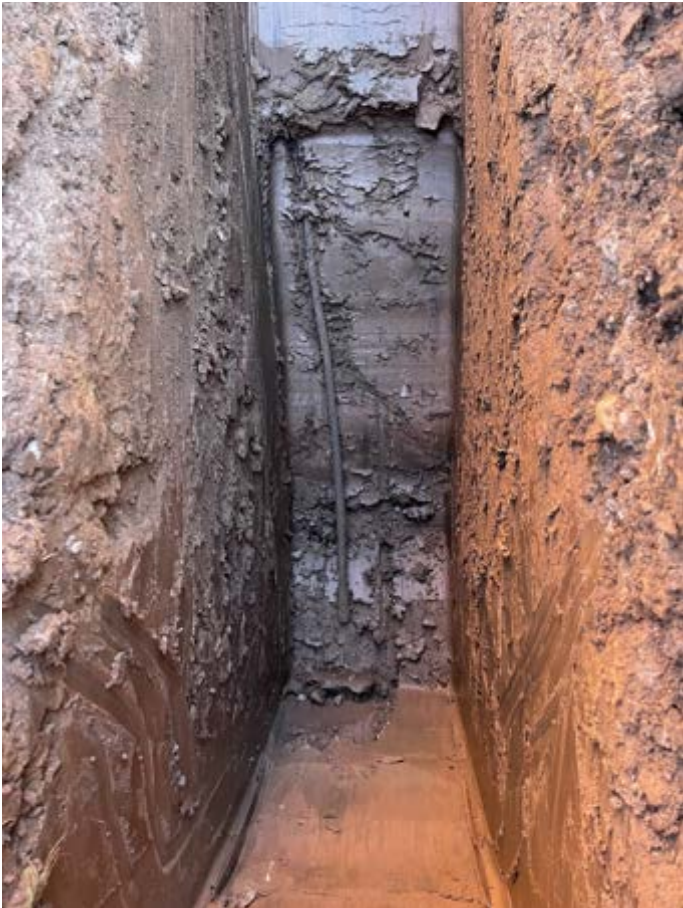
TP105 wire at base

| Project No | G24001 | Level | 32.52 mAOD | Termination Reason | Potential service encountered (metal wire / cable). | |

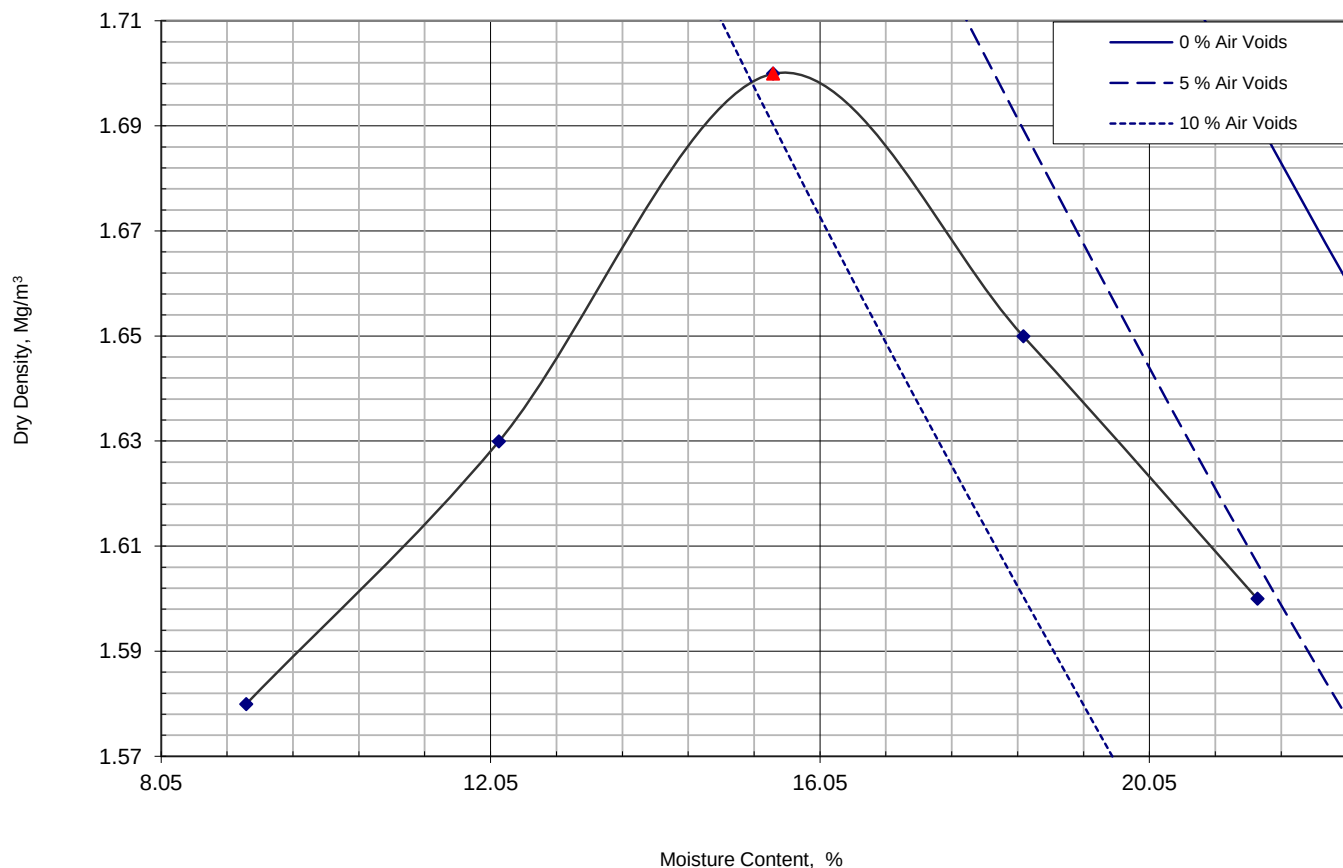
**Dry Density / Moisture Content Relationship  
BS 1377:Part 4:1990**

| Sample Description | Brown silty CLAY | Single or Separate Sample Used | Single |

| Moisture Content | 9.1 | 12 | 15 | 19 | 21 | | | | | | |

| Optimum Moisture Content | 15 | % |

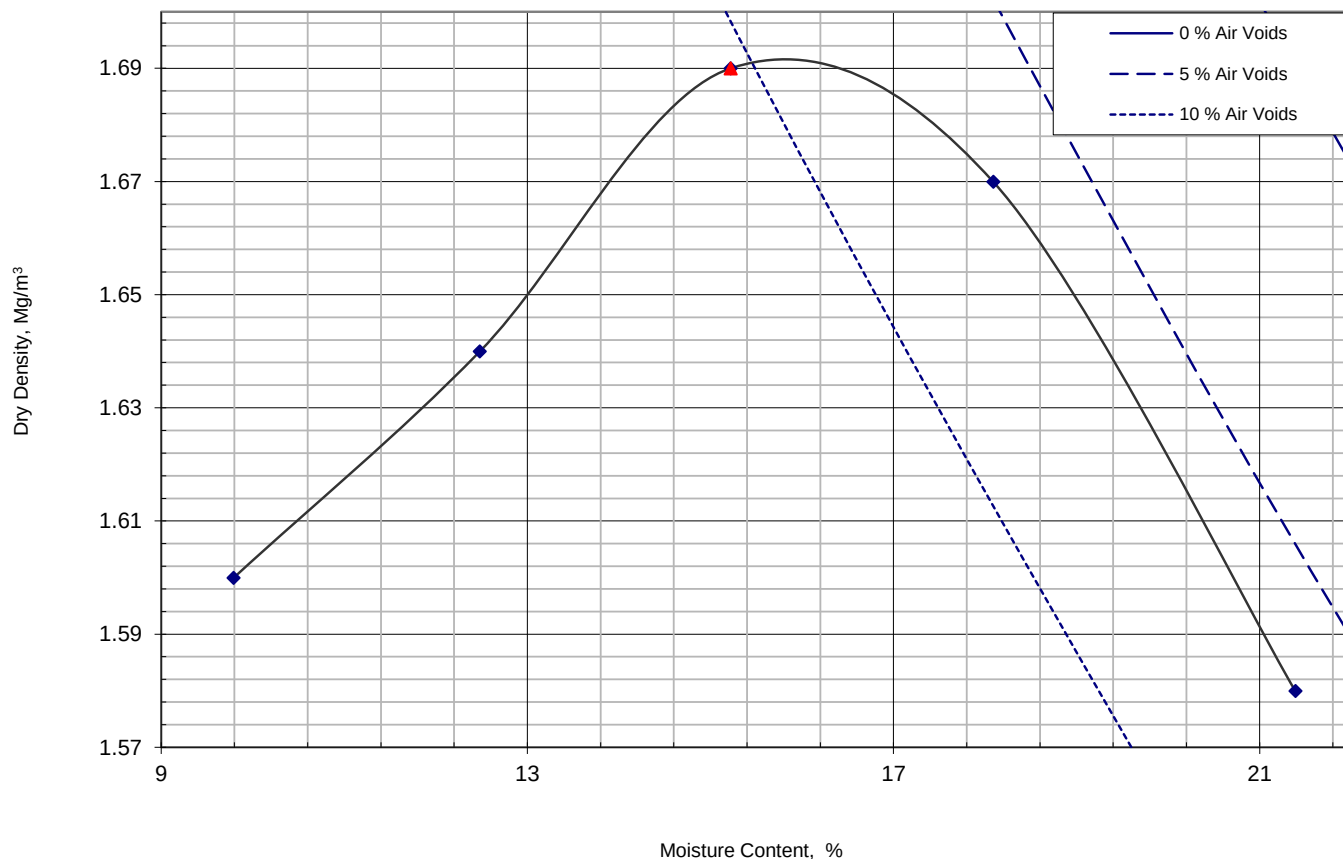
**Dry Density / Moisture Content Relationship  
BS 1377:Part 4:1990**

| Sample Description | Brown fine to medium gravelly silty CLAY | Single or Separate Sample Used | Single |

| Moisture Content | 9.8 | 12 | 15 | 18 | 21 | | | | | | |

| Optimum Moisture Content | 15 | % |

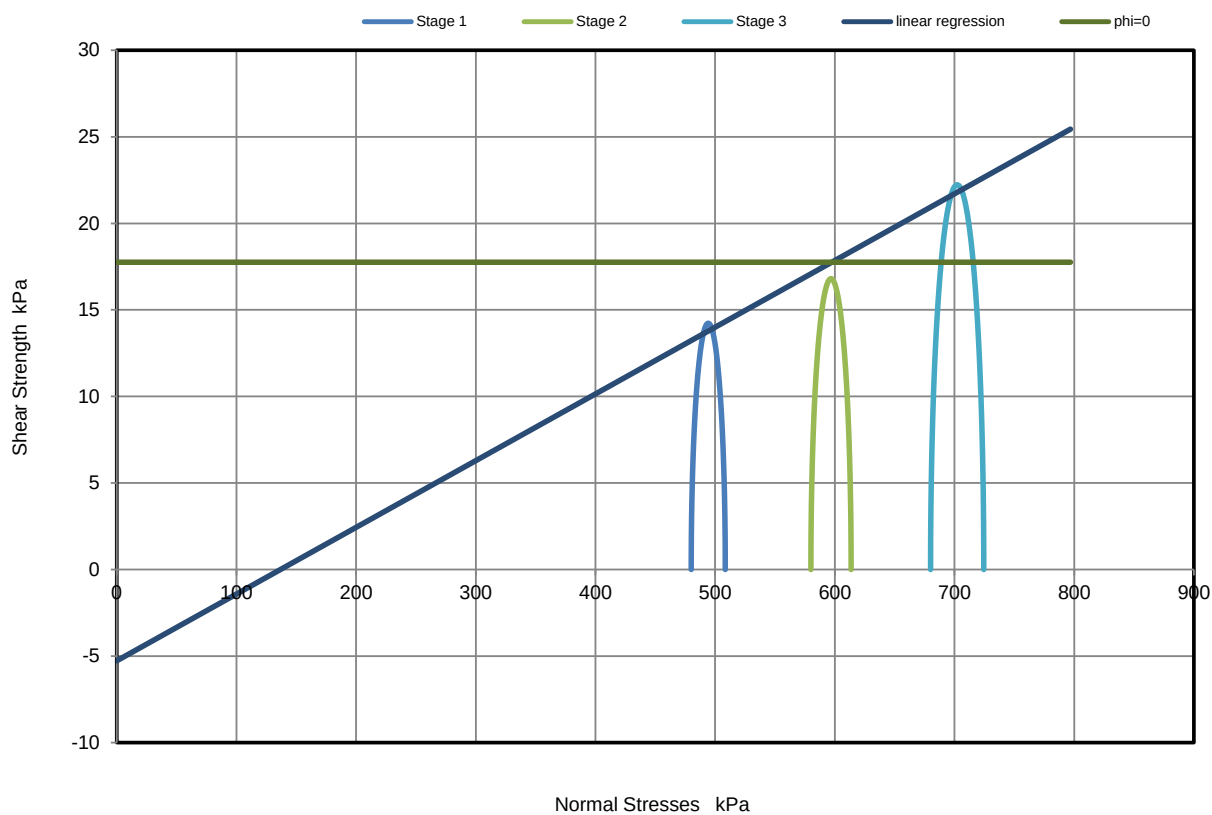
**Mohr Circles**

| Average $c_u$ | 18 kPa | $\phi_u$ | 2.2 ° |

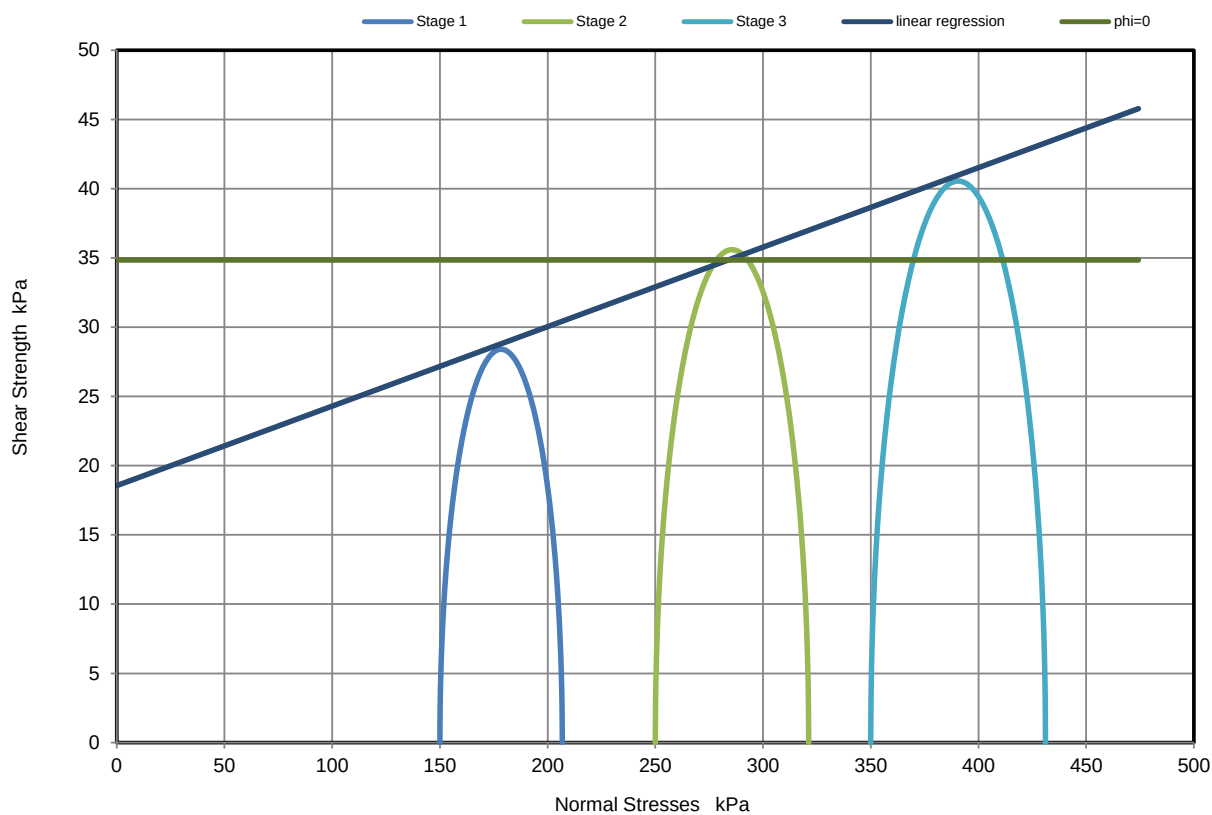
**Mohr Circles**

| Average $c_u$ | 35 kPa | $\phi_u$ | 3.3 ° |

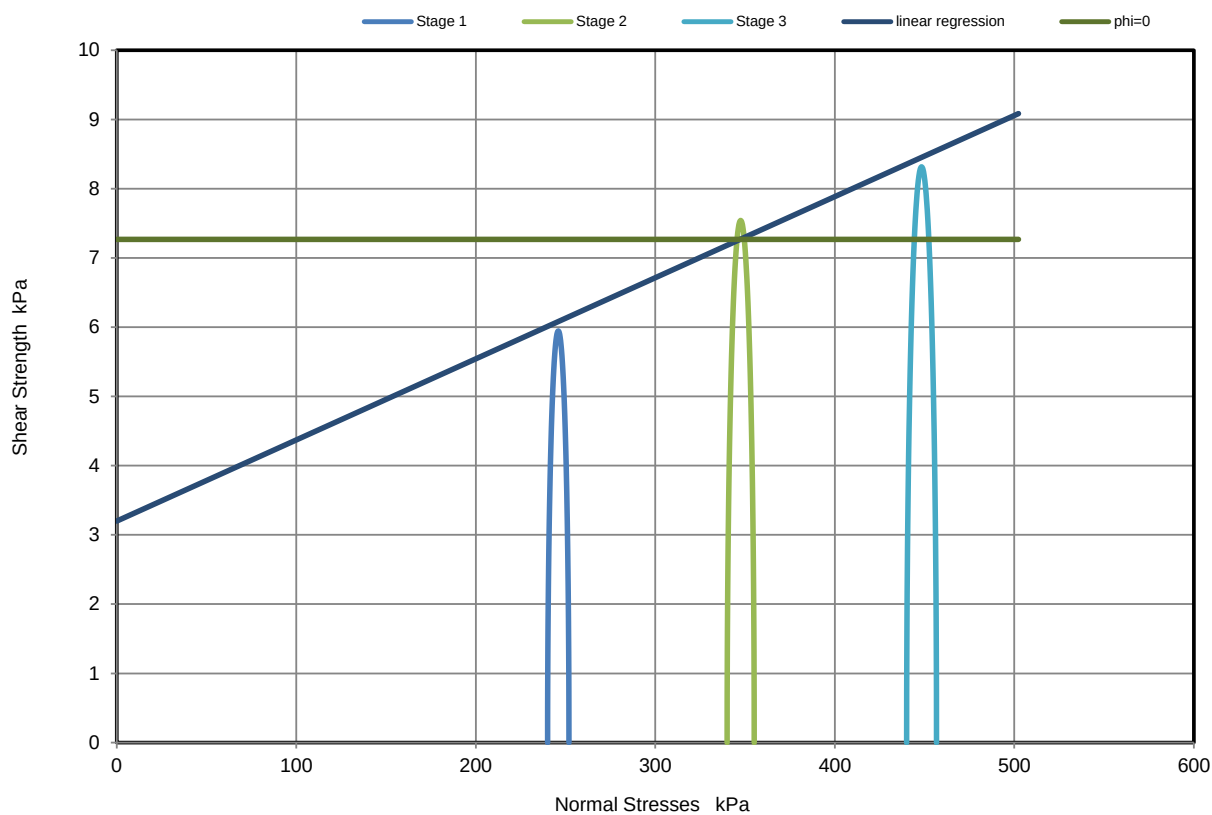
**Mohr Circles**

| Average $c_u$ | 7 kPa | $\phi_u$ | 0.7 ° |

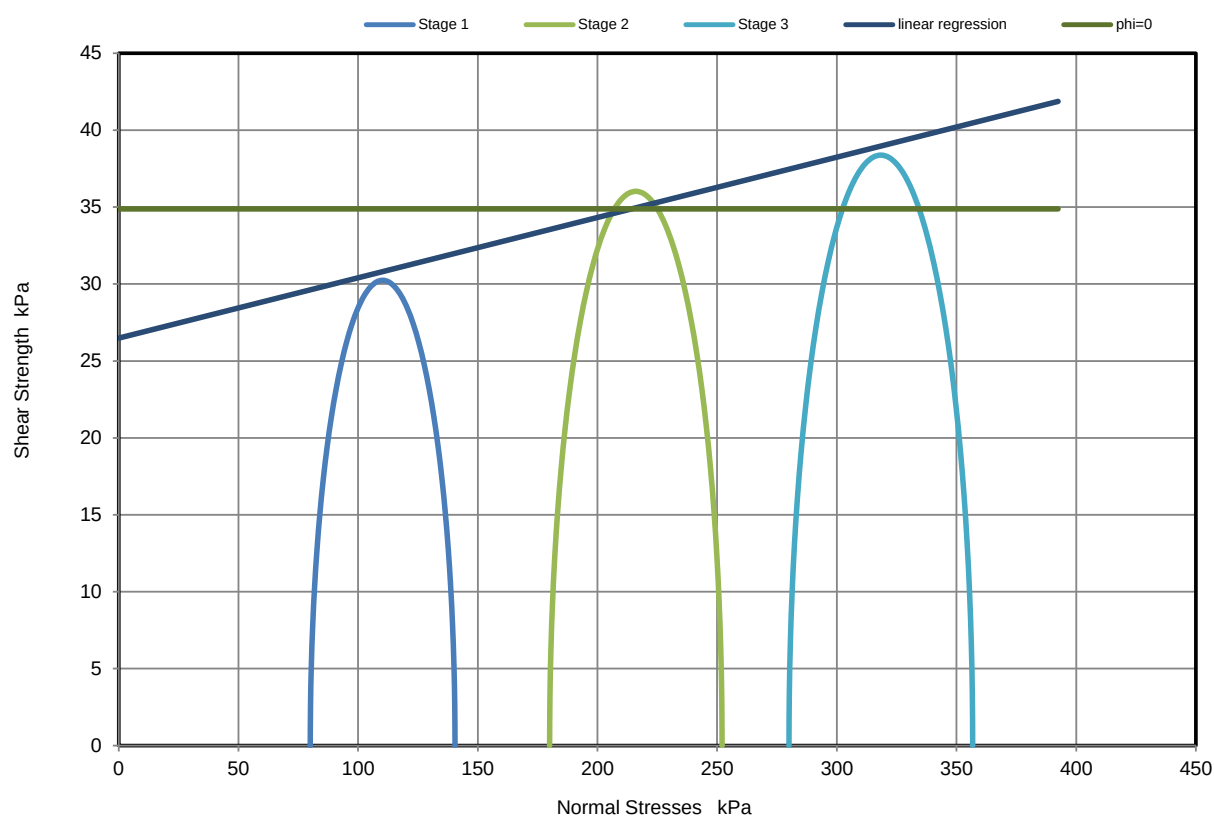
**Mohr Circles**

| Average $c_u$ | 35 kPa | $\phi_u$ | 2.2 ° |

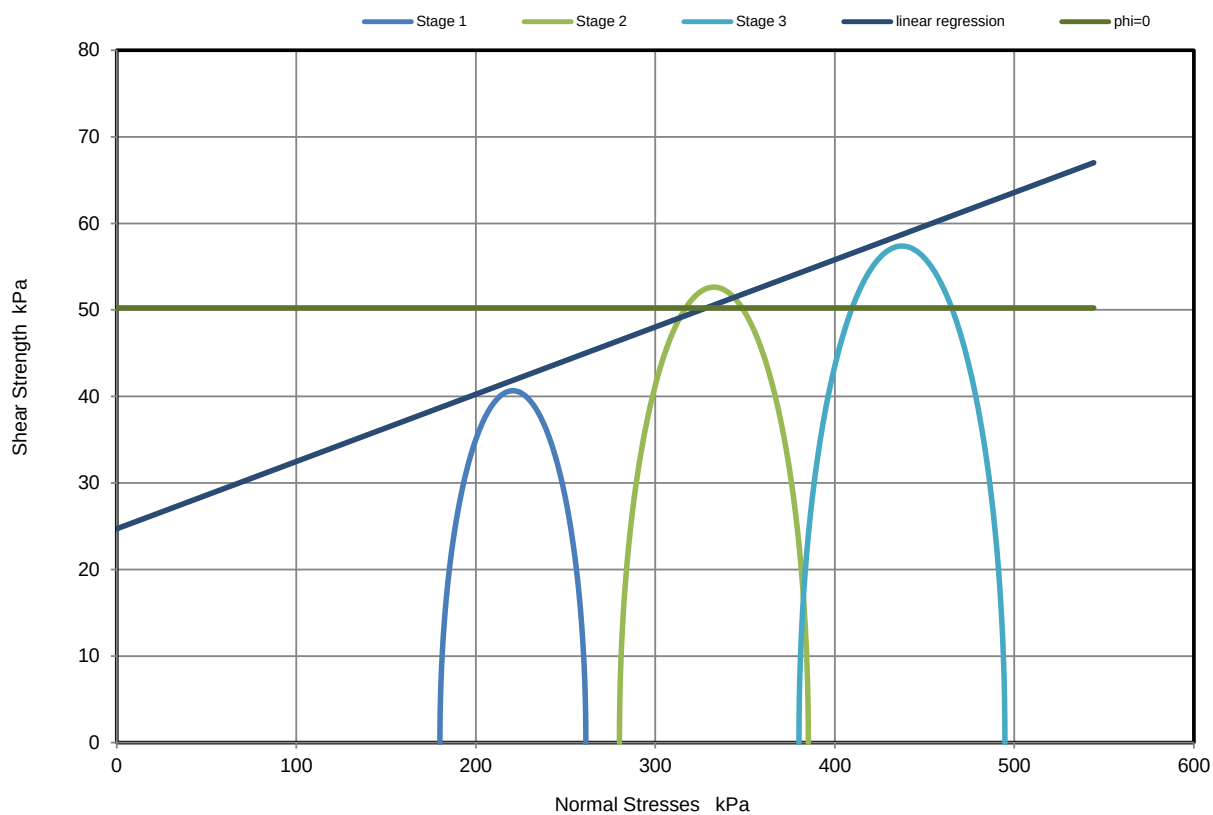
**Mohr Circles**

| Average $c_u$ | 50 kPa | $\phi_u$ | 4.4 ° |
