# Ground Gas Addendum Report

Site: Tupa, Penley  
Reference: 17-510-R3  
Date: July 24

## E3P

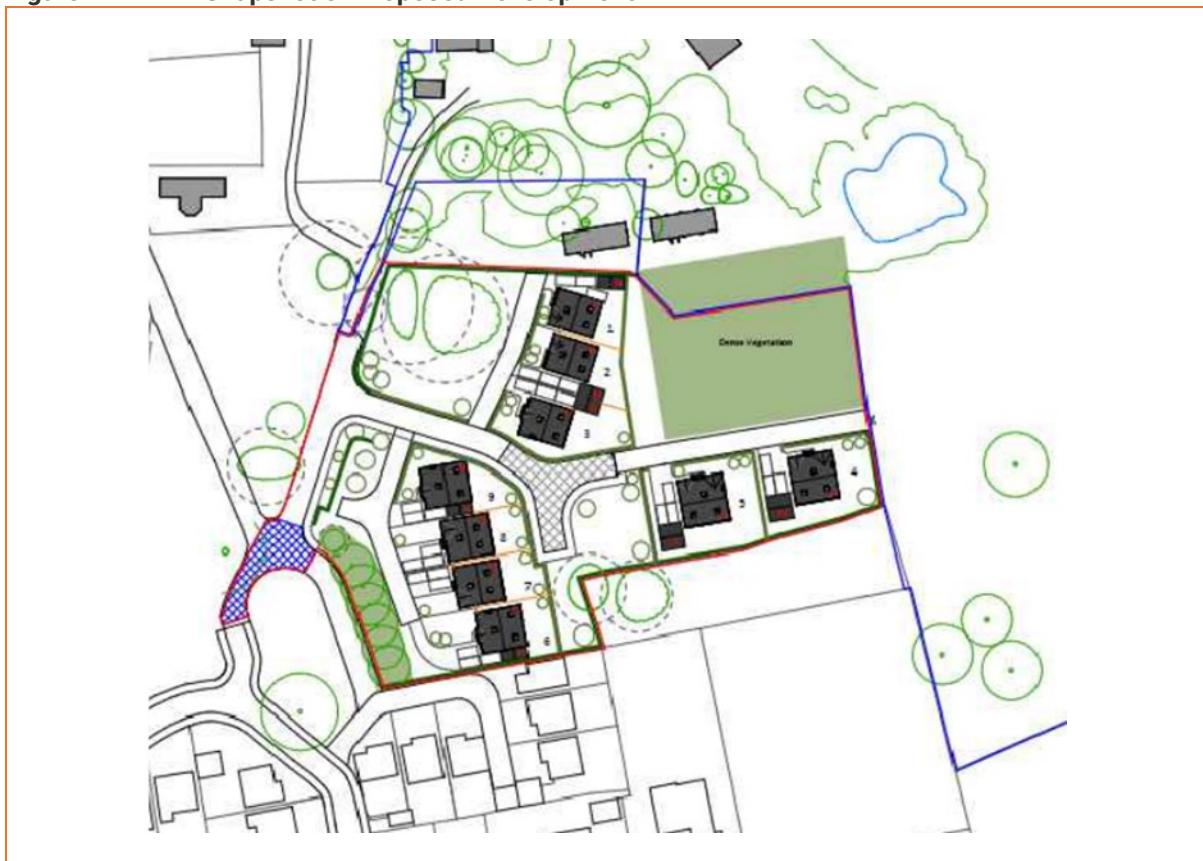
**Figure 1**      **Snapshot of Proposed Development**

E3P understands that the landowner intends to construct a 9 unit low-rise residential development with associated gardens, estate roads and infrastructure. Drawing 17-510-002 (APPENDIX III) identifies the proposed development layout.

A snapshot of the proposed development layout is indicated in Figure 1.

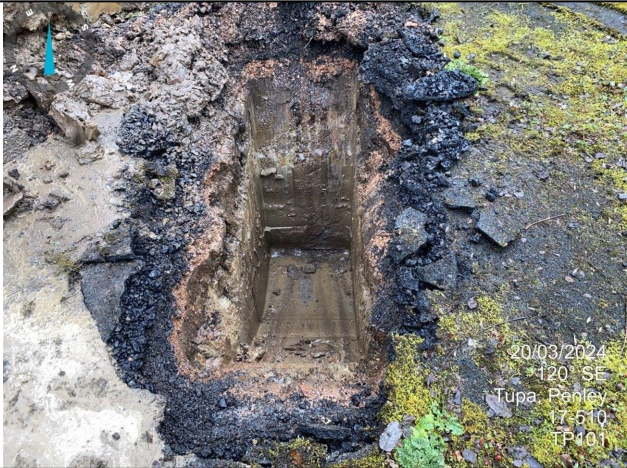
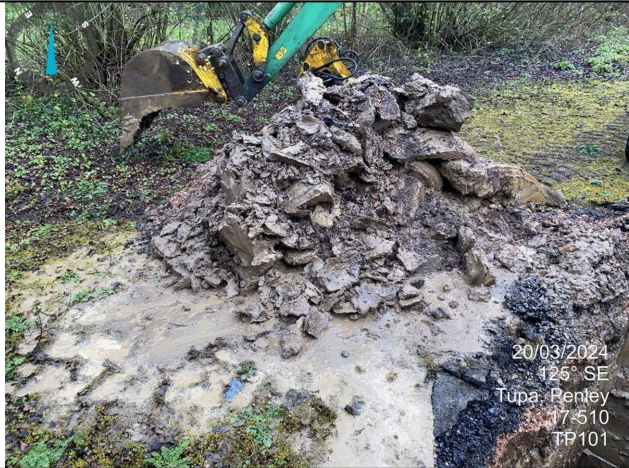
| <div>Remarks: 1. Complete. 2. Water strike noted as moderate ingress at 0.30 m bgl. 3. W3W: bonnet.severe.ensemble</div> | | | | | | | | | | |

WS101 and TP101 were advanced in the position of the former tennis courts in the south east and with a thin layer of tarmacadam (up to 0.05 m in thickness) overlying reworked sandy gravels of mudstone, sandstone and fragments of brick. Within TP101 between 0.05–0.20 m bgl black sandy gravel of ash and clinker has been identified.

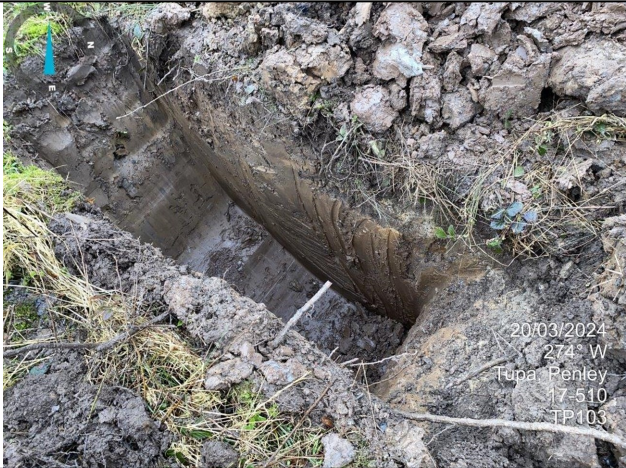
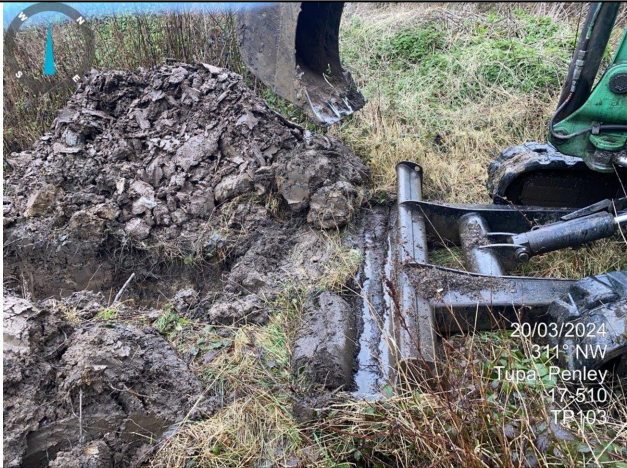
| Remarks: 1. Complete. 2. Water strike noted as slow ingress at 0.40 m bgl. 3. W3W: left.shorts.correctly | | | | | | | | | |

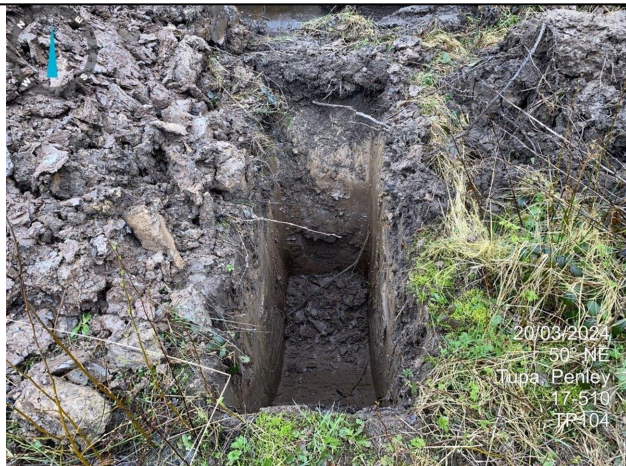
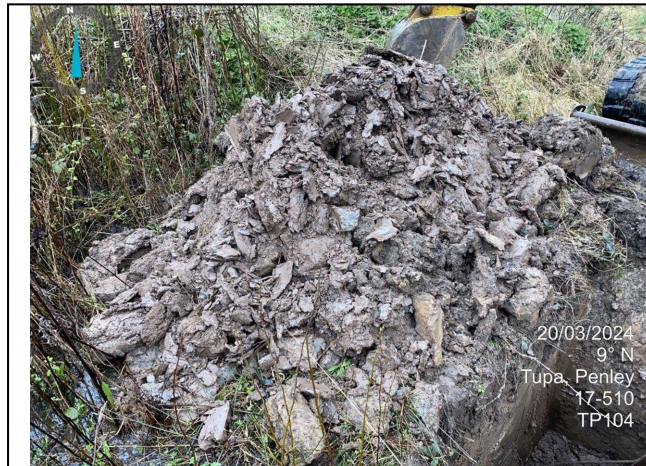
TP104 - Excavation

Remarks: 1. Complete. 2. Water strike noted as slow ingress at 0.30 m bgl. 3. W3W: onto.claps.manicured

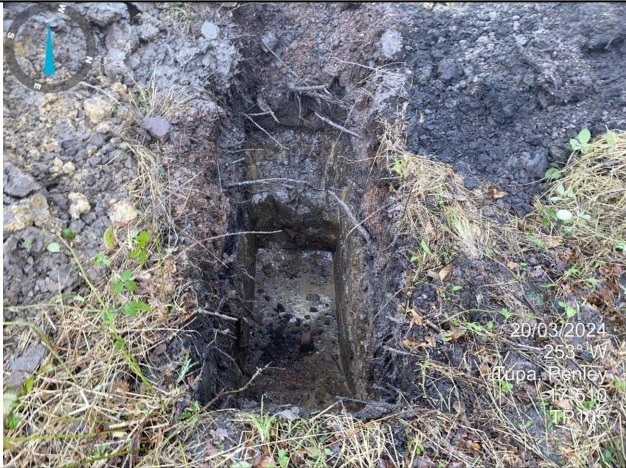
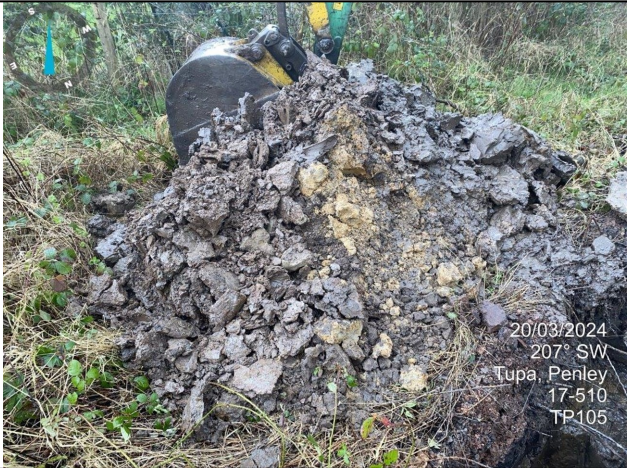
| <div>Remarks: 1. Complete. 2. Water strike noted as slow ingress at 1.00 m bgl. 3. Slight organic odour between 0.40 m bgl and 0.80 m bgl. 4. W3W: tadpole.tilt.waxing</div> | | | | | | | | <div></div> | | |

Deposits within TP105 are believed to be in the position of the former pond feature and comprise reworked silty, sandy clay topsoil above brown sandy gravels of sandstone and brick with cobbles of whole brick identified within the matrix. Between 0.40–0.50 m bgl an organic odour has been noted within the Made Ground deposits.

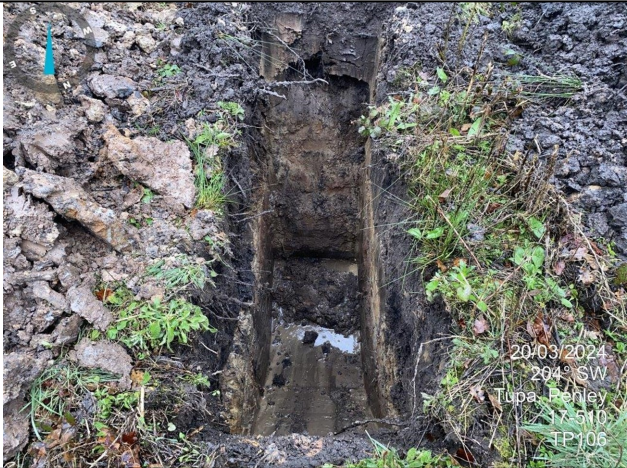
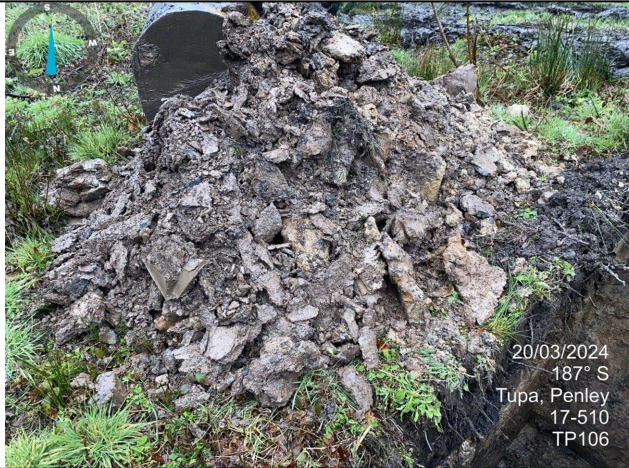
| Remarks: 1. Complete. 2. W3W: peach.products.contact | | | | | | | | | | |

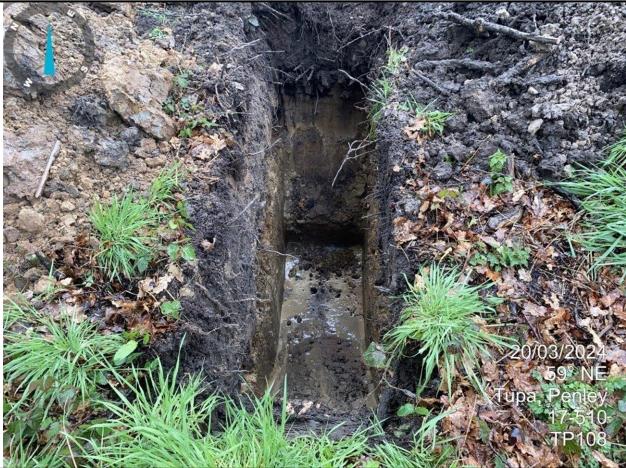
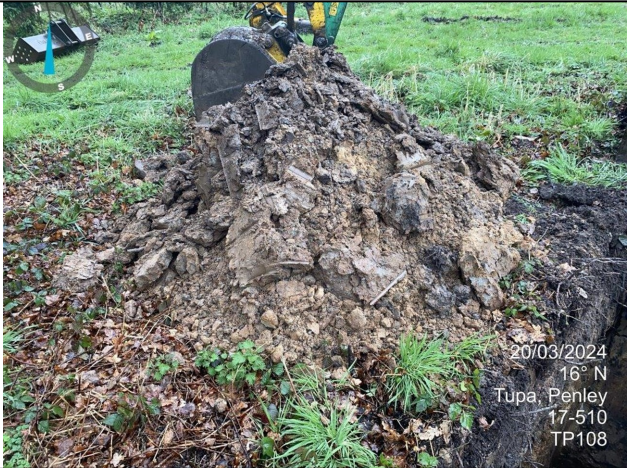
| Remarks: 1. Complete. 2. Water strike noted as slow ingress at 0.60 m bgl. 3. W3W: constrain.represent.saves | | | | | | | | | |

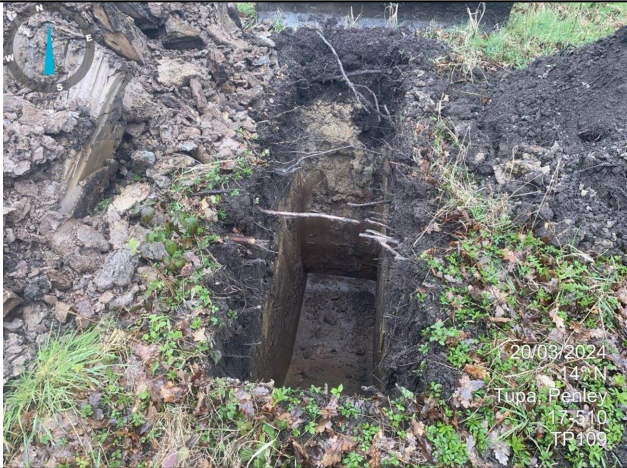
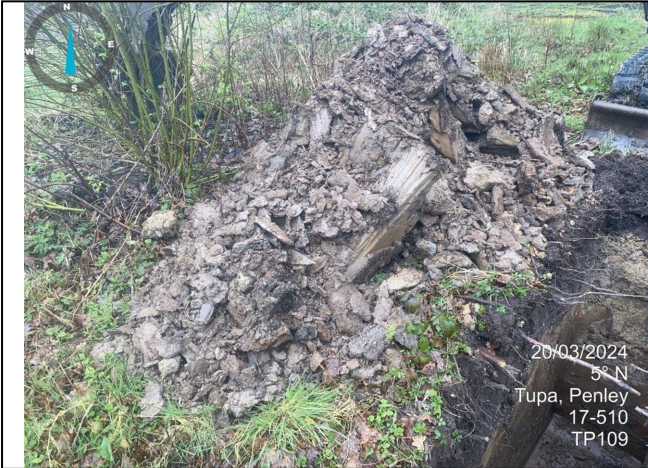
| Remarks: 1. Complete. 2. Water strike noted as slow ingress at 0.30 m bgl. 3. W3W: mysteries.rising.beaks | | | | | | | | | |

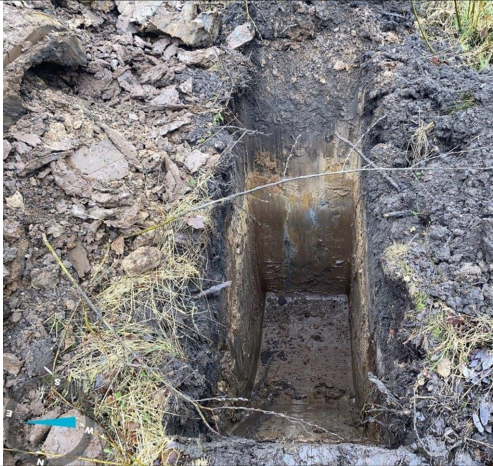
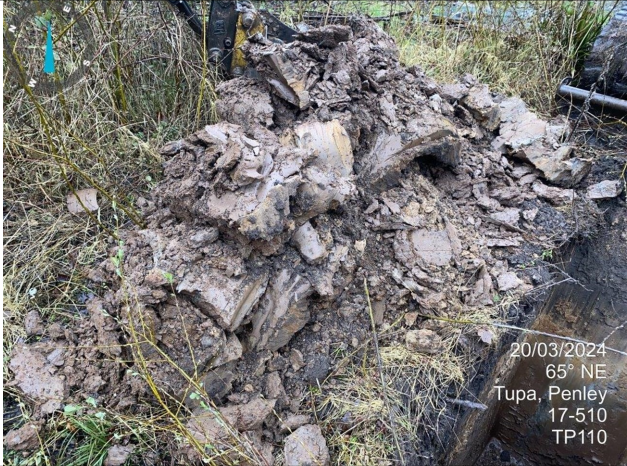
| <div>Remarks: 1. Complete. 2. Water strike noted as slow ingress at 0.40 m bgl. 3. W3W: redefined.dividers.digital</div> | | | | | | | | | |
