## **BAT PRESENCE / ABSENCE SURVEY**

### **Bridgeway Centre**

Bridge Road  
Wrexham Industrial Estate  
Wrexham  
LL13 9QS

Date: 17<sup>th</sup> November 2020  
Updated (V2): 27<sup>th</sup> August 2024  
UES reference: UES03012/13

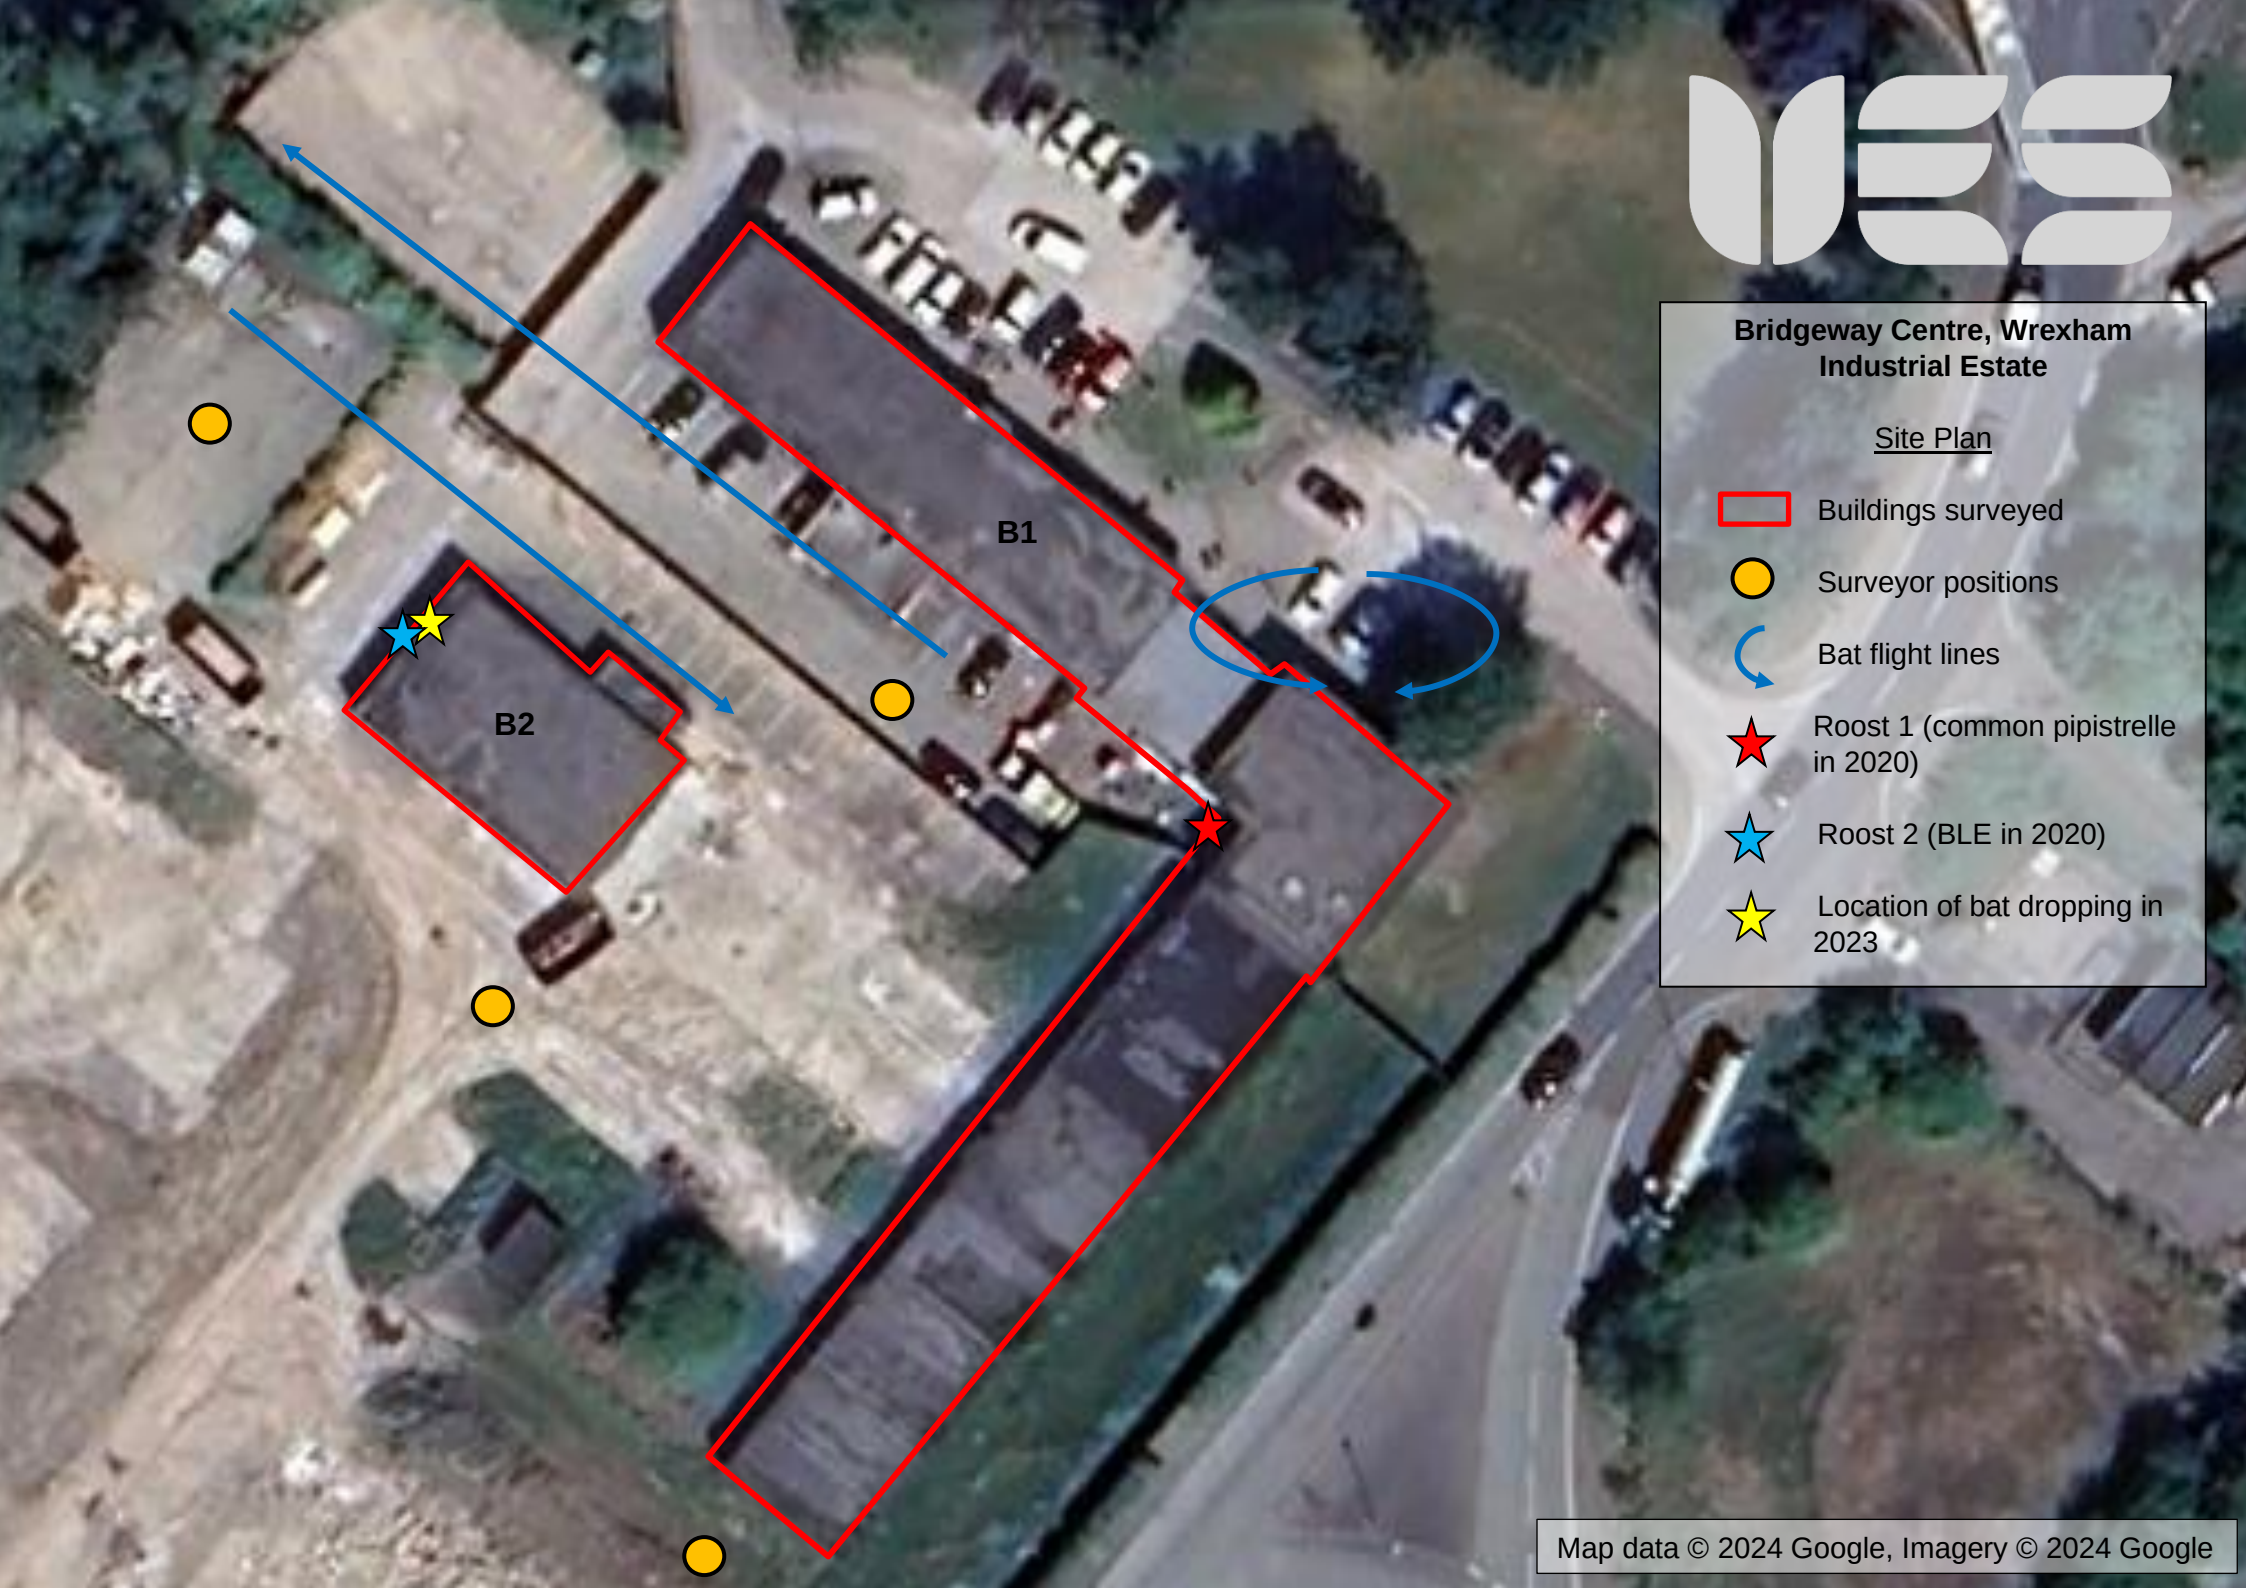
Site Plan

Buildings surveyed
-

Surveyor positions
-

Bat flight lines
-

Roost 1 (common pipistrelle in 2020)
-

Roost 2 (BLE in 2020)
-

Location of bat dropping in 2023

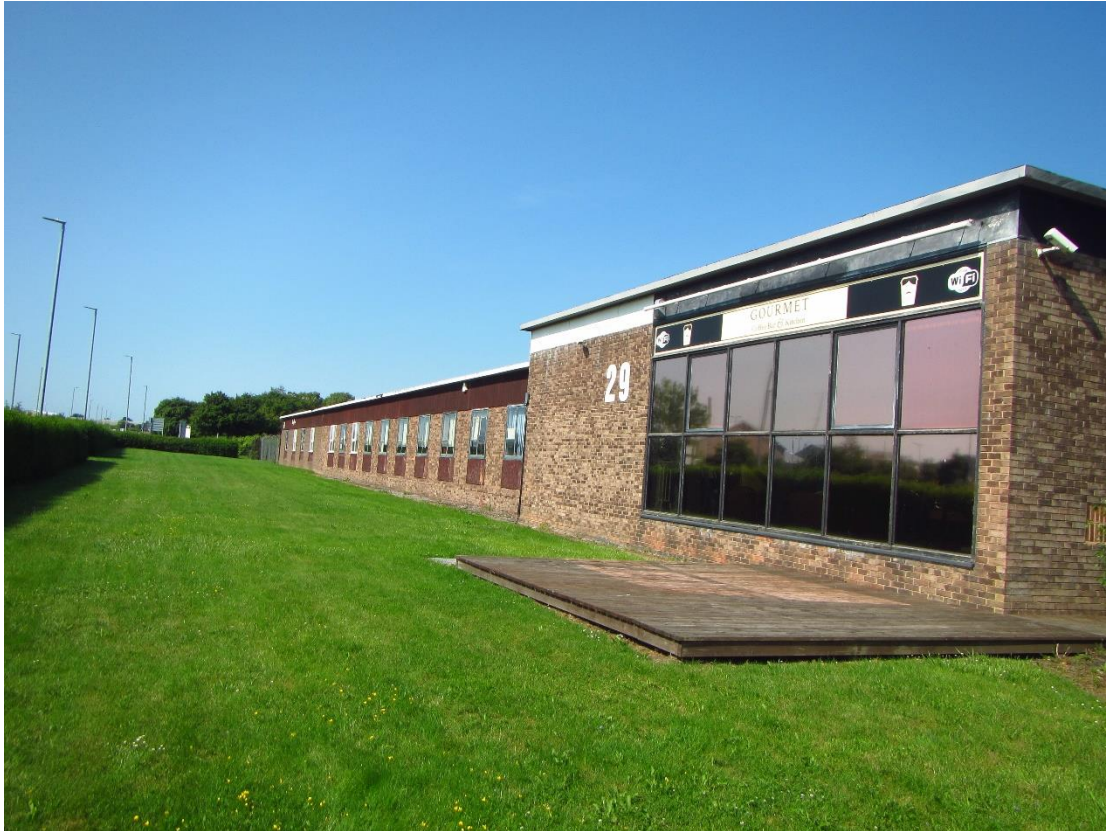
**Building 1** is a multi-purpose single-storey commercial building, used for offices and retail. The building is an 'L' shape and is constructed from brick with a flat roof lined with 1F bitumen roofing felt (See appendix 3 Photograph 1-3). The brickwork and roof are in excellent condition. There is a small amount of wooden cladding present on the eastern and western aspects of the building which is tightly sealed. Metal boxed soffits are also present on several aspects of the building. There is one gap in the brickwork immediately below the boxed soffit on the southern aspect of the building (Photograph 4). The windows have a mixture of wooden window frames and UPVC, all of which are in good condition. There is a small extension on the south-eastern aspect of the building. The extension is constructed of corrugated metal with a flat roof lined with 1F bitumen roofing felt.

Photograph 1 – Eastern aspect of Building 1.

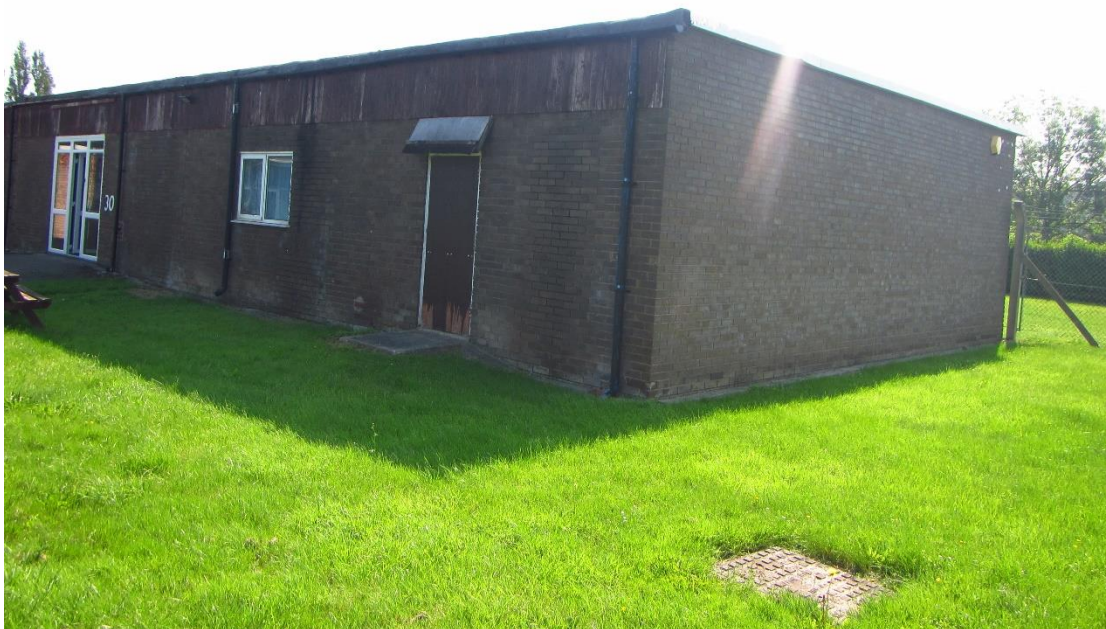
Photograph 2 – Southern aspect of Building 1.

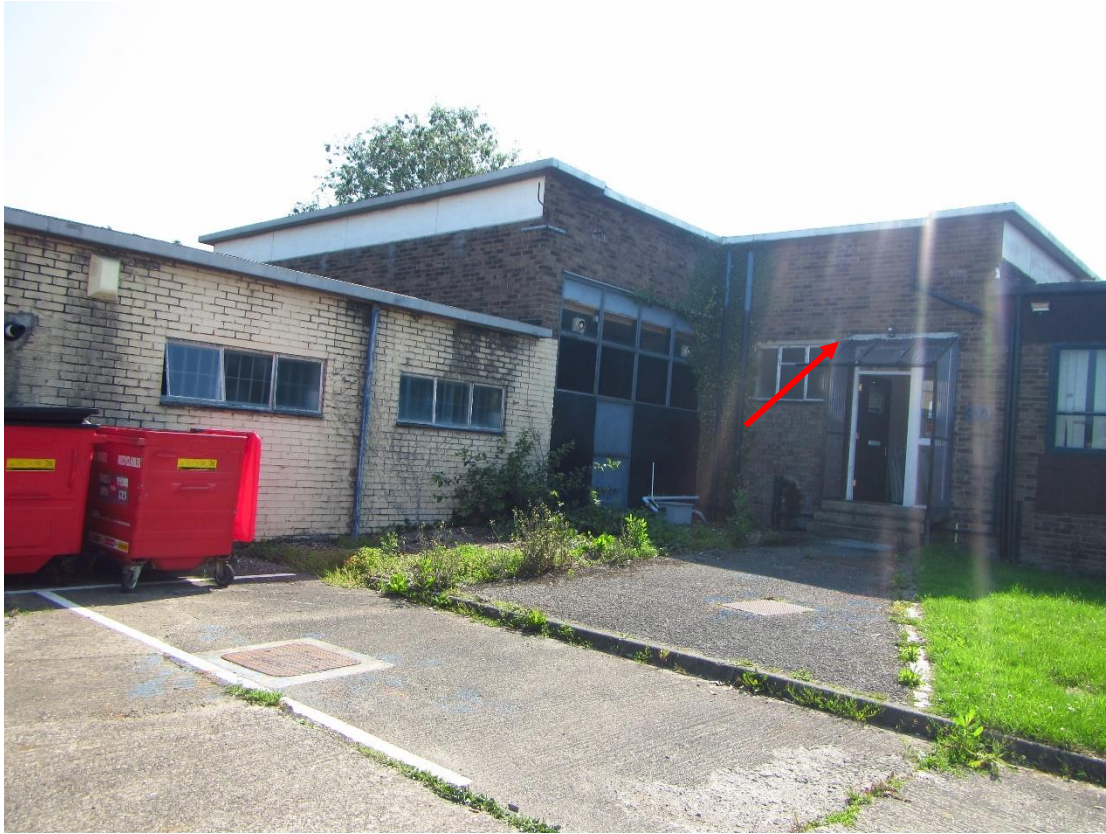
**Roost 1** was located beneath the lead flashing of a corrugated plastic porch, on the western aspect of the L-shaped Building 1 (close to the corner of the L-shape) – a single common pipistrelle was recorded to be using the roost. Due to the small dimensions of the roosting feature and the single bat recorded, it is considered likely that the roost was used as a day / transitional roost on a casual basis, by an individual bat (Photograph 3).

Photograph 3 – Northwestern aspect of Building 1, showing the location of Roost 1.

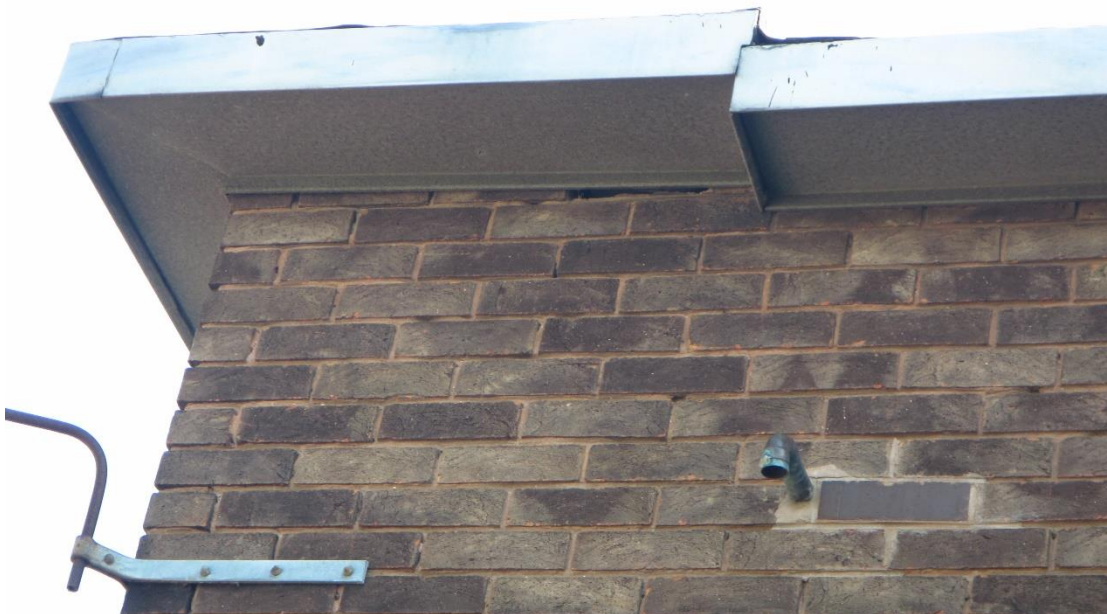
Photograph 4 - Gap in brickwork on southern aspect of Building 1.

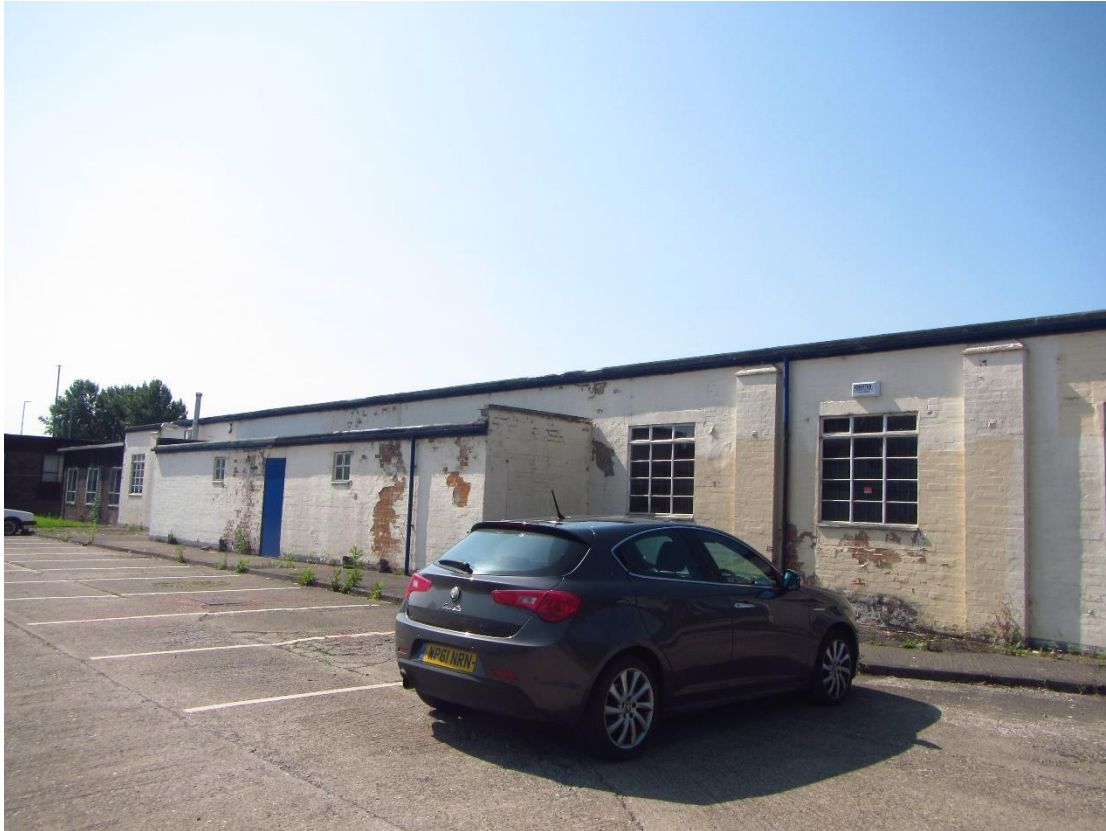
**Building 2** is a similar design but is rectangular in shape and has been painted white (Photograph 5-7). There are wooden barge boards present on all aspects of the building, which are mostly in good condition. However, the barge board on the western aspect is broken and lifted (Photographs 8) which leaves the bitumen roofing felt exposed, and a gap is present beneath.

Photograph 5 – Northern aspect of Building 2.

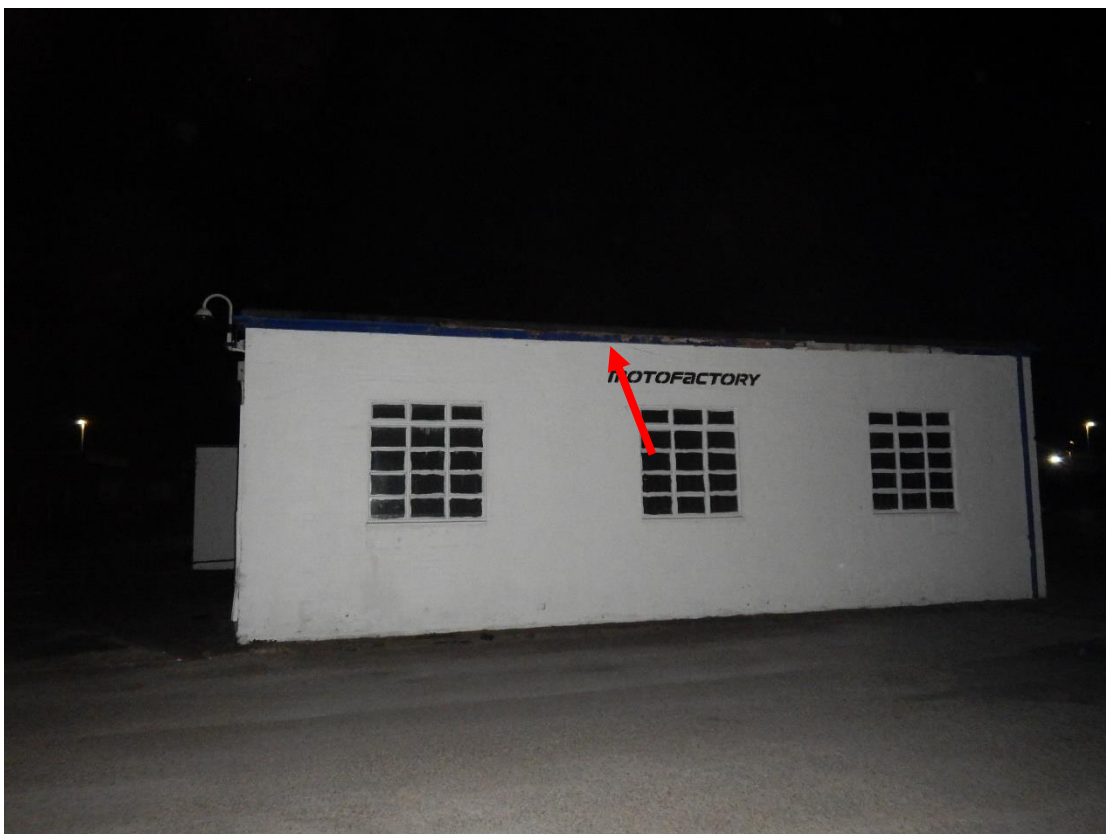
**Roost 2** was located on the western aspect of Building 2. An individual BLE bat was recorded emerging from between the raised roofing felt and the damaged wooden fascia board. The structure of this roost (a small crevice) makes it unsuitable for a large number of this species of bat (usually found in larger loft voids). Therefore, it is considered likely that the roost was used as a day / transitional roost on a casual basis, by an individual bat (Photograph 6).

Photograph 6 – Western aspect of Building 2, showing the location of Roost 2.

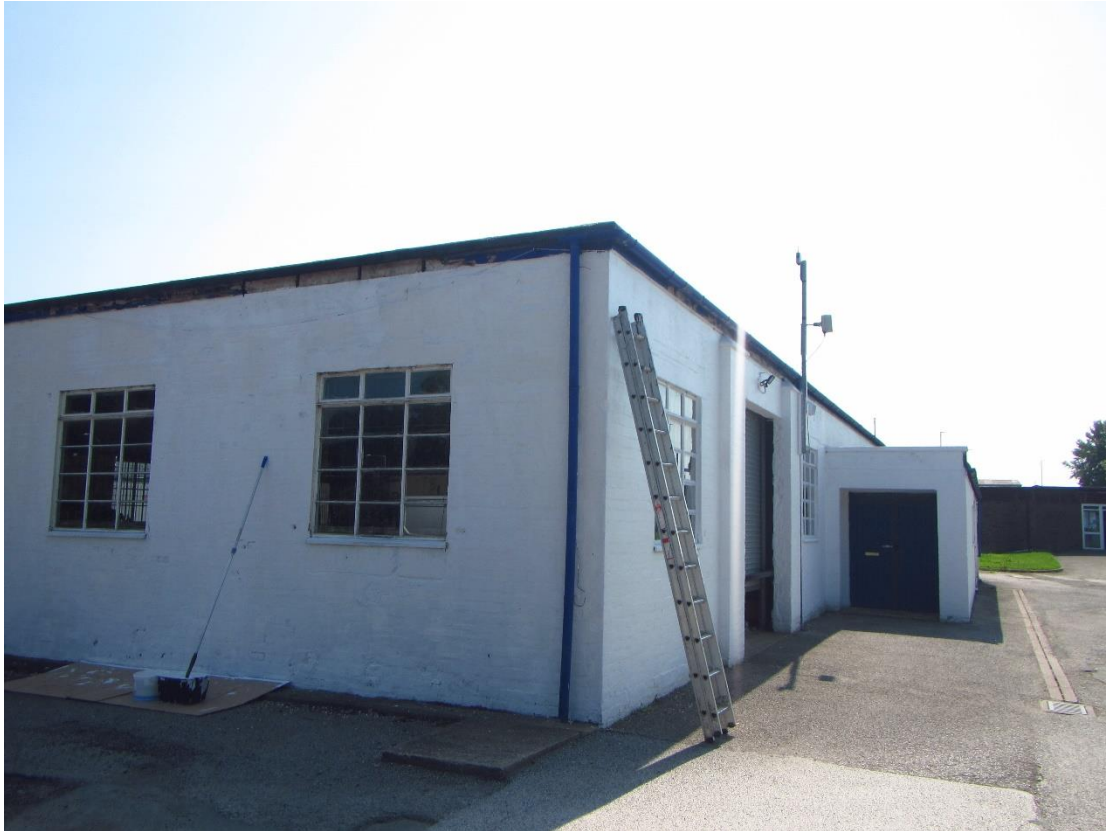
Photograph 7 – Western and southern aspects of Building 2.

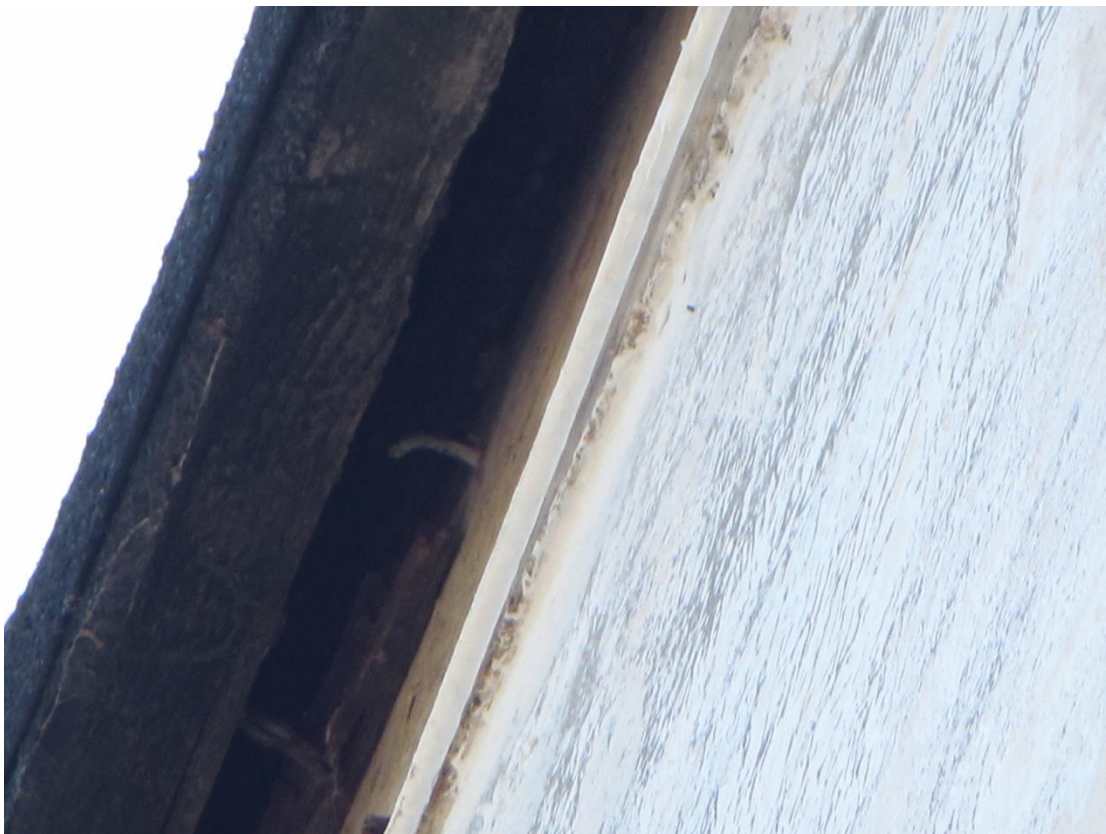
Photograph 8 – Gap between overhanging roofing felt and fascia board on western aspect of Building 2.
