# WEST VIEW, MARCHWIEL;

## BAT AND NESTING BIRD SURVEY

Report Ref: EE.1005.22.JK

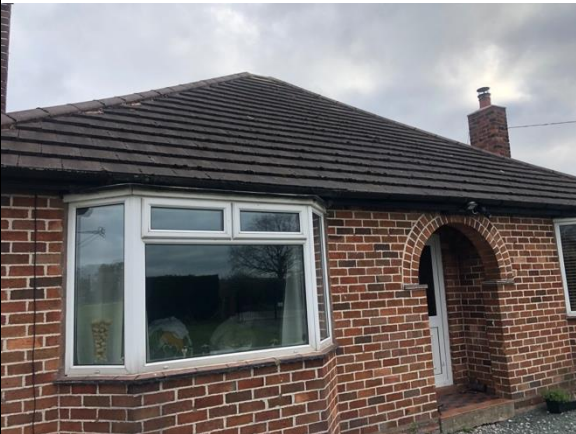
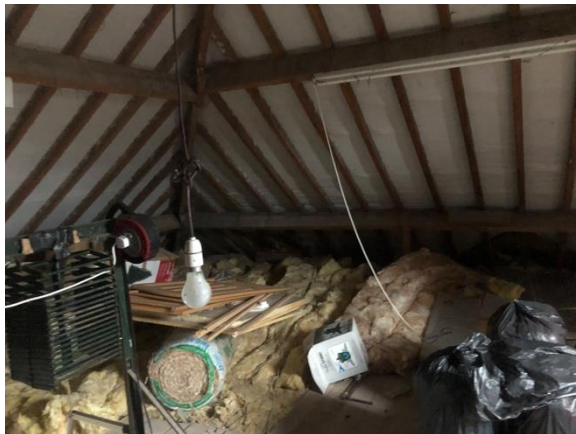
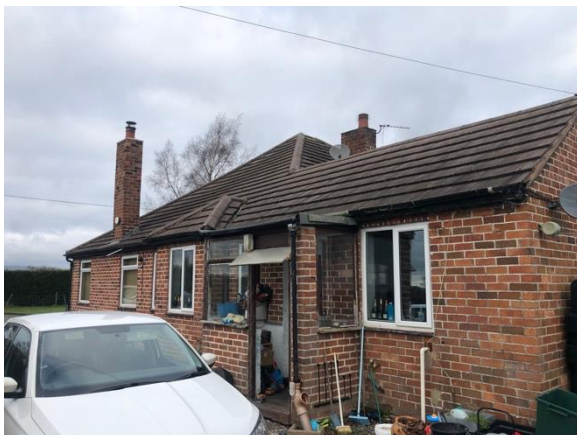
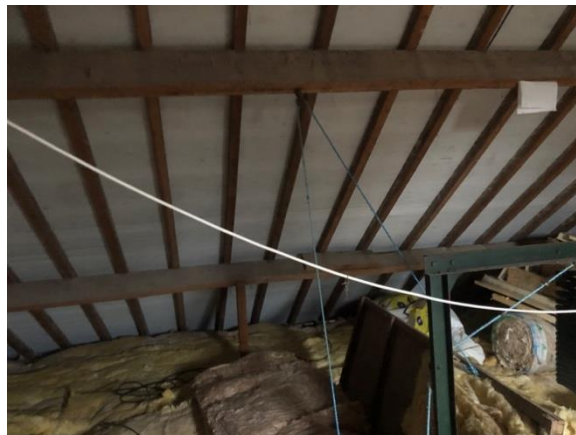
| External Description | External Photo | Internal Description | Internal Photo |
|---|---|---|---|
| <p>The bungalow was of a brick - built construction. The main roof was pyramid hipped with the wing having a pitched roof and one gable end. The roof and ridge tiles were concrete; the barge boards and soffits were wooden. The western elevation had two bay windows and an inset porch. The south side of the house was fully glazed and had a small flat roofed</p> | <p><b>WEST ELEVATION</b></p> | <p>The loft space spanned the length and width of the building and was open throughout; it had an apex of approx. 4m high.</p> <p>Under the concrete roof tiles, the loft had timber frames and was lined with a breathable membrane lining.</p> | <p><b>LOFT SPACE LOOKING TOWARDS WEST CORNER</b></p> |
| | <p><b>SOUTH ELEVATION</b></p> | | <p><b>LOFT SPACE LOOKING SOUTH</b></p> |

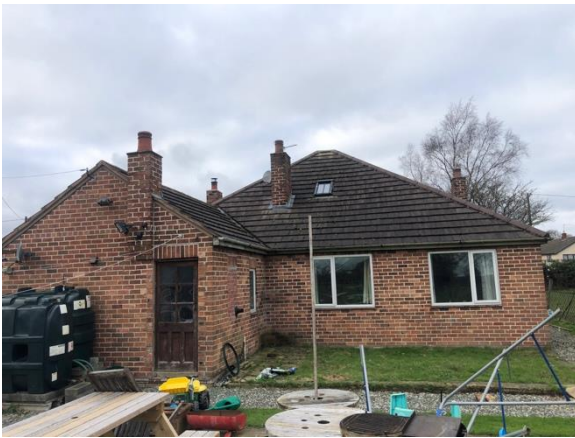
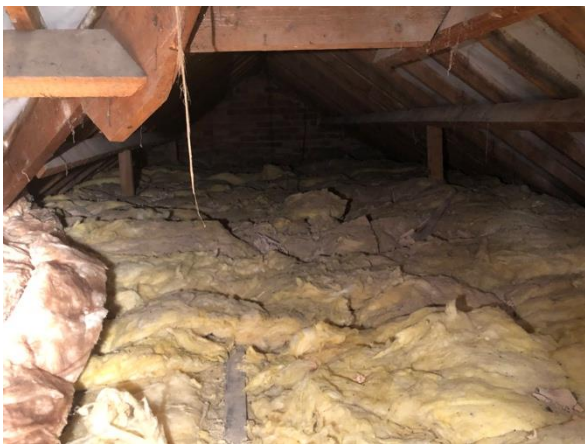
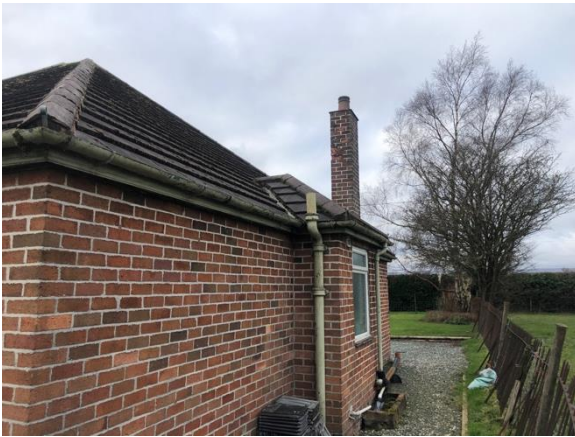
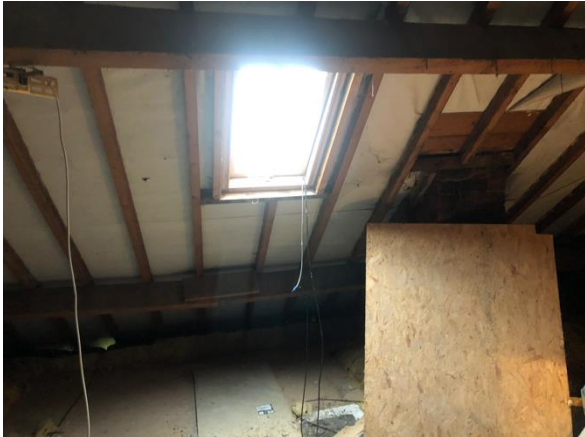
| External Description | External Photo | Internal Description | Internal Photo |
|---|---|---|---|
| <p>porch extending from the main building. There was a chimney (one of four) on this elevation. The wing on the south east corner had a pitched roof with a gable end.</p> | <p><i>EAST ELEVATION</i></p> | <p>The loft space extended above the wing on the south east elevation.</p> <p>The main loft space was well illuminated by the skylight on the eastern pitch.</p> | <p><i>LOFT SPACE ABOVE SOUTH EAST WING</i></p> |
| <p>Below was a brick chimney breast and a doorway below.</p> <p>The roof to the east elevation had a further chimney and a skylight into the loft. On the north side of the house was a fourth chimney breast.</p> | <p><i>NORTH ELEVATION</i></p> | | <p><i>LOFT SPACE LOOKING NORTH</i></p> |

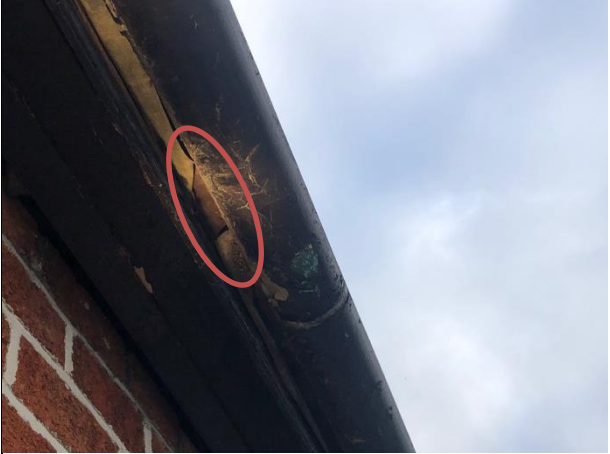
| Location | Description | Example photos |
|---|---|---|
| <p><b>1</b></p> <p><b>South Elevation</b></p> | <p>Access behind the barge boards through tears in the membrane lining</p> | |

- The removal of the roof structure including ridge tiles, slates, and fascia’s; must be undertaken by hand and supervised (where areas cannot be inspected beforehand) by a licensed ecologist who is named on and authorised to act under the specific licence granted by NRW for this works. Areas that can be inspected, such as behind fascia’s, will be looked at with a torch and/or endoscope prior to works commencing by the licenced ecologist. If a bat is found and accessible it should be captured and placed in an appropriate bat box that will be made available onsite prior to works commencing (which will contribute to one of the proposed mitigation bat roosts). If a bat is found and is not accessible works will start from the furthest point from the

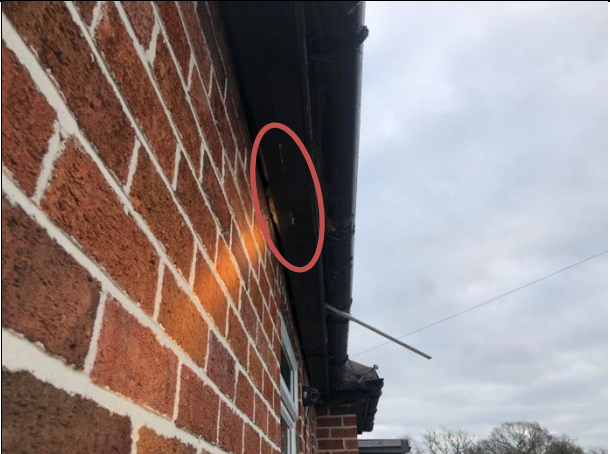
| Location | Description | Example photos |
|---|---|---|
| <p><b>2</b></p> <p><b>To most elevations</b></p> | <p>Gaps between walls and the wooden soffits</p> | |

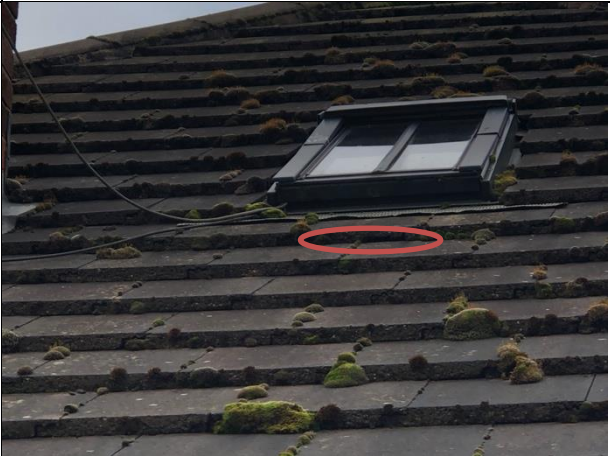
| Location | Description | Example photos |
|---|---|---|
| <p><b>3</b></p> <p><b>Below loft window on east elevation</b></p> | <p>Gaps underneath the roof tiles</p> | |

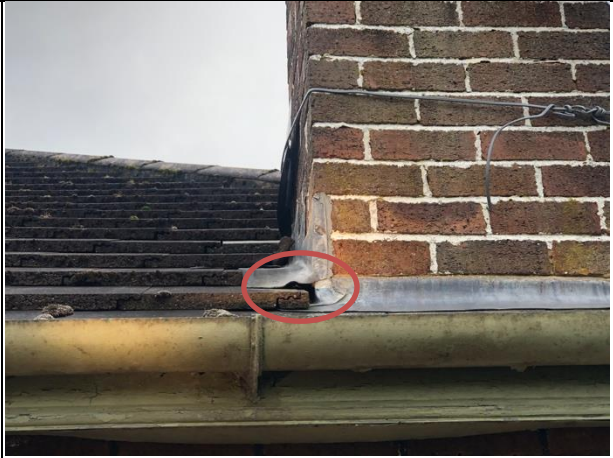
| <p><b>4</b></p> <p><b>North elevation, and East gable end</b></p> | <p>Gaps under lead flashing</p> | |

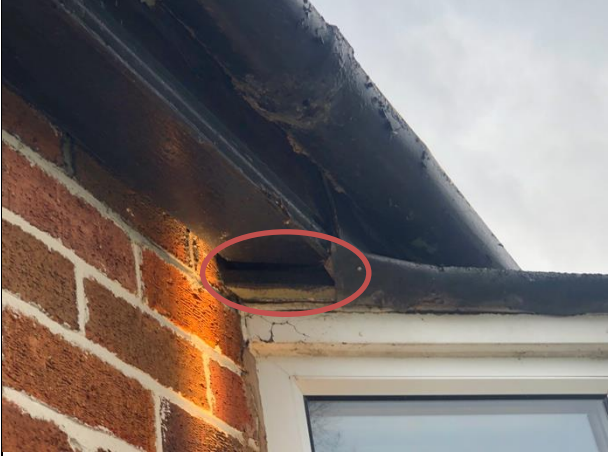
| <p><b>5</b></p> <p><b>West Elevation</b></p> | <p>Gaps between bay window timbers and soffits</p> | |

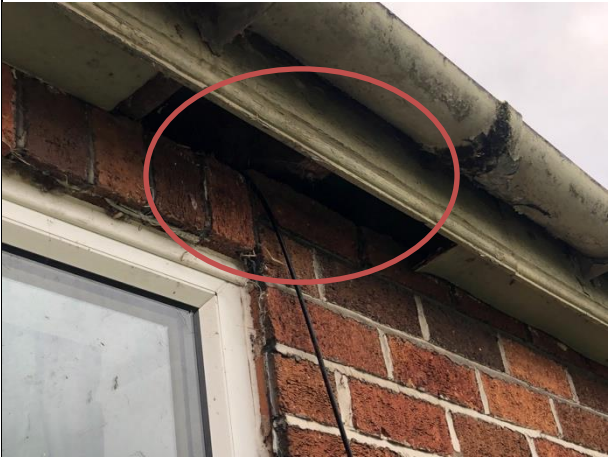
| <p><b>6</b></p> <p><b>East Elevation</b></p> | <p>Missing soffit boards</p> | |

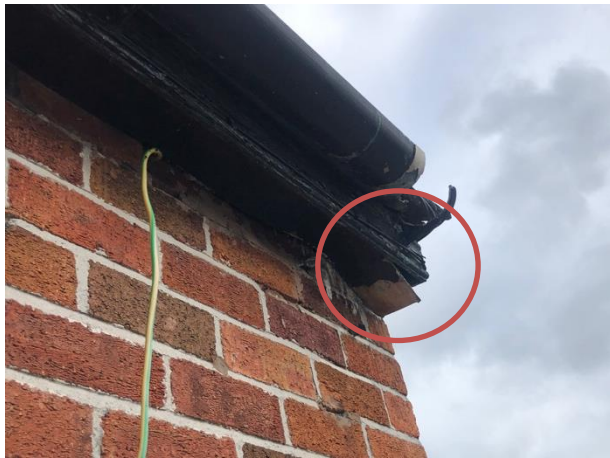
| <p>7</p> <p>South east corner</p> | <p>Broken soffit board</p> | |

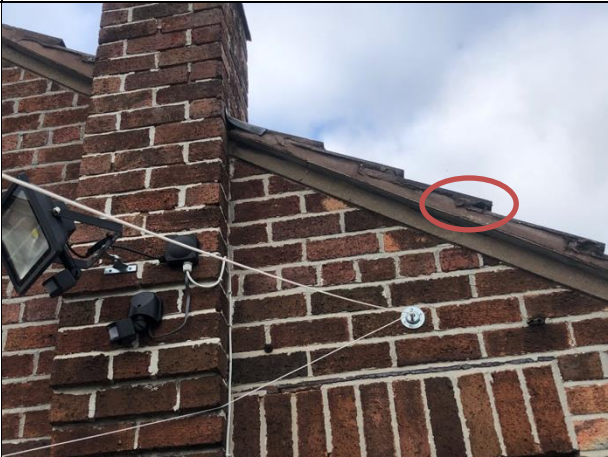
| <p>8</p> <p>Gable end on east elevation</p> | <p>Missing mortar under roof tiles</p> | |

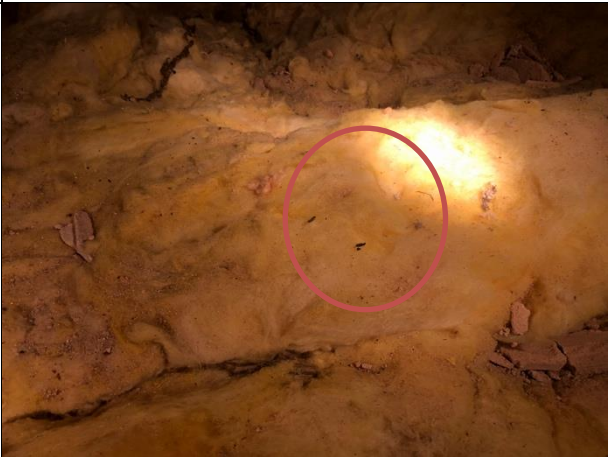
| <p>9</p> <p>Scattered throughout loft space</p> | <p>Bat droppings</p> | |

4.4.1 A sample of the bat droppings was sent off for DNA analysis and was confirmed to be those of a whiskered bat.

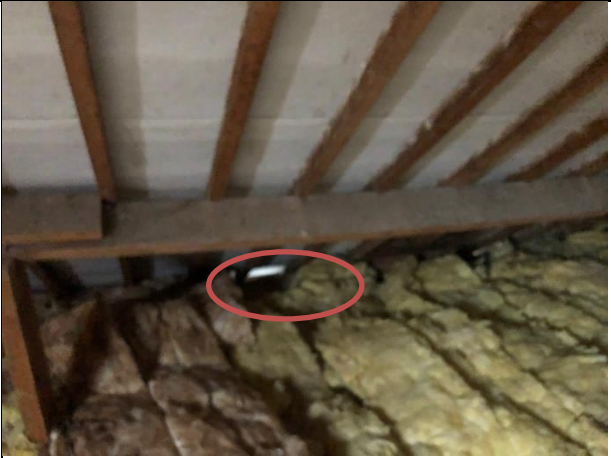
| <b>Most elevations</b> | Light gaps at eaves under roof joists | |

Light could be seen coming from the eaves under the roof joists to most elevations providing access points for birds, and a dead blue-tit was found on the loft floor. There was also evidence of a bird's nest behind the soffit board on the south east corner.
