**Report Type:** Ecological Appraisal

**Site Address:** Glyndale  
Wrexham  
LL13 0YH

**Report Reference:** PRA BJ23-010.1

**Date of Issue:** 21<sup>st</sup> November 2023

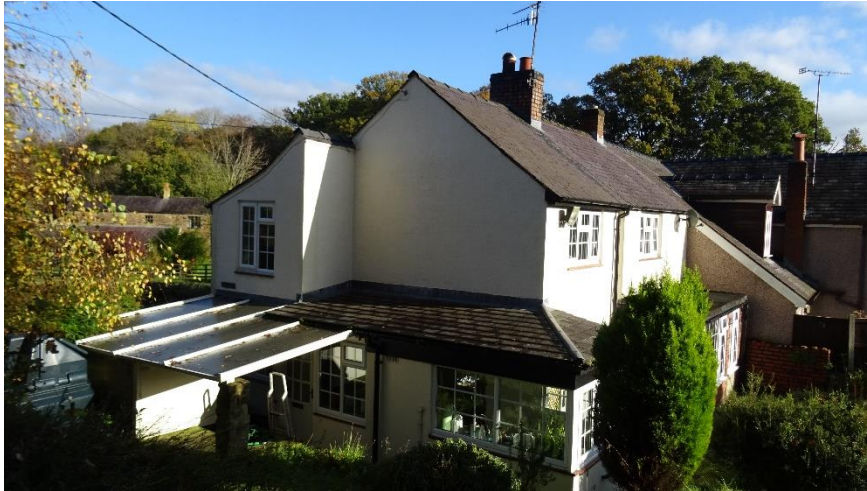
The site comprises a semi-detached rendered house supporting a slate tile roof lined with a mixture of traditional bitumastic hessian felt and modern breathable membrane. The building is surrounded by ornamental garden to the south and west, the road to the north, and the attached house to the east.

**Figure 4.2. House from southwest**

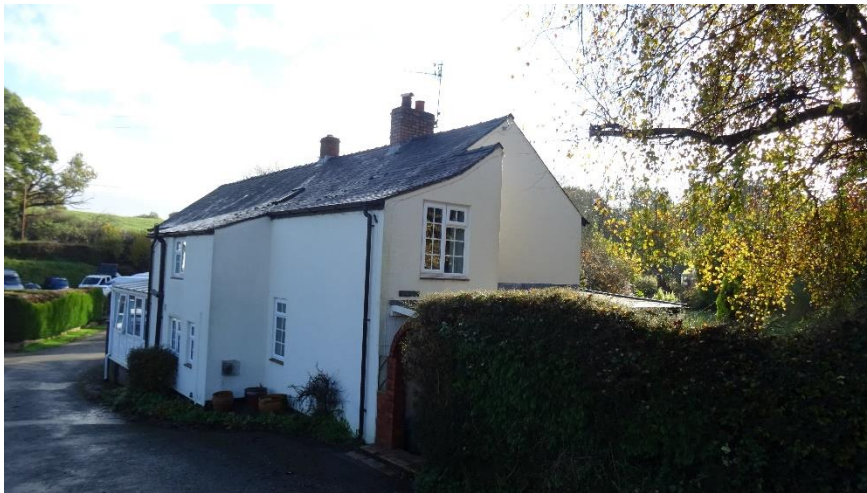
**Figure 4.3. House from northwest**

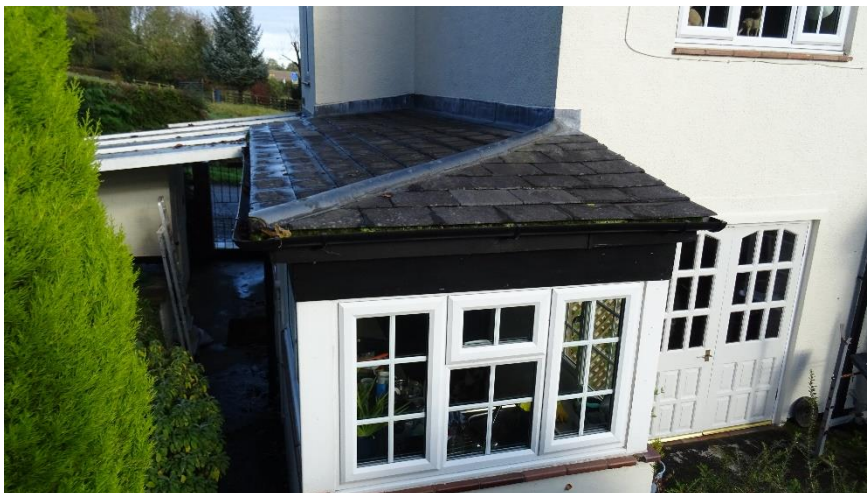
**Figure 4.4. Single storey section to be removed**

The single-storey section to be removed had no loft space and was of negligible value for roosting bats.

The current plans are for a two-storey extension on the southern and western sides of the building, necessitating the removal of the shallow pitch single-storey extension. Specific proposed site plans have not been provided at the time of writing.

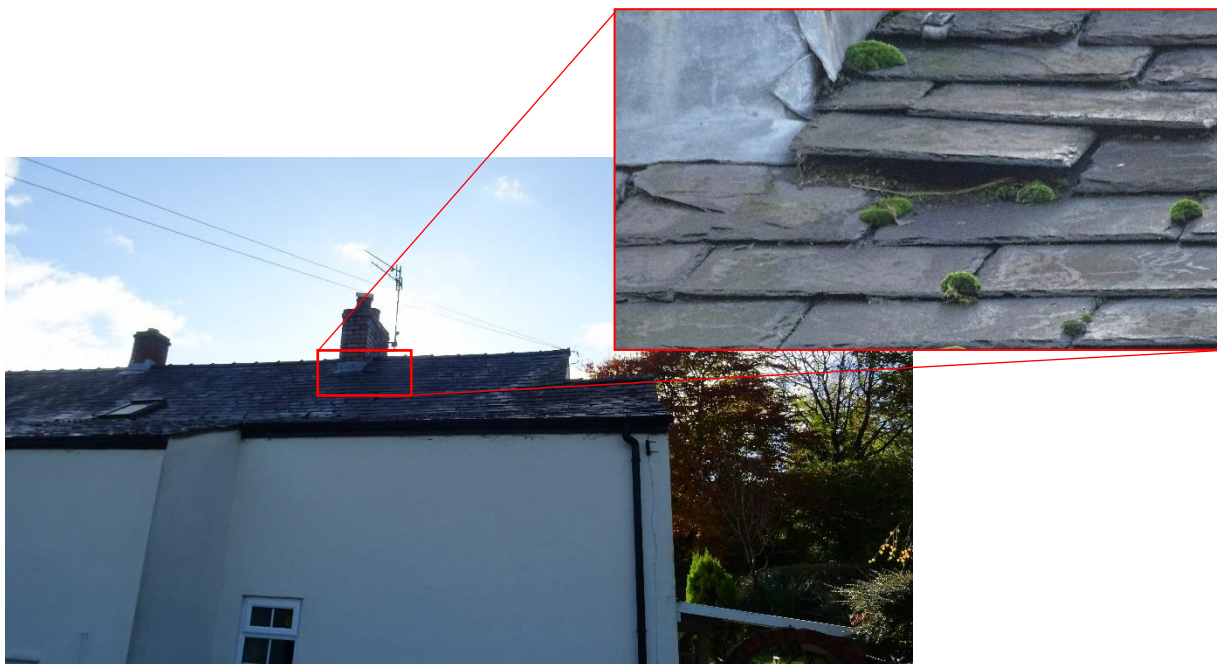
No evidence of bats was found on site, and there is no anecdotal understanding of bat presence on site. The roof was inspected for potential bat access points and the only feature of potential value was a single slightly raised tile. Inspection with a 12x55 scope did not see any greasing or droppings that would indicate bat presence, and the use of a bright torch revealed that the gap beneath the tile did not extend further into the roof than the single tile itself. The gap is full of moss and detritus, suggesting no animals have gained access beneath in some time.

**Figure 4.5. Small gap beneath raised tile**

The only potential roost features for bats identified on site was a single slightly raised tile adjacent to the chimney on the northern roof aspect. This was inspected with a 12x55 scope and revealed to be full of moss and roof detritus and not leaving to a suitable roost feature. No evidence of bats was found inside either loft and no other potential access points were identified.

As the only potential roost feature is highly unlikely to support roosting bats, work can be conducted immediately once planning permission has been granted without the need for further surveys or a licence from Natural Resources Wales.

A Precautionary Working Method Statement will be followed to further negate any risk to bats found in unexpected locations.

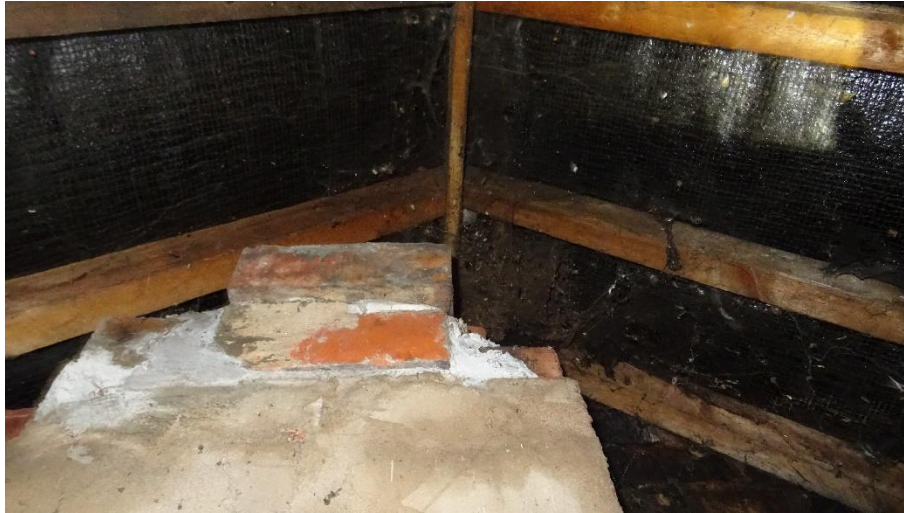
Both loft spaces were checked for evidence of bats and none was found. The ridges had dense cobwebs which are indicative of a lack of bat presence.

**Figure 4.6. Heavy cobwebbing around ridge in western loft**

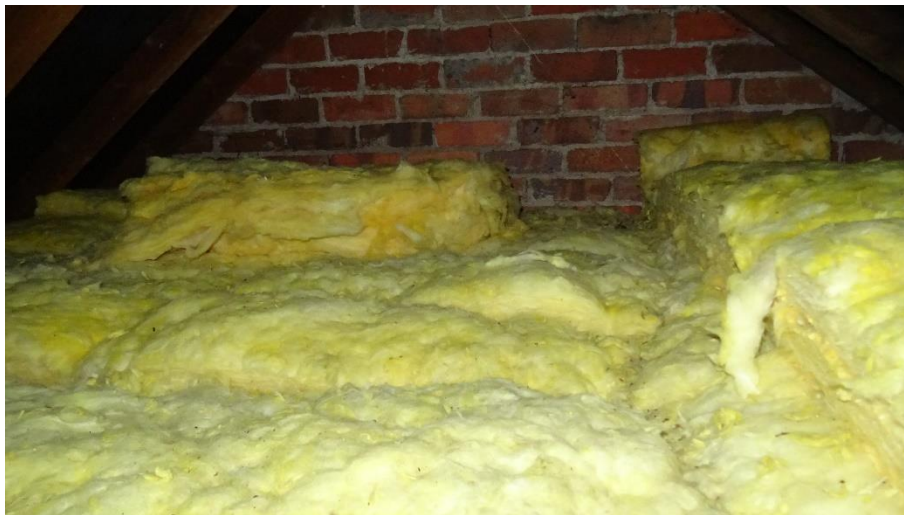
**Figure 4.7. Clean insulation in western loft**

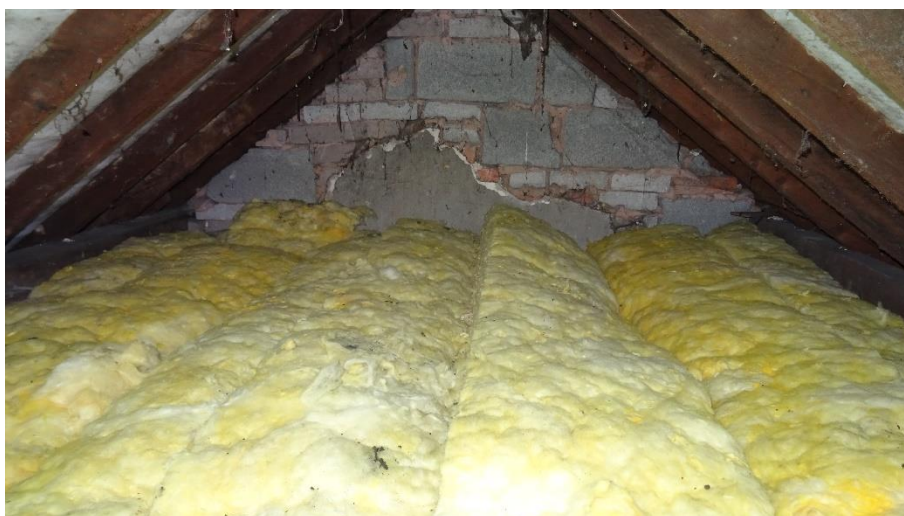
**Figure 4.8. Clean insulation in eastern loft**

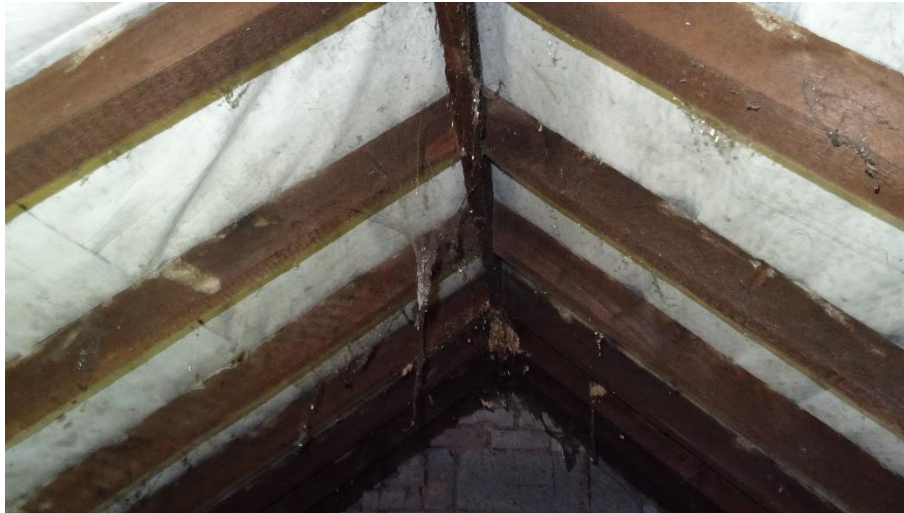
**Figure 4.9. Cobwebbing around timbers in eastern loft**

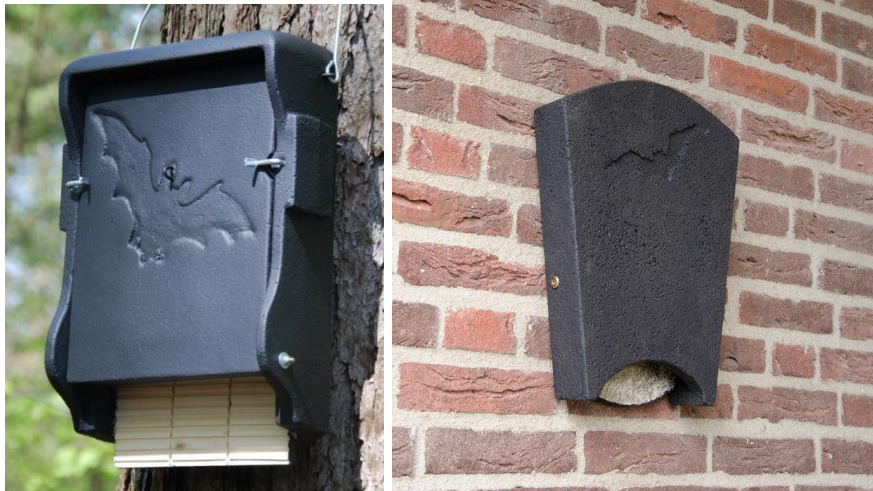
**Figure 6.1. Example woodcrete bat box: Schwegler 1FF & Beaumaris Bat Box Midi**

It is recommended that provision be made for roosting opportunities for bats with the erection of at least one bat box on site. These will be erected at a height of 3-4 m and in a southerly, westerly or easterly facing direction.

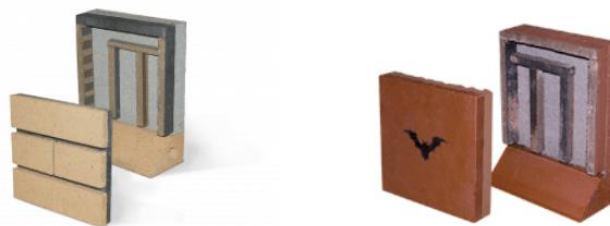
- Designed specifically for the pipistrelle bat
- Available in all brick types
- Discrete home for bats
- Various sizes
- Several roosting zones are created inside the box
- Bats are contained within the bat box itself
- Maintenance free with entrance at the base
- Ideal for new build & conservation work

**Figure 6.2. Example integrated bat box**

It may be possible to provide permanent provision for bats with the inclusion of an integrated bat box in the extension. This will be erected at a height of 3-4 m and in a southerly, westerly or easterly facing direction.

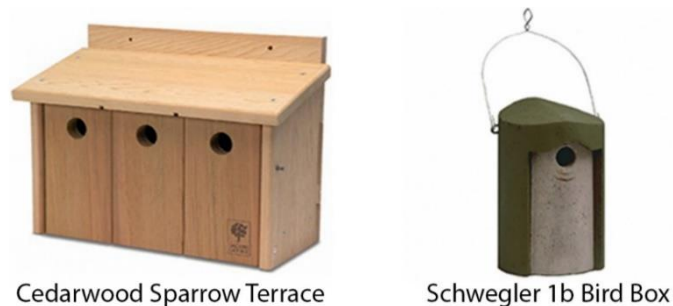
**Figure 6.3. Bird boxes**

- a. Sparrow Terraces should be erected under the eaves of a building at a minimum height of 3m, in a westerly, northerly or easterly aspect.
- b. 26/32mm hole nest boxes (e.g., Schwegler 1b) should be installed at a minimum height of 3m in a westerly, northerly or easterly aspect.
