## **APPENDIX G**

### **Borehole Logs**

## BOREHOLE LOG

| Project<br><b>Wynnstay Technology Park, Ruabon</b> | | | | BOREHOLE No<br><br><b>WS01</b> | |

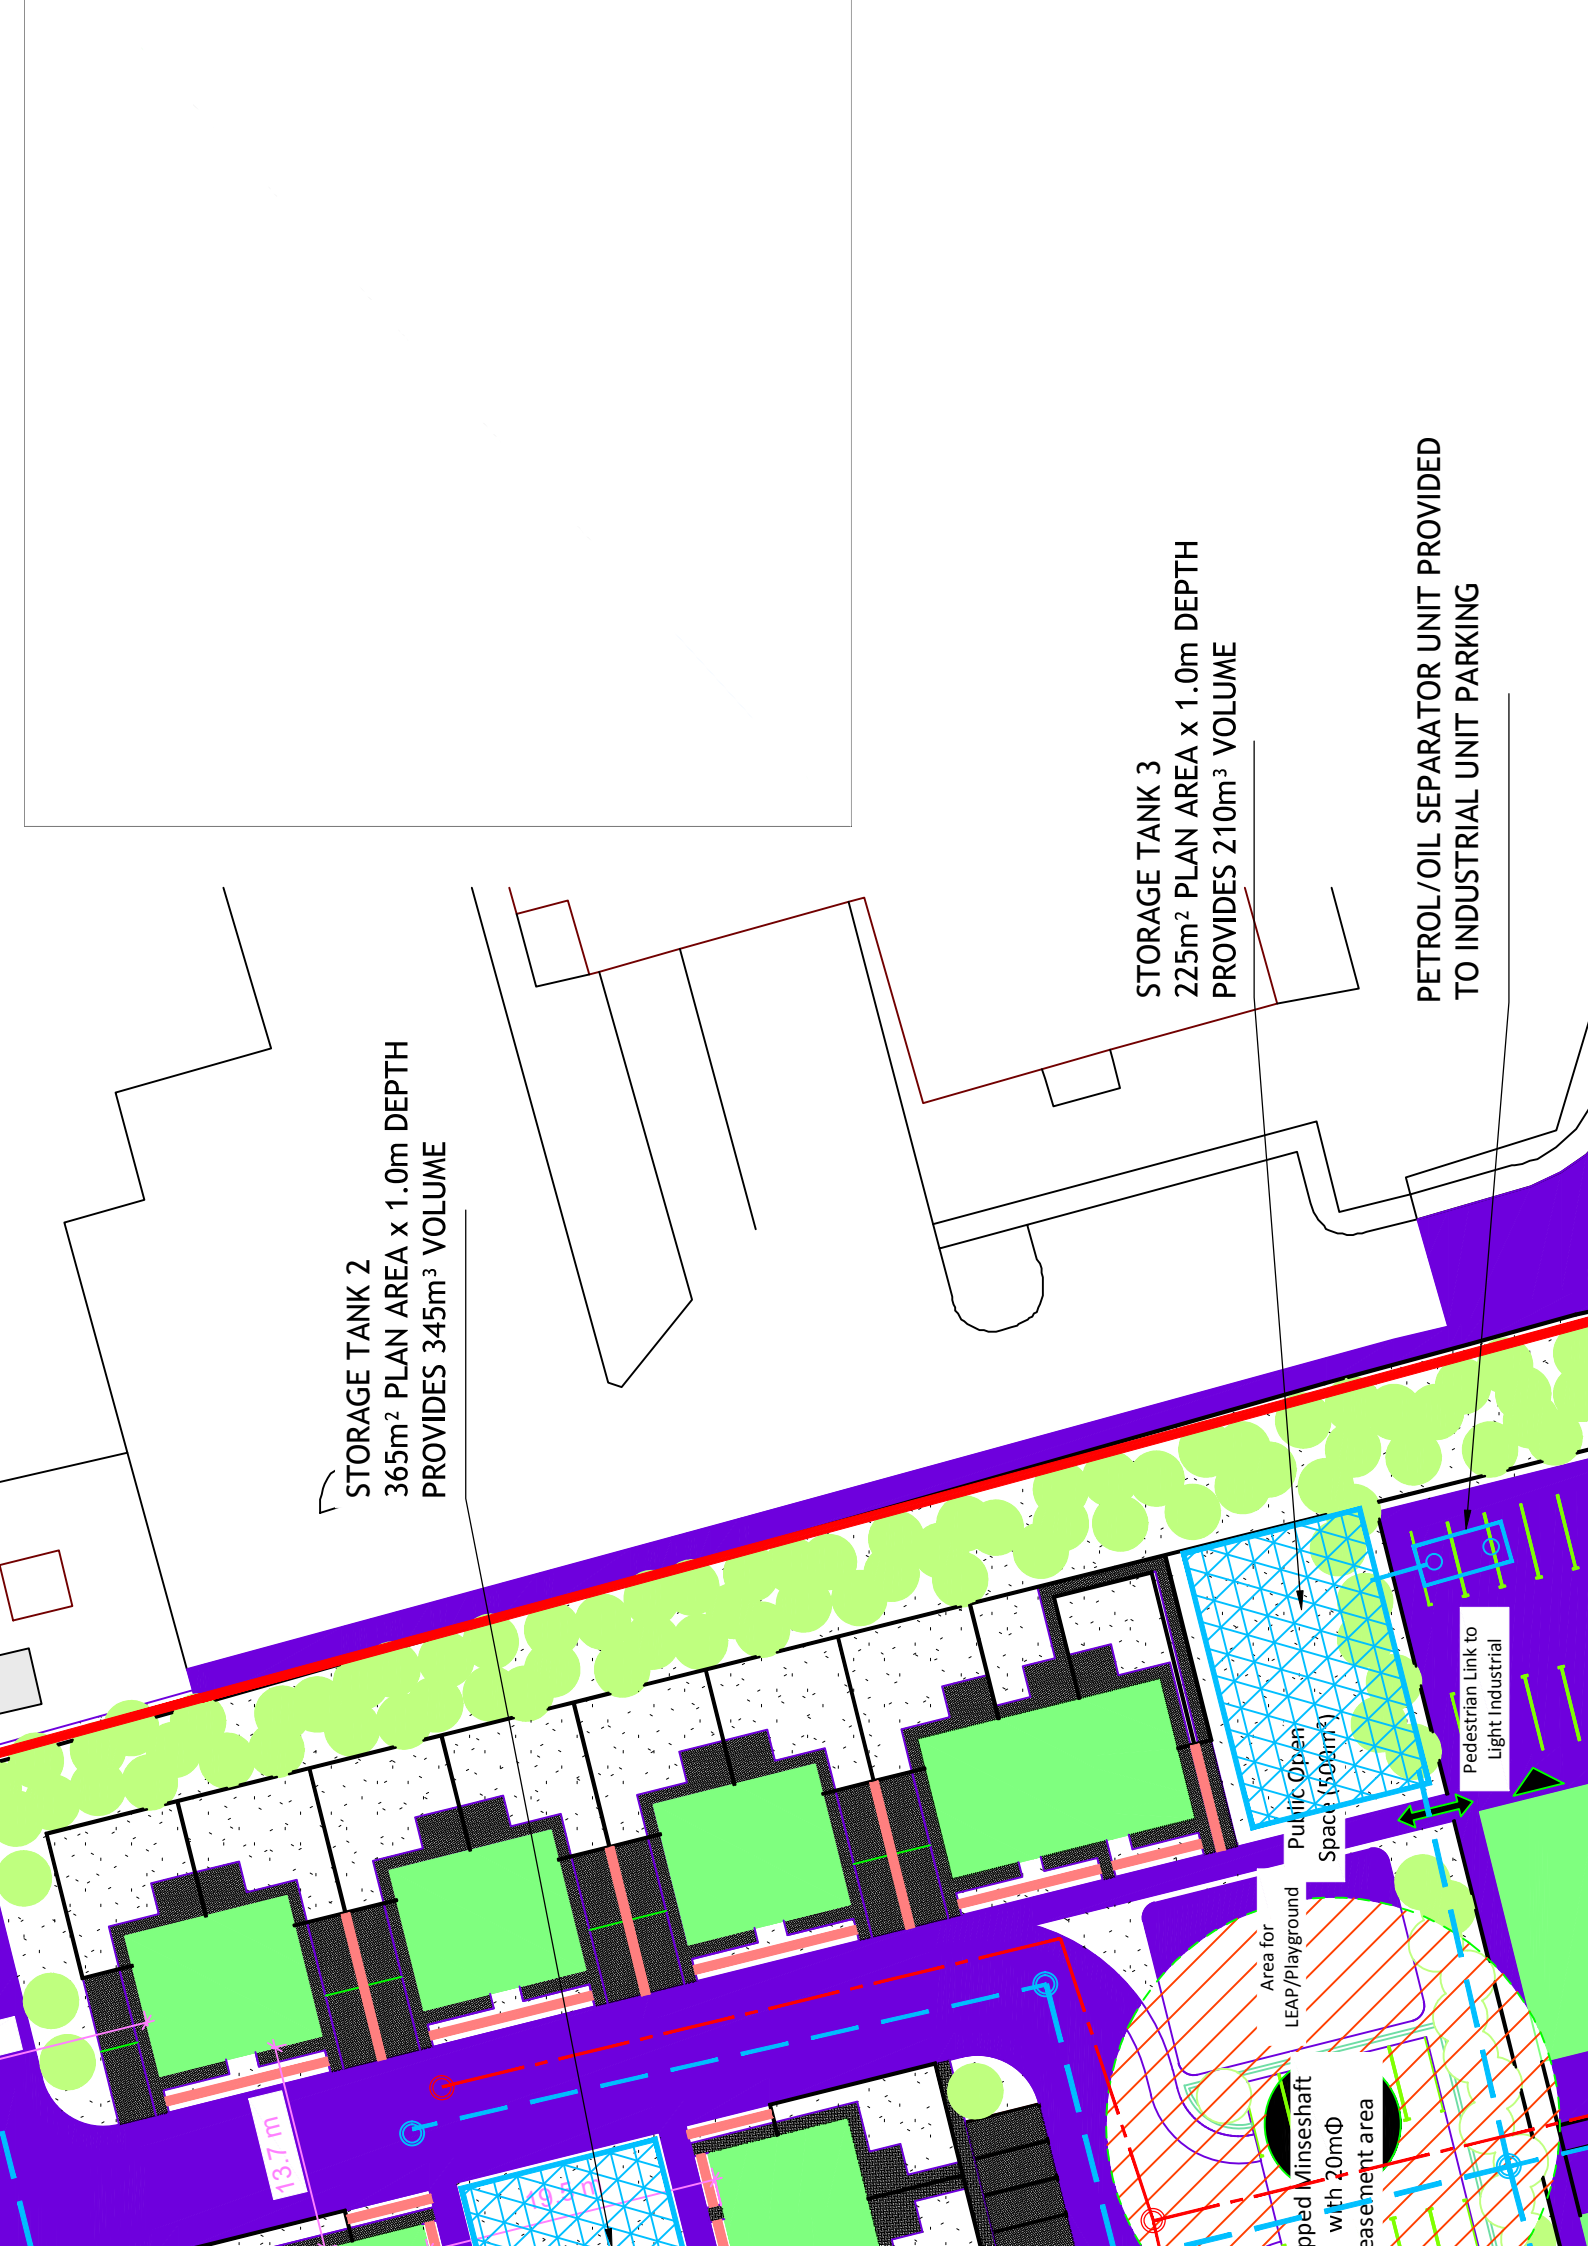
STORAGE TANK 2  
365m<sup>2</sup> PLAN AREA x 1.0m DEPTH  
PROVIDES 345m<sup>3</sup> VOLUME

STORAGE TANK 3  
225m<sup>2</sup> PLAN AREA x 1.0m DEPTH  
PROVIDES 210m<sup>3</sup> VOLUME

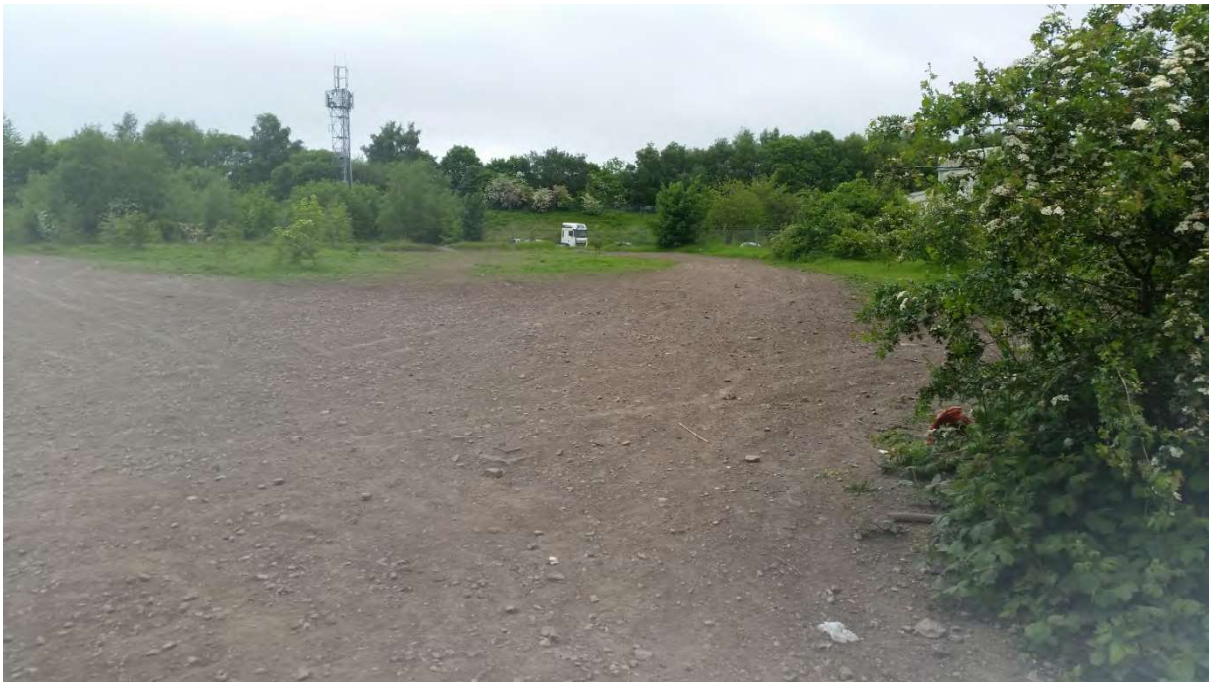
Photo 1: General view of the Site looking north

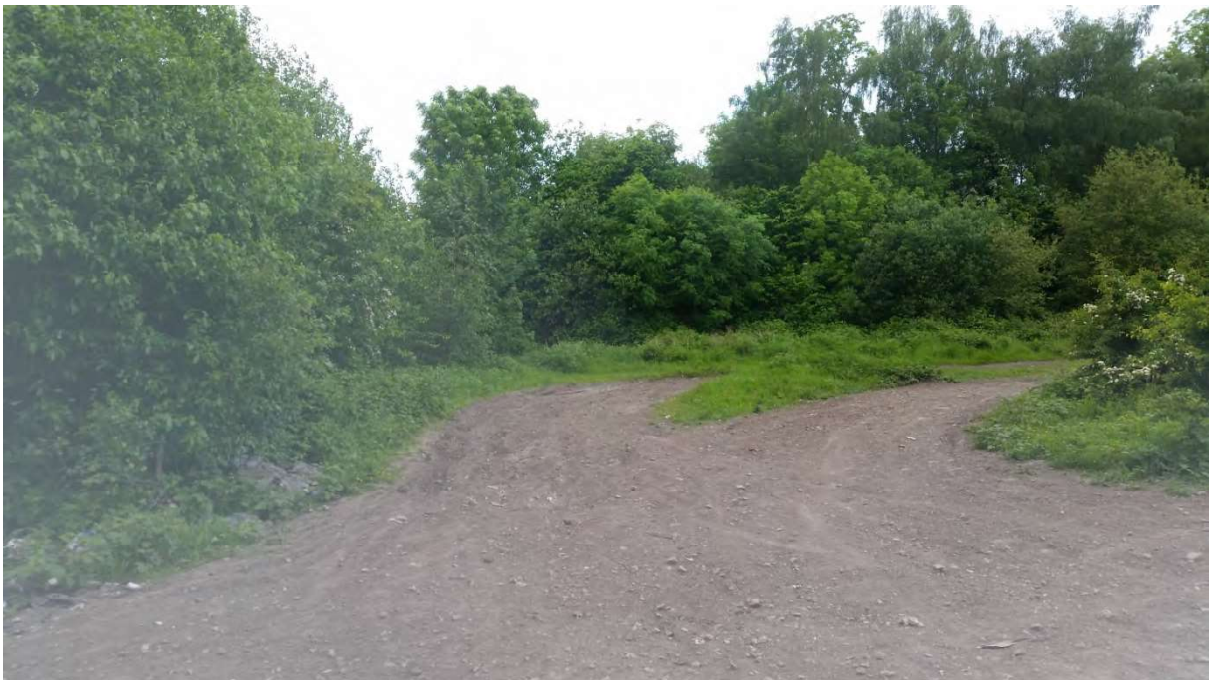
Photo 2: View of vegetated areas towards the north and northwest of the Site.

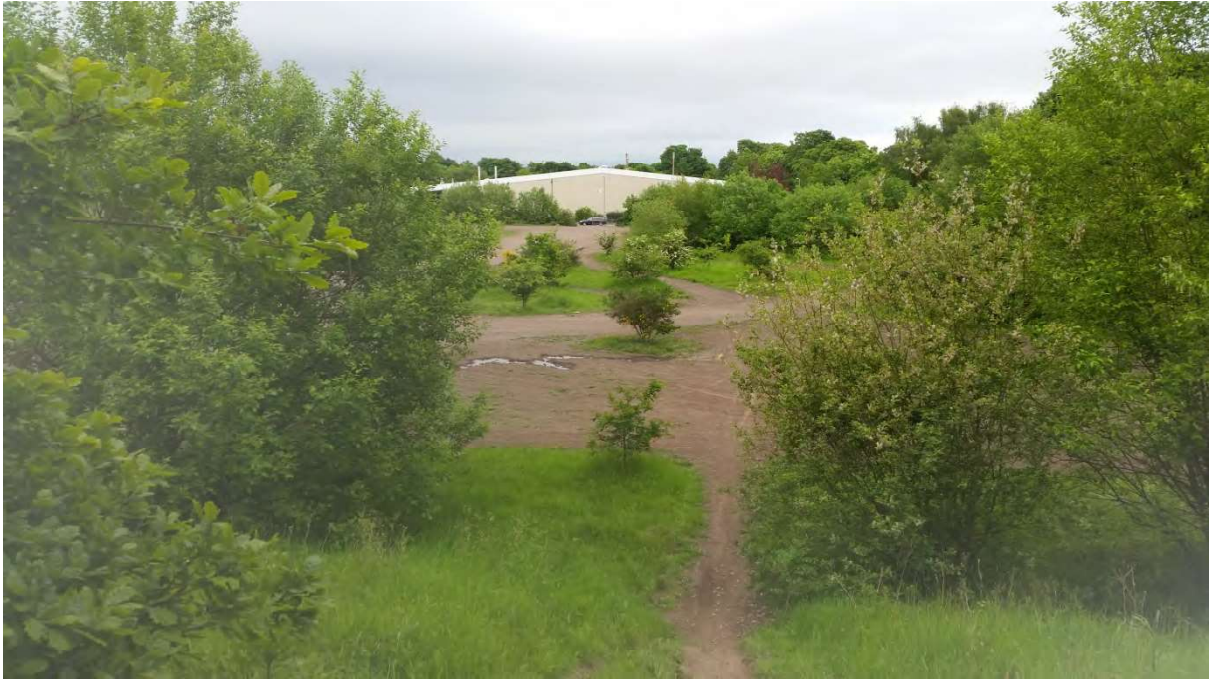
Photo 3: View looking south over the Site from the top of the embankment along the northern Site boundary.
