## **BAT SCOPING & BAT PRESENCE / ABSENCE SURVEY**

**Bridgeway Centre**

Wrexham

Date: 23<sup>rd</sup> November 2023  
UES reference: UES03012/12

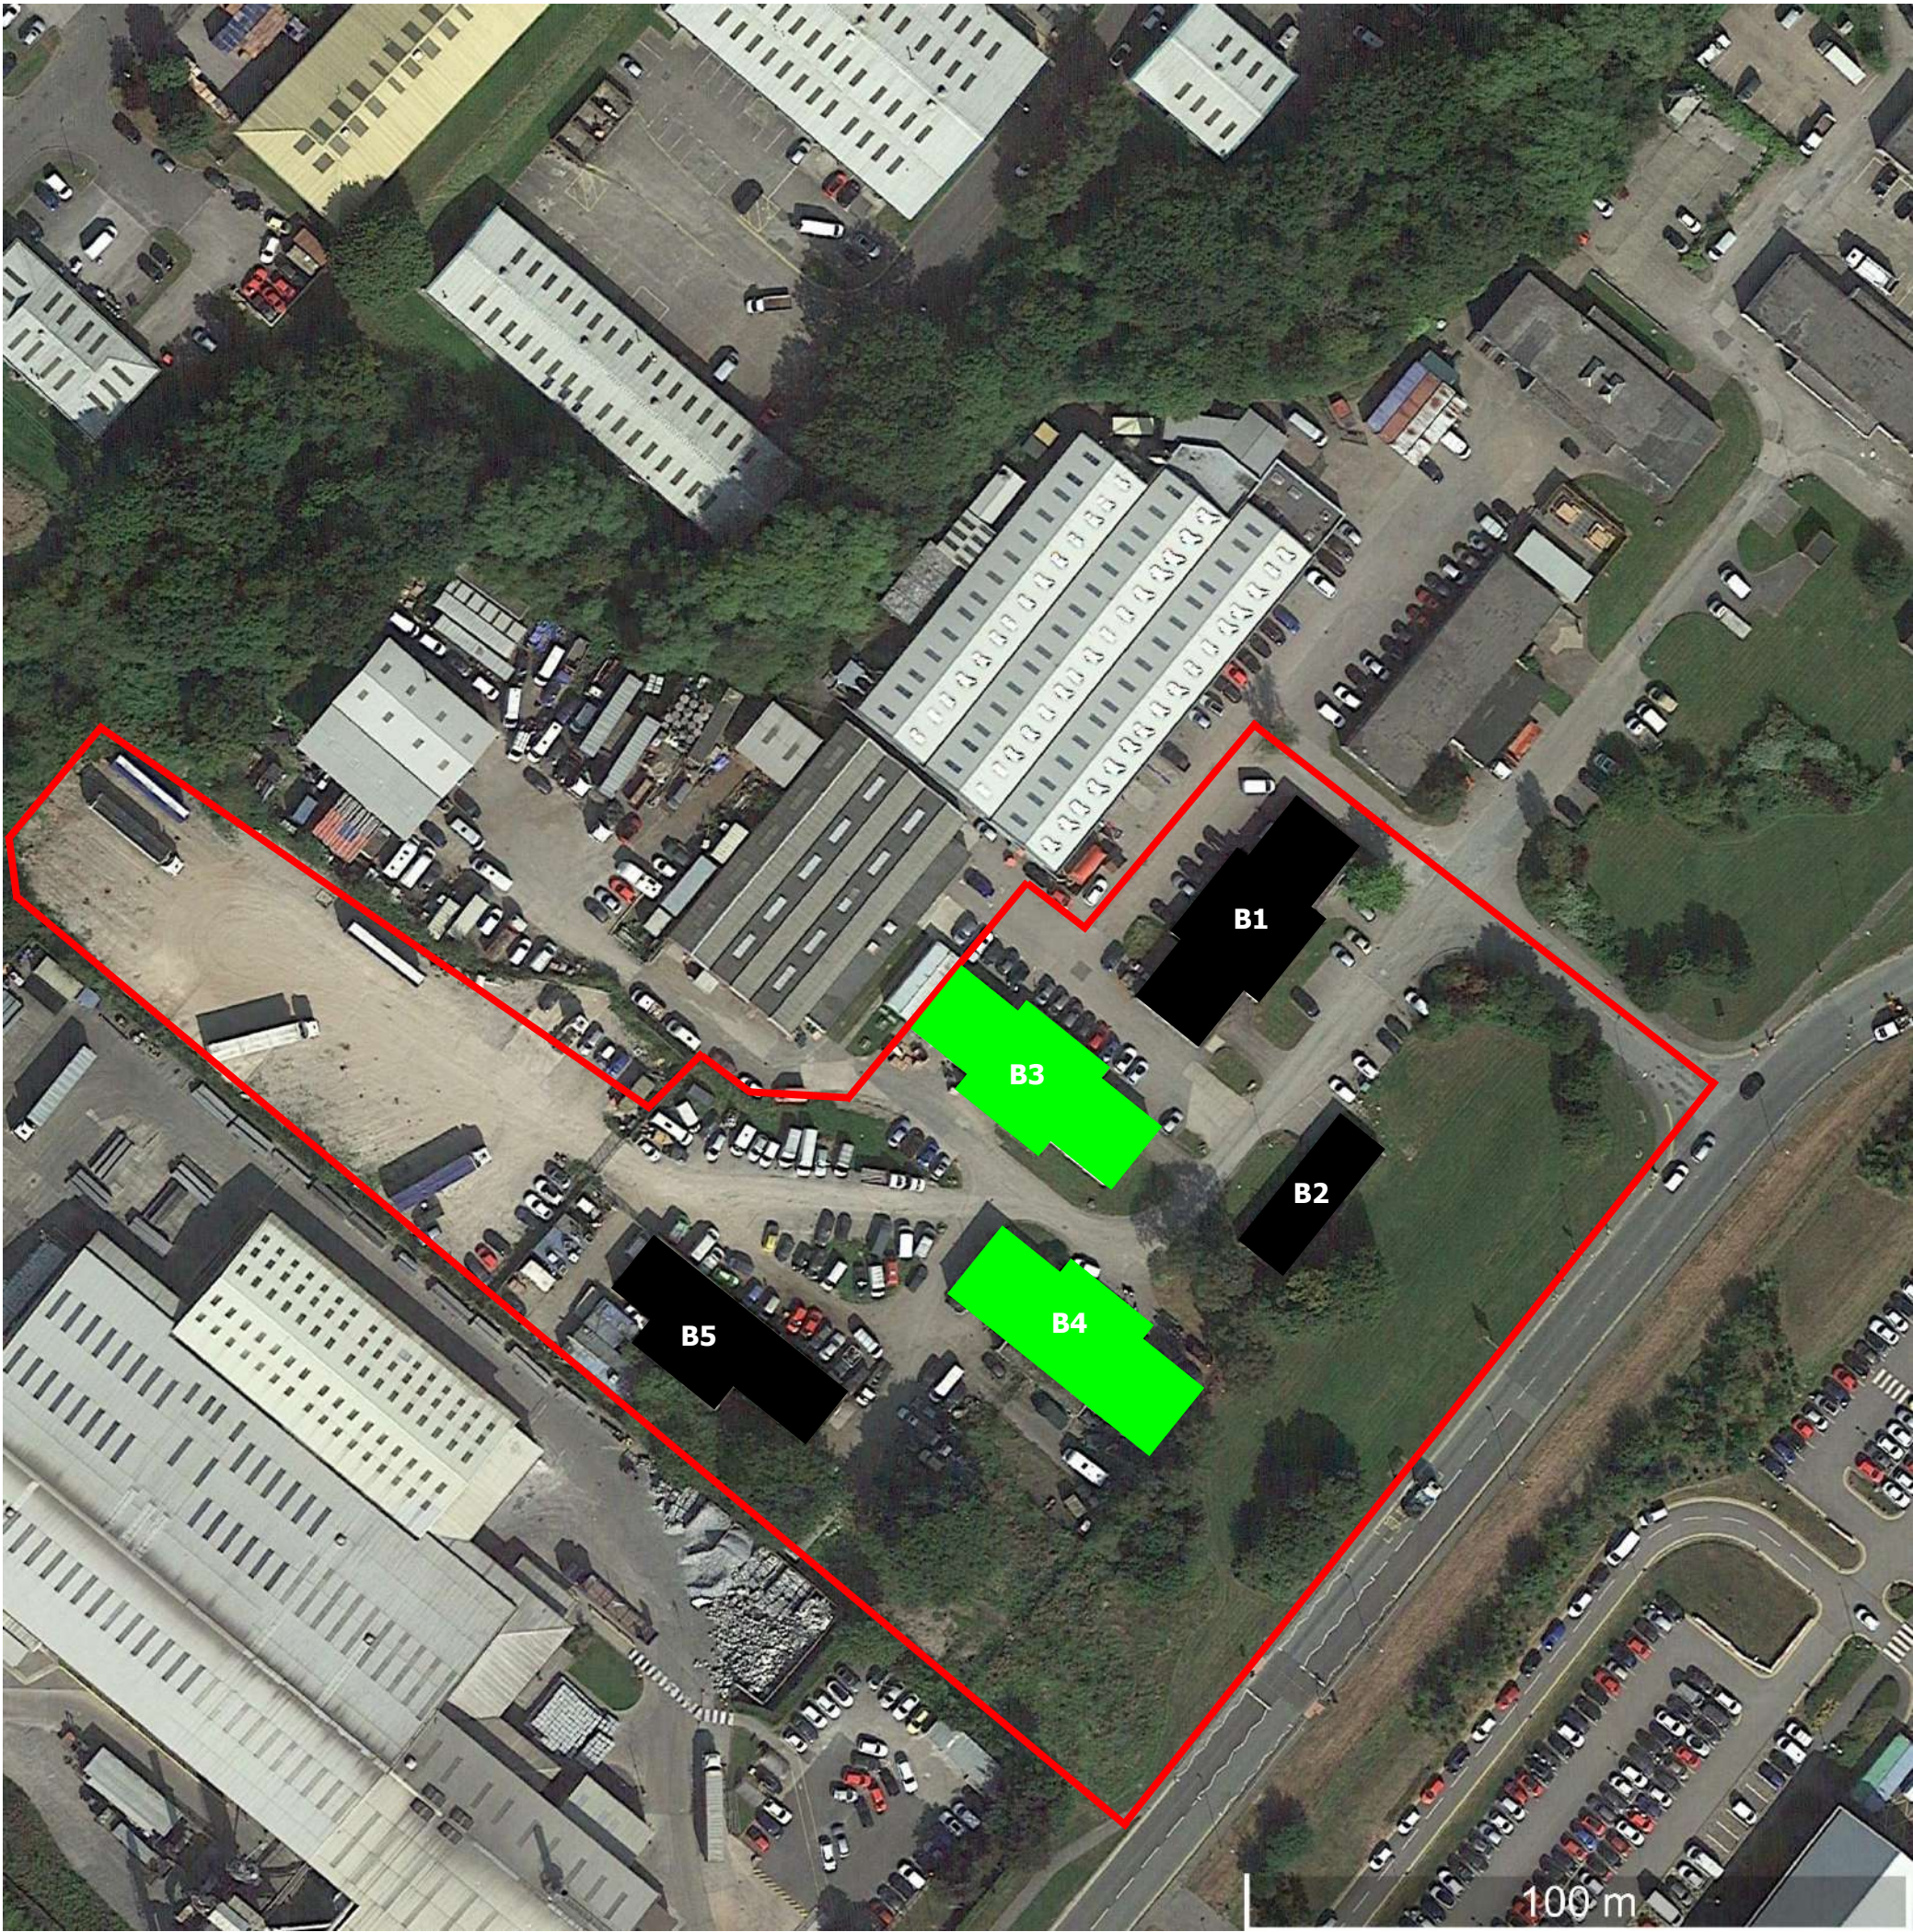
Site plan

There are five buildings within the survey boundary covered by this assessment, which have been numbered for the purposes of this report (see Appendix 1 – Site plan).

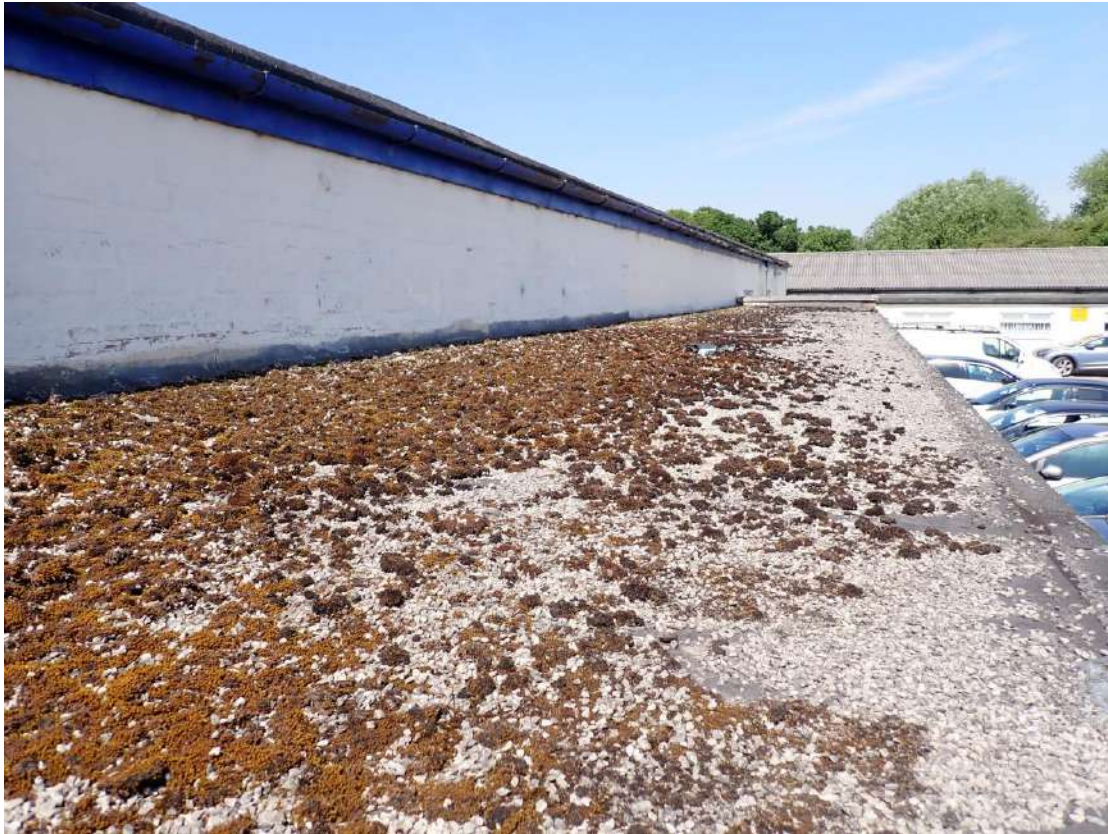
**Building 3** is a brick built rectangular building that has a similar construction to Building 2 (Photographs 9, 10, 13). There is a small extension on the northwestern aspect which is constructed of corrugated metal. The roof and walls are in excellent condition. The wooden fascia board on the southeastern aspect is slightly lifted (Photograph 11) and there is a gap at the end of the guttering on the same aspect, with raised bitumen felt (Photograph 12). These PRFs were inspected with an endoscope revealing no evidence of bats although a sheltered feature still remains.

Photograph 9 – Southeastern aspect of Building 3.

Photograph 10 – Southern aspect of Building 3.

Photograph 13 – Northeastern aspect of Building 3.

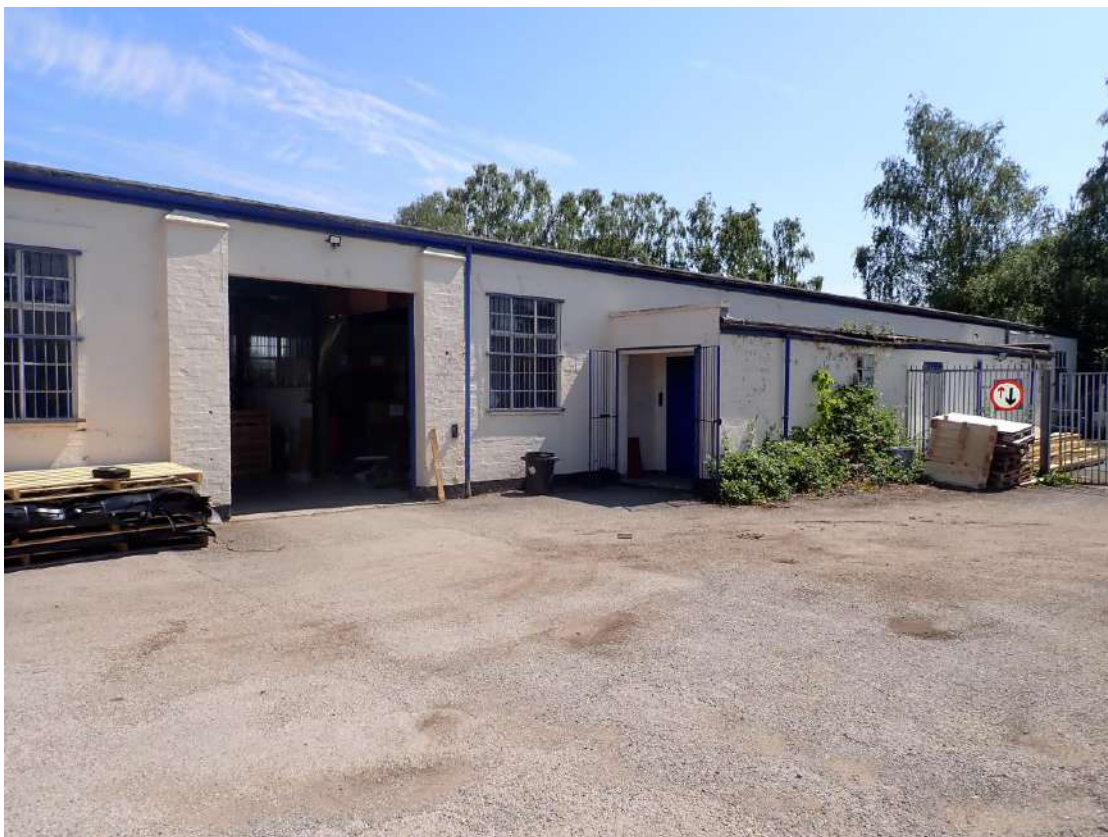
**Building 4** is a brick built rectangular building that is a similar design to Building 2 (Photographs 14, 17, 18, 19). The fascia boards are well fitted with the exception of a gap above the roller shutters on the southwestern aspect (Photograph 15), and further along on the same aspect there's a hold in the brickwork at the top of a brick pillar (Photograph 16). These PRFs were inspected with an endoscope and no evidence of bats were found.

Photograph 14 – Southwestern aspect of Building 4.

Photograph 17 – Northwestern aspect of Building 4.

Photograph 18 – Northeastern aspect of Building 4.

Photograph 19 - Roof of Building 4.

Photograph 20 – Southwestern aspect of Building 4.
