# Arboricultural Report

**Erection of a new dwelling  
Land next to Church View  
School Lane  
Bronington  
Whitchurch**

**Report Date:**  
15 November 2023

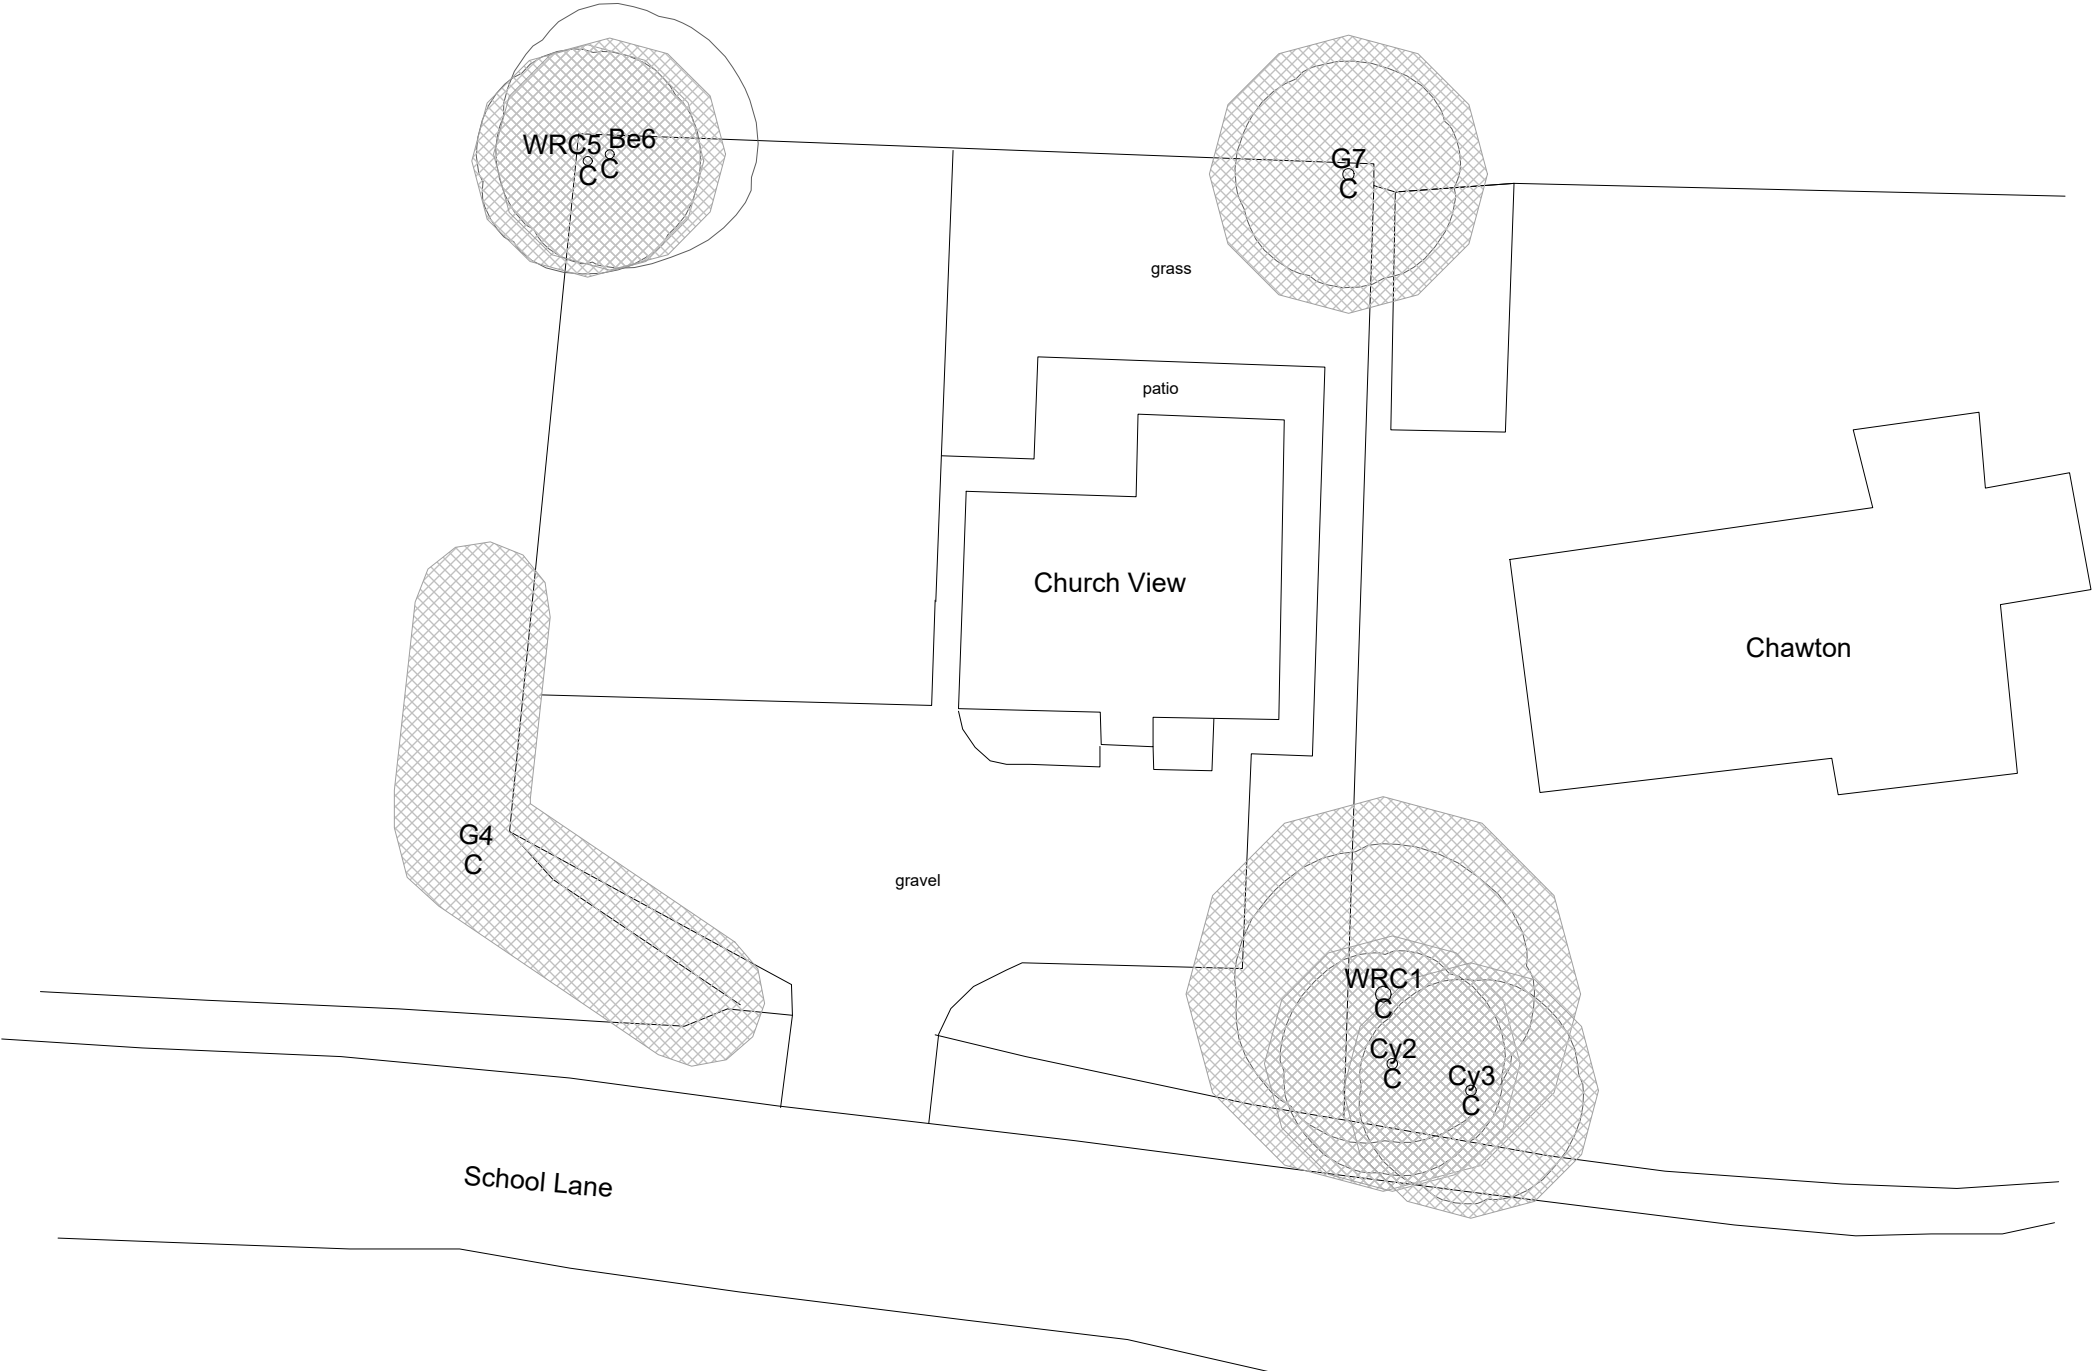
Map reference:  
PC23/652/TCP

Tree Constraints Plan  
Showing all trees, crown dimensions, tree categories and  
root protection areas (RPAs)

- 8.1 Appendix A and B show the category of trees, their crown spread and their root protection area (RPA), an area of rooting around the tree which if retained will provide suitable medium for the tree to continue to grow without significant harm.

- 8.2 RPAs do not show the entire rooting area of the tree. They may show just  $\frac{1}{2}$  or  $\frac{1}{3}$  of it depending upon site conditions. The RPA is usually drawn as a circle 12 times the diameter of the tree at 1.5m from the ground or, for multiple stemmed trees, its mathematical equivalent given in BS5837. However, site conditions may require the RPA to be drawn differently depending upon the most likely area where good rooting is found for the tree. In this case, No RPA has been altered.

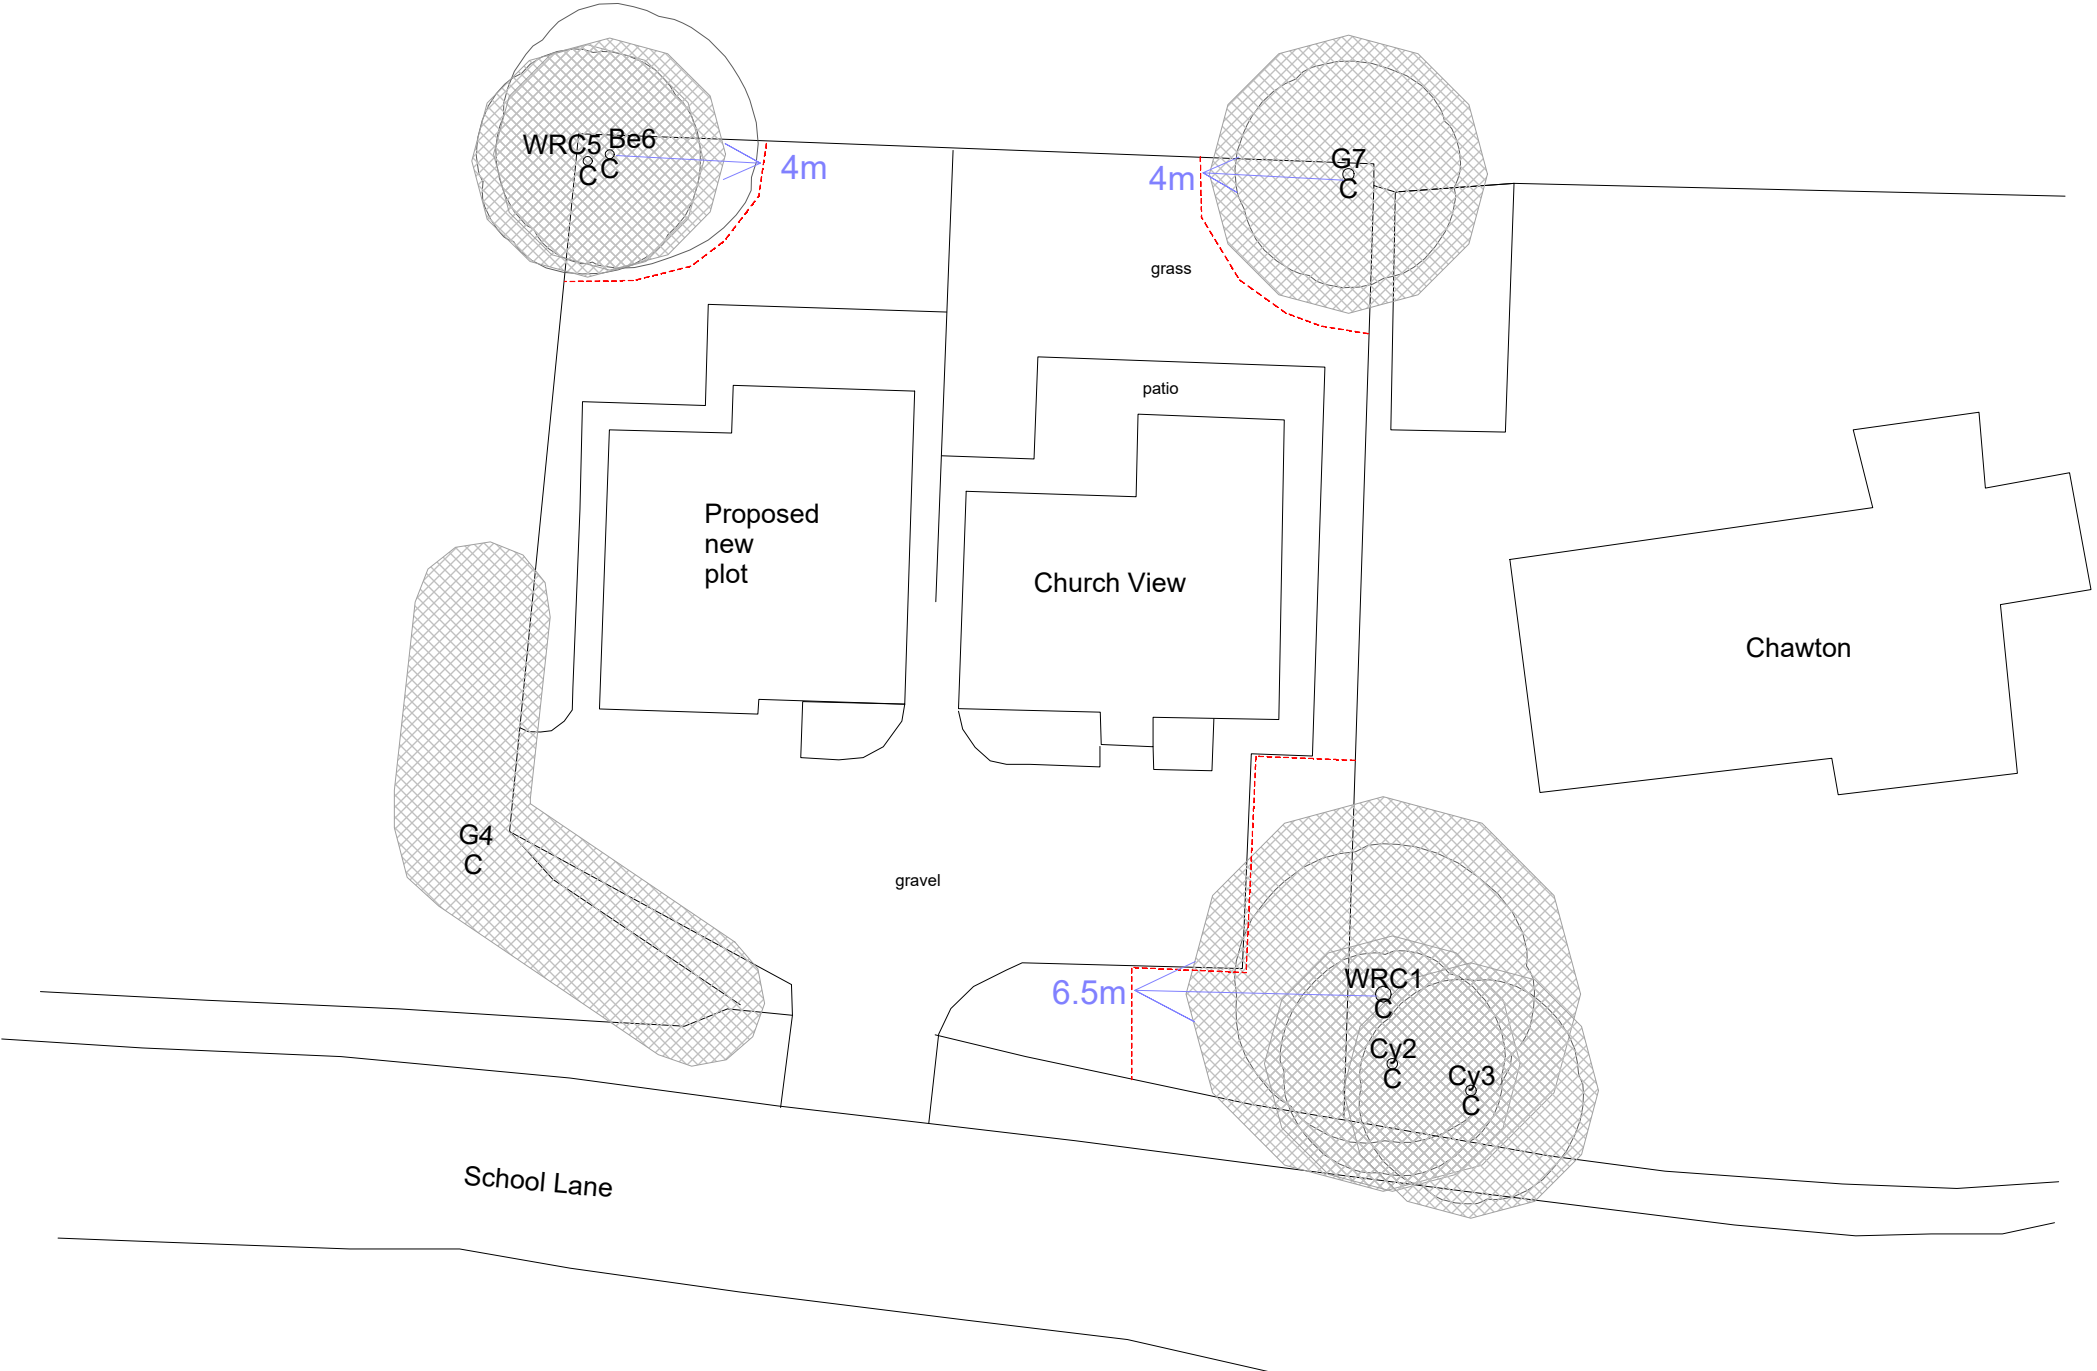
Map reference:  
PC23/652/TPP

Tree Protection Plan  
Showing all retained trees, crown dimensions, tree categories,  
root protection areas (RPAs) and protective fencing

- 8.4 Protective fencing should be in place before any plant, materials, deliveries, site offices or skips arrive. No demolition or construction work is to take place until protective fencing is installed and approved for use.
- 8.5 Protective fencing similar to that presented in BS5837, shown in Appendix D, is to be used to protect RPAs from vehicular and foot access. The fencing is to be securely joined and attached to immovable objects to prevent it from being moved. Fencing should be firmly attached into the ground and will require tools to move it. The positioning of fencing is shown in appendix B with minimum distances shown in purple.
- 8.6 There is plenty of space for services to enter the site below the drive. Should a service run need to be positioned within an RPA it will need to be dug by hand under the guidance of a site-specific arboricultural method statement.
