*Site – Former HSBC Bank*

*Reference – 20230066-Bat*

*Location – Cefn Mawr, Wrexham*

## ***Bat Survey***

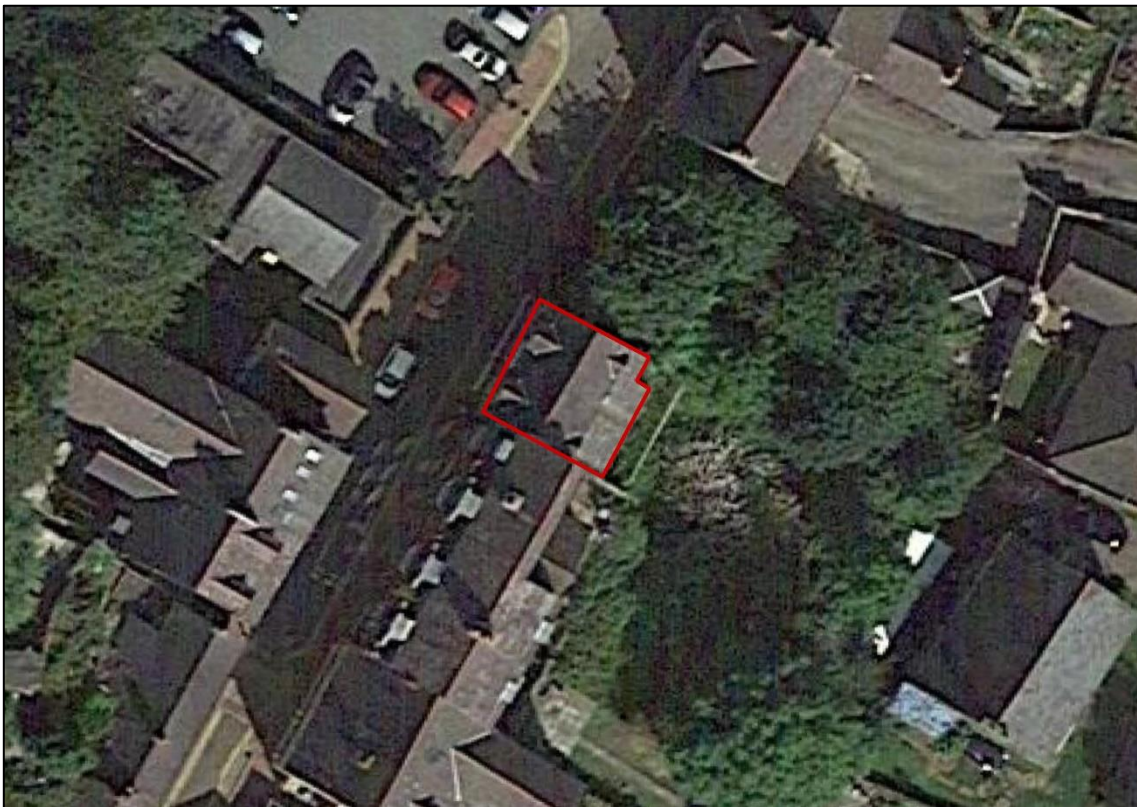
*Figure 1: Showing the building covered by this survey.*

2.2.2. The building comprises a semi-detached, previously commercial, property that is three-storey to the west and extends to four storeys to the east. The building is disused and has been empty for some time.

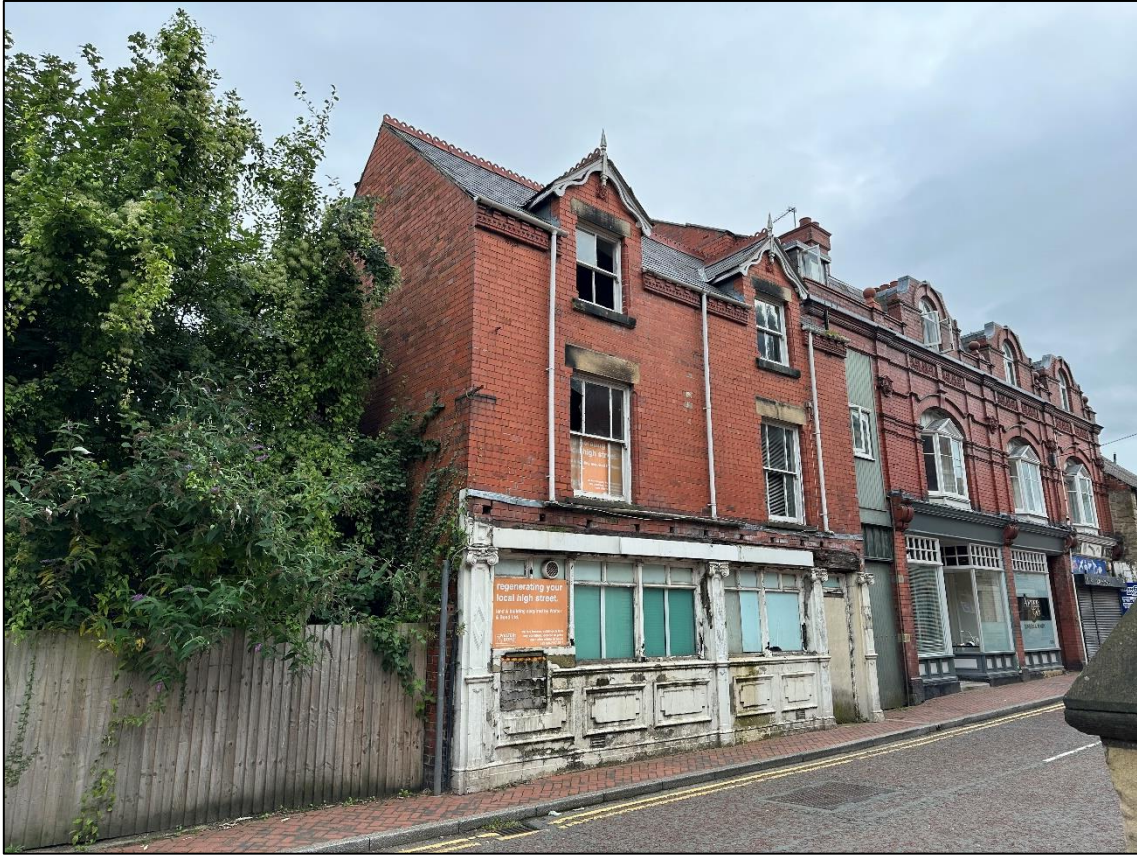
2.2.3. The walls of the building comprise cavity brick walls with a commercial frontage on the ground floor to the west. Decorative brickwork is present around the eaves on the western elevation with wooden sash windows present throughout that elevation.

Figure 2: The western elevation of the building.

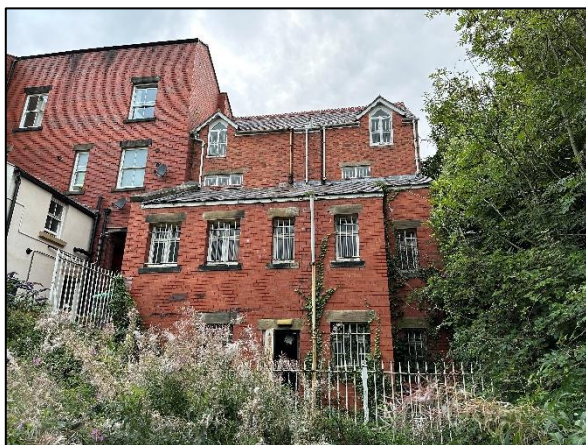
2.2.4. To the east there is a two-storey extension to the building. The eastern elevation displays wooden fascia boards to the eaves and wooden windows with metal bars.

Figure 3: The eastern elevation of the building.

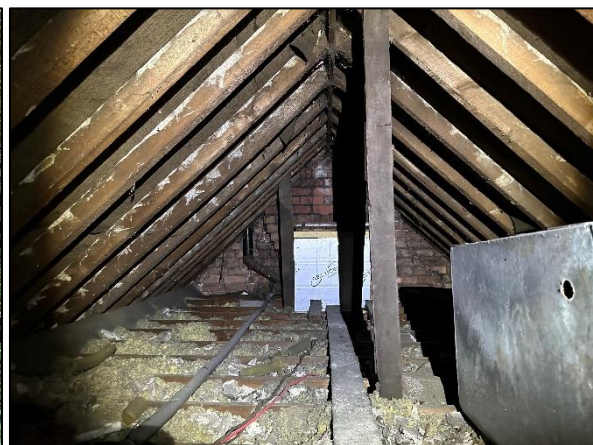
Figure 4: The loft space of the building.

2.2.6. Internally the building has a single loft space that extends throughout the roof void. The loft space displays purlin and rafter timbers with a bituminous lining felt on the inside of the roof tiles.

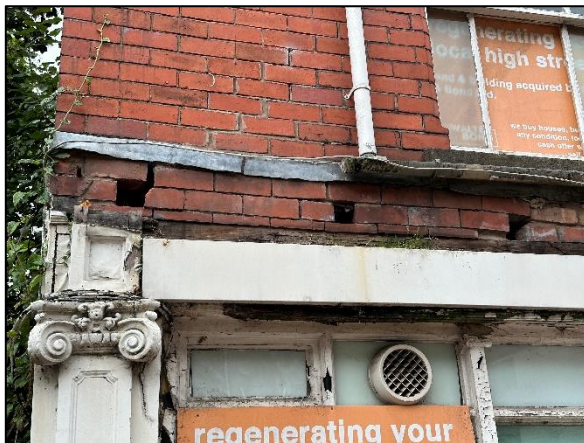
4.2.1. The walls of the building were found to be in a generally good condition although occasional shallow voids were identified on the western elevation, where part of the shop front has been removed.

Figure 6: Shallow voids in the western elevation.

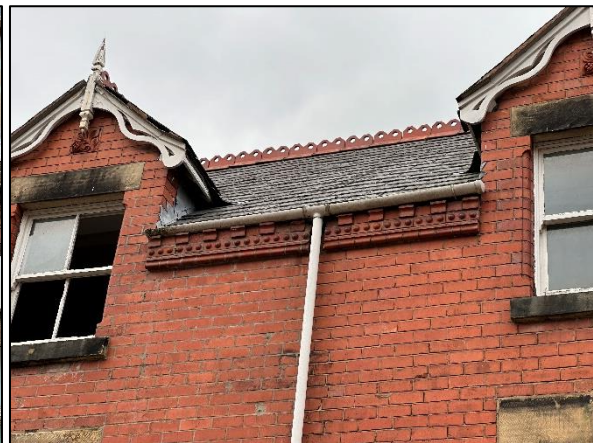
4.2.3. The decorative brickworks around the eaves to the west of the building were found to be in a good condition providing minimal opportunities for bats to access the eaves of the building.

Figure 7: Decorative brickwork at the eaves to the west.

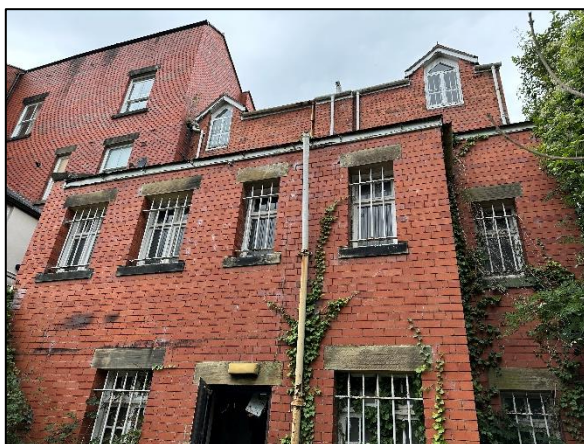
4.2.4. To the east the eaves displayed a small wooden fascia board that was in a deteriorating condition with occasional voids identified leading behind the fascia.

Figure 8: The eastern elevation of the building.

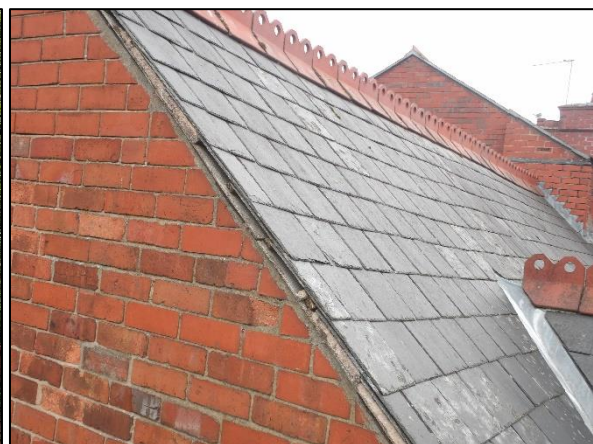
Figure 9: Voids around the verge of the building.

4.2.5. Voids were identified around the verge of the building due to areas of missing cement providing potential for bats to access the void between the roof tiles and lining felt.

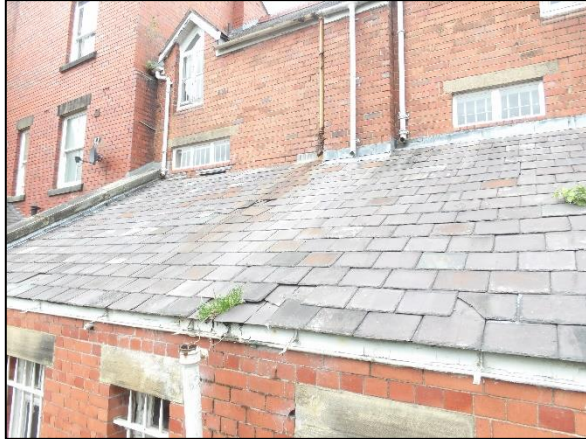
4.2.6. The roof of the building was found to be in a generally good condition with tight fitting roof tiles and the ridge tiles in place. Occasional missing or slipped tiles were identified, in both the main roof and the sloping roof over the extension, providing potential for bats to access between the roof tiles or under the ridge tiles.

Figure 10: Missing and slipped roof tiles in the extension.

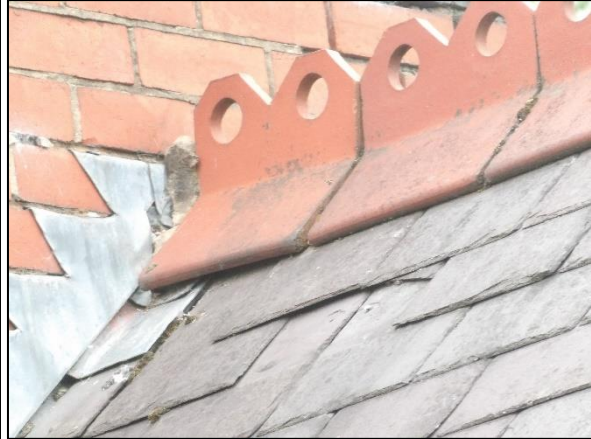
Figure 11: Voids under the ridge tiles of the building.

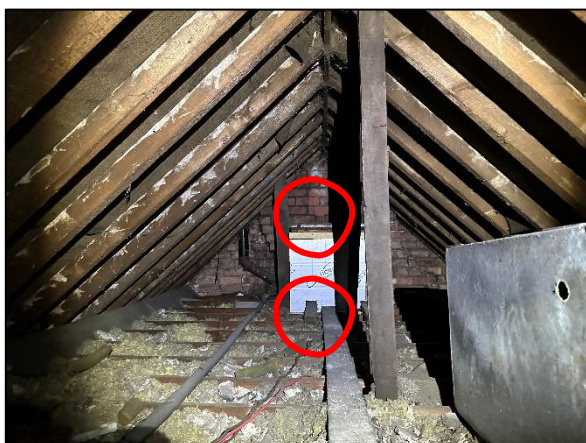
4.2.9. To the south approximately 50-100 fresh bat droppings were identified on the top of a small tank at the gable end with an additional 20-30 bat droppings on the floor in front of the tank. The droppings were concentrated underneath the ridge with no bats visible at the time of the survey.

Figure 12: The south of the roof void, droppings circled.

5.1. Due to the potential in the building being predominantly in the roof it is recommended that the works are carried out in a way that will retain the existing roof and maintain the roof void in an unaltered manner. If works can be carried out in this manner it is recommended that the works commence without the requirement for a Natural Resources Wales (NRW) licence, although it is recommended that the works are carried out under a strict RAMS, outlining measures to ensure that the roosts present in the building undisturbed.

5.2. If it is not possible to carry out the works in a manner that will retain the existing roof and roof void it is recommended that no works commence on the building until NRW licence has been obtained to cover the works.

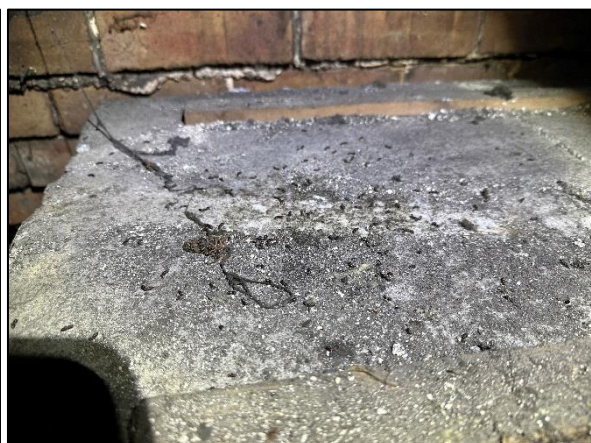
Figure 13: Bat droppings on the tank.

5.2.3. It is also recommended that bat droppings collected during the PRA are sent for eDNA analysis, to accurately confirm the species of bats present.

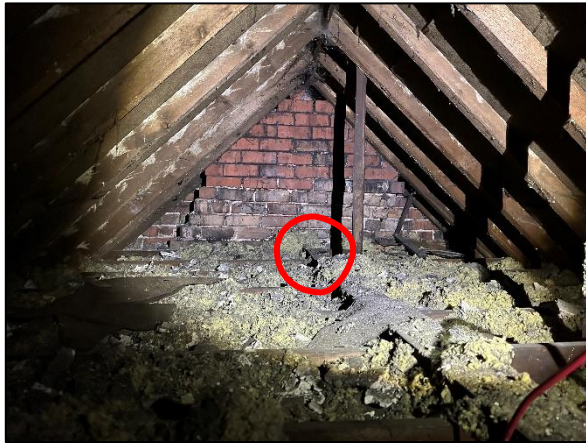
4.2.10. To the north an additional 50-100 fresh bat droppings were identified on the loft floor underneath the ridge. No bats were visible in the area of the droppings at the time of the survey.

Figure 14: The north of the roof void, droppings circled.

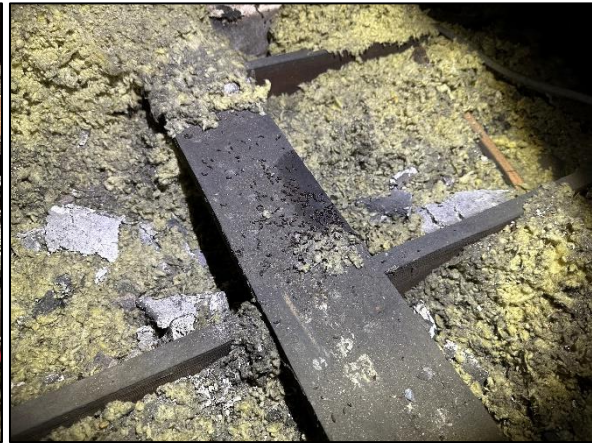
Figure 15: Bat droppings on the loft floor.

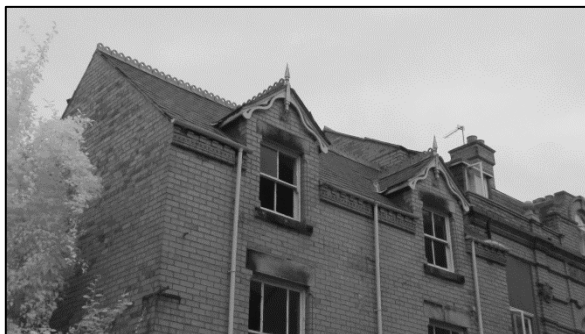
Figure 16: Camera C1 at the start of the survey.

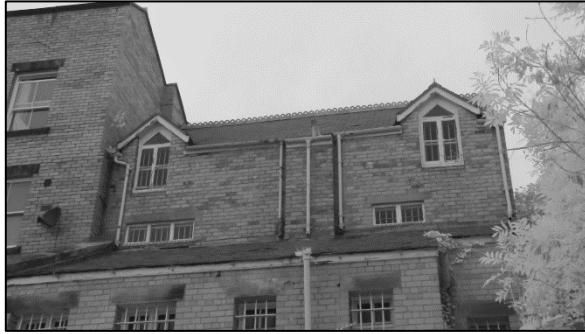
Figure 18: Camera C2 at the start of the survey.

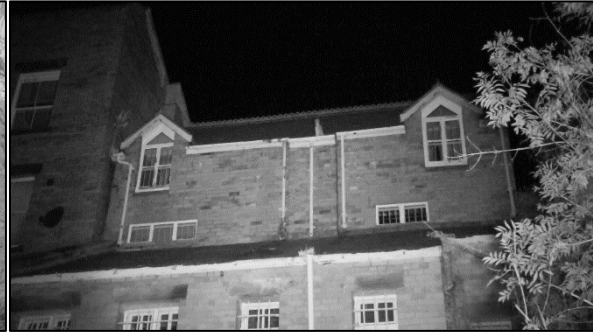
Figure 19: Camera C2 at the end of the survey.

4.3.2. No bats were identified to emerge from the building during the survey.

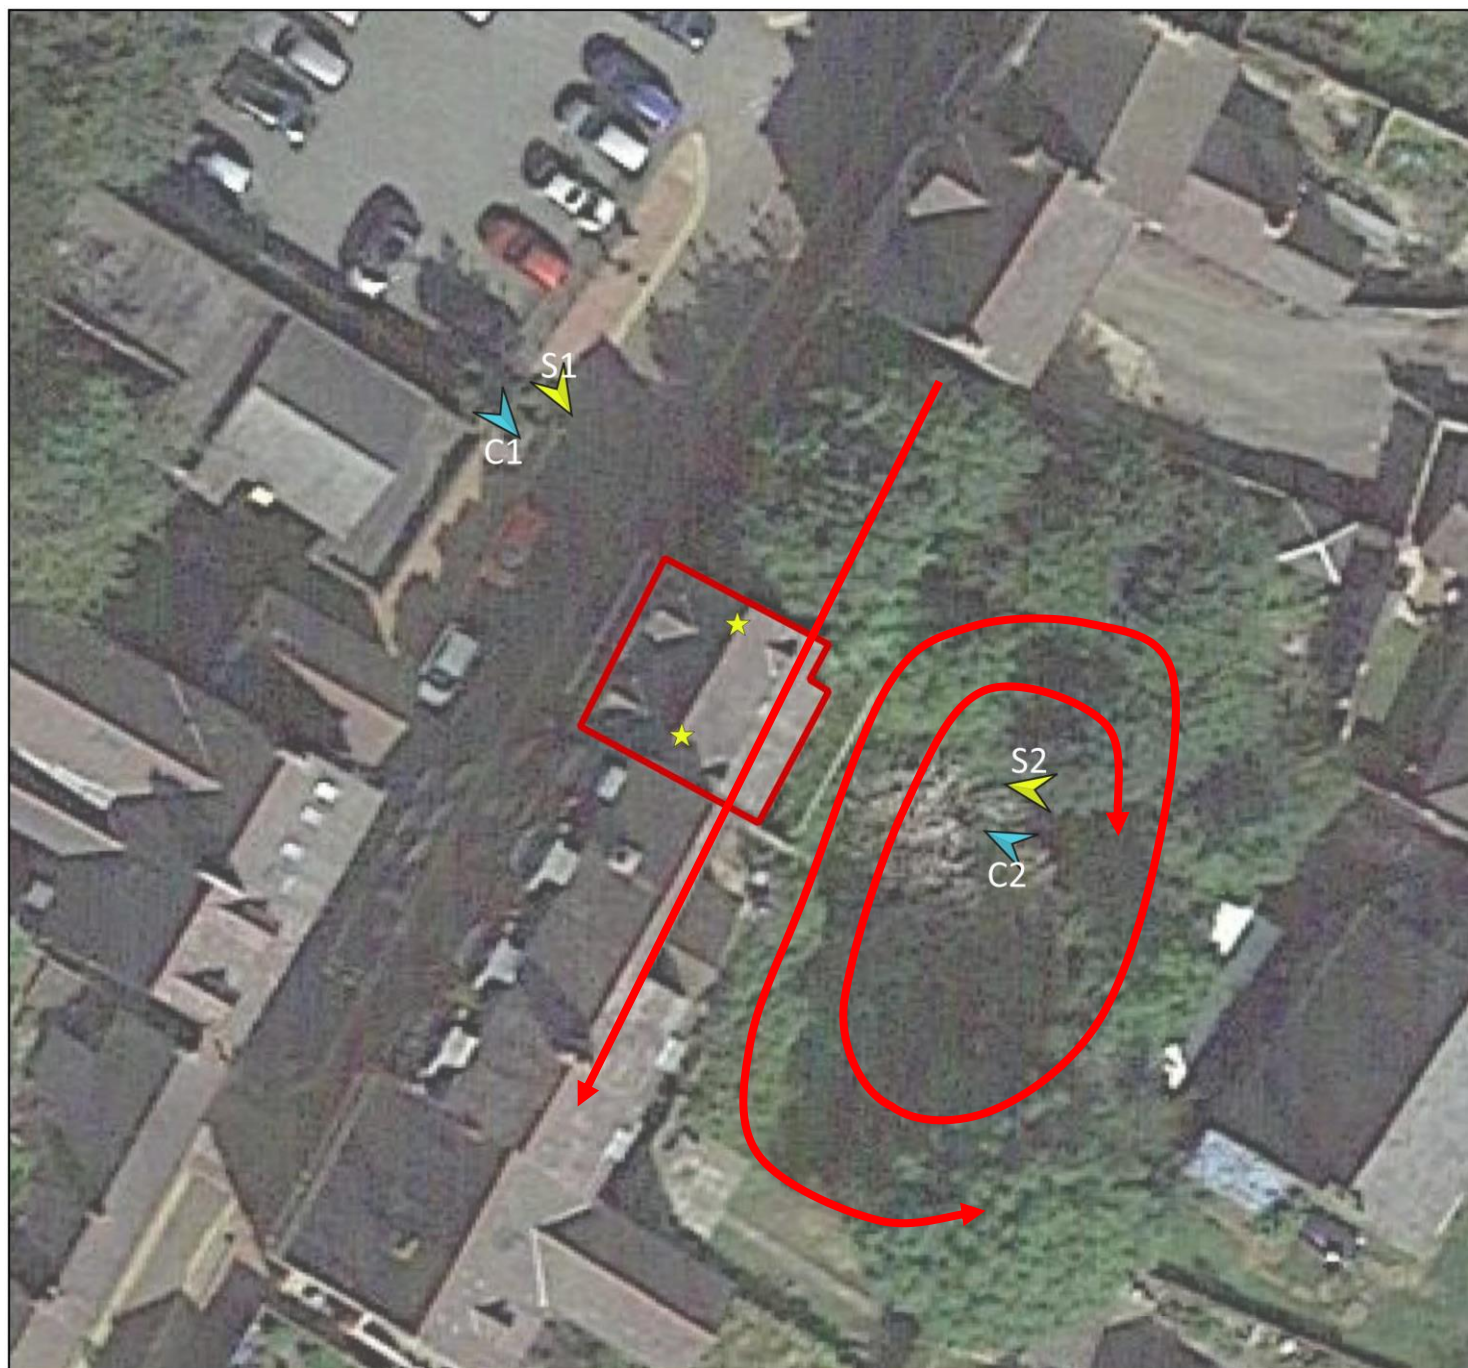
4.3.1. The plan in Appendix II of this report shows the surveyor locations and bat activity recorded during the survey.

4.3.3. Bat activity was identified in close proximity to the building, predominantly to the east with common pipistrelle (*Pipistrellus pipistrellus*) and myotis species bats (*Myotis sp.*) identified foraging over the vegetation and around the trees to the north. Occasional brief soprano pipistrelle (*Pipistrellus pygmaeus*) passes were also recorded and several noctule (*Nyctalus noctula*) were identified passing high over the site from north to south.
