# **TANK REMOVAL VALIDATION REPORT**

**J10 PLANNING**

**GWERSYLLT**

**BFG1042 R01**

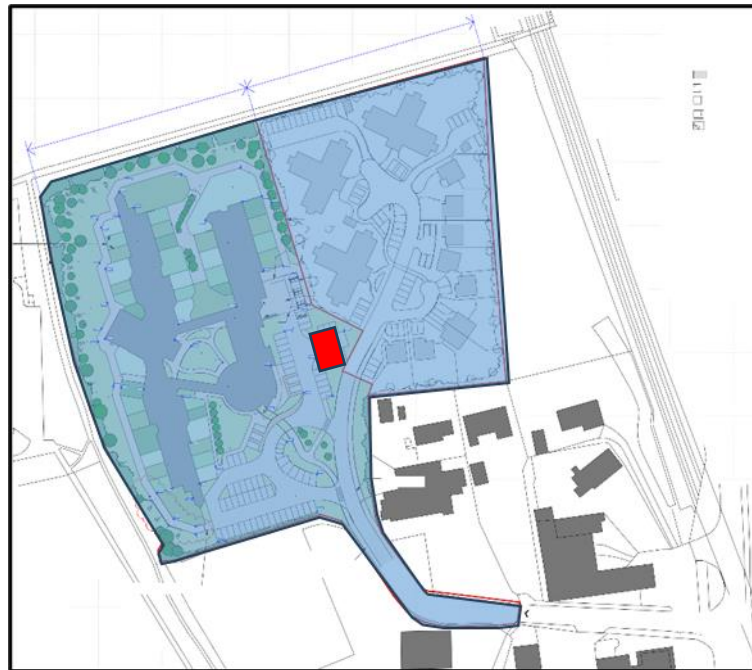
**Figure 2** UST Location

The Clancy Phase 2 report confirmed the presence of underground storage tanks and recommended the inspection and removal of fuel storage tanks prior to site development. Recommendations also included the excavation of trial pits to be carried out directly beneath and around the tanks, with further soil samples recovered for chemical testing.

Peter confirmed the tanks (three) were excavated down the front and sides, prior to removing for disposal as scrap metal off-site. Once the tanks were removed, excavated materials were placed back in the excavation and tracked to provide a compacted surface.

6No. validation samples were taken in the area of the former USTs (TP01) in order to confirm removal of the tank and any potential residual contamination. All samples were submitted for TPH CWG and BTEX. (one sample per face and one sample from the base of the excavation and one sample from the backfill).
