**Final Factual Environmental Report for**

**Maelor, Wrexham**

*Areas A and C Stage 1 Risk Mitigation Works Factual Report*

*Authored By: IKM Consulting, dated July 2014 Project Reference 13627-REP-002*

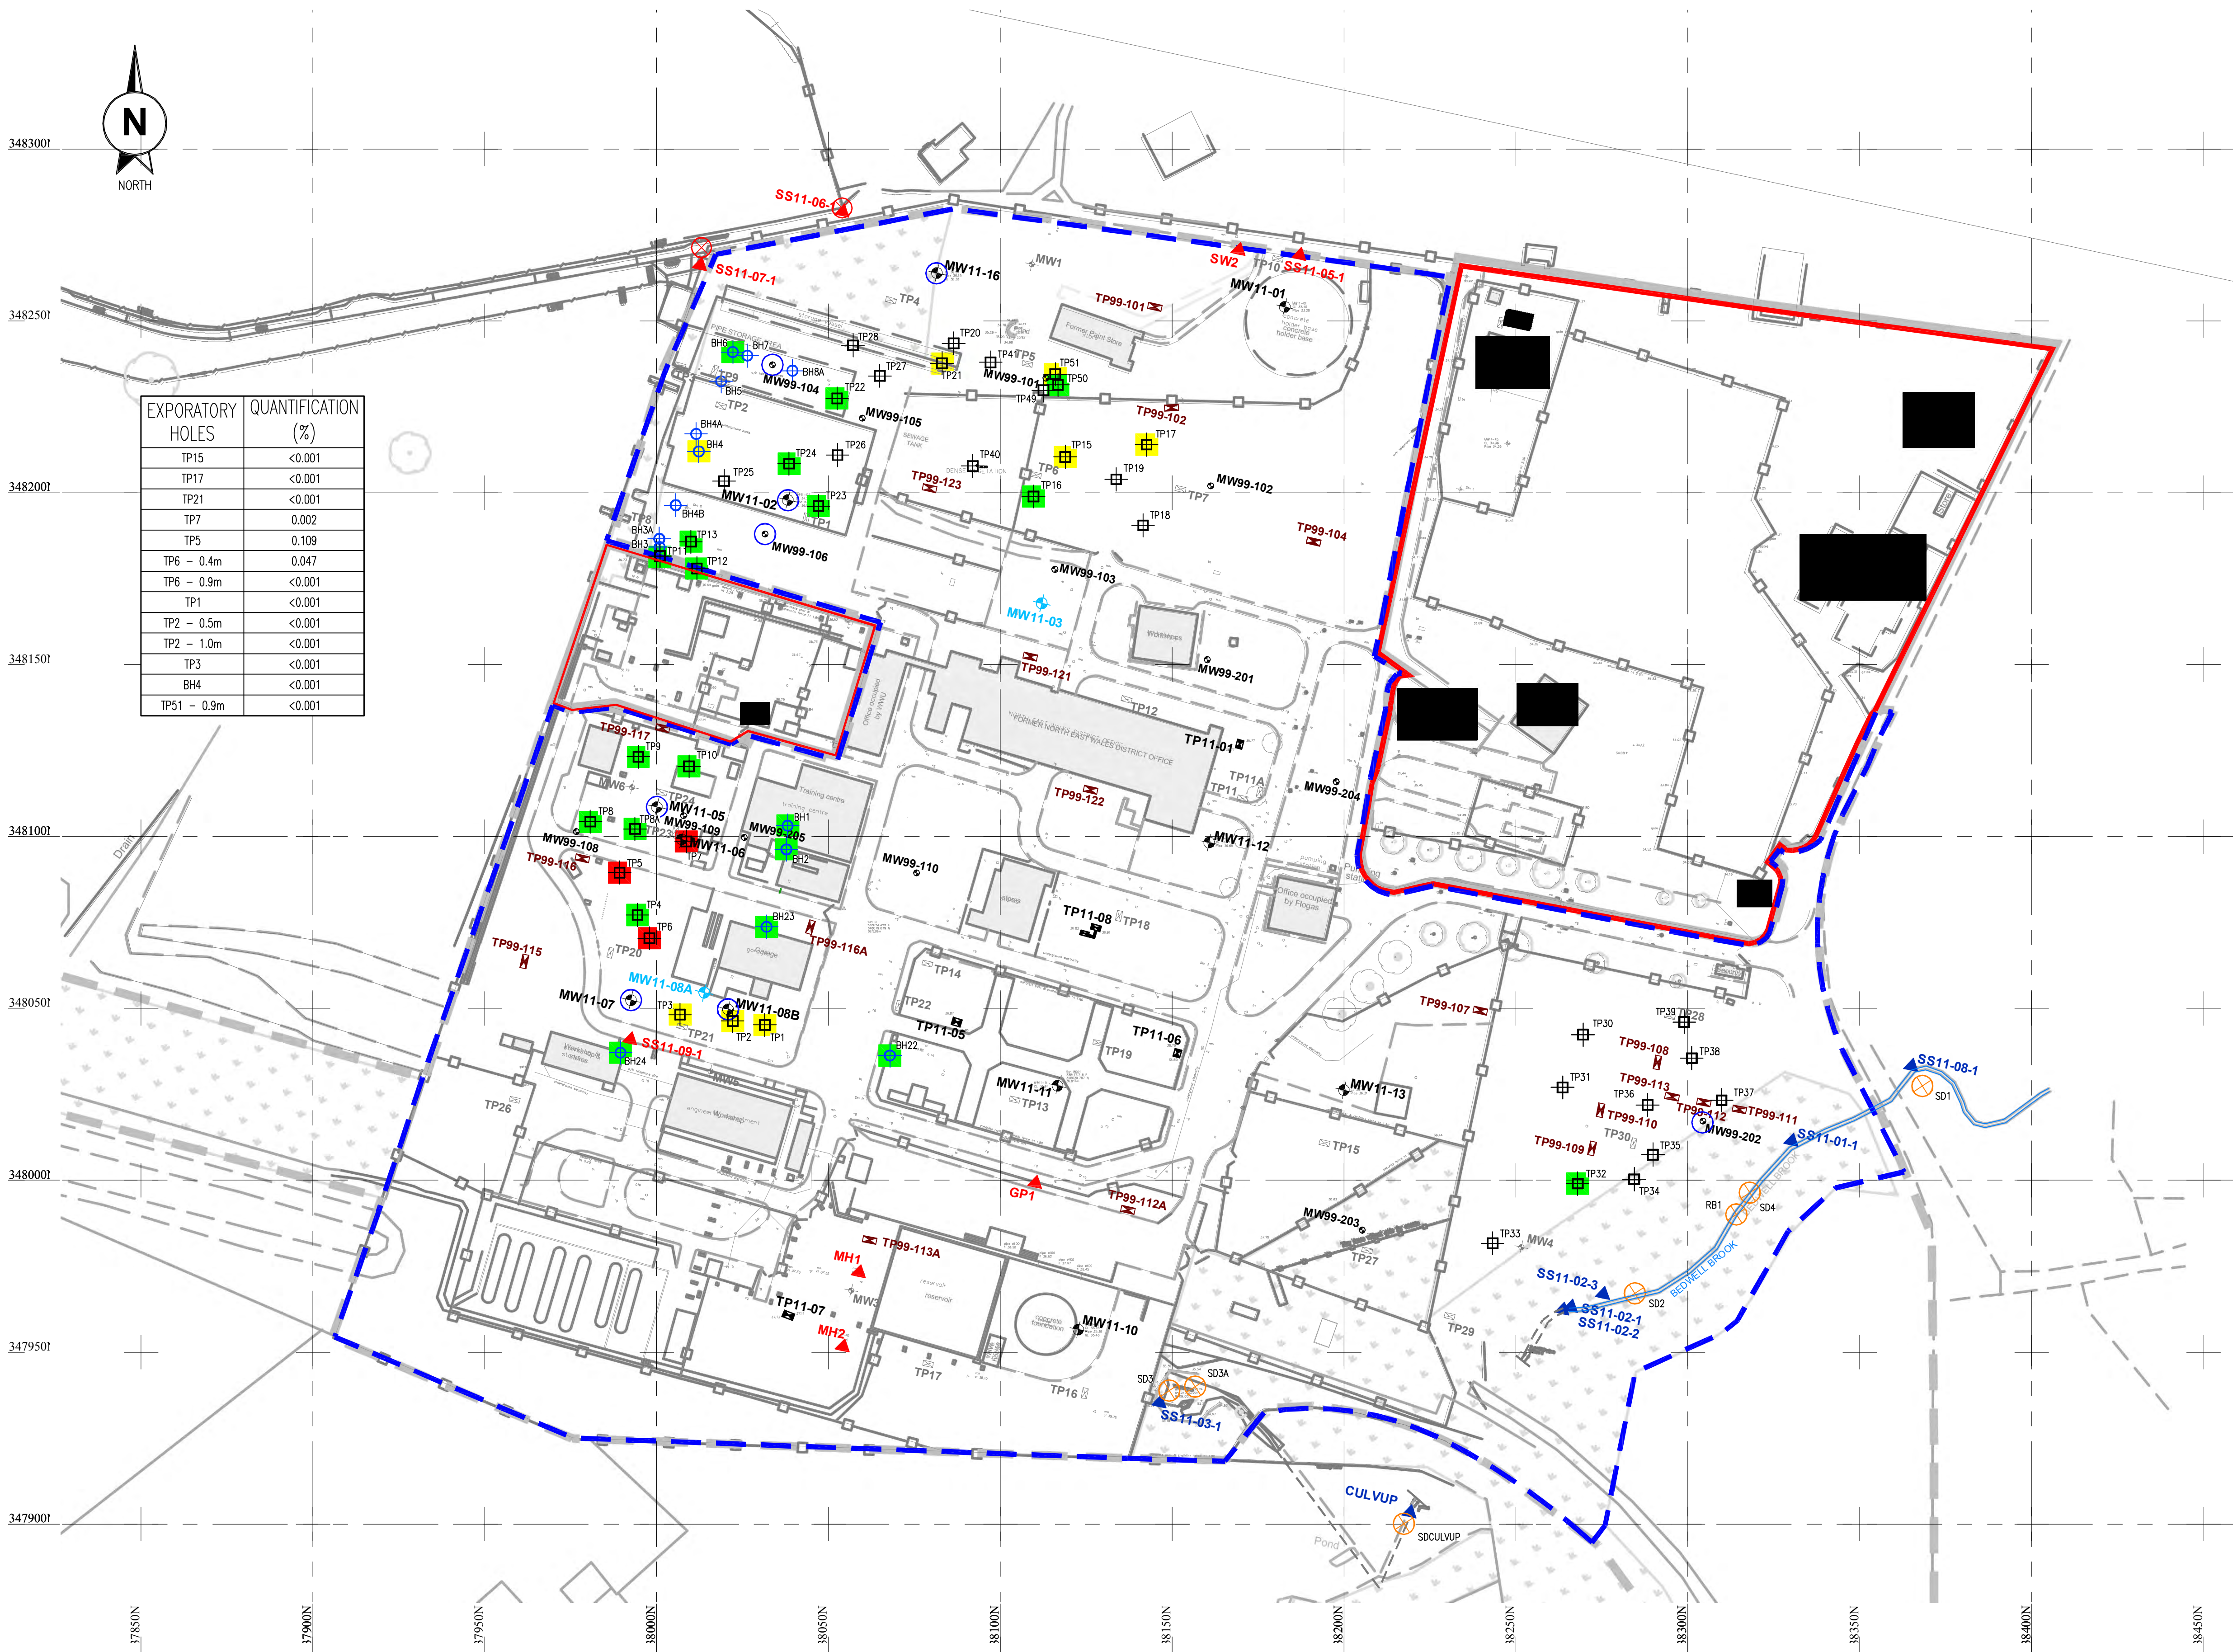
**Asbestos Testing Location Plan - Area A**

| EXPOSITORY HOLES | QUANTIFICATION (%) |
| TP15 | <0.001 |

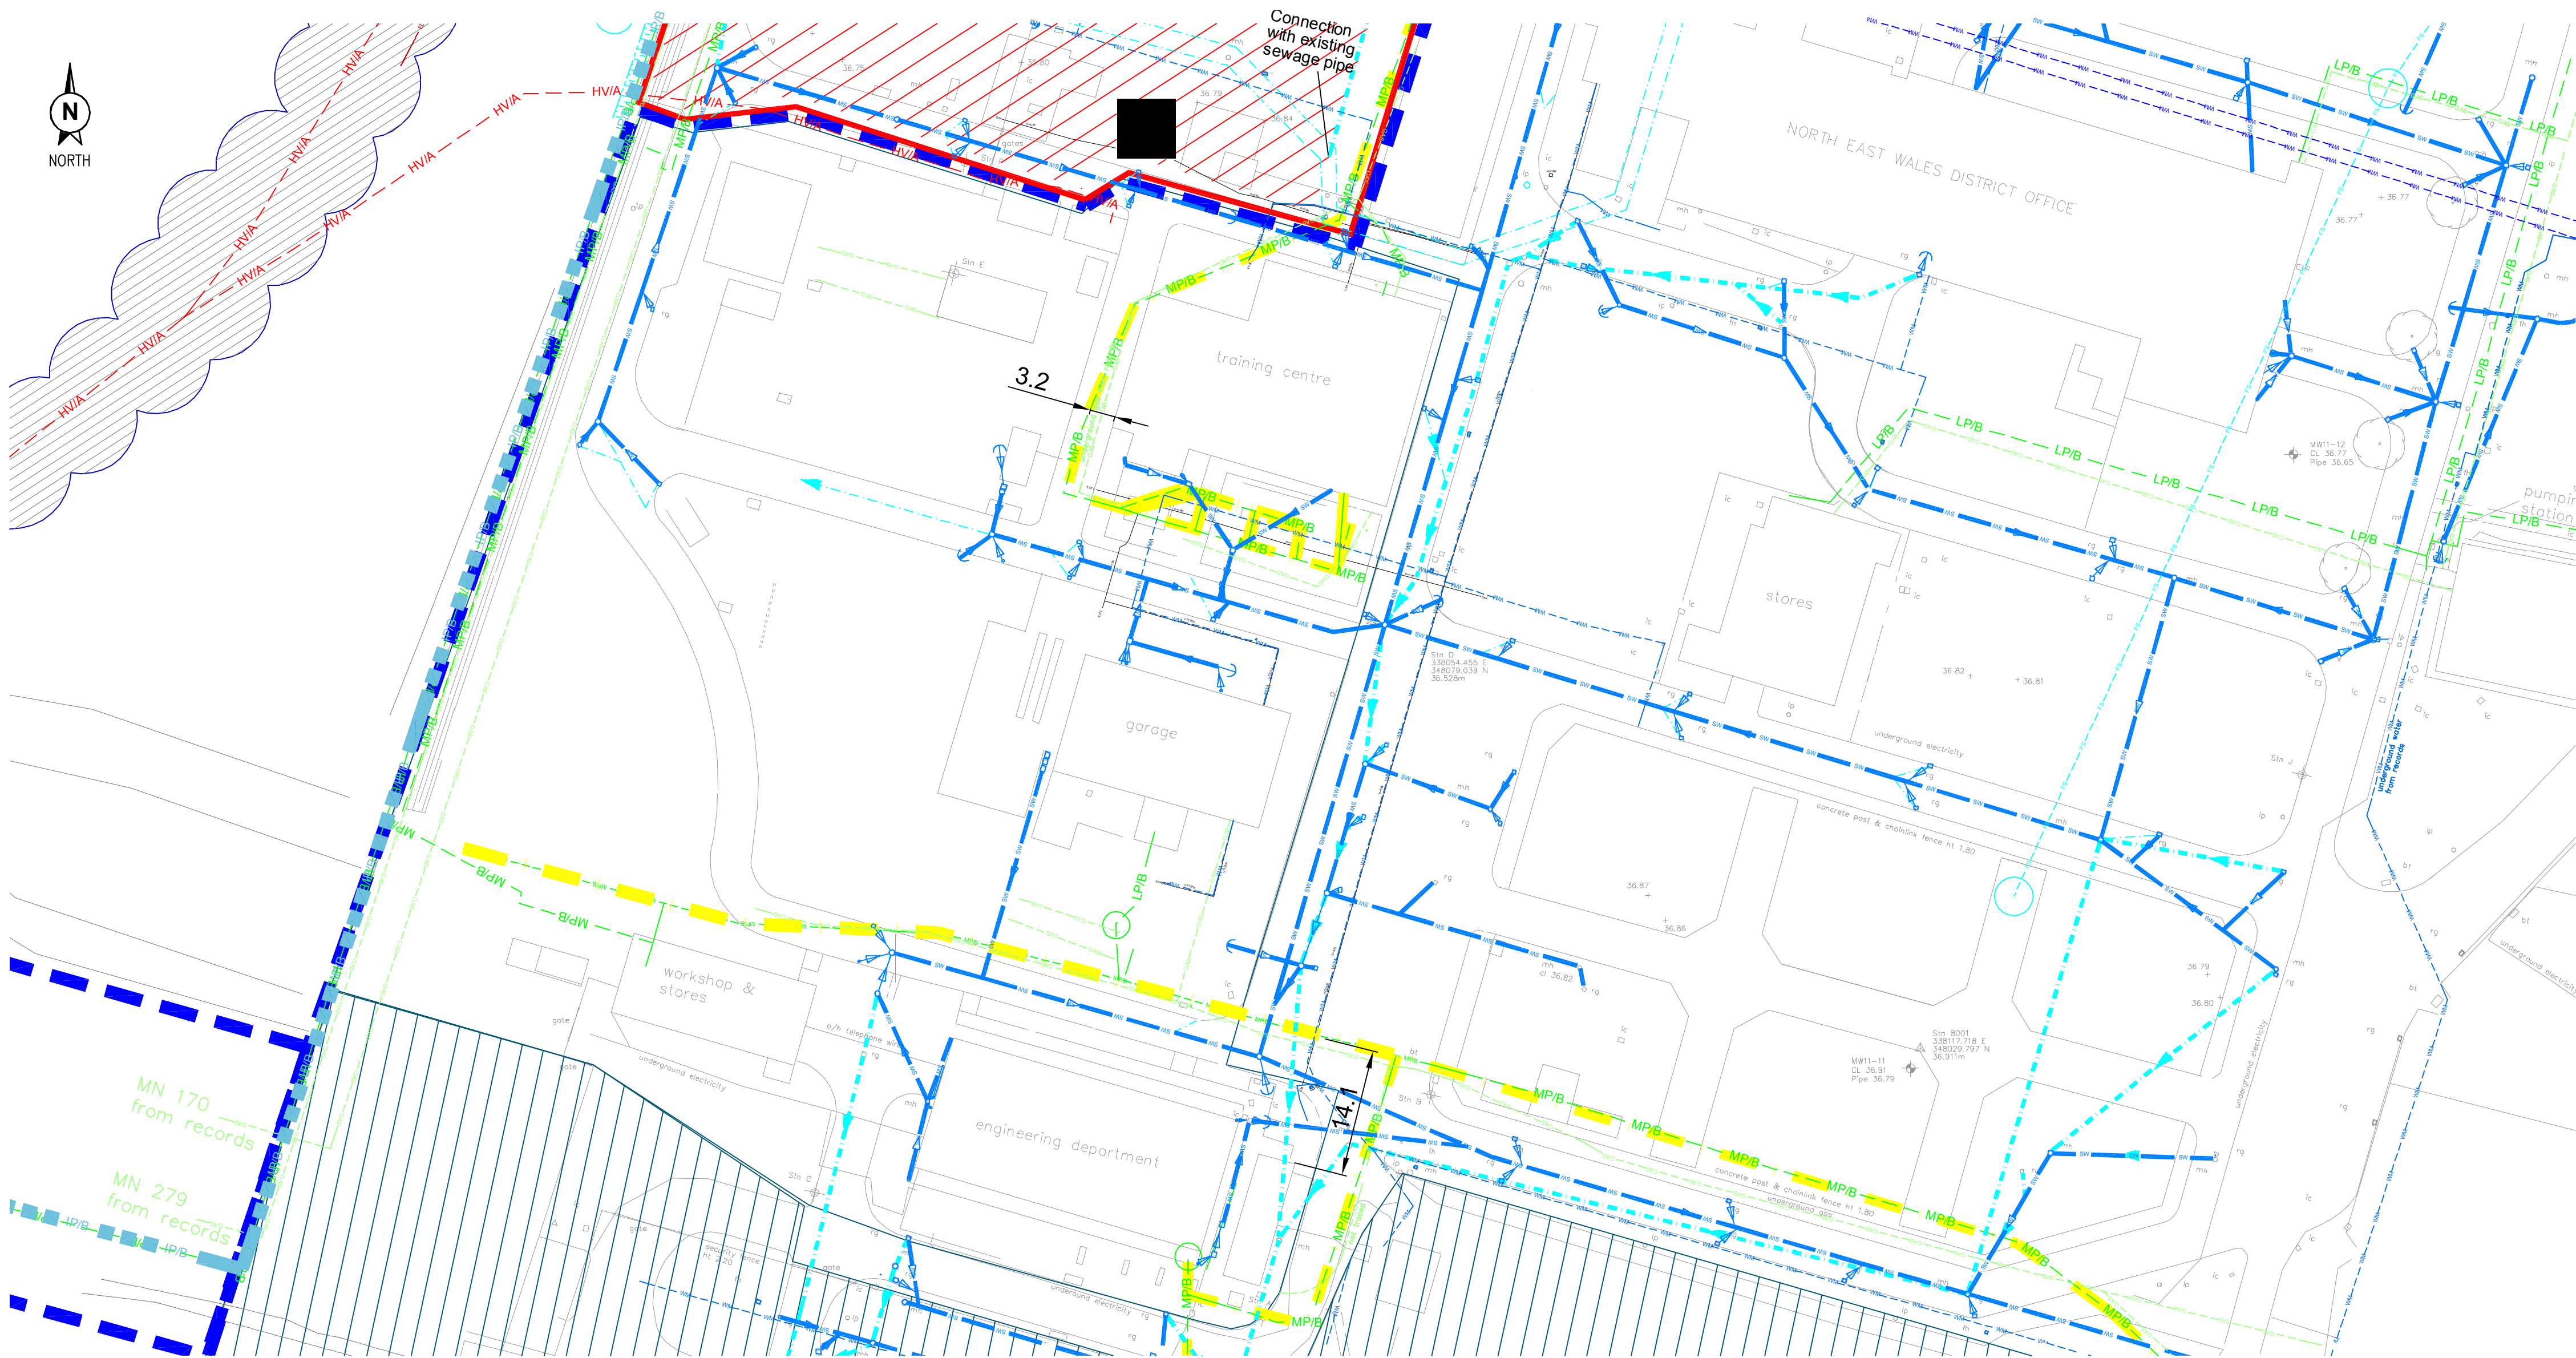
AREA AC2 CONSTRAINTS PLAN  
SCALE 1:500

- NATIONAL GRID PROPERTY HOLDINGS LTD BOUNDARY
- WALES & WEST UTILITIES BOUNDARIES
- IP GAS MAINS
- MP GAS MAINS
- HIGH VOLTAGE OVERHEAD POWER LINES
- OPERATIONAL WWU SITE
- OPERATIONAL COMAH SITE

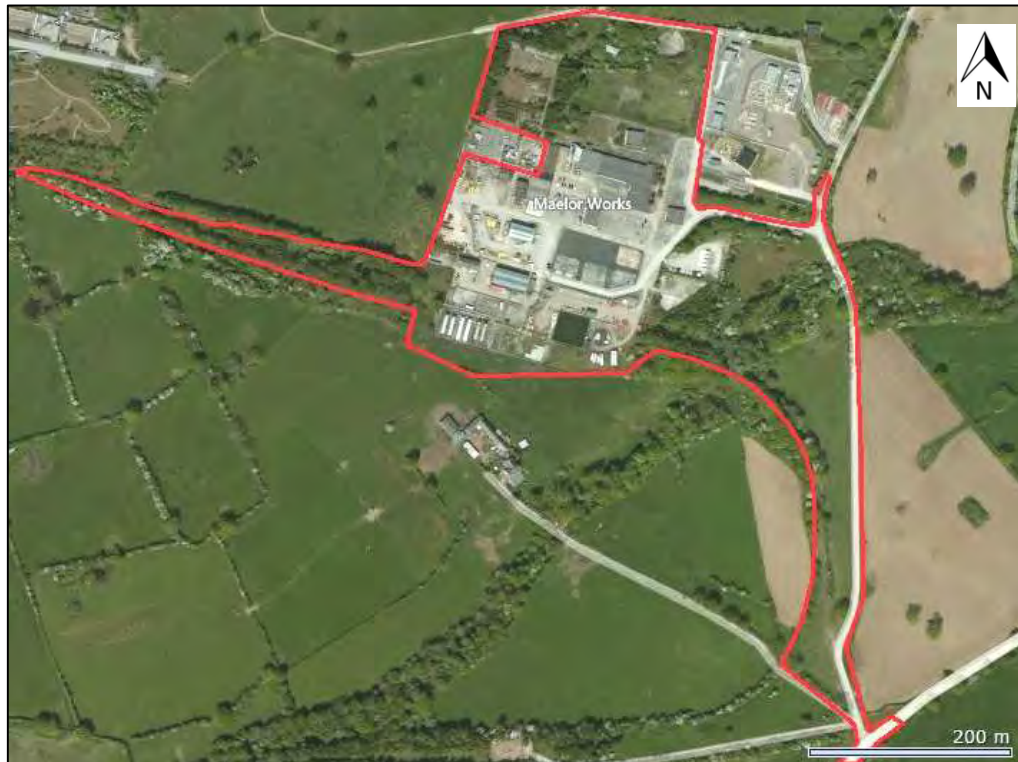
**Figure 1:** A map showing the location of the site in relation to the surrounding landscape (indicated by the red boundary).

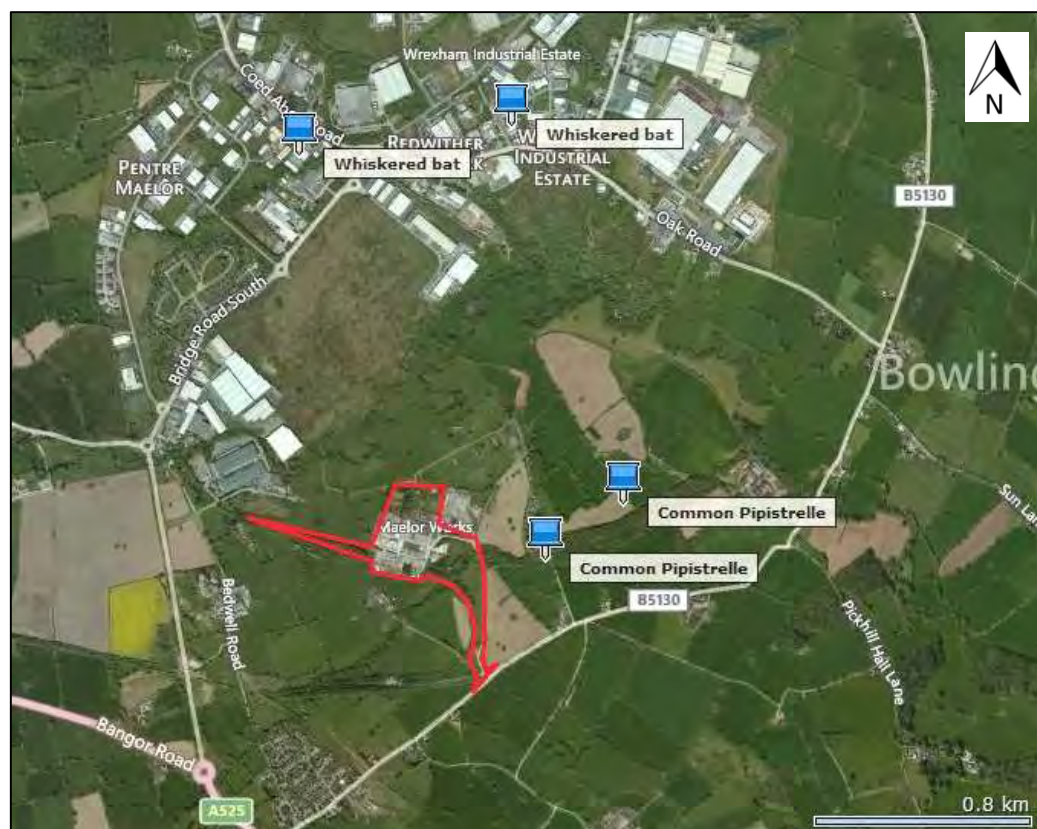
**Figure 3:** A map illustrating the approximate locations of some of the bat species recorded in the surrounding area of the gasworks site.

With regards to bats, two distinct species were recorded; the Common Pipistrelle (*Pipistrellus pipistrellus*) and the Whiskered bat (*Myotis mystacinus*). The closest of these records was of a Common Pipistrelle (*Pipistrellus pipistrellus*) and it was located approximately 500m to the east of the gasworks site.

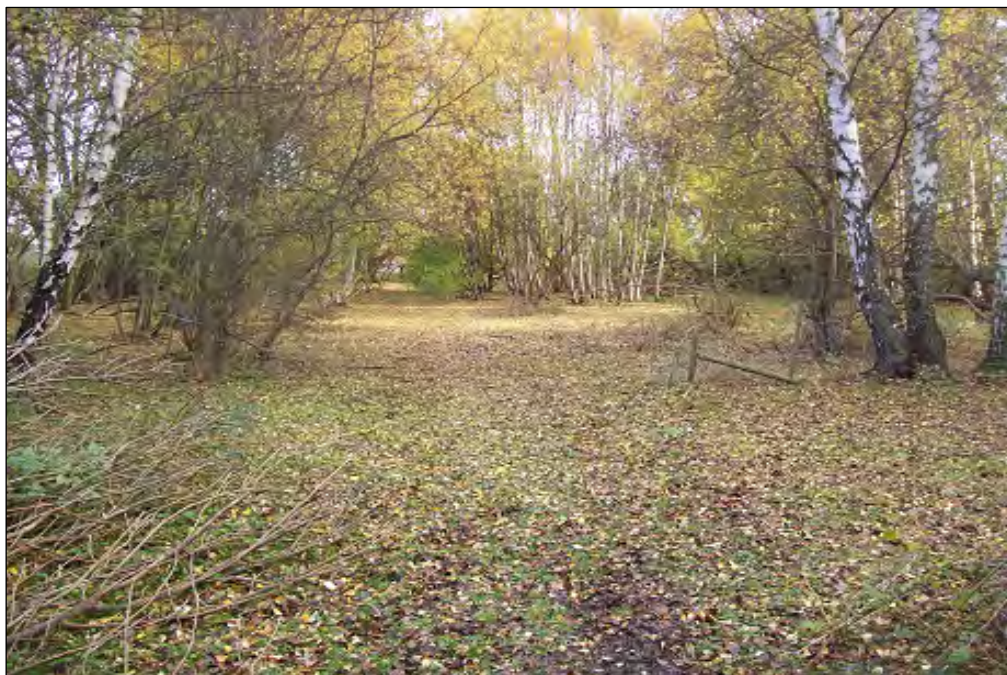
**Figure 5:** The woodland and semi-improved grassland within the western extension. Silver Birch (*Betula pendula*) trees are once again abundant throughout the wooded areas.

structure (some trees older than others) which often provides a greater variety of habitats for invertebrate species, and in turn, birds. Although this stretch of land is fenced off from the adjacent embankment along the southern boundary and the fields to the north, two badger setts were identified within these areas. The first had two entrances (at least one of which is thought to be active) and was located in the south-eastern corner, adjacent to the main gasworks site. The second was also located outside the proposed works boundary, but this time on the northern side (within the adjacent fields). As both of these setts are within very close proximity to the proposed development works, it will be necessary to ensure that the works are conducted at least 10m away from each sett. This distance to maintain is less than the usual (20m when using machinery) when a badger sett is discovered, but as the setts are situated within lands which raise above ground level (therefore leading away from the site), it is unlikely that any badgers will be disturbed as the tunnels should lead away from the site to the north and south. As well as the badger setts located offsite, there is also a rabbit warren within the northern field to the north-east of this section. But, as rabbit are not protected under UK or European legislation, this will not be an issue. The locations of all of the setts/warrens within this area can be found on the Phase 1 Habitat Map within the appendix.

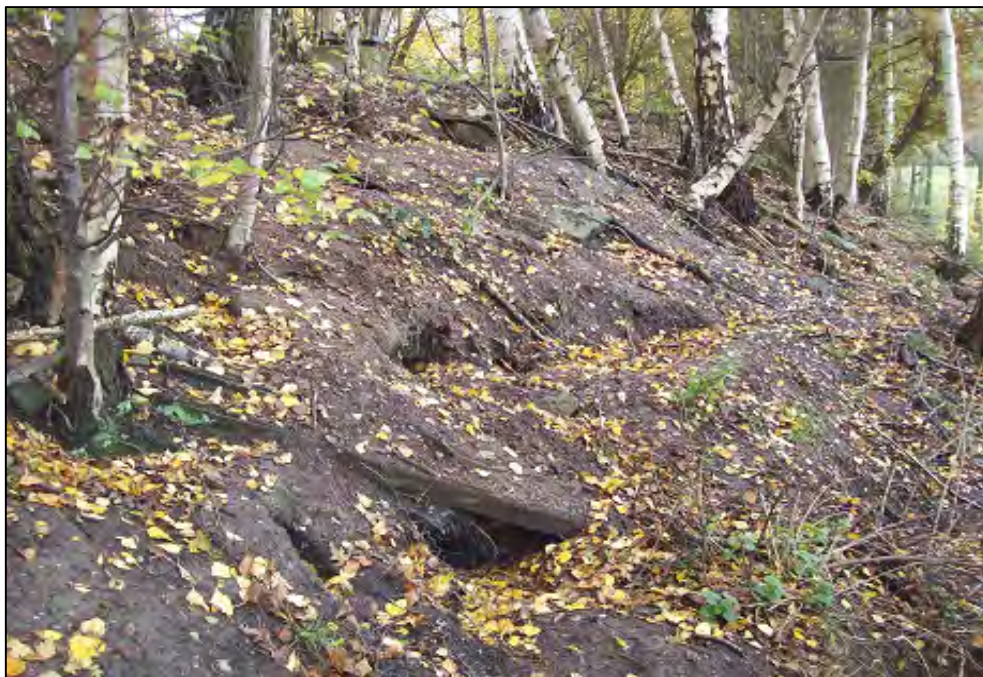
**Figure 6:** This image illustrates the area of Silver Birch (*Betula pendula*) woodland along the north-western boundary of the site. A number of the rabbit warren entrances can also be seen.

In addition to the first area of woodland, a further three patches were discovered to the north-west of the site. One of these areas ran adjacently to the site boundary on the north-western corner and was situated on a steep embankment. This woodland consisted predominantly of semi-mature Silver Birch (*Betula pendula*) trees and in addition to this, in excess of 100 rabbit warren entrances (which were of missed use) and droppings were discovered. As mentioned previously, two further patches of woodland were located in the northern portion of the site. These were adjacent to one another and both consisted of young Silver Birch (*Betula pendula*) trees with stands of Bramble (*Rubus fruticosus*), Nettle (*Urtica dioica*), Creeping Thistle (*Cirsium arvense*) and Rosebay Willowherb (*Chamerion angustifolium*) also being abundant. The final area of woodland is quite possibly the densest and most mature (although still not classed as 'mature'), and it is located to the east of the site. As access to this area was restricted (as mentioned previously) it is difficult to ascertain the precise species present. However, from a distance, Silver Birch (*Betula pendula*) was observed. Due to the fact that this woodland is located upon a steep embankment which leads to a running water course, it is unlikely that any of the proposed works will be able to take place within this area. This is correlated with the information received by I & H Brown Ltd regarding the areas to be impacted, this woodland of which, is not one.

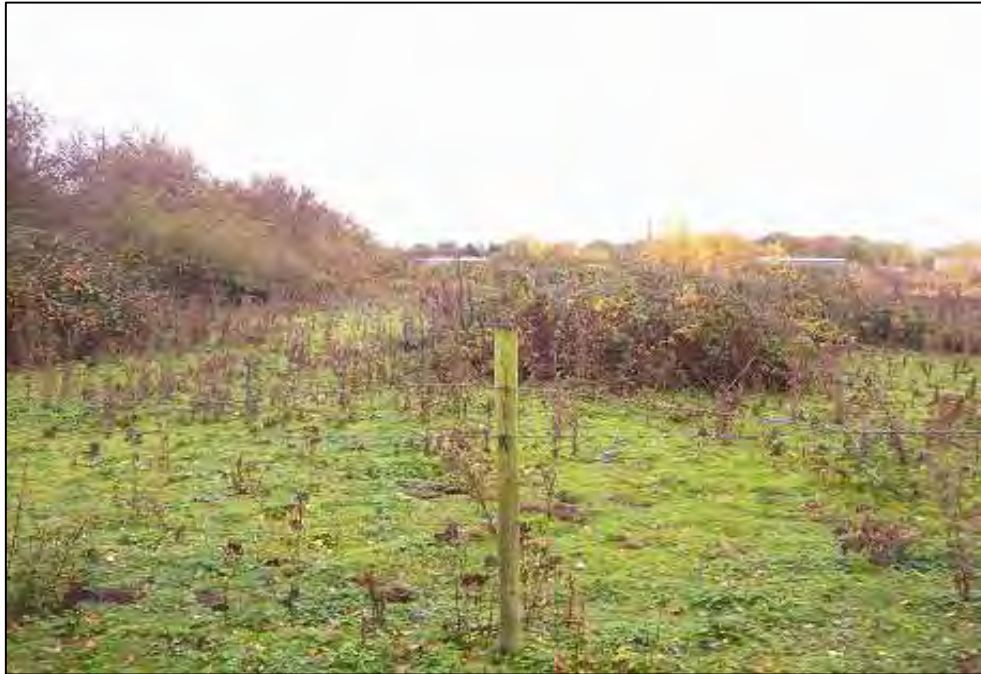
**Figure 7:** The dense scrub which separates the northern semi-improved grassland from B2 can be observed to the left of the photograph.

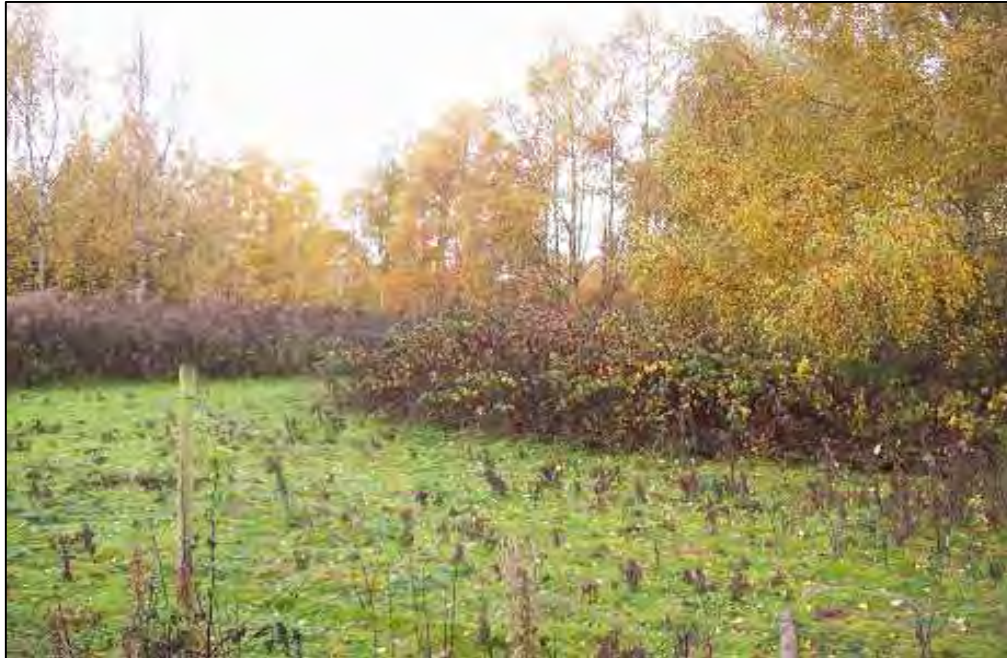
**Figure 8:** The poor semi-improved grassland to the north of the site can be seen in the foreground, followed by the patch of scrub and scattered trees to the rear.

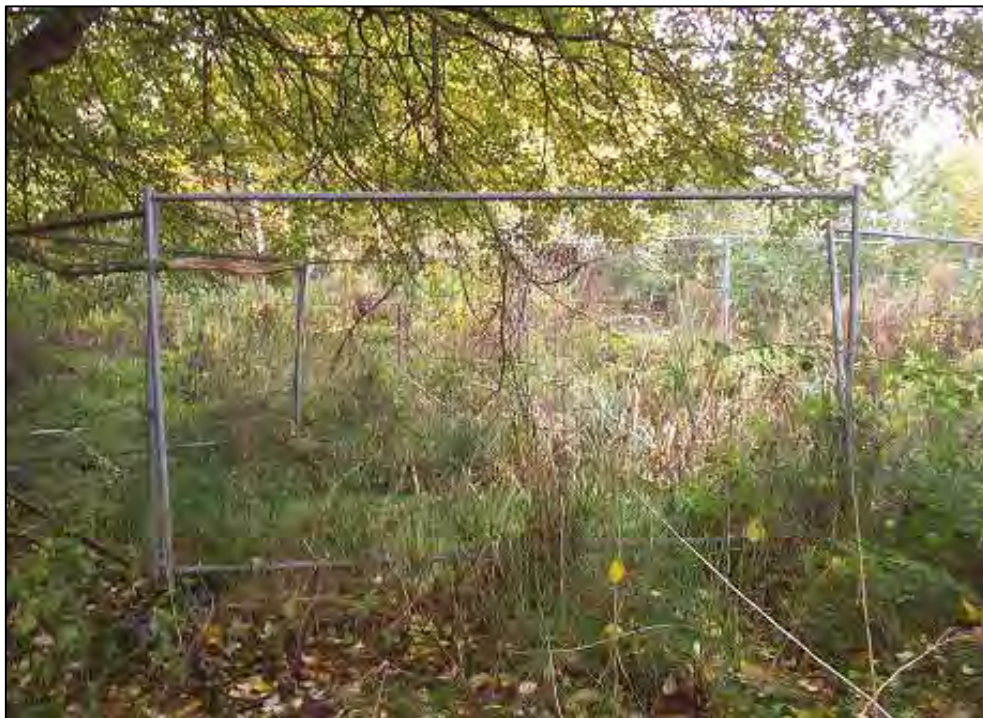
**Figure 9:** The pond located towards the north of the site. This image illustrates some of the species present (Rushes are abundant), the small size of the pond and its shaded nature (by the overhanging tree).

There is one small standing water body located on site, but it is outside of all of the proposed work zones (refer to figure 2). It is located directly to the west of the most northerly building and is approximately 10m<sup>2</sup> in size. A number of floral species which are typical colonizers of pond margins have established within/on the edge of the pond. These include; Common Reed (*Phragmites australis*), Bulrush (*Typha latifolia*) and Rush species (*Juncus spp.*).

A Habitat Suitability Index (HSI) was conducted on this pond by Ecosulis in 2010 to establish its potential for housing the Great Crested Newt (*Triturus cristatus*) which is a European Protected Species (EPS). The results from this HSI can be found in table 1.

After comparing these results with the current condition of the pond, it can be concluded that no change has occurred in the pond's suitability since this HSI was conducted.

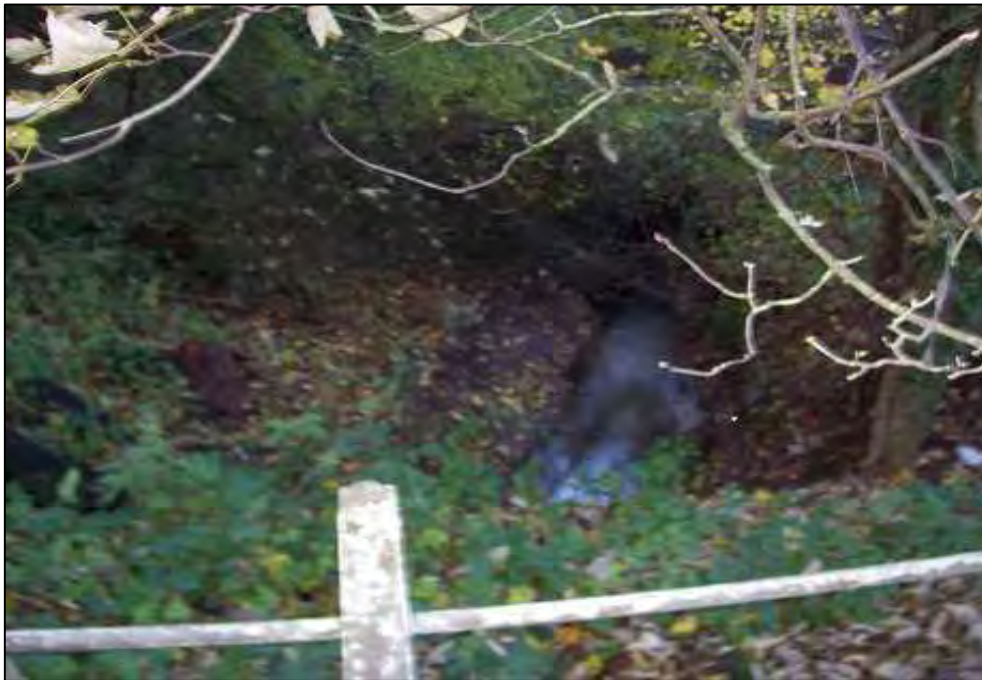
**Figure 10:** A view of the running water course that cuts through the site. The steep embankments can be observed to either side, particularly to the left in this image.

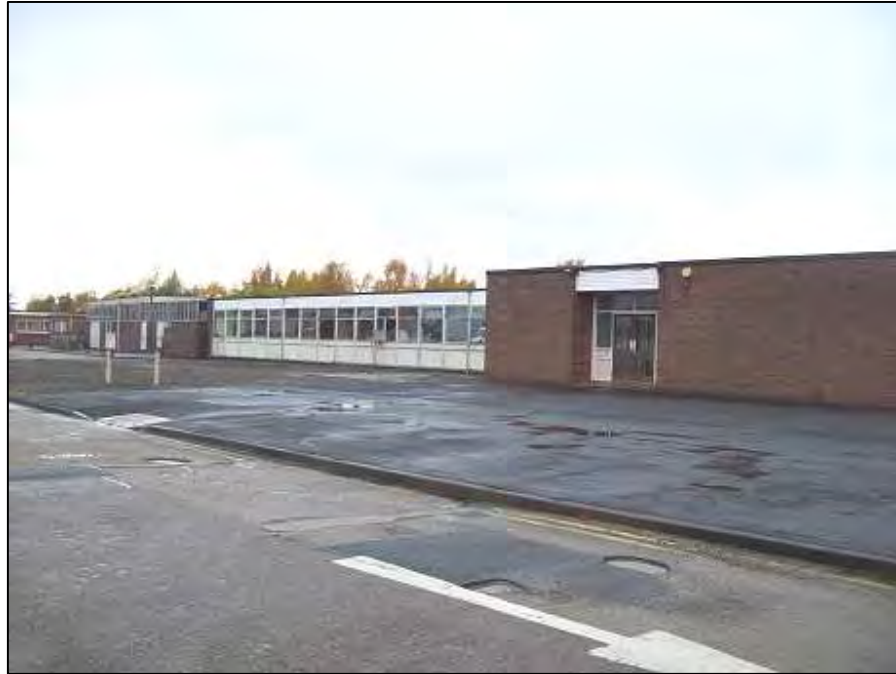
**Figure 11:** Building 1 (B1) and some of the hard standing from a south-eastern viewpoint.

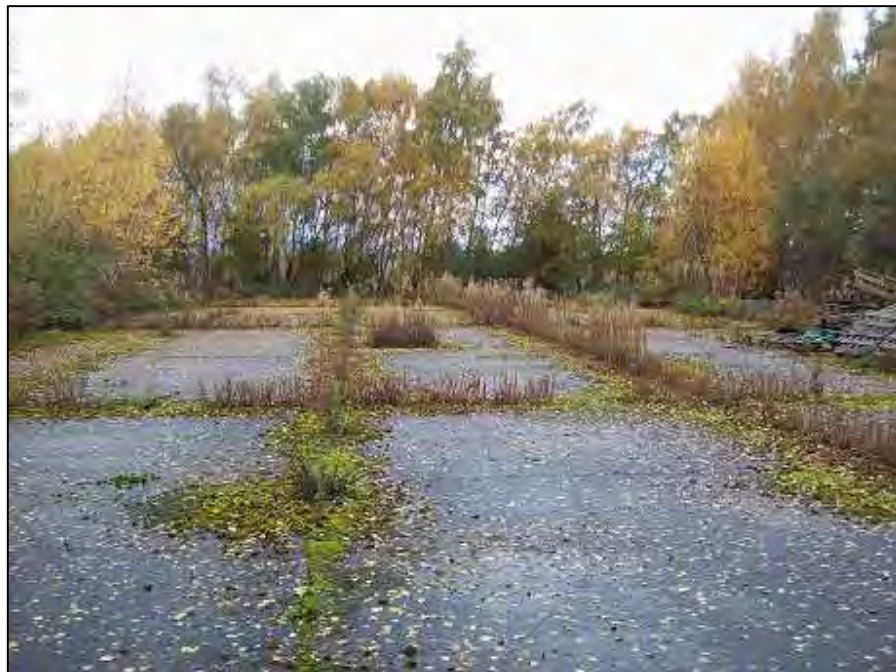
**Figure 12:** The area of hard standing which is situated next to the woodland located on the north-western boundary of the main site.

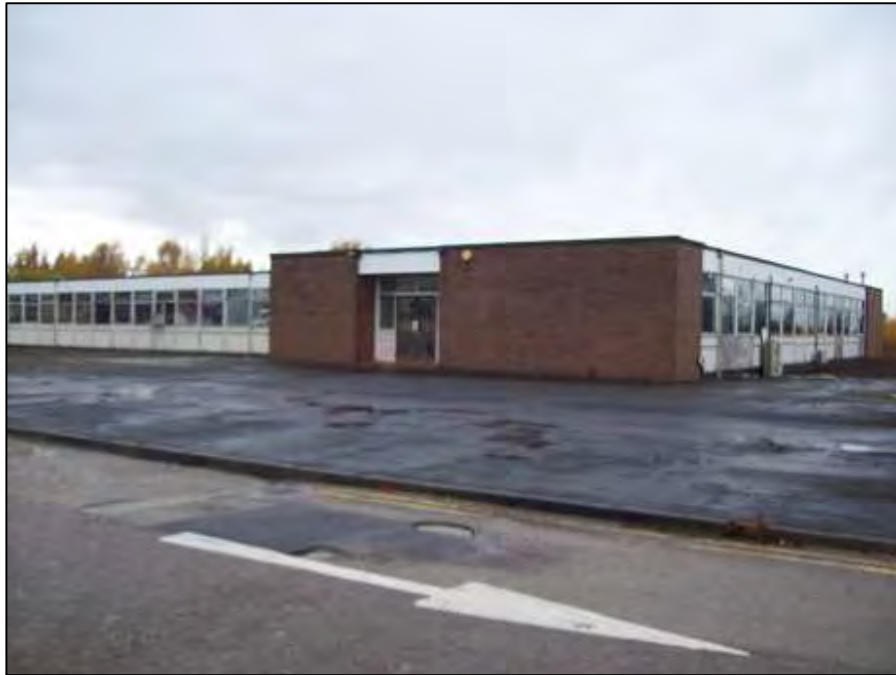
Another view of building 1 (B1) which is proposed to be demolished as a part of the proposed works.

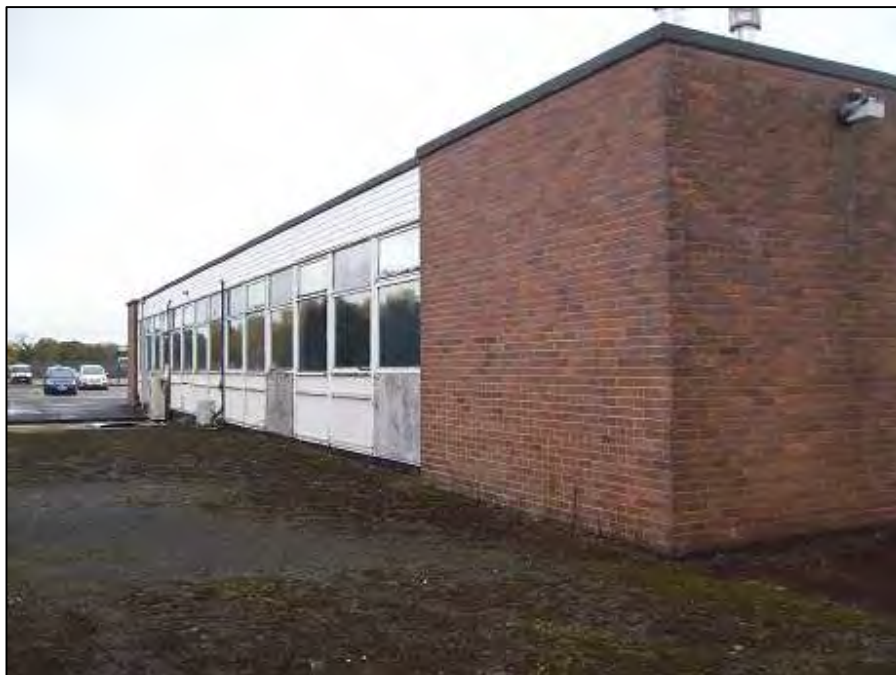
A view of the east side of B1 from a north-eastern viewpoint.

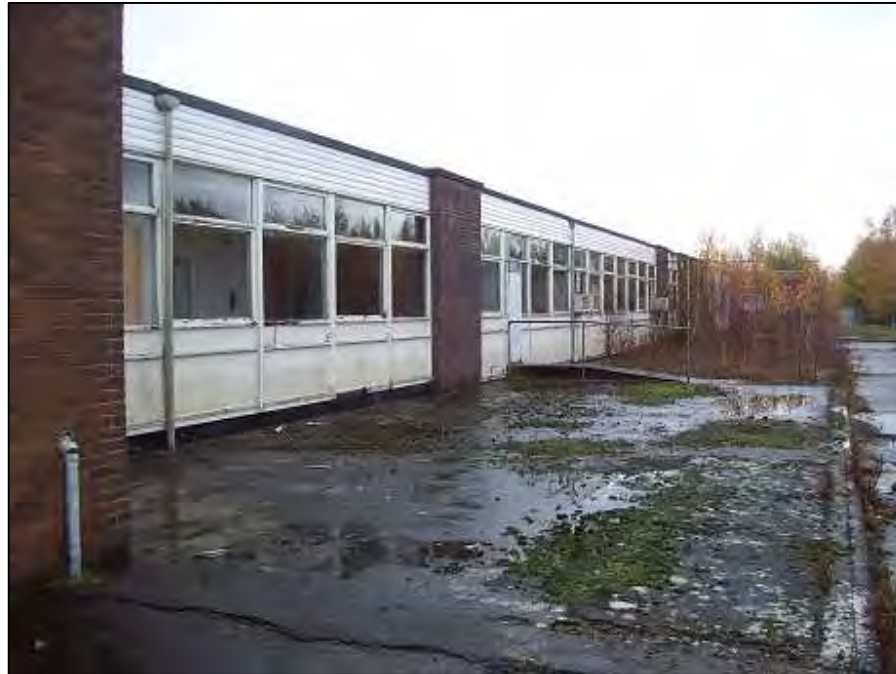
A view of the northern side of B1 from a north-eastern viewpoint.

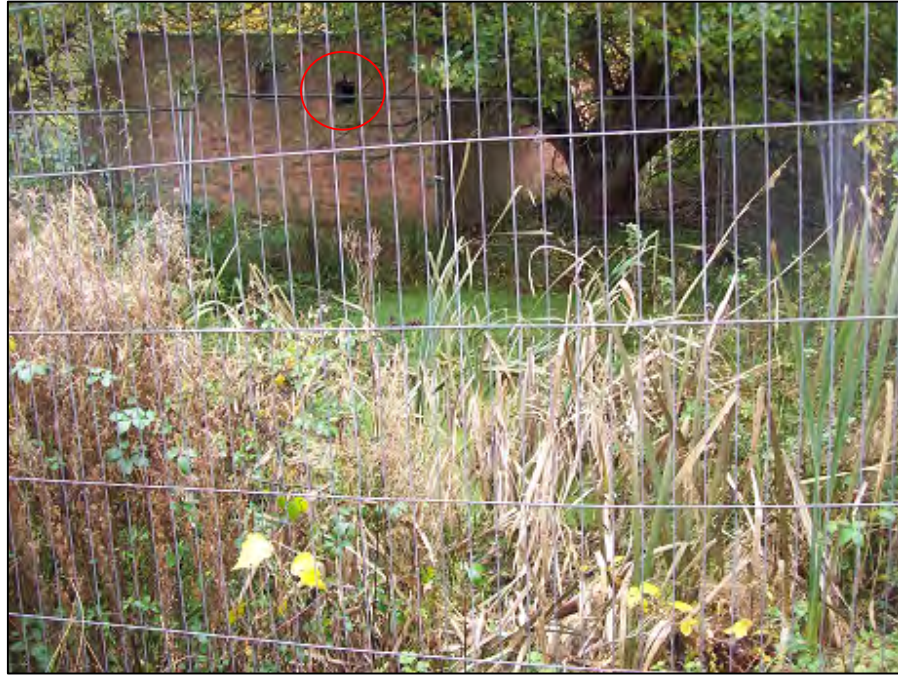
The pond located outside the development zone, with the adjacent building in the background. [REDACTED]  
[REDACTED]

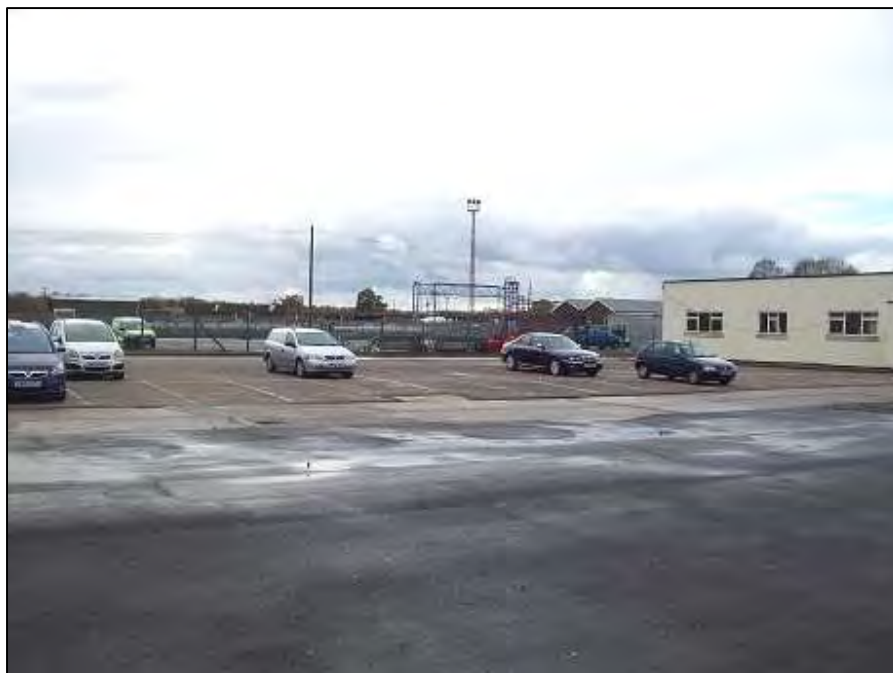
One of the main areas of hard standing located on site. This particular area is located within the 'proposed works' zone, but the building to the right however, is not.

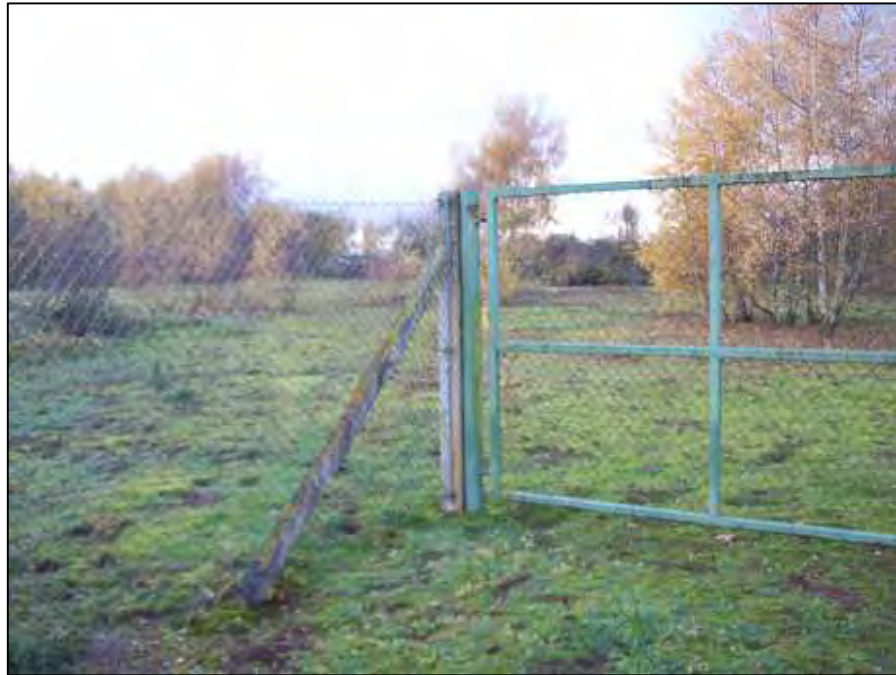
The chain link fence and gate which limited access to the eastern woodland/scrub area.

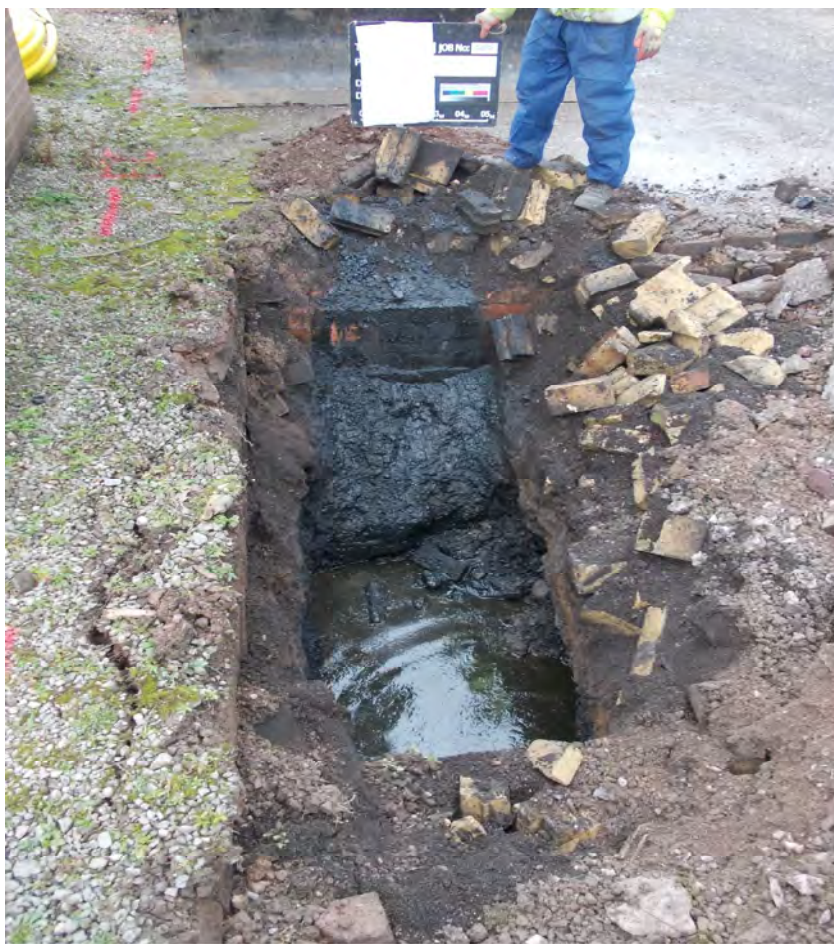
**Trial Pit TP13-01**

| Samples & In Situ Testing | | | Depth (m) | Level (m AOD) | Legend | Stratum Description |
|---|---|---|---|---|---|---|
| 0.17 | | | 0.17 | 36.48 | | MADE GROUND: Concrete foundation. |

Groundwater: At 0.9m, groundwater ingress of fast flow with strong hydrocarbon odour and black oily sheen.

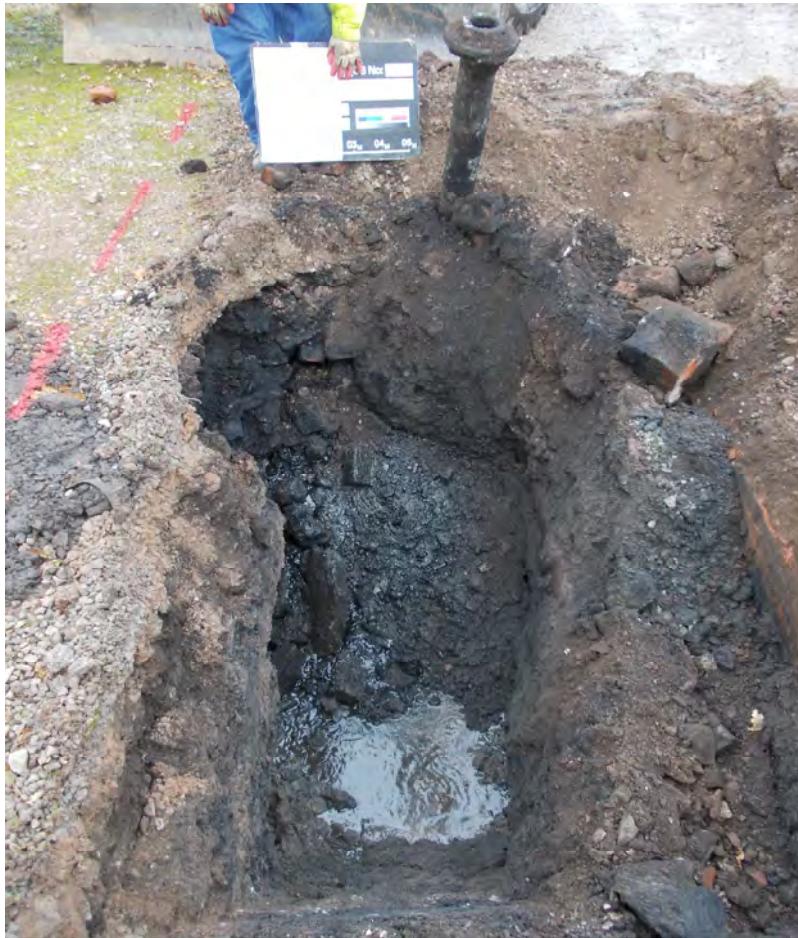
**Trial Pit TP13-02**

| | | IKM Consulting Ltd<br>Tel: 01324 878822<br>Fax: 01324 878823<br>email: info@ikmconsulting.co.uk | | Trialpit No<br><b>TP13-02</b><br>Sheet 1 of 1 | |
|---|---|---|---|---|---|
| Groundwater: At 1m, groundwater ingress of fast flow with strong hydrocarbon odour and black oily sheen. | | | | | |

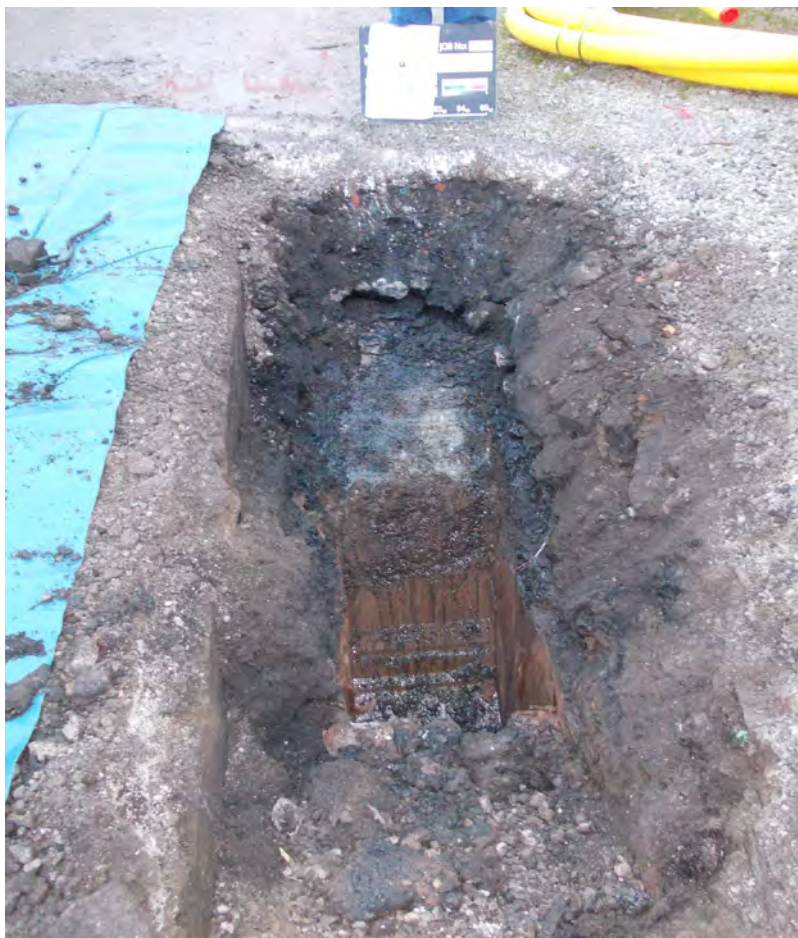
**Trial Pit TP13-03**

| Samples & In Situ Testing | | | Depth (m) | Level m AOD | Legend | Stratum Description |
|---|---|---|---|---|---|---|
| | | | 0.20 | 36.84 | | MADE GROUND: Concrete foundation with re-bar. |

| Remarks: | Brick foundations observed in East face of pit from 0.1mbgl. Pocket containing large number of blue circular pellets (spacers) observed at 0.25mbgl in eastern face of pit within made ground. |
| Groundwater: | At 1m, groundwater ingress of fast flow with a hydrocarbon odour and brown/black oily sheen. |

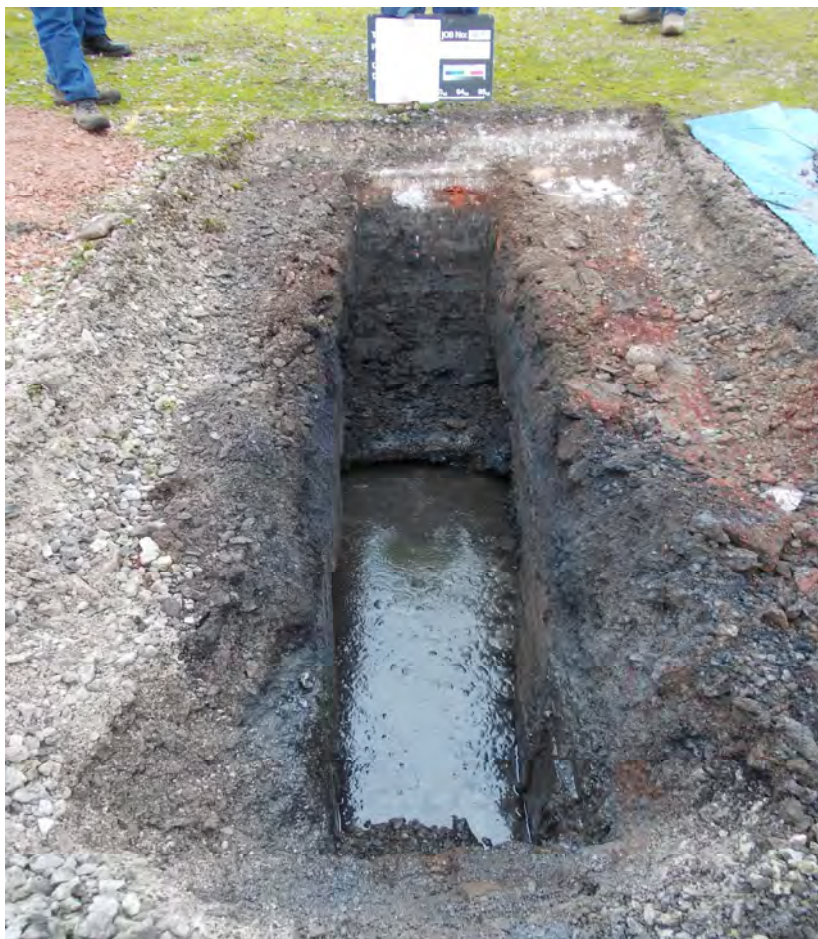
**Trial Pit TP13-04**

Remarks: No surface or subsurface structures observed.

Groundwater: At 1.4m, groundwater ingress of fast flow with strong hydrocarbon odour and black oily sheen.
