**Final Factual Environmental Report for**

**Maelor, Wrexham**

*Areas A and C Stage 1 Risk Mitigation Works Factual Report*

*Authored By: IKM Consulting, dated July 2014 Project Reference 13627-REP-002*

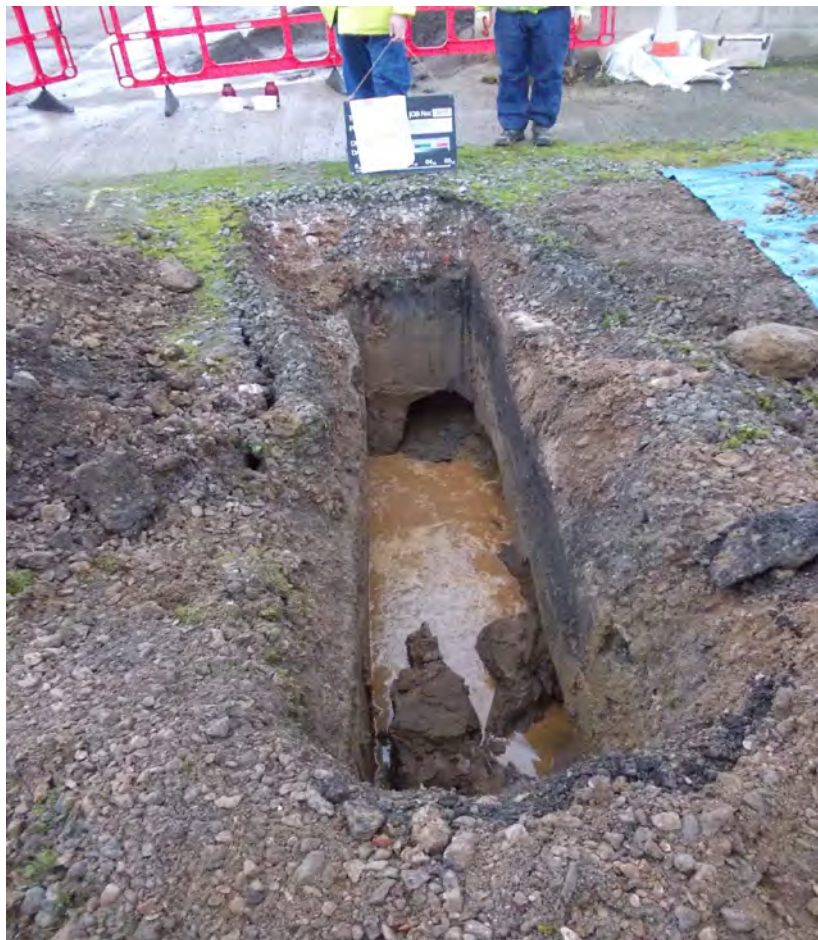
**Trial Pit TP13-05**

| Remarks:<br>Trial pit terminated on concrete base. PID reading of 0.8ppm from soil sample at 0.8m bgl. Concrete structure resembling a tank visible in the west of the trial pit. | |
| Groundwater:<br>At 1.2m groundwater visible in east of trial pit. Groundwater has a strong hydrocarbon odour and black oil. | |

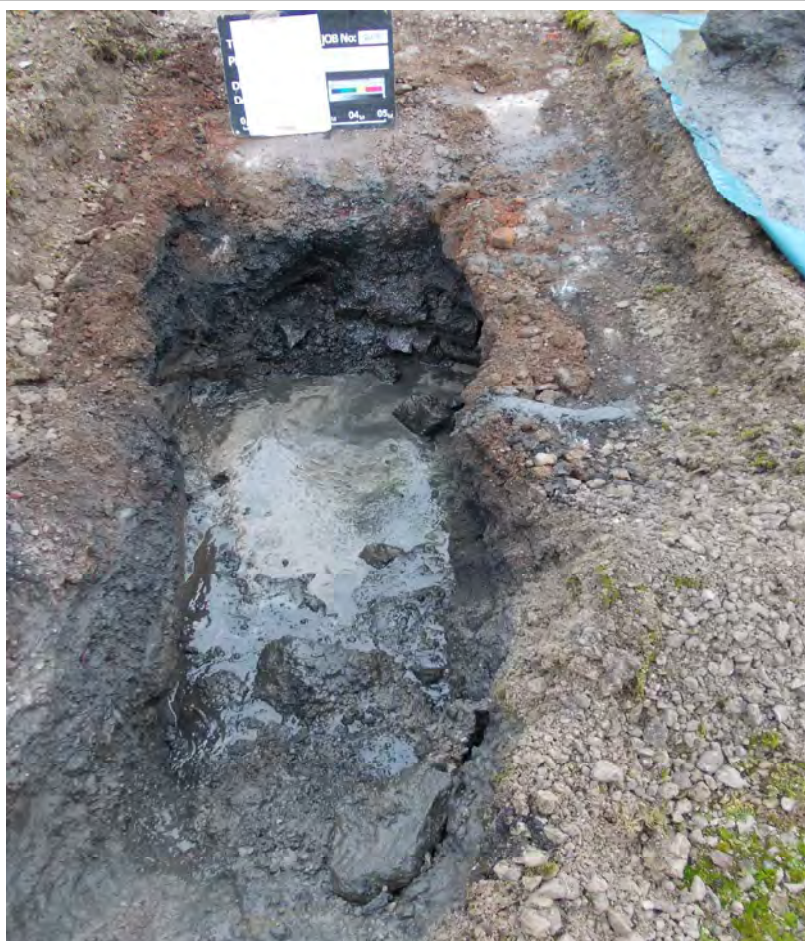
**Trial Pit TP13-06**

| | | iKM Consulting Ltd<br>Tel: 01324 878822<br>Fax: 01324 878823<br>email: info@ikmconsulting.co.uk | | Trialpit No<br><b>TP13-06</b><br>Sheet 1 of 1 | | |
|---|---|---|---|---|---|---|
| Groundwater: At 0.9m, groundwater ingress of fast flow with scum on the surface and a strong hydrocarbon odour and black oily sheen. | | | | | | |

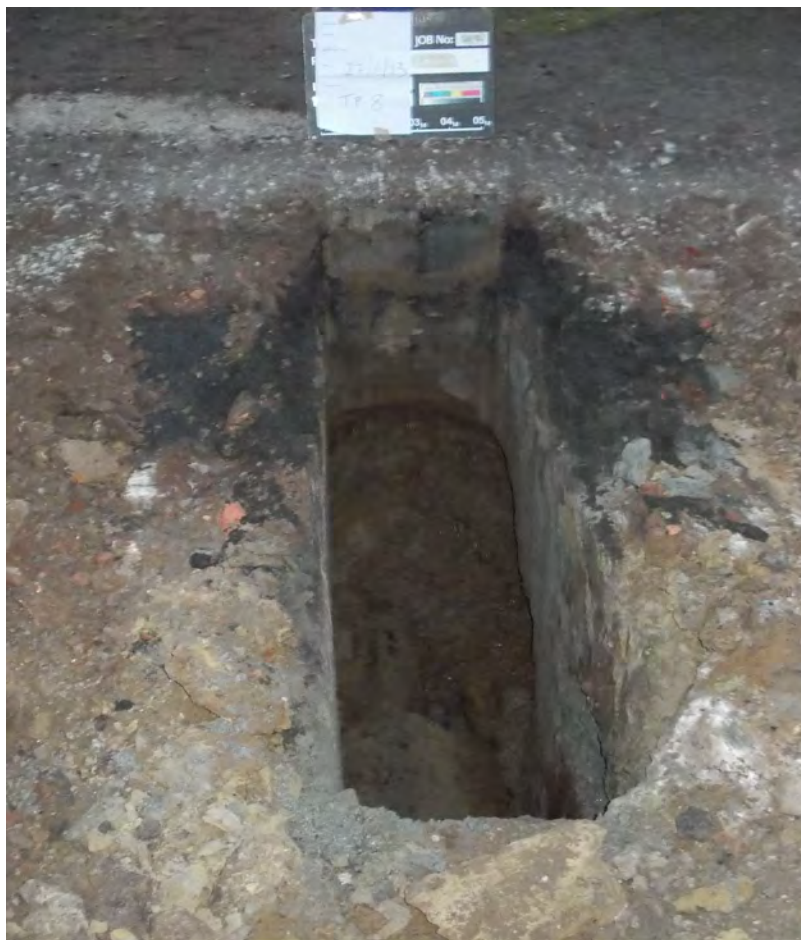
**Trial Pit TP13-08**

Remarks: Trial pit terminated due to collapse.

Groundwater: At 1.5m, groundwater ingress of fast flow with slight hydrocarbon odour.

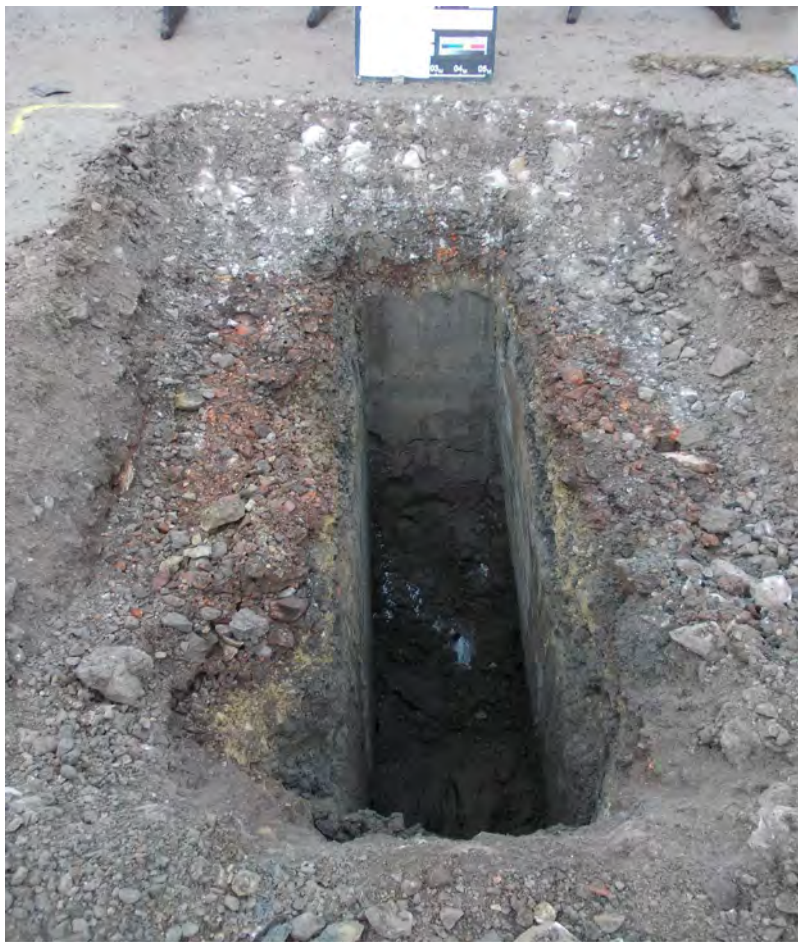
**Trial Pit TP13-08A**

| Remarks: Concrete slab observed at 0.1mbgl at front of trial pit. | | | | | | |
| Groundwater: At 2.7m, groundwater ingress of fast flow with a hydrocarbon sheen and a hydrocarbon odour. | | | | | | |

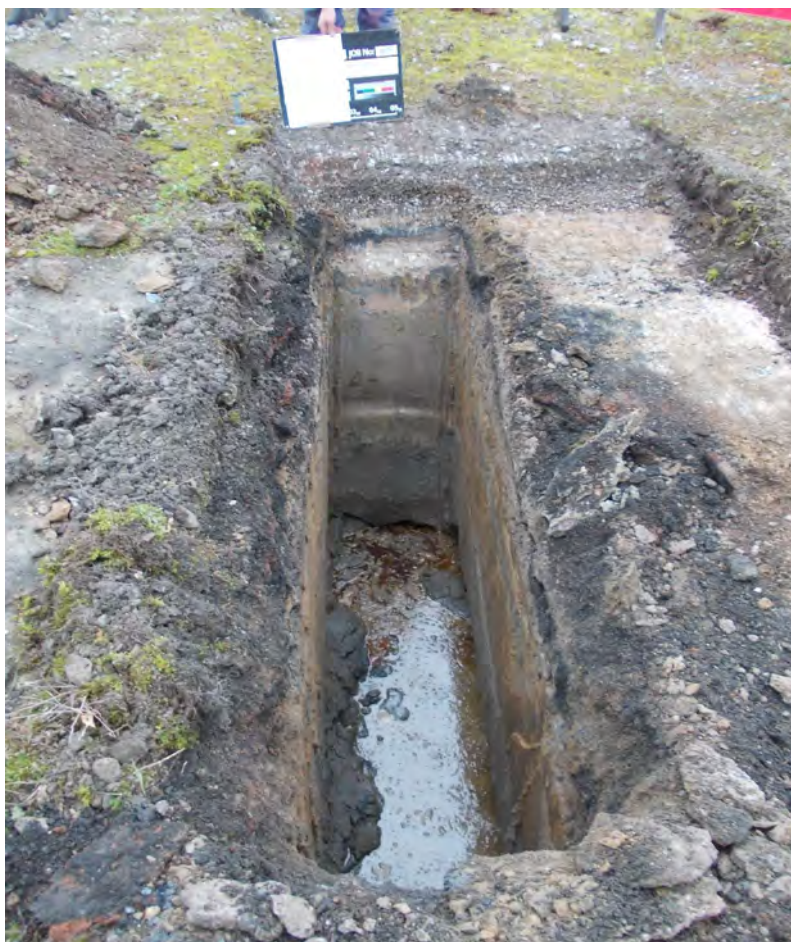
**Trial Pit TP13-10**

| Remarks: | No surface or subsurface structures observed. PID reading of 4.4ppm for a soil sample taken at 1.8mbgl and 4.4ppm for soil sample taken at 2mbgl. |
| Groundwater: | At 1.9m, groundwater ingress of fast flow with a dark brown sheen on groundwater and a strong hydrocarbon odour. |

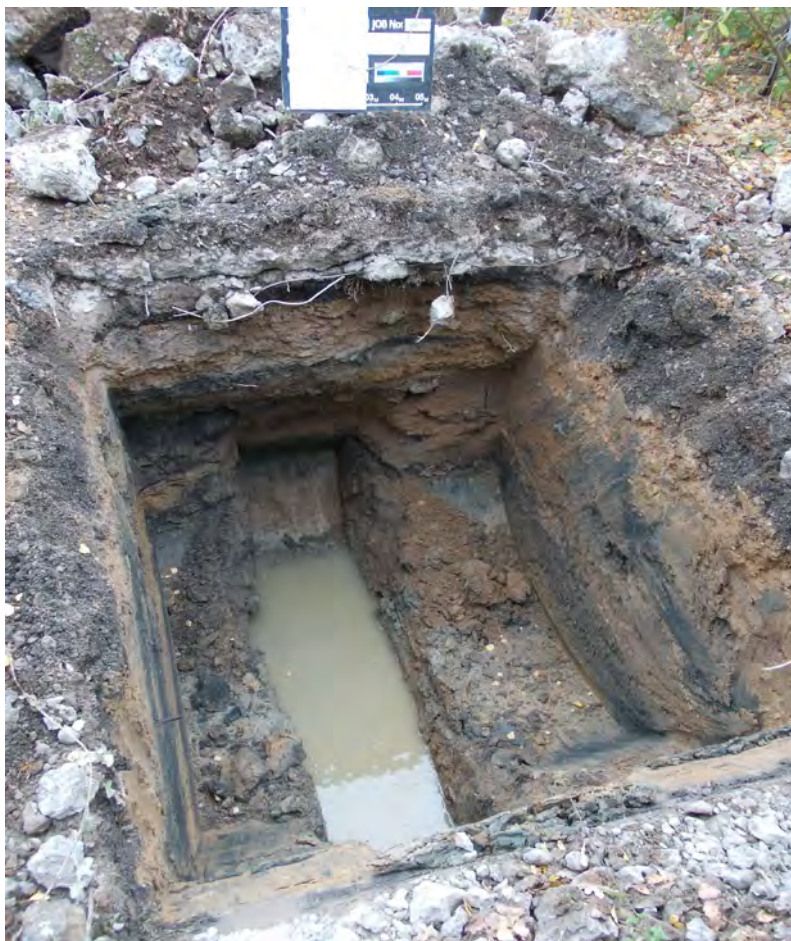
**Trial Pit TP13-11**

Groundwater: At 2.6m, groundwater ingress of moderate flow with a slight hydrocarbon/phenolic odour.

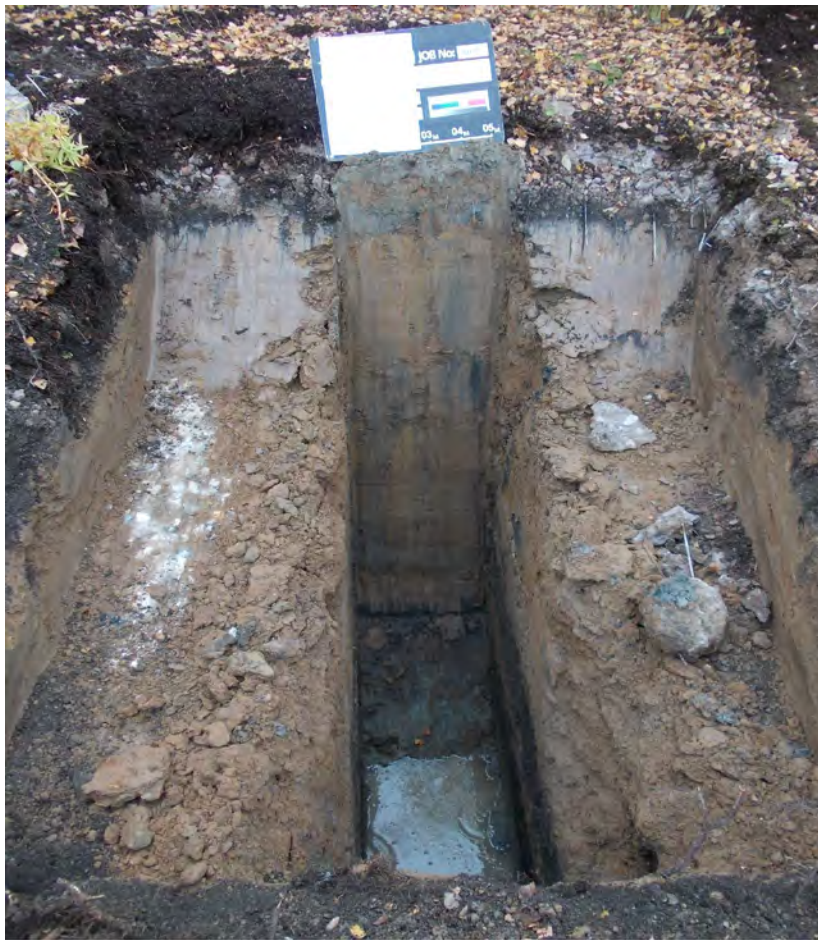
Trial Pit TP13-13

| | | IKM Consulting Ltd<br>Tel: 01324 878822<br>Fax: 01324 878823<br>email: info@ikmconsulting.co.uk | | Trialpit No<br><b>TP13-13</b><br>Sheet 1 of 1 | | |
|---|---|---|---|---|---|---|
| | | | 0.20 | 36.42 | | MADE GROUND: Concrete foundation with re-bar. |
| Remarks: Concrete slab with re-ar observed at ground level. | | | | | | |
| Groundwater: At 2.8m, groundwater ingress of moderate flow with a slight hydrocarbon/phenolic odour. | | | | | | |

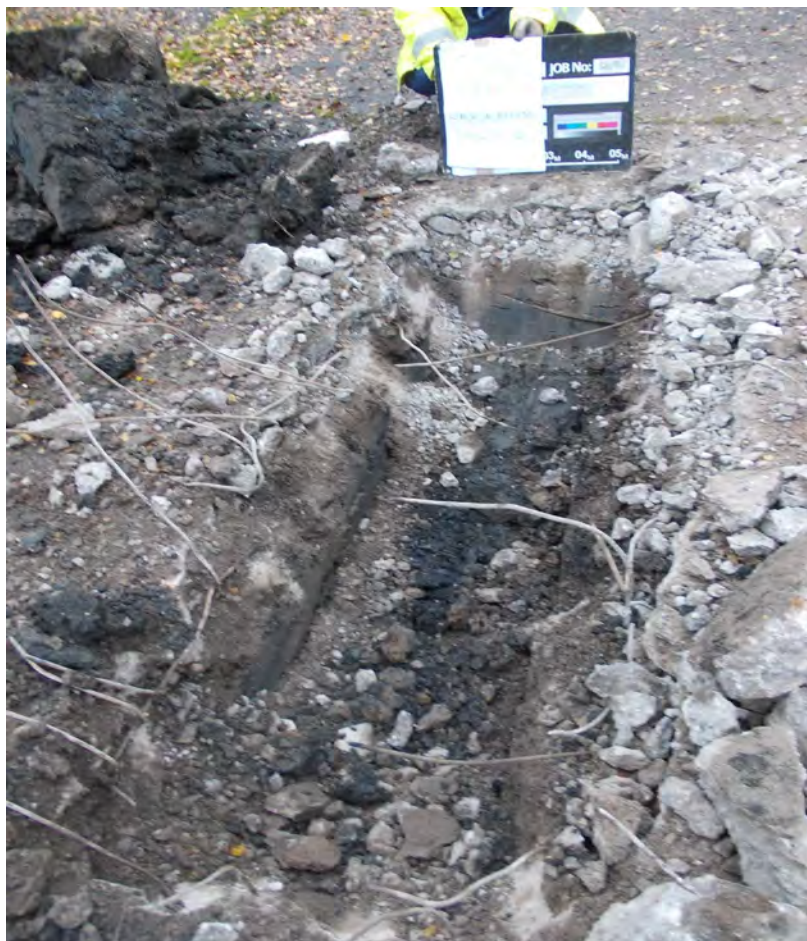
**Trial Pit TP13-22**

| Remarks: Concrete slab with re-bar observed at ground level. | | | | | |

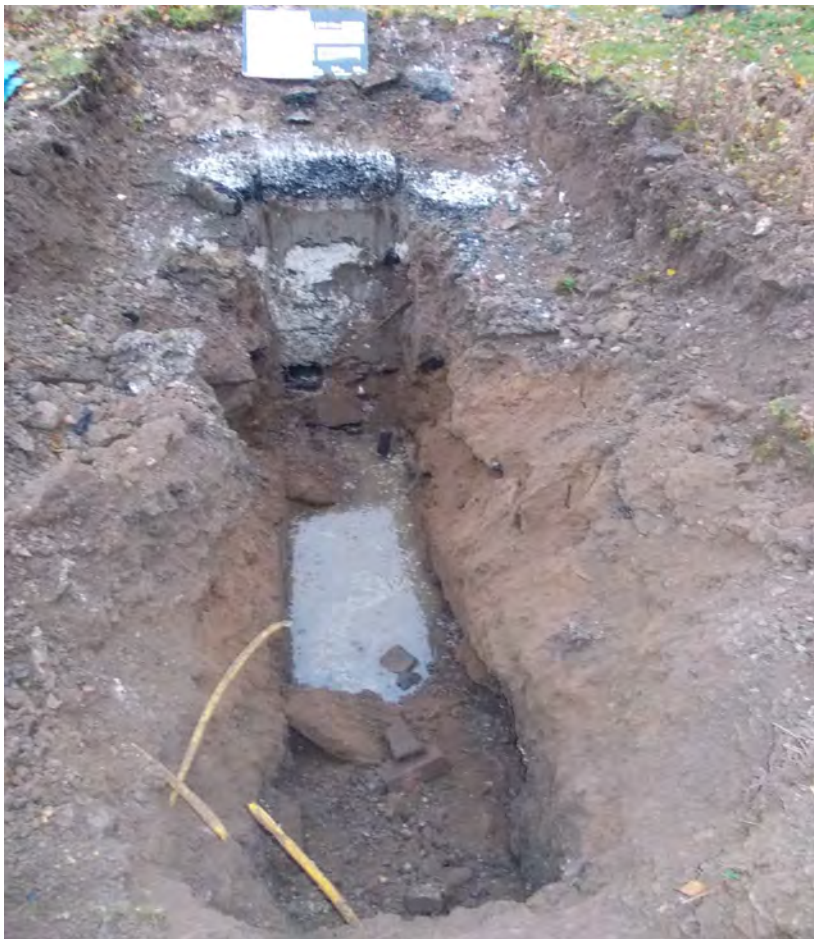
**Trial Pit TP13-24**

Remarks: Band of tarmac observed from 0.2mbgl - 0.6mbgl.

Groundwater: At 1.5m, groundwater ingress of moderate flow.

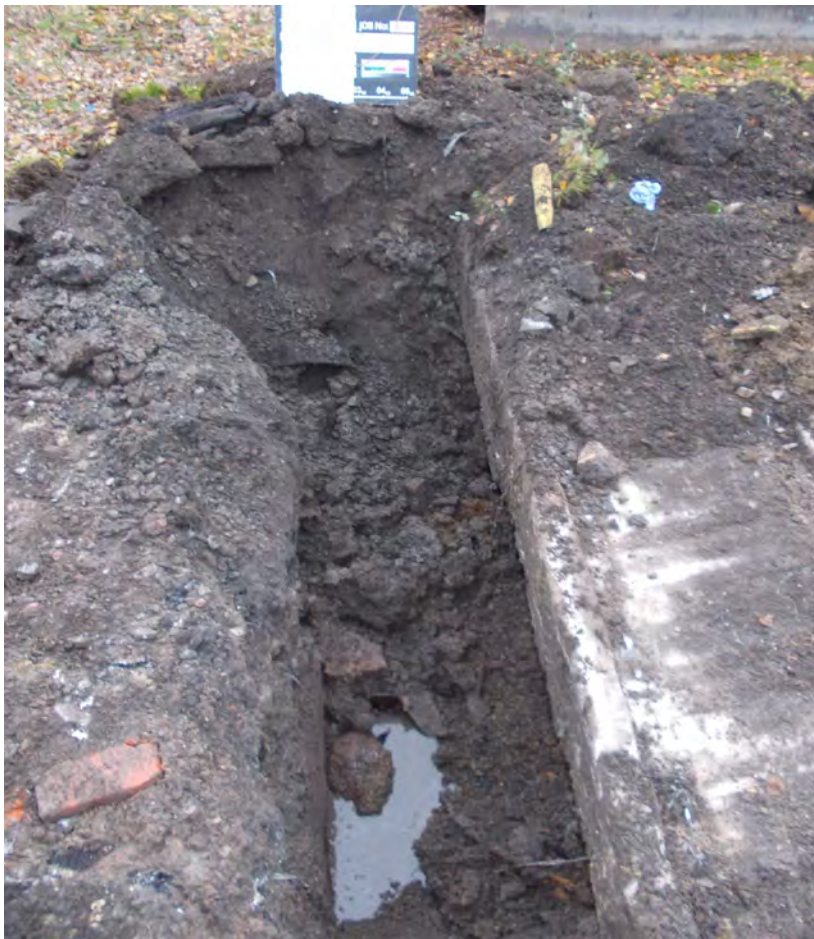
**Trial Pit TP13-25**

| Remarks: Concrete platform (possible walkway) observed in the western face of the pit. Trial pit is in a large chamber shaped structure. | | | | | |
| Groundwater: At 1.6m, groundwater ingress of low flow. | | | | | |

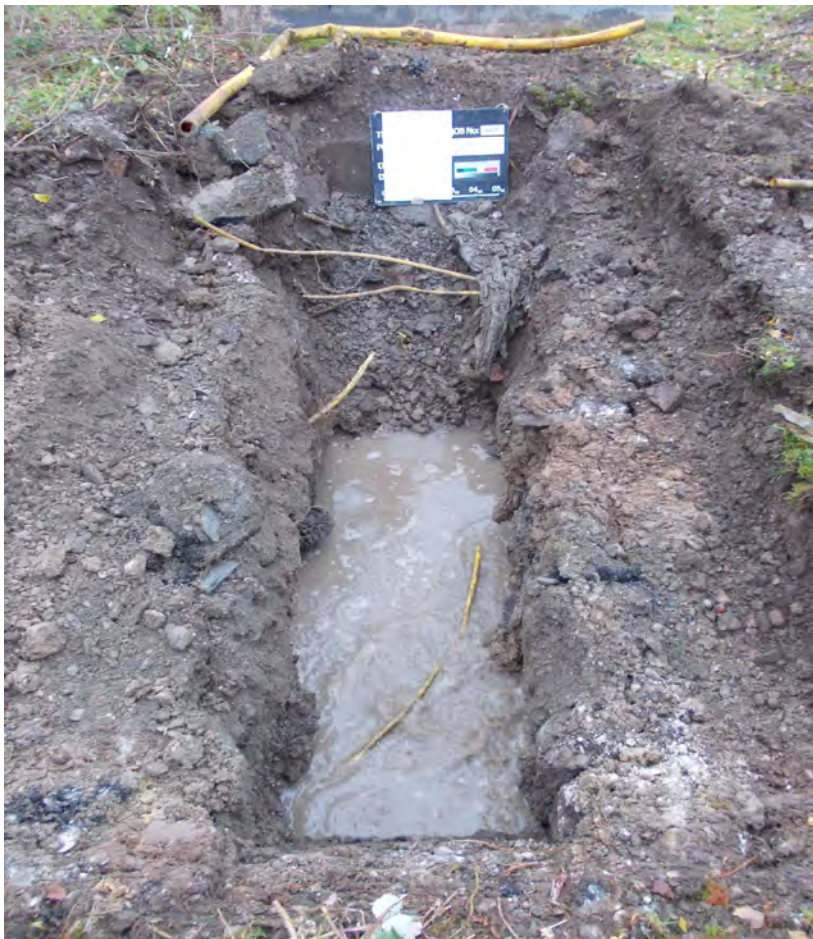
**Trial Pit TP13-26**

| | | IKM Consulting Ltd<br>Tel: 01324 878822<br>Fax: 01324 878823<br>email: info@ikmconsulting.co.uk | | Trialpit No<br><b>TP13-26</b><br>Sheet 1 of 1 | | |
|---|---|---|---|---|---|---|
| Remarks: Concrete wall observed in North face of the pit from 0.1mbgl to 0.3mbgl. | | | | | | |
| Groundwater: At 1.6m, groundwater ingress of low flow. | | | | | | |

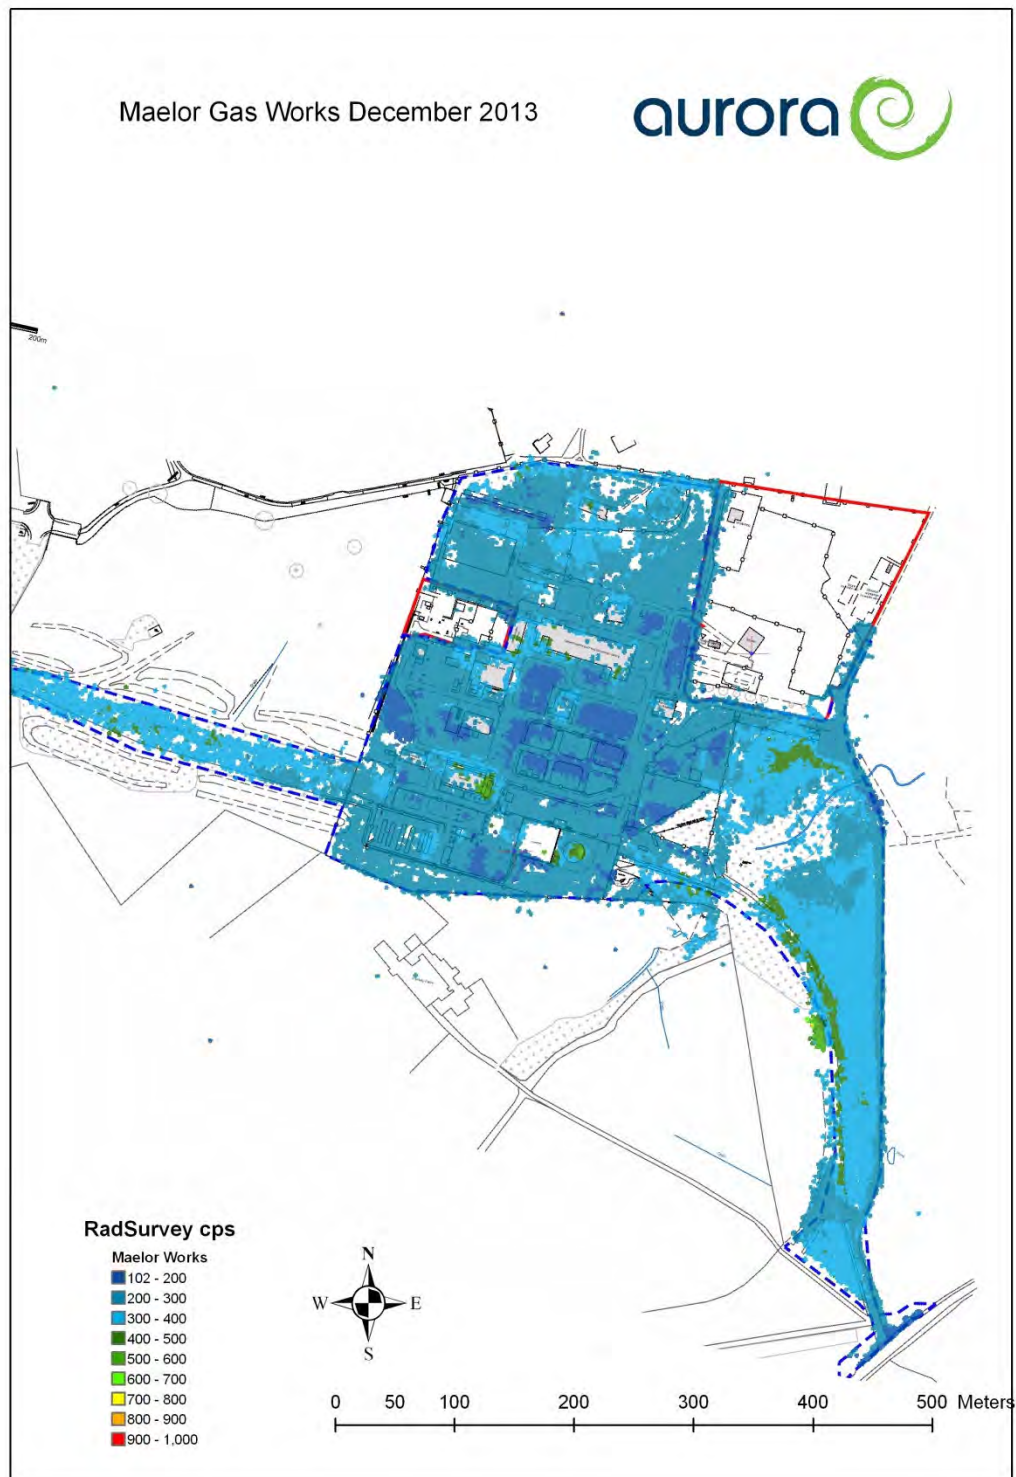
Figure 1 RadSurvey Map of Maelor Gas Works Site.

Typical background count rates vary from 150 to 250 cps which are indicated in blue on the above figure. There were some areas of [REDACTED] count rate on the main site in the range 400 to 600 cps as indicated in green on the above figure. [REDACTED]

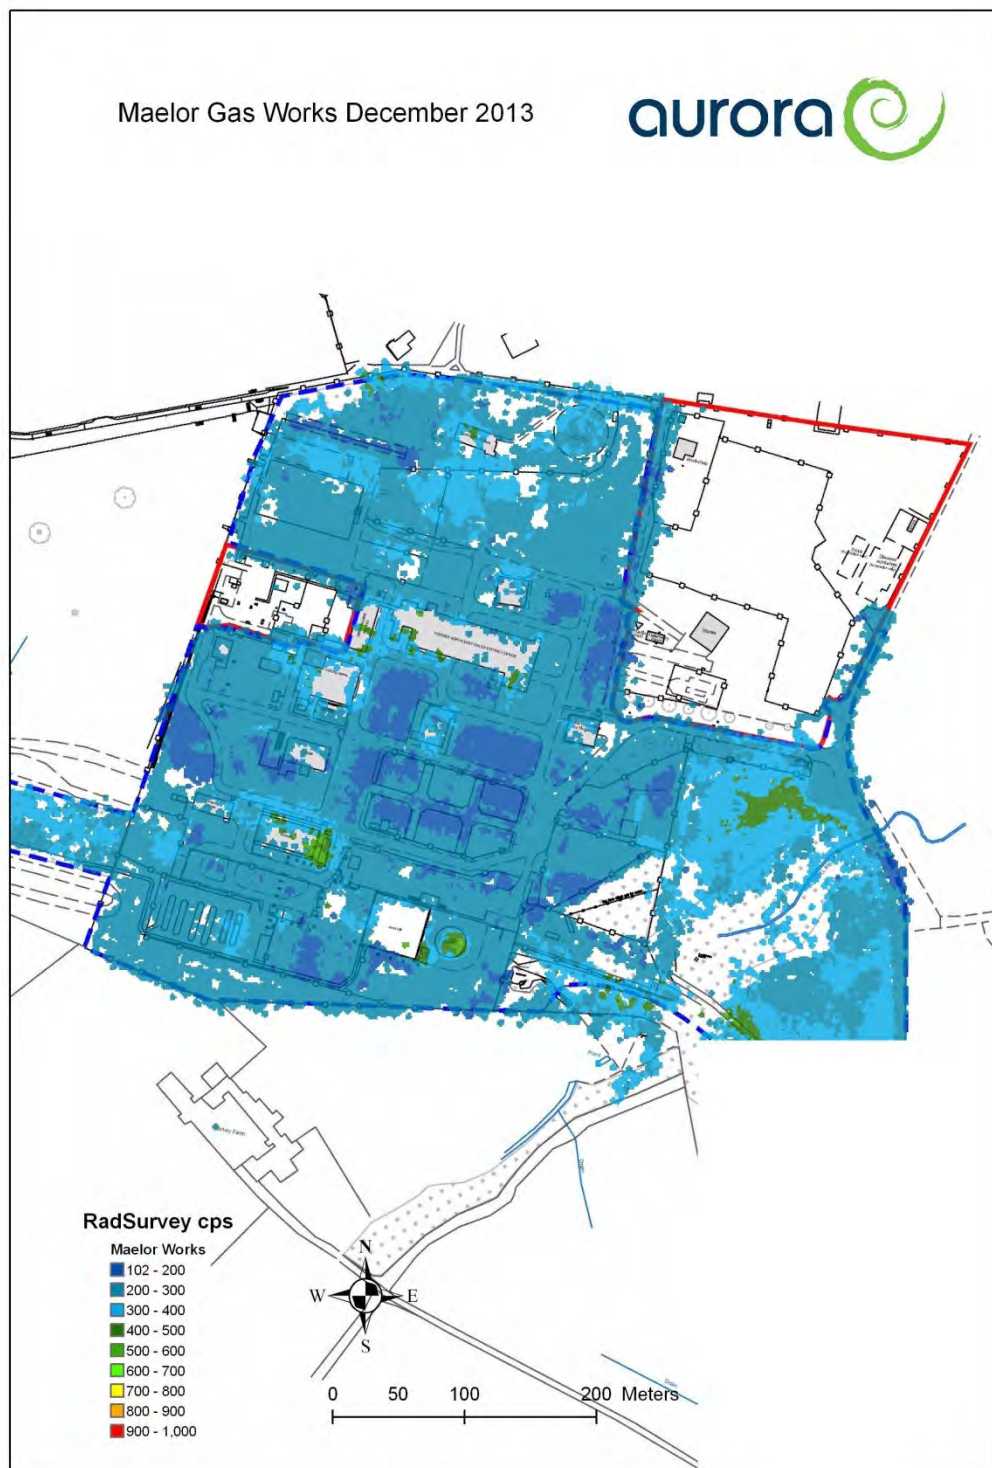
Figure 2 RadSurvey Map of Maelor Gas Works Main Site.

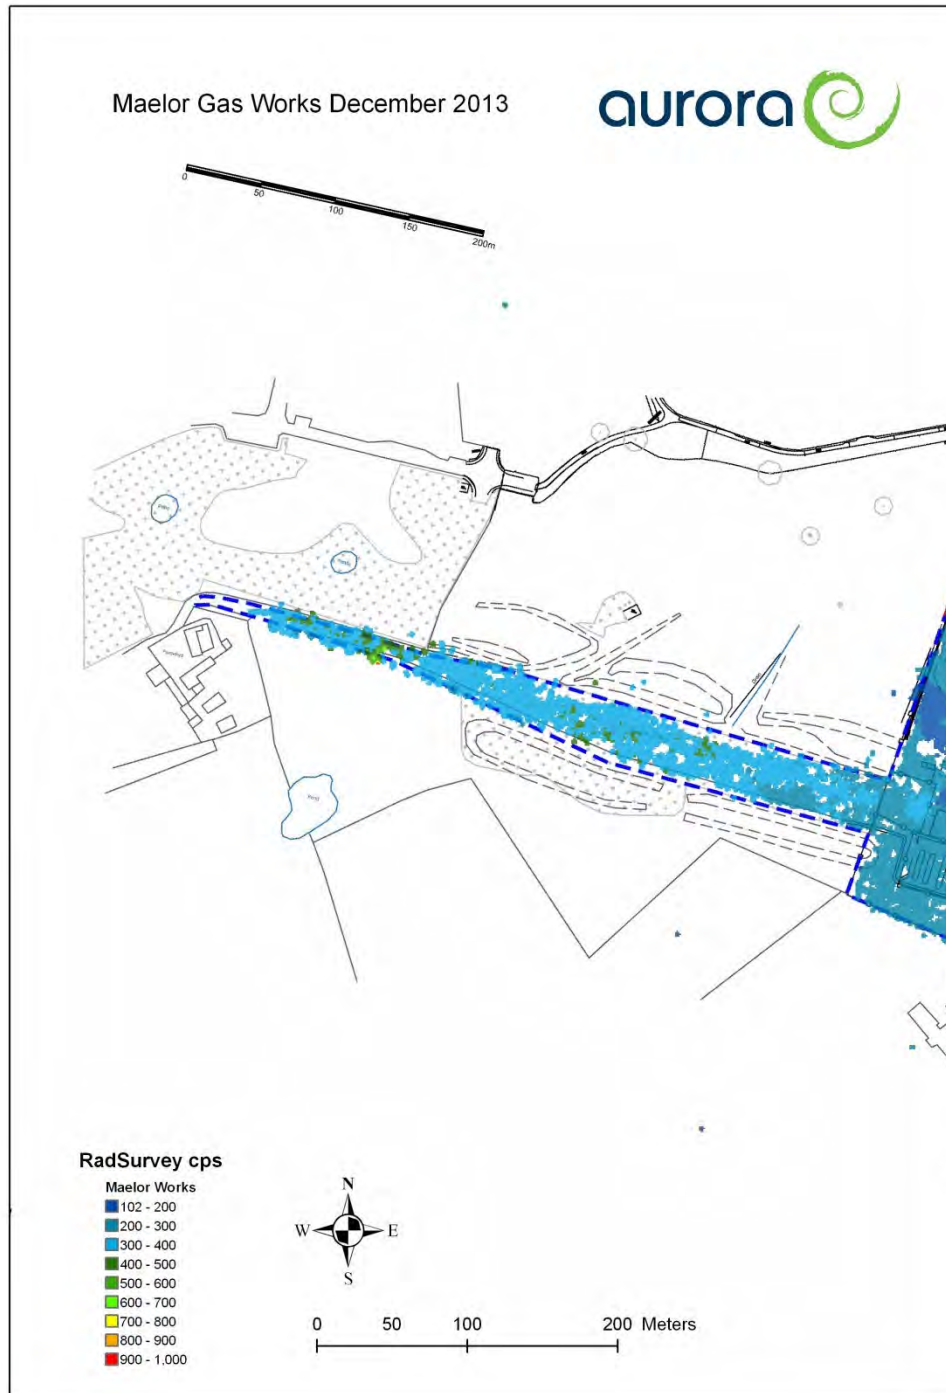
Figure 3 RadSurvey Map of Maelor Gas Works Site Area B West.

Typical background count rates vary from 150 to 250 cps which are indicated in blue on the above figure. There were some areas of [REDACTED] count rate on the Area B West site in the range 400 to 600 cps as indicated in green on the above figure. [REDACTED]

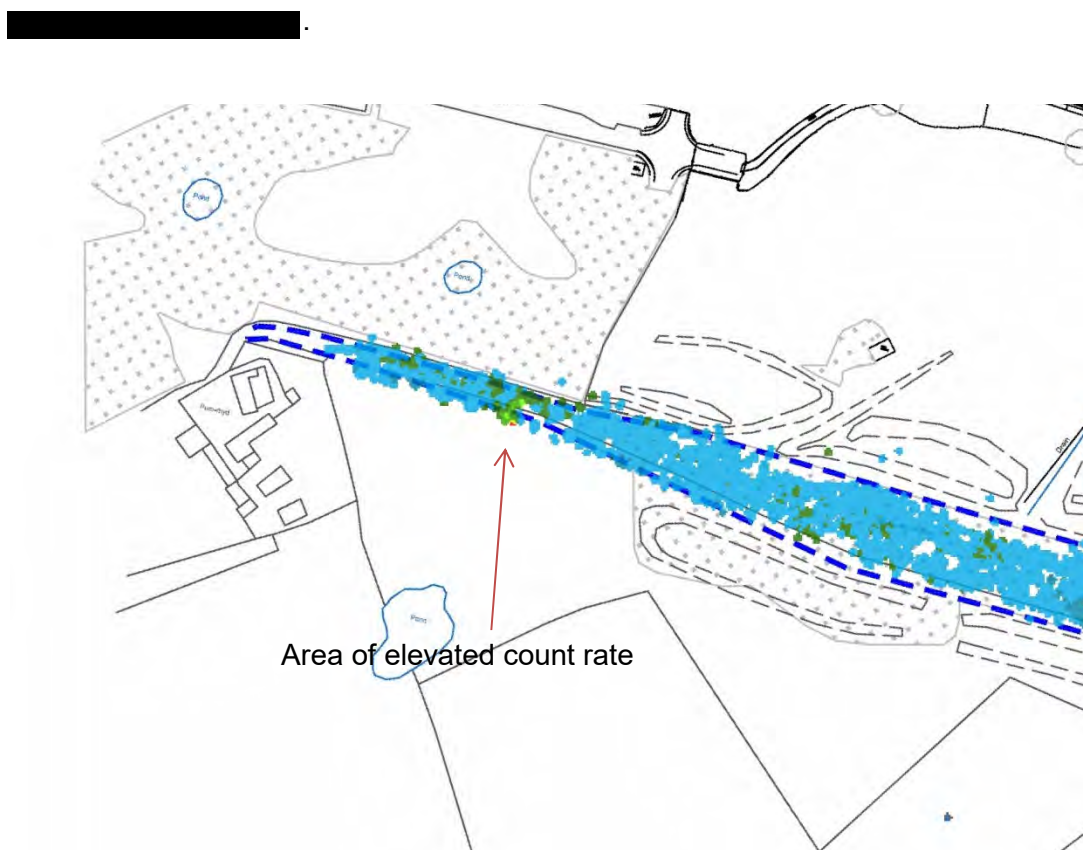
Figure 4 Area of Elevated Count Rate at Area B West.

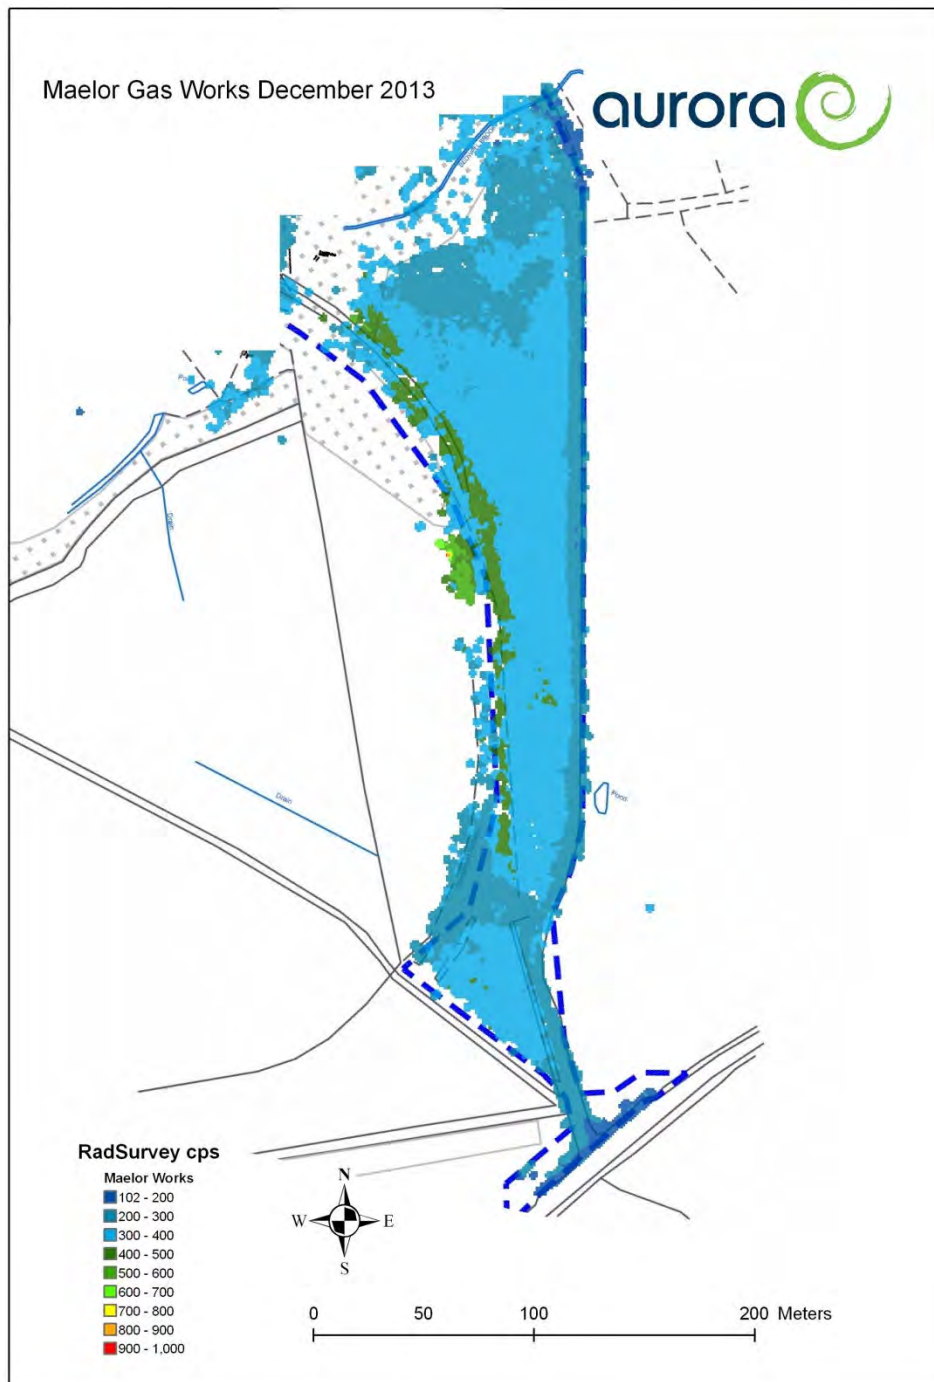
Figure 5 RadSurvey Map of Maelor Gas Works Site Area B East.

Typical background count rates vary from 150 to 250 cps which are indicated in blue on the above figure. There were some areas of [REDACTED] count rate on the Area B East site in the

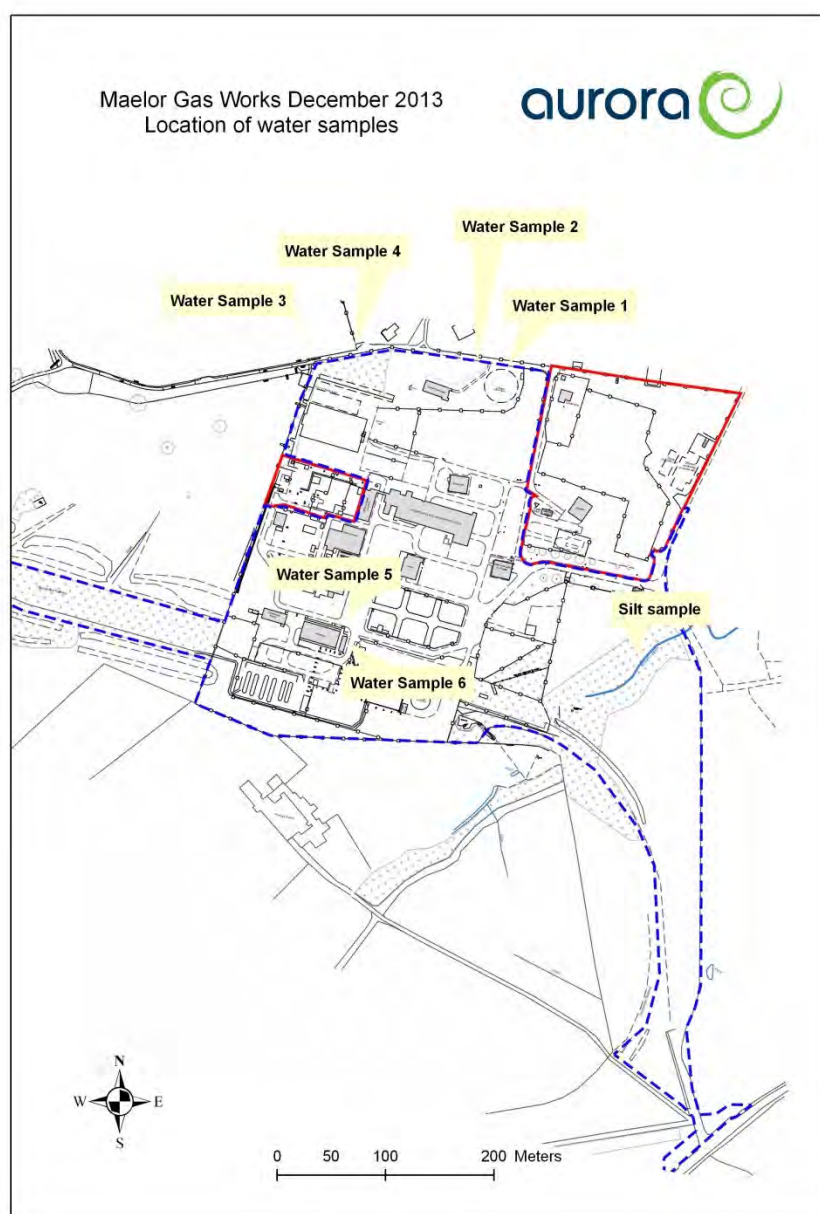
Figure 8 Location of water samples

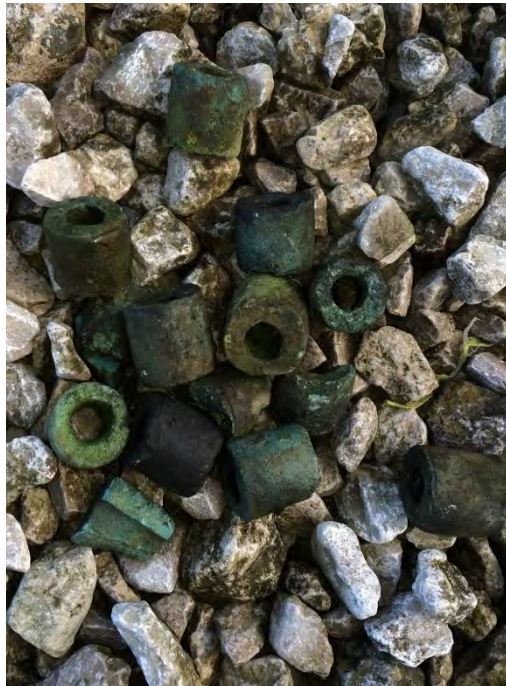
Figure A1      Non\*radioactive pellets found on main site

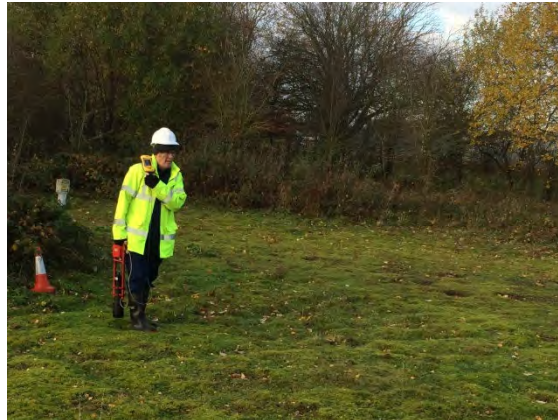
Figure A2      Using the RadSurvey system on the Maelor site.

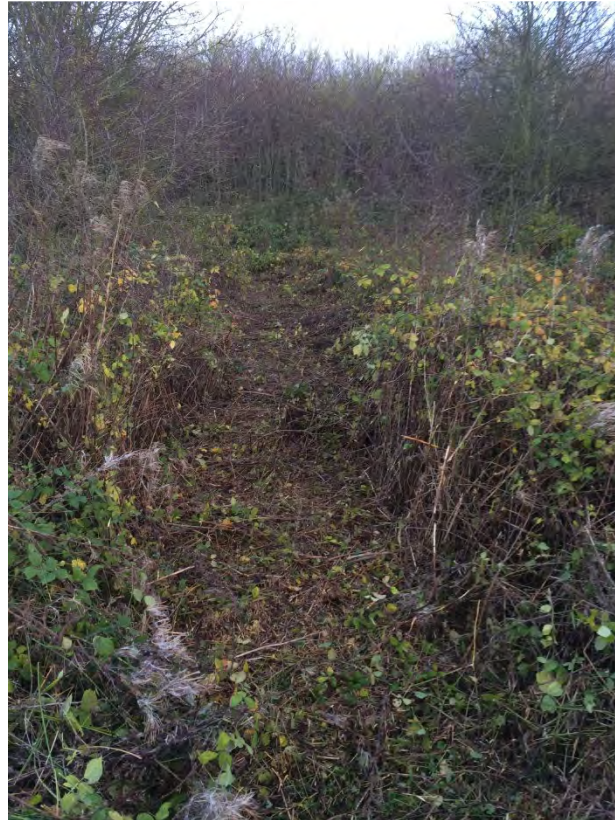
Figure A3 Pathways cut through heavy vegetation to facilitate survey

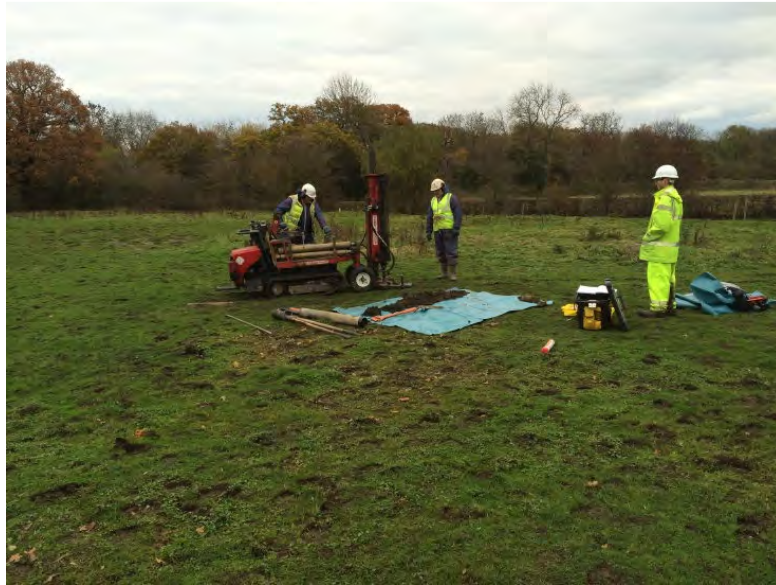
Figure A7 The health physics surveyor supervises drilling works and monitors excavated material.

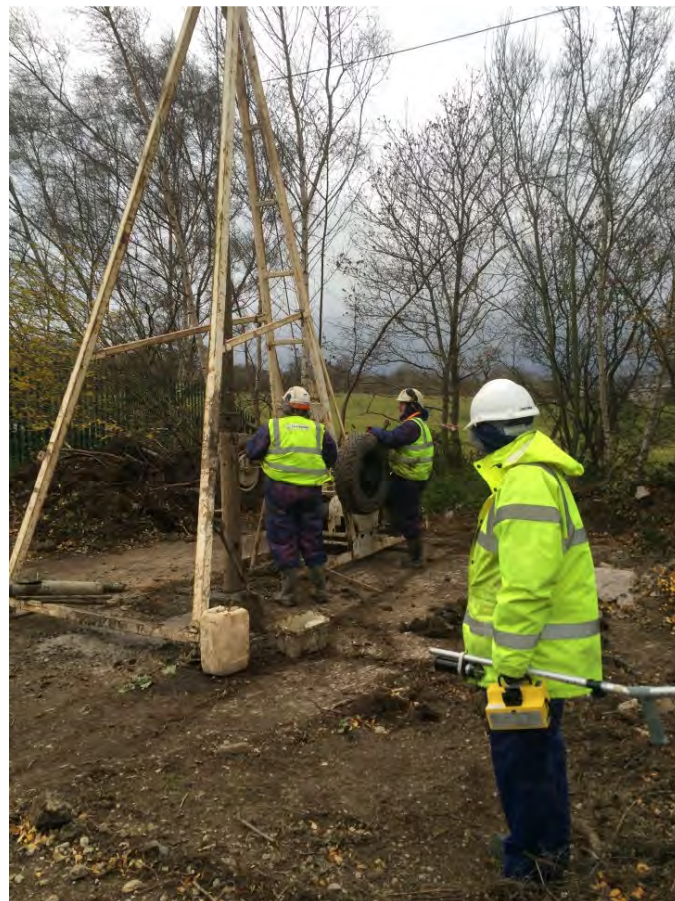
Figure A8 Supervising and monitoring drilling works.

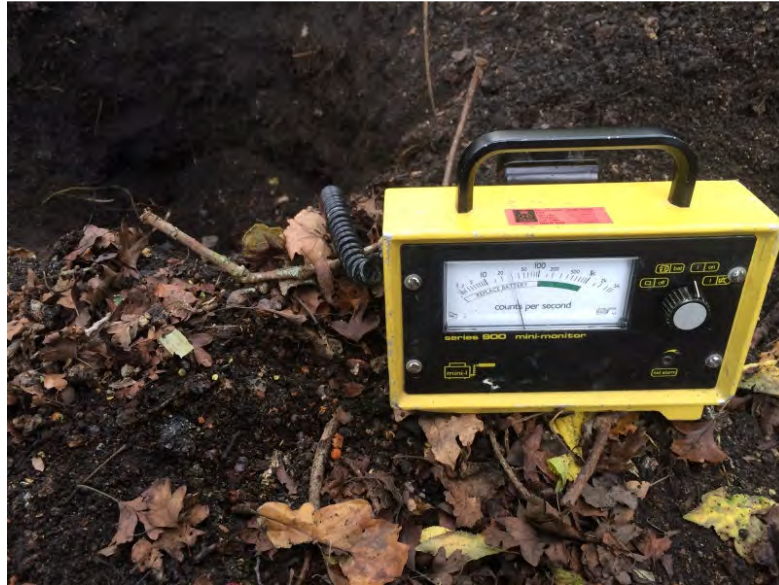
Figure A9 [REDACTED] count rates due to naturally occurring radioactivity in ash.

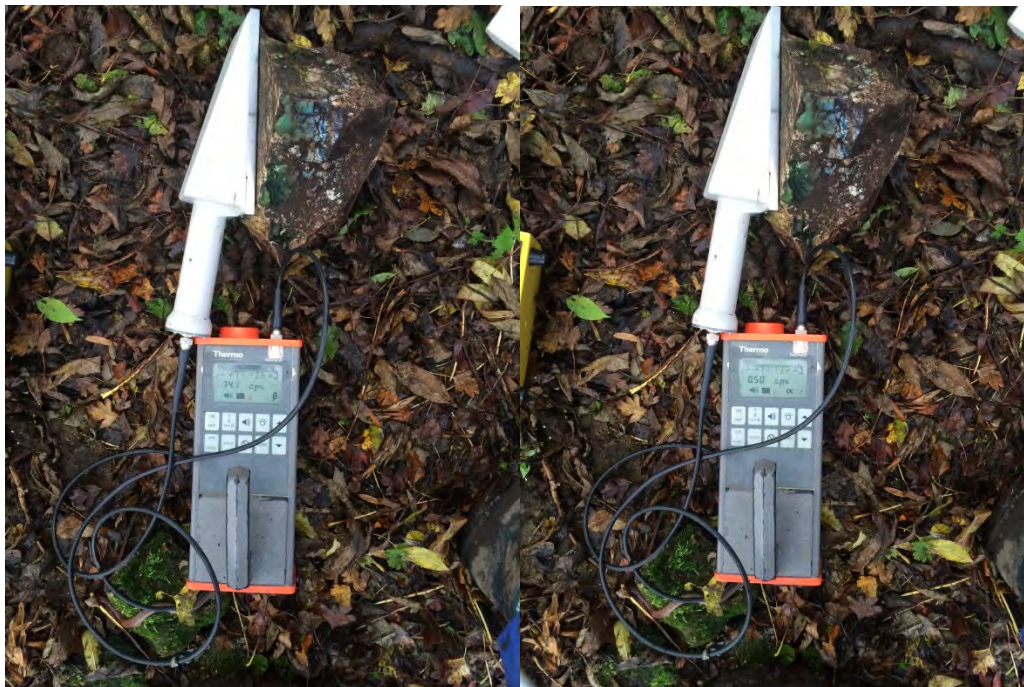
Figure A10 [REDACTED] beta and alpha count rates from naturally occurring radioactivity in a ceramic glazed brick.

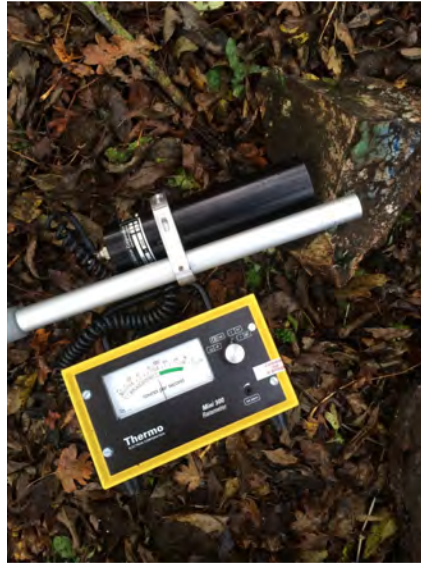
Figure A11 [REDACTED] gamma count rates from naturally occurring radioactivity in a ceramic glazed brick.

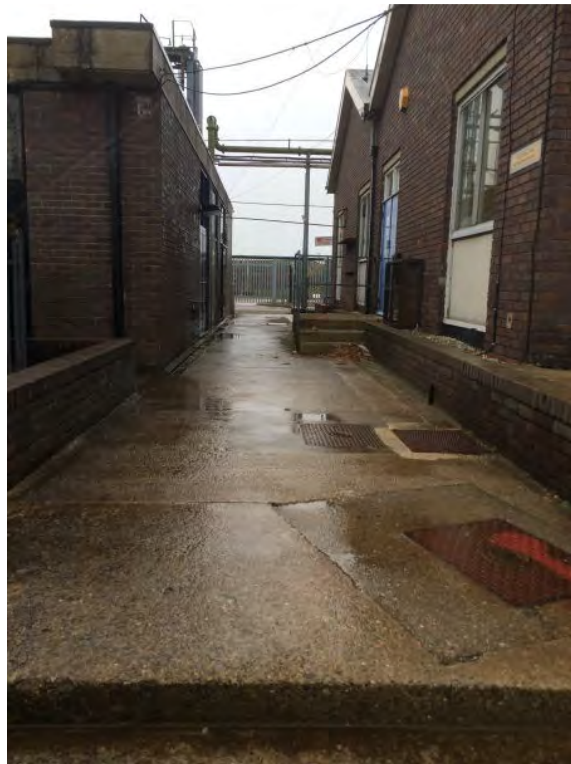
Figure A12 [REDACTED] count rate on the RadSurvey were due to the proximity of naturally occurring radioactivity in brick.
