Dwg Title  
Proposed demolition of existing outriggers and alterations and extension Existing Dwelling

Project  
The Old Croft  
(Formerly The Long Croft)  
Green Street  
Holt

Drawing Number  
680 PL10  
Revision  
A

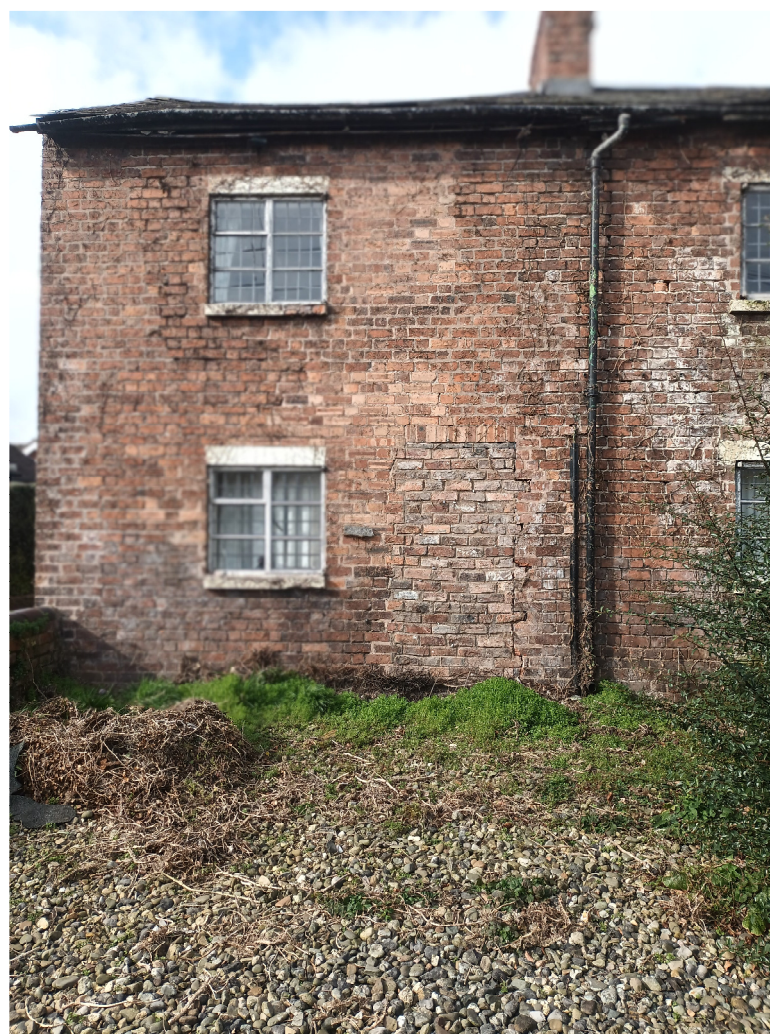
End Front Elevation

Existing Roof - Remedial Works  
Strip off existing slate roof on store for re-use. Assume 50% loss due to breakages and damaged slates.  
Strip off existing battens and any underlay, recover with BS 747 F1 bitumised slates felt underlay and re-batten with 50 x 25mm treated battens, re-slate to match existing with existing slates to one plane.  
Supply and fix new slates to match existing to remaining planes. Assume Welsh Slates to match existing.  
Repair and replace damaged or decayed rafters to match existing and instigate repairs to existing supporting structure subsequent to site inspection once exposed.

Existing Gable to be raked and epointed to agreed specification.

All existing windows to the front elevation to be replaced with purpose made hardwood painted flush Casement windows in style indicated.

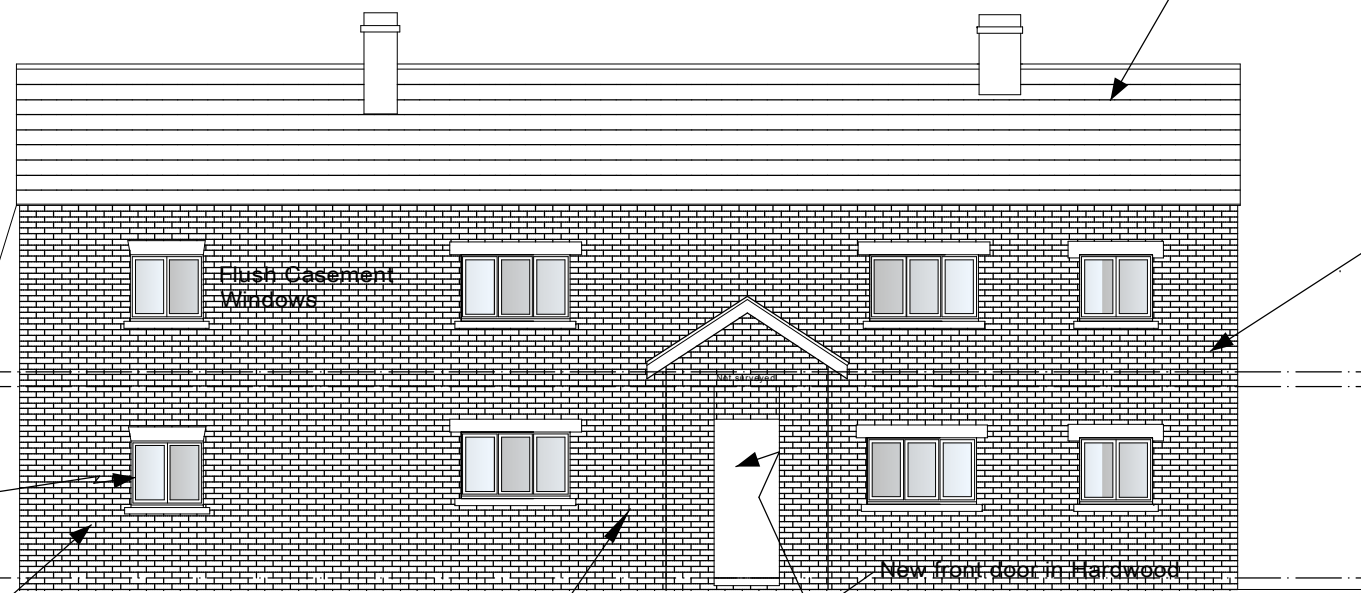
Front Elevation

Existing structurally unstable porch re-constructed to match existing materials. Existing materials to be used as possible. Porch has settled and rotated away from the main structure.

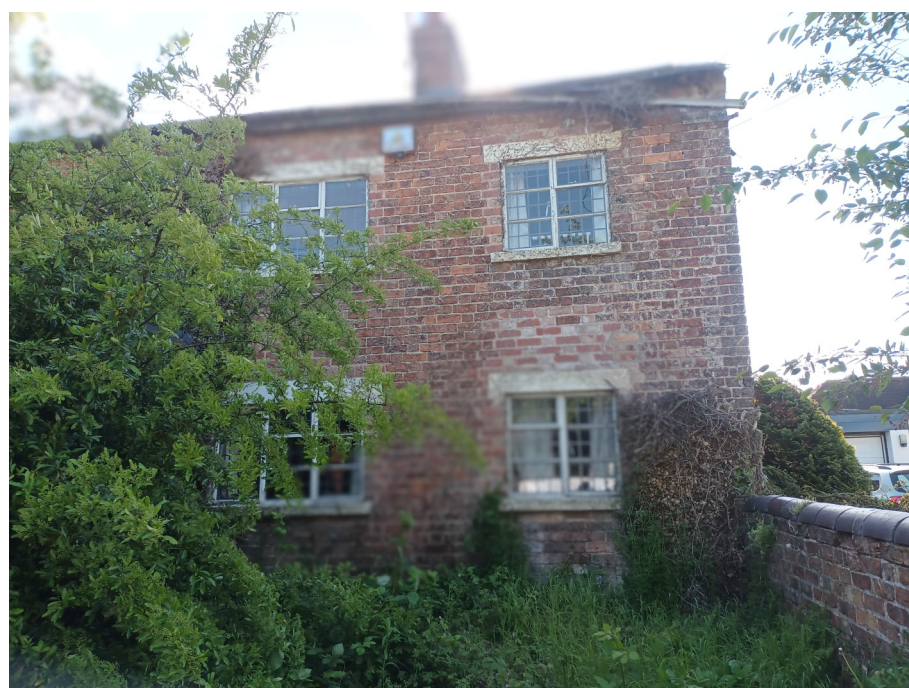
End Front Elevation Showing varying brickwork
