34 Erw Deg, Acrefair,  
Wrexham, LL14 3YA  
Daytime Bat Survey  
2024

Client ████████████████████  
Project Title 34 Erw Deg, Acrefair, Wrexham  
Project Reference RHE.4058  
Project Leader Kate Reed  
Contact Details kate@rachelhackingecology.co.uk

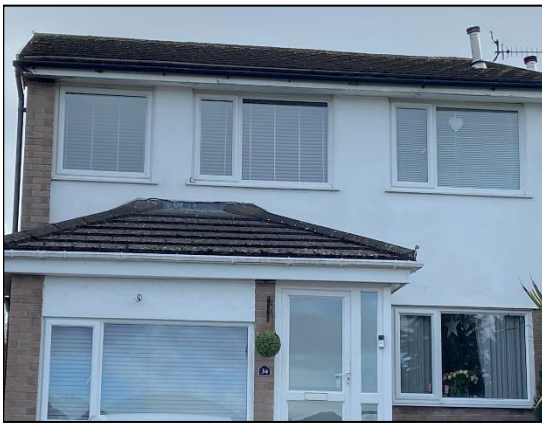
- 3.3.1 The site is a semi-detached, two-storey house, built c.1980 (see Photograph 1). The walls are brick, and the front facing and rear facing elevations have been rendered and painted. A single-storey porch exists on the front and rear of the property, these are constructed from brick and breeze-block. uPVC windows and doors are present and well-sealed within the buildings structure. The masonry features are generally in a good conditional, a few minor cavities were located where the mortar has recessed but the resulting gaps are considered too shallow to offer shelter for bats (see Photograph 2).

*Photograph 1 showing the front facing elevation of the property*

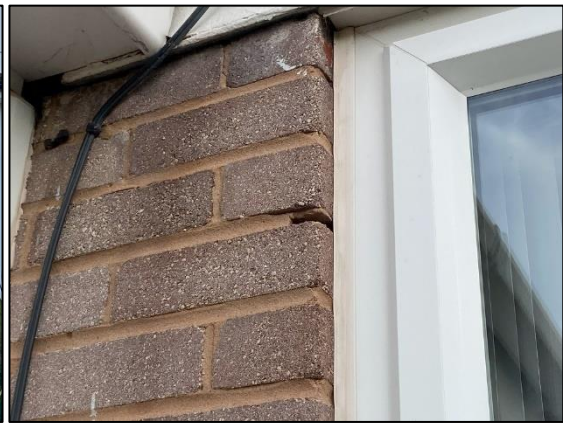
*Photograph 2 showing a minor gap in the brickwork*

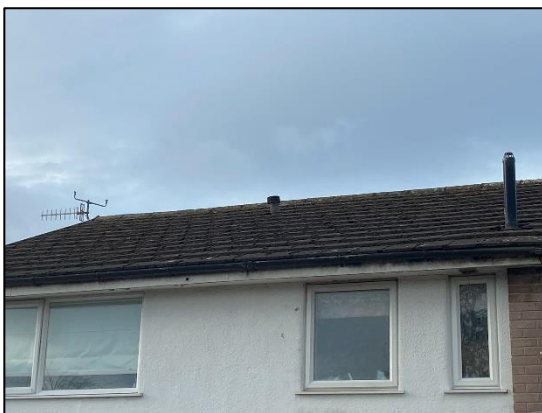
- 3.3.2 The roof of the property is pitched and covered with concrete tiles, these are all in position and lie flush to each other with no potential gaps that would provide roosting opportunities for access points for bats (see Photograph 3). The tiles on the rear extension mean small gaps exist at the roof edge here, there was no evidence to suggest that bats were using these spaces (see Photograph 4).

*Photograph 3 showing the roof of the property*

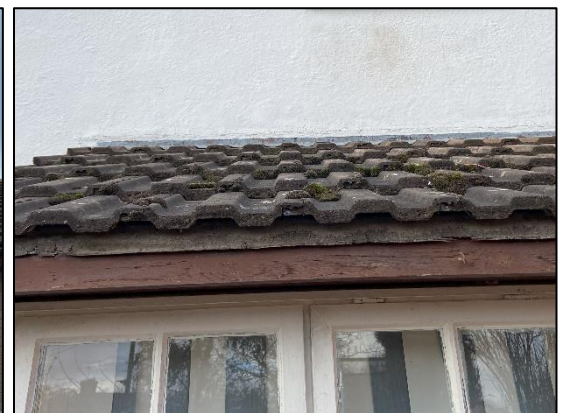
*Photograph 4 showing the gaps under the extension tiles*

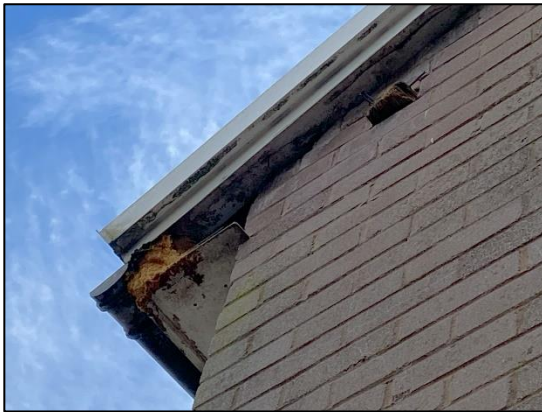
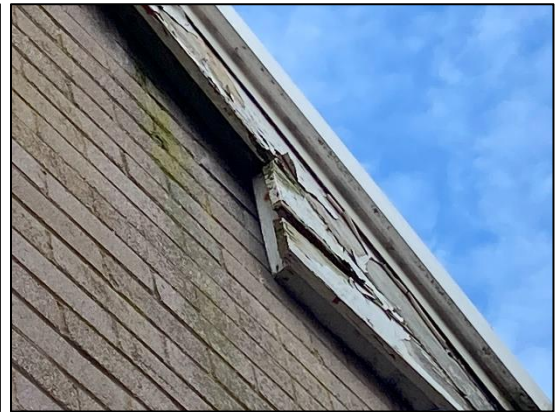
- 3.3.3 The roof edges are finished with wooden soffit and bargeboards, these support areas of significant water damage/rot on the gable end (see Photographs 5 and 6). Attempts have been made to temporarily repair the damage, patching the hole with roofing insulation. This does provide a potential access point to the internal roof void. Other small gaps exist where the wooden soffit boards meet the brickwork, where the wooden soffit boards have warped due to water damage and a small hole in the bargeboards at the rear of the property.

*Photograph 5 showing an area of water damage*

*Photograph 6 showing minor areas of water damage*

- 4.1.1 The site was fully accessible at the time of the survey. The building is generally in a good condition with only the rotten soffit and bargeboards offering some access points, these are considered to be of limited value to bats due to the damp, rotten and mouldy nature of the resultant cavities/ internal roof void. The building on site is assessed as offering negligible potential to support roosting bats. No evidence of feeding, roosting or hibernating bats was found internally or externally.
- 4.1.2 The shed onsite is also considered to offer negligible potential to support a bat roost as it constructed from materials of poor-thermal capacity, supports no roof void and is well-lit internally.

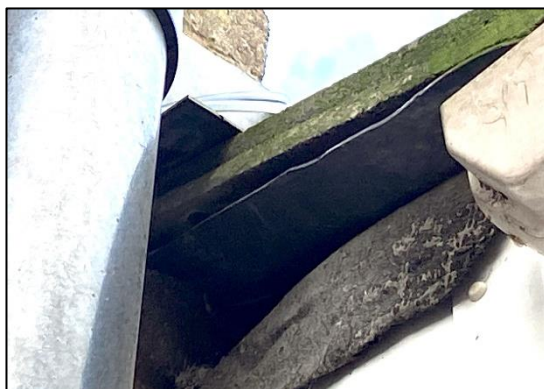
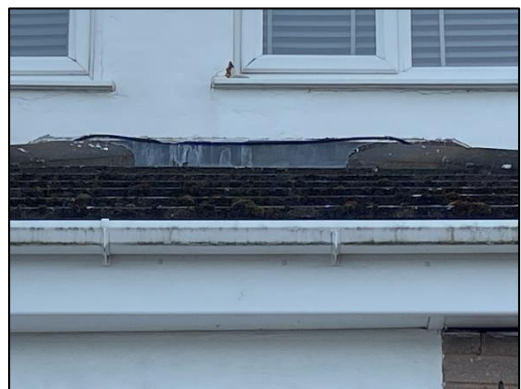
- 3.3.4 The single-storey porches are connected to the main property with lead flashing this is all in position and lies flush to the brickwork. A small cavity does exist between the main property and the extension an old bird's nest exists within this gap, reducing the likelihood that bats would use this cavity (see Photographs 7 and 8).

*Photograph 7 showing the gap between the extension and the main house*

*Photograph 8 showing the lead flashing*

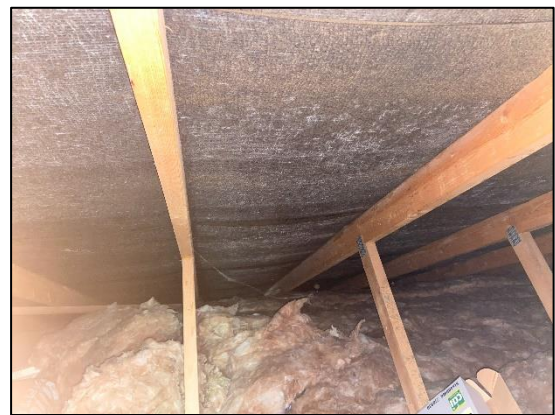
- 3.4.1 A single roof void exists within the property, this is used for occasional storage. The roof is supported by a wooden frame which is all complete and intact. The roof is lined with bitumen which is all complete and flush to the tiles above, a small section has been removed for the installation of the ventilation pipe, however this appears to be well-sealed externally and therefore is not considered to be a roosting/access feature for bats. The survey revealed two areas in which light was visible, these corresponded with the areas on water damage on the northern elevation. The roof void is cold and damp which has resulted in a layer of mould to form on the lining material. No signs of bat activity, such as droppings were found within the roof void during the survey (see photographs 9 and 10).

Photograph 9 showing the roof void

Photograph 10 showing the mould growth on the lining

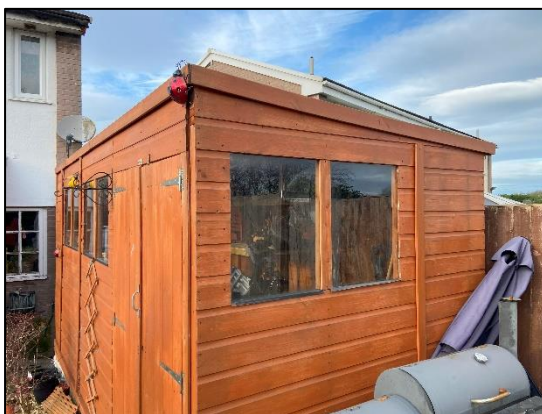
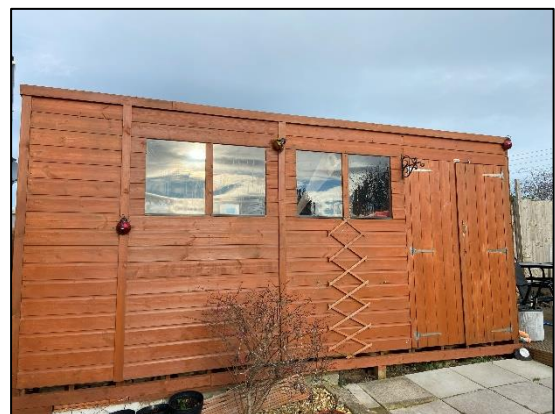
- 3.5.1 A large shed exists to the rear of the property. This is a well-maintained single-storey structure with a flat, felt covered, roof. Numerous windows are present, and the wooded bargeboards are present along the roof edging. The internal space does not support a roof void, is well-lit and un-insulated (see photographs 11 and 12).

Photograph 11 showing the shed looking west

Photograph 12 showing the front elevation of the shed
