# Life River Dee - Weir Fish Pass Detailed Design

Erbistock Weir  
Appendix B.d - Sediment Sampling note

Natural Resources Wales

15 August 2022

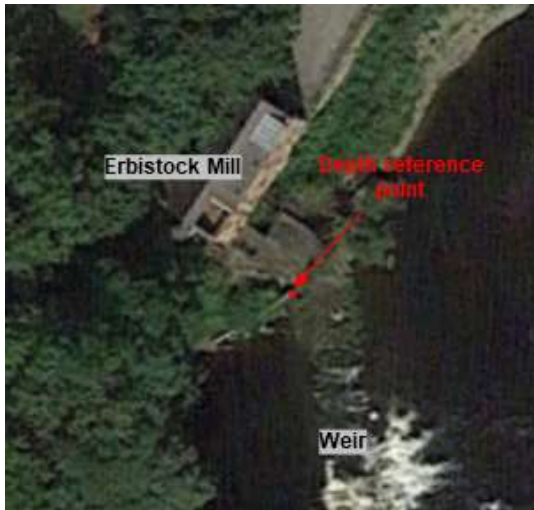
**Plate 1 Depth data reference point (Erbistock Mill cottage and weir highlighted)**

Note that in Table 1 the depth to soft/loose and hard/bedrock sediment were measured on site with respect to a data reference point located in correspondence of a corner of the concrete retaining wall on the left-hand bank (LHB) just upstream of the Erbistock Weir. This is pinpointed in Plate 1 and Plate 2 below.

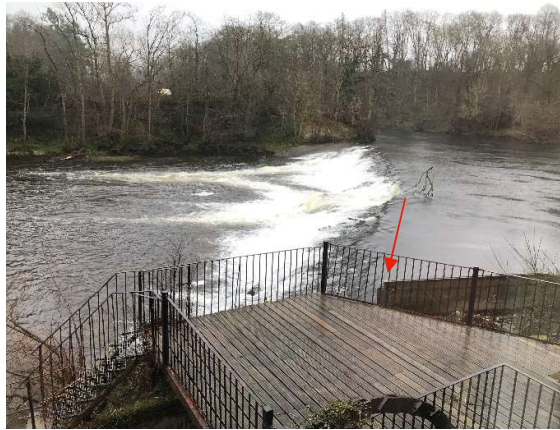
**Plate 2 View of depth data reference point from Erbistock Mill cottage (16/03/2022)**

According to the latest topographic survey (2020), the upper and lower surface of the timber decking (Plate 2 and Plate 4) are respectively at 22.51 and 22.40mAOD. Although the exact elevation of the reference point is unknown, this appears to be between 20-30 cm below the upper surface of the timber decking (Plate 4). For this reason, an elevation of 22.30 mAOD was deemed to be an acceptable ballpark estimation. This elevation has been used to estimate the bed elevations in Table 1.

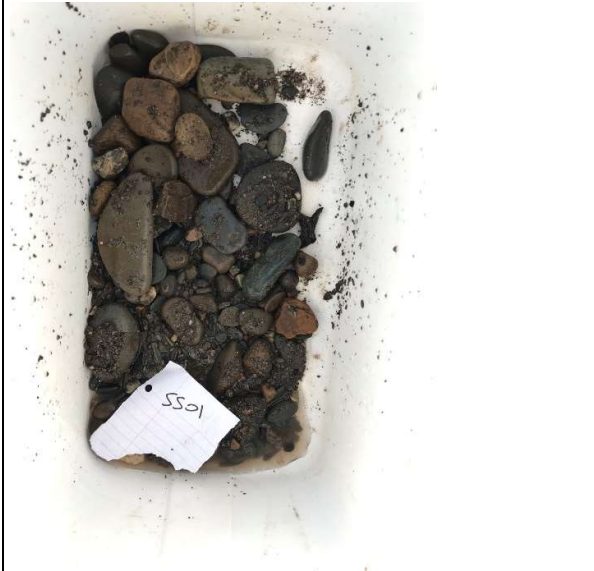
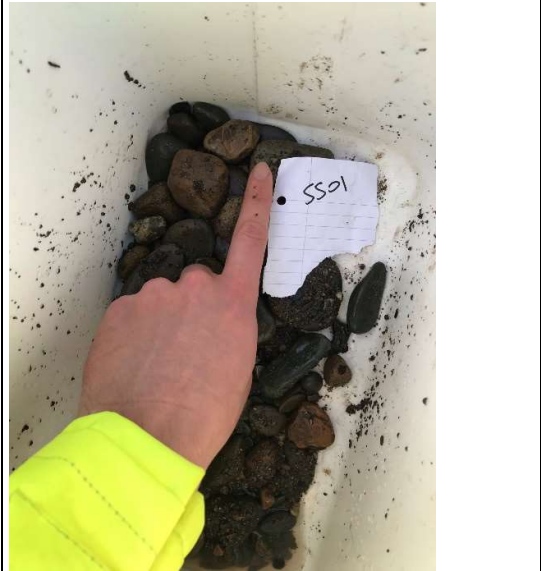
| SS01 | |
|---|---|
| Plate 5 SS01 | Plate 6 SS01 |

| Location ID | Date of sample | NGR | Depth <sup>1</sup> to bed sediment (m) | | Depth of soft/loose sediments (m) | Approximate elevation of bed sediments (m AOD) | | Comments |
|---|---|---|---|---|---|---|---|---|
| SS01 | 16/03/2022 | SJ 35484 42091 | 2.00 | 2.80 | 0.80 | 19.08 | 18.28 | Water sample collected but soil sample was not suitable for soil/leachate analysis. Water sample only sent to laboratory for analysis. |

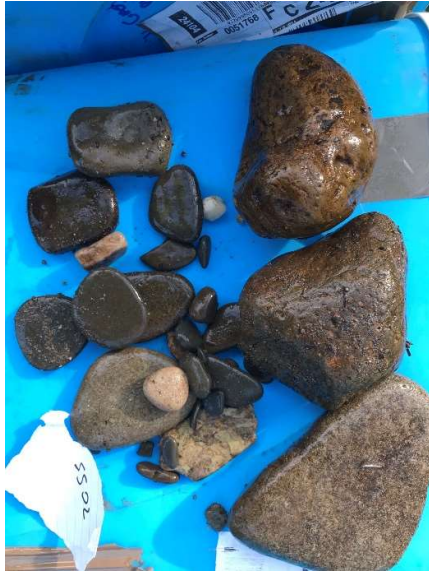
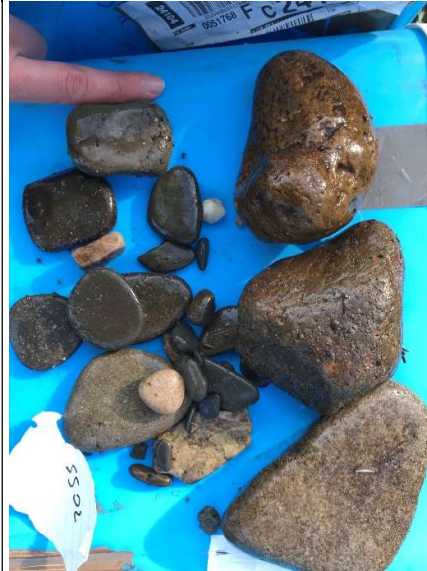
**SS02**

| Location ID | Date of sample | NGR | Depth <sup>1</sup> to bed sediment (m) | | Depth of soft/loose sediments (m) | Approximate elevation of bed sediments (m AOD) | | Comments |
|---|---|---|---|---|---|---|---|---|
| SS02 | 16/03/2022 | SJ 35473 42079 | 2.10 | 2.36 | 0.26 | 18.98 | 18.72 | As per above |

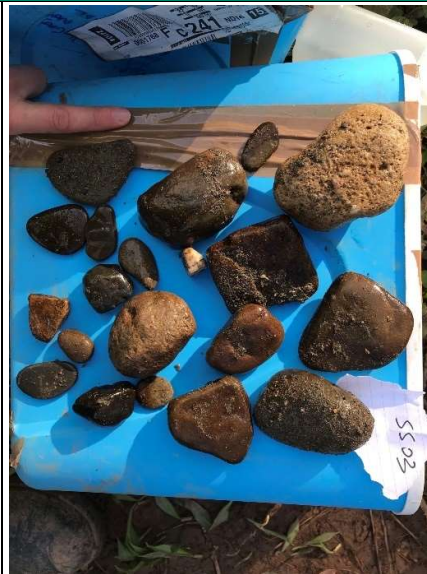
**SS03**

| Location ID | Date of sample | NGR | Depth <sup>1</sup> to bed sediment (m) | | Depth of soft/loose sediments (m) | Approximate elevation of bed sediments (m AOD) | | Comments |
|---|---|---|---|---|---|---|---|---|
| SS03 | 16/03/2022 | SJ 35460 42070 | 2.12 | 2.40 | 0.28 | 18.96 | 18.68 | As per above |

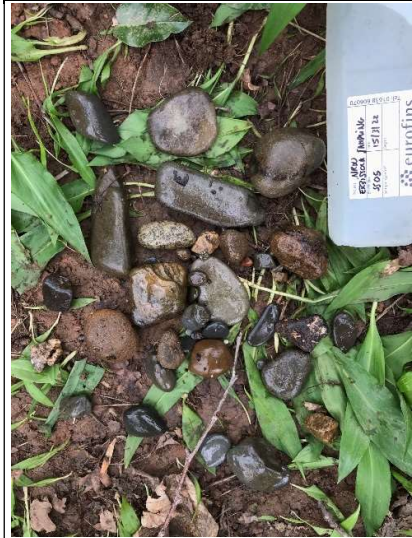
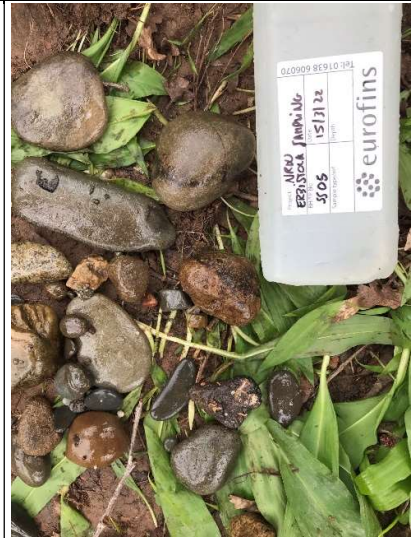
| Location ID | Date of sample | NGR | Depth <sup>1</sup> to bed sediment (m) | | Depth of soft/loose sediments (m) | Approximate elevation of bed sediments (m AOD) | | Comments |
|---|---|---|---|---|---|---|---|---|
| SS05 | 16/03/2022 | SJ 35457 42096 | 2.20 | 2.35 | 0.15 | 18.88 | 18.73 | Water sample collected but soil sample is not suitable for soil/leachate analysis. Water sample only sent to laboratory for analysis. |

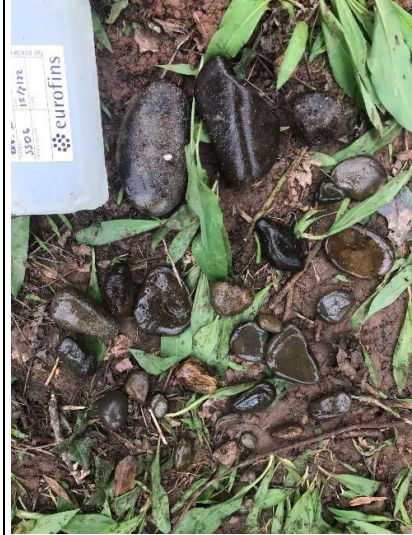
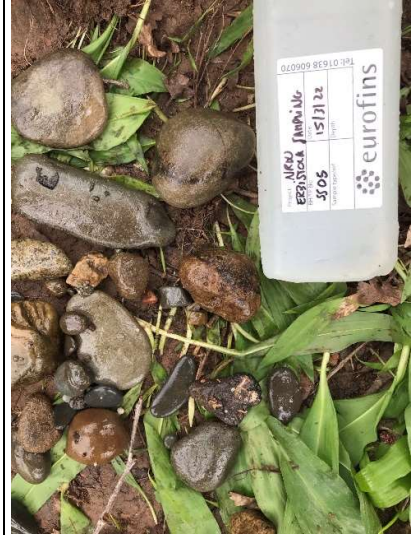
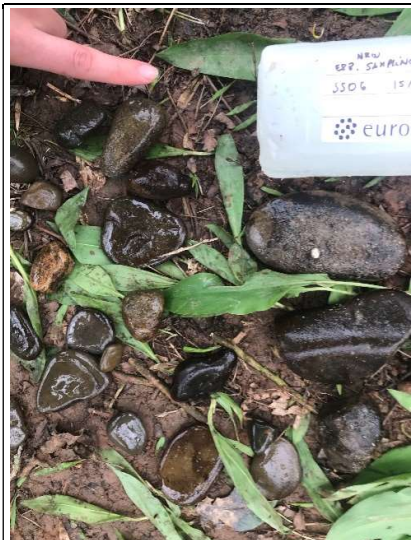
| Location ID | Date of sample | NGR | Depth <sup>1</sup> to bed sediment (m) | | Depth of soft/loose sediments (m) | Approximate elevation of bed sediments (m AOD) | | Comments |
|---|---|---|---|---|---|---|---|---|
| SS06 | 16/03/2022 | SJ 35444 42081 | 2.79 | 2.95 | 0.16 | 18.29 | 18.13 | As per above |

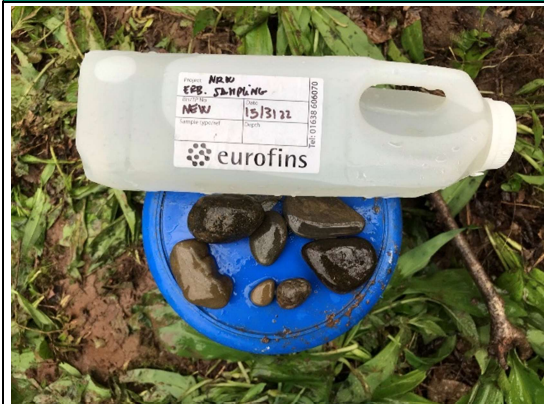
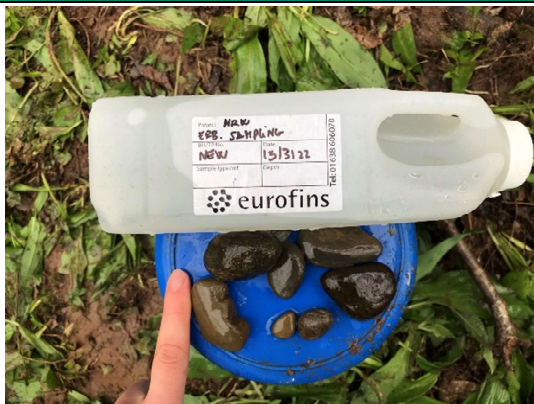
| Location ID | Date of sample | NGR | Depth <sup>1</sup> to bed sediment (m) | | Depth of soft/loose sediments (m) | Approximate elevation of bed sediments (m AOD) | | Comments |
|---|---|---|---|---|---|---|---|---|
| SSNEW | 16/03/2022 | SJ 35444 42113 | 3.30 | 3.50 | 0.20 | 17.78 | 17.58 | Water sample collected but soil sample was not suitable for soil/leachate analysis. Water sample only sent to laboratory for analysis. |

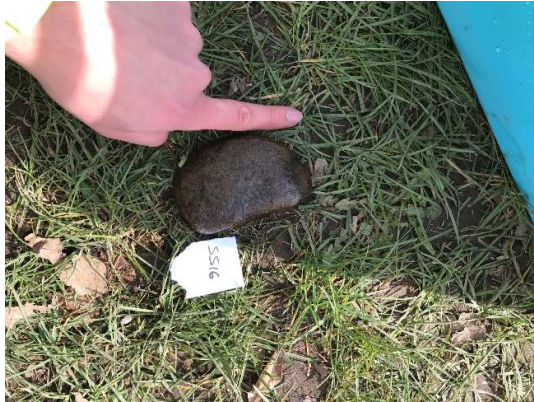
**Plate 18 SS16**

| Location ID | Date of sample | NGR | Depth <sup>1</sup> to bed sediment (m) | | Depth of soft/loose sediments (m) | Approximate elevation of bed sediments (m AOD) | | Comments |
|---|---|---|---|---|---|---|---|---|
| SS16 | 15/03/2022 | SJ 35477 42185 | 1.29 | 1.42 | 0.13 | 17.99 | 17.86 | As per above |

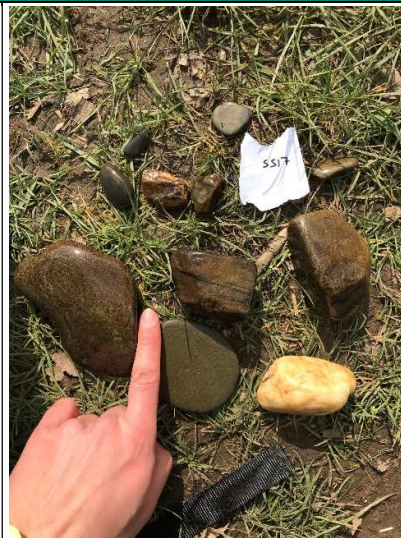
**Plate 20 SS17**

| Location ID | Date of sample | NGR | Depth <sup>1</sup> to bed sediment (m) | | Depth of soft/loose sediments (m) | Approximate elevation of bed sediments (m AOD) | | Comments |
|---|---|---|---|---|---|---|---|---|
| SS17 | 15/03/2022 | SJ 35465 42198 | 1.37 | 1.60 | 0.23 | 17.91 | 17.68 | As per above |

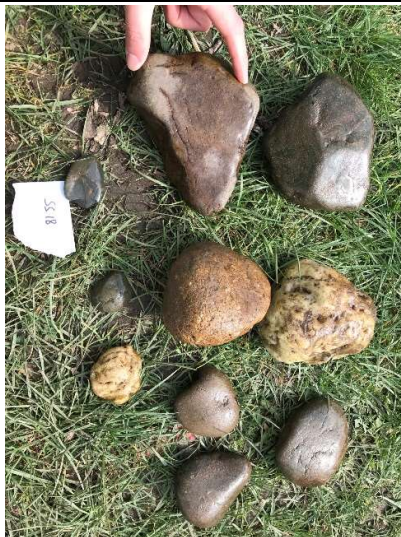
**Plate 21 SS17**

| Location ID | Date of sample | NGR | Depth <sup>1</sup> to bed sediment (m) | | Depth of soft/loose sediments (m) | Approximate elevation of bed sediments (m AOD) | | Comments |
|---|---|---|---|---|---|---|---|---|
| SS18 | 15/03/2022 | SJ 35455 42209 | 1.20 | 1.30 | 0.10 | 18.08 | 17.98 | As per above |

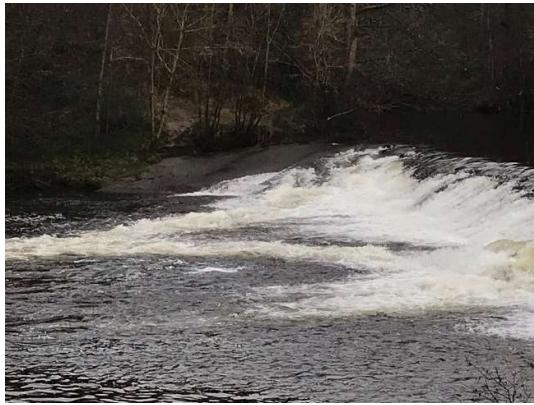
**Plate 27 Concrete glacis partially wet  
(16/03/2022)**

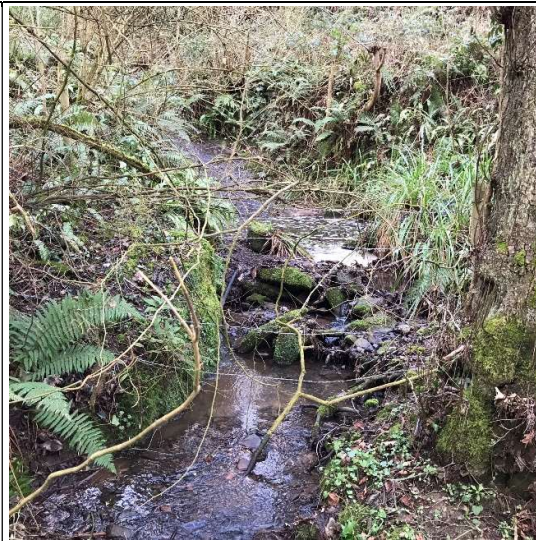
Upstream of Erbistock Weir, some bedrock was observed outcropping along a tributary that flows down from the left-hand bank into the River Dee (between SS12 and SS13, see Plate 28 and Plate 30). At this location, the river bed seemed to consist of bedrock for a 4-5 meter reach from the riverbank into the channel until a sudden drop in bed channel levels (3-4m). For this reason SS12 and SS13 no sediments were available to be obtained, and the sediments could not be sampled for soil analysis and/or substrate depth measurements.

**Plate 28 Bedrock outcrop on stream on  
River Dee LHB (photo taken on  
January 2022)**

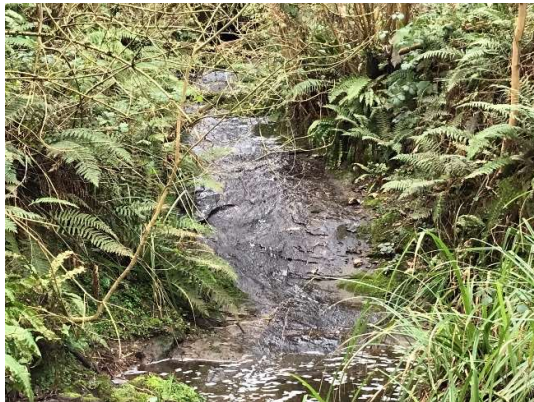
**Plate 29 Flow on bedrock (photo taken on  
January 2022)**

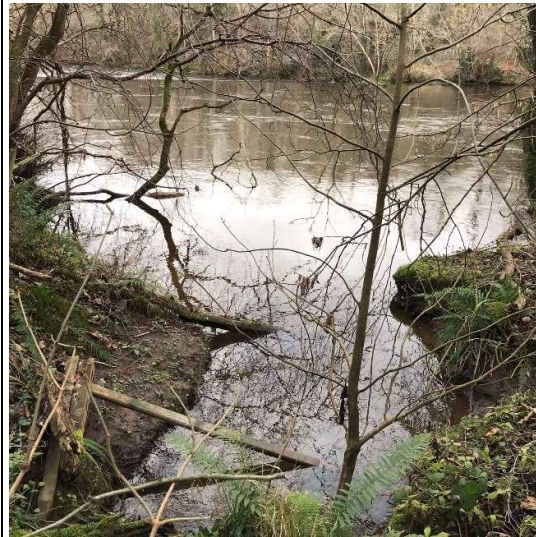
**Plate 30 Stream flowing into River Dee into  
pool upstream of Erbistock weir  
(between SS12 and SS13)**
