**ADDITIONAL PHASE 2 GROUND  
INVESTIGATION: WYNNSTAY  
TECHNOLOGY PARK, RUABON**

**GSL3060R01**

**28 MARCH 2024**

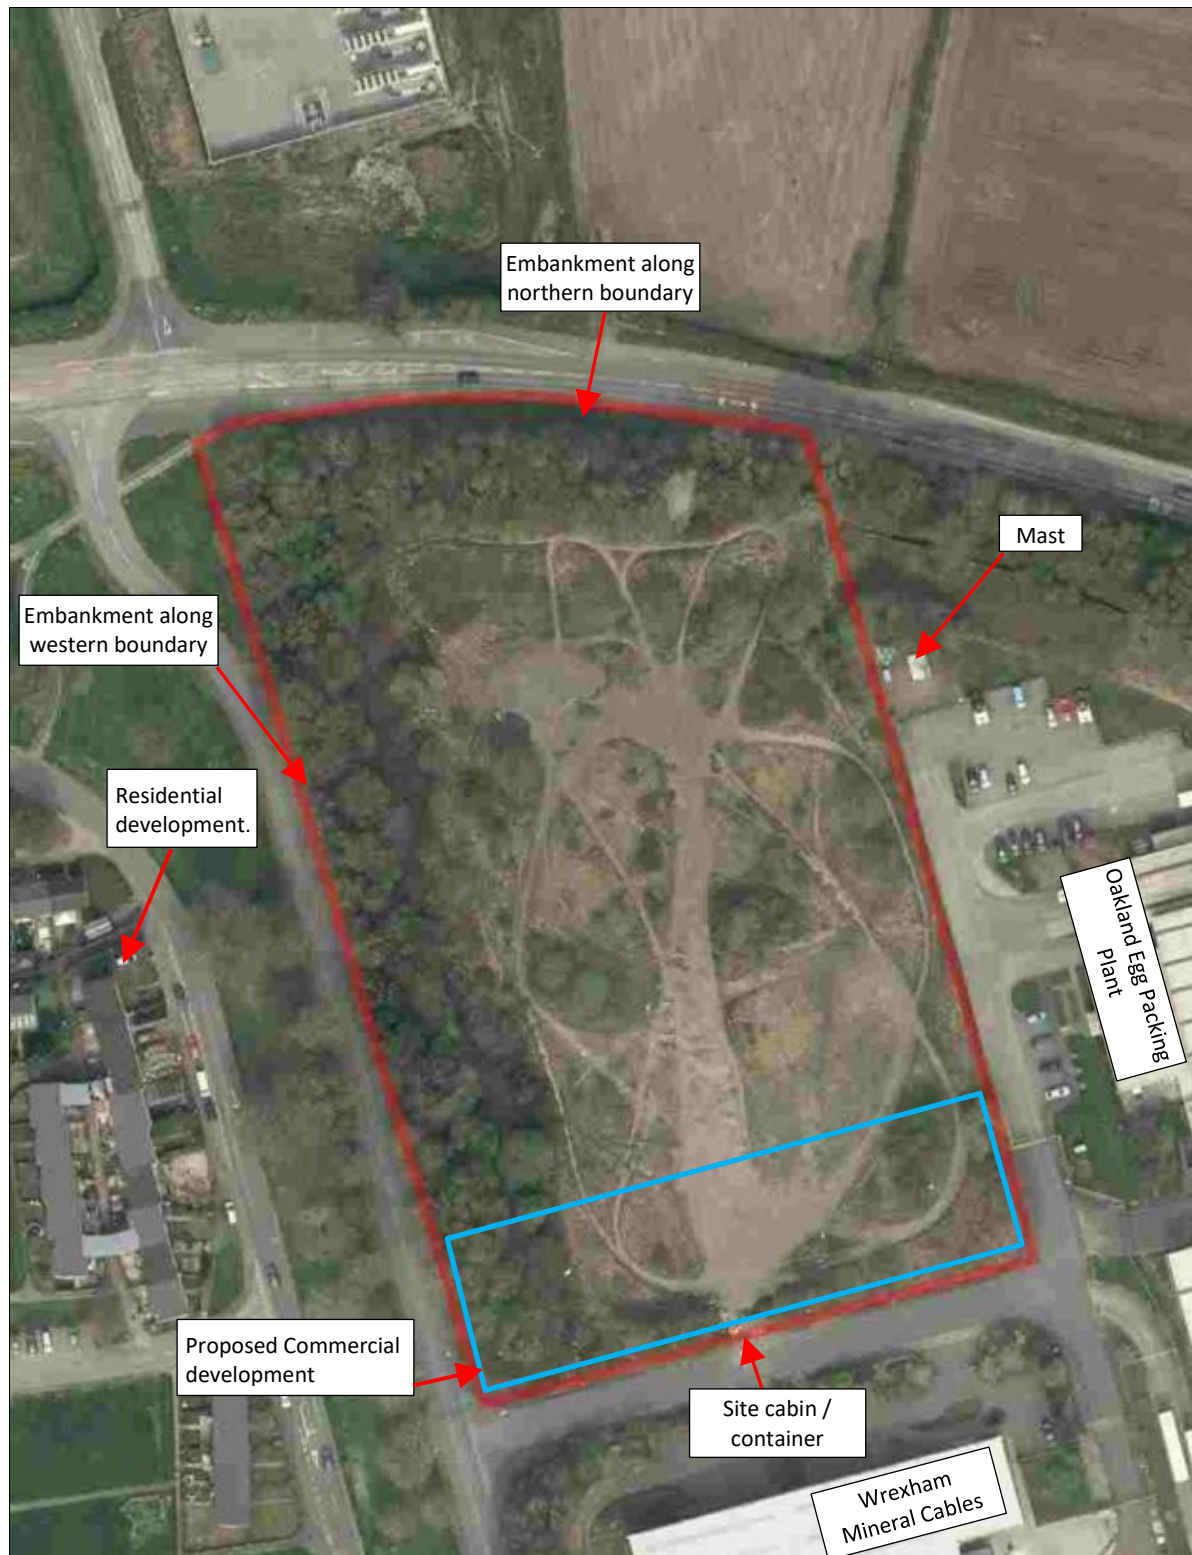
**Figure 2 - Extract from Aerial photography from Groundsure Report**

| <b>Surrounding Area</b> | Two commercial sites border to the east (Oakland Egg Packing Plant) and south (Wrexham Mineral Cables). Residential properties are present to the west and an electricity substation is present to the north. The site is bordered by Llangollen Road to the north and Wynnstay Lane to the west. See <b>Figure 2</b> |

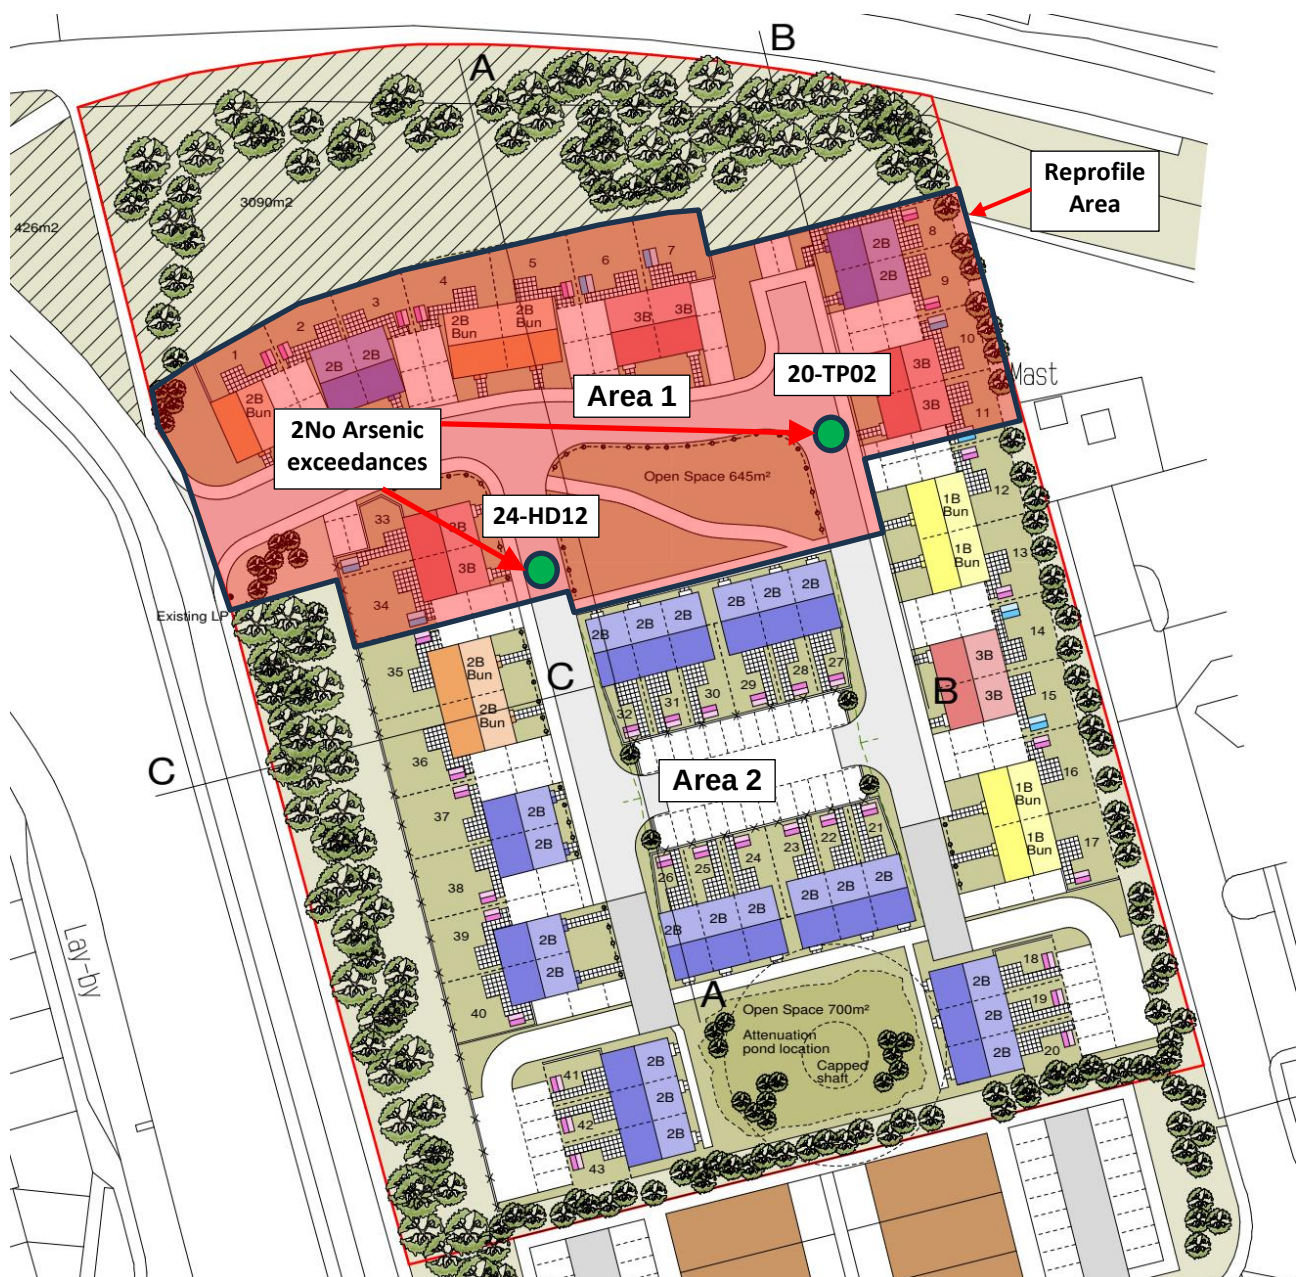
**Figure 3 - Extract from development plan**

The risk assessments have concluded that full remediation measures are required, where ground levels are to be raised potentially reusing material from the existing embankment. The embankment material will be excluded from the top 600mm from the proposed soft landscaped areas. It is understood that the western embankment will not be disturbed and will not extend into the gardens at these locations.

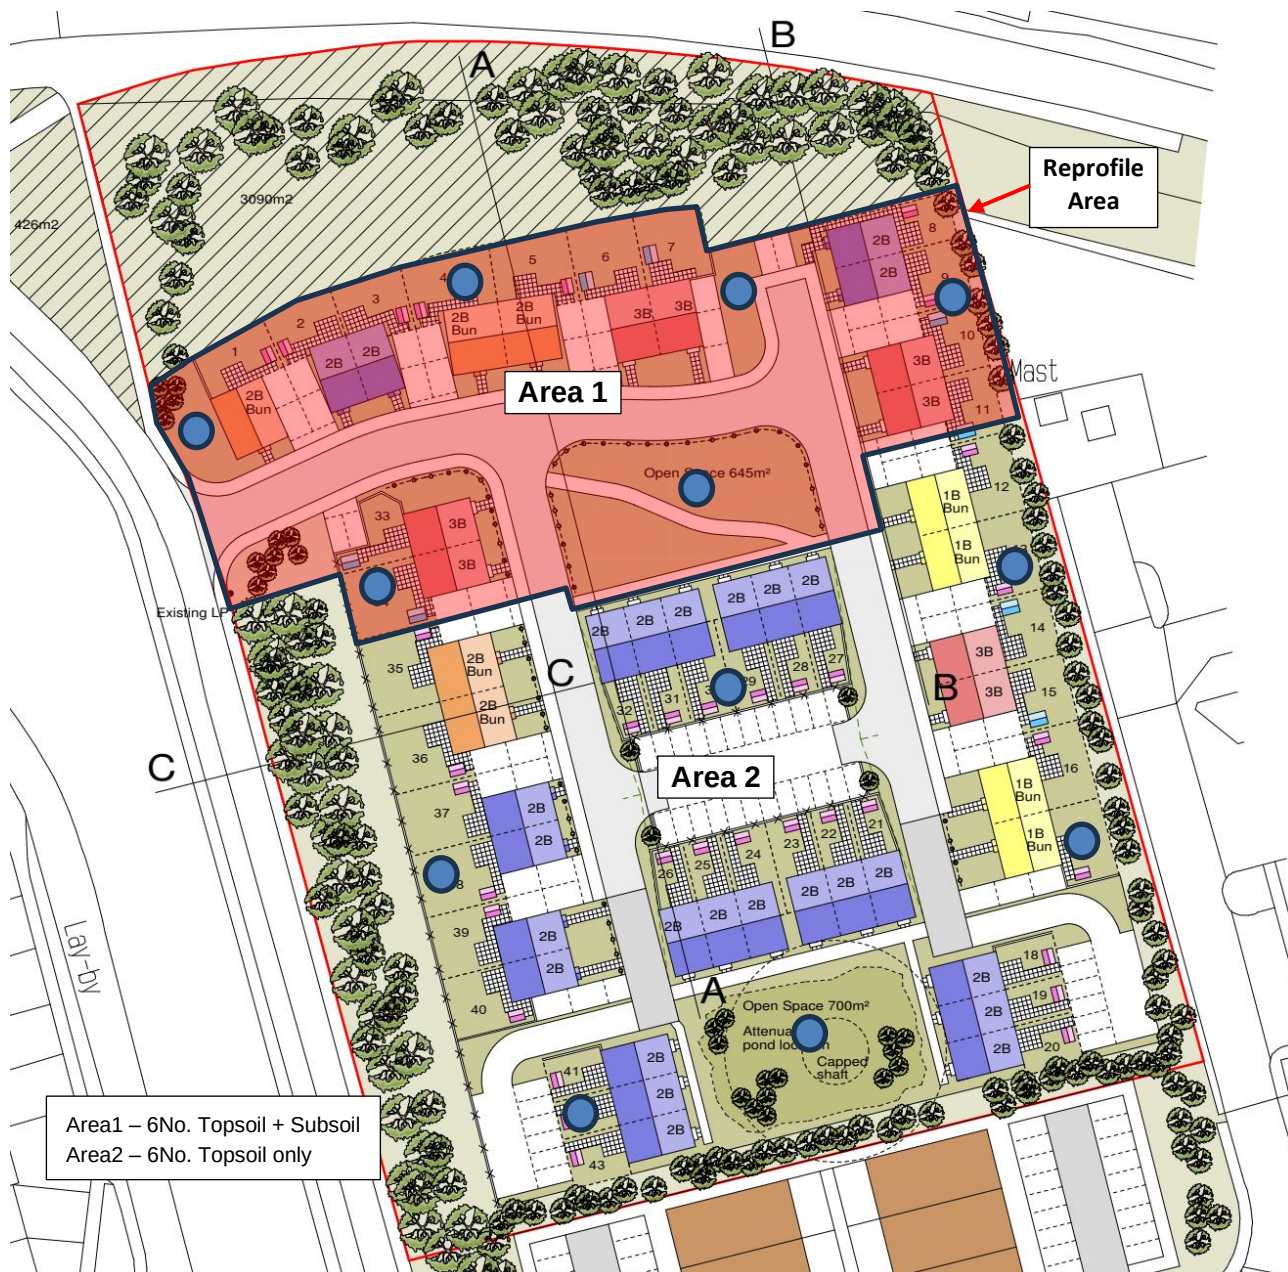
**Figure 4 - Extract from development plan with proposed sampling points**

The Welsh Land Contamination Working Group (WLGA) document *Requirements for the Chemical Testing of Imported Materials for Various End Uses and Validation of Cover Systems* suggests the minimum frequency for developments with 40 plots should be 1 sample (separate topsoil and subsoil) every 4 plots meeting the requirements of Table 4.2. The proposed development comprises 43 Plots with the additional of two communal landscaped area in the northern and southern areas of the site.

It is therefore proposed there will be a **minimum** of 12No. topsoil and 6No. subsoil samples from the proposed soft landscaped areas. If plots are to be completed in stages, there will be a minimum of 3 samples for each material.

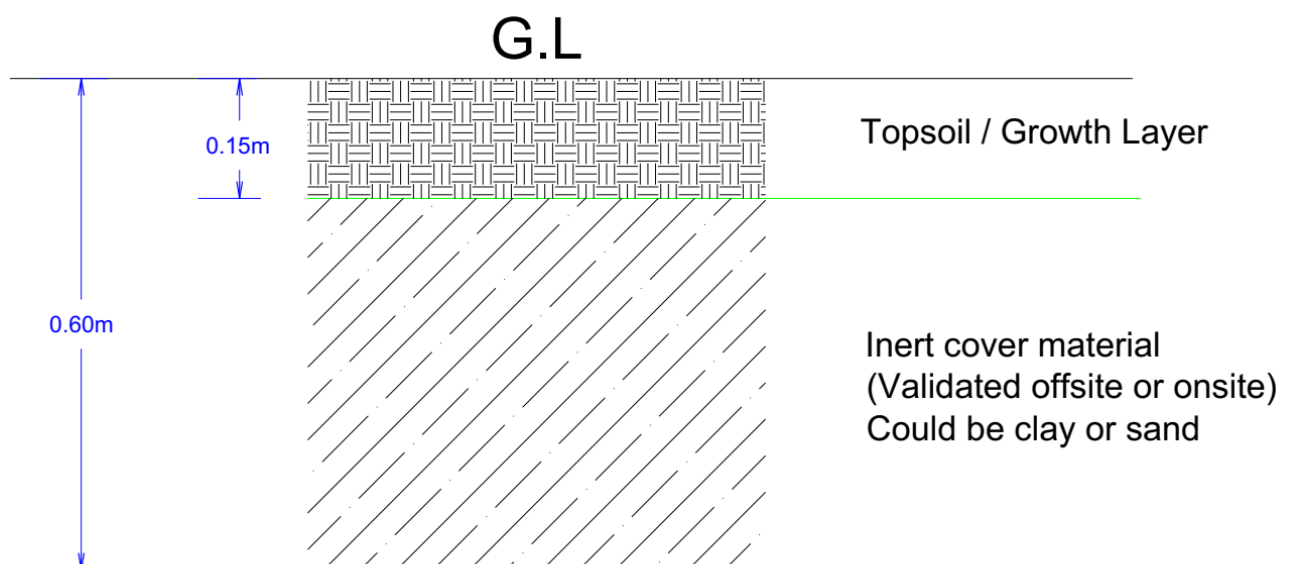
Figure 5: Schematic drawing showing typical cover system construction within garden and soft landscaping in Area1

- Clean cover in garden and soft landscaping area to comprise a minimum thickness of 150 mm of topsoil over a 450 mm thick subsoil.
- Should extensions be proposed to properties which are known to have cover systems, it is essential that the cover system is maintained, and soils at depth are not moved to the surface, compromising the cover system. It is recommended that the presence of a cover system at the property is conveyed to new house owners within the sale pack for their awareness, as permitted development rights allow some forms of extensions for which planning permission is not required.

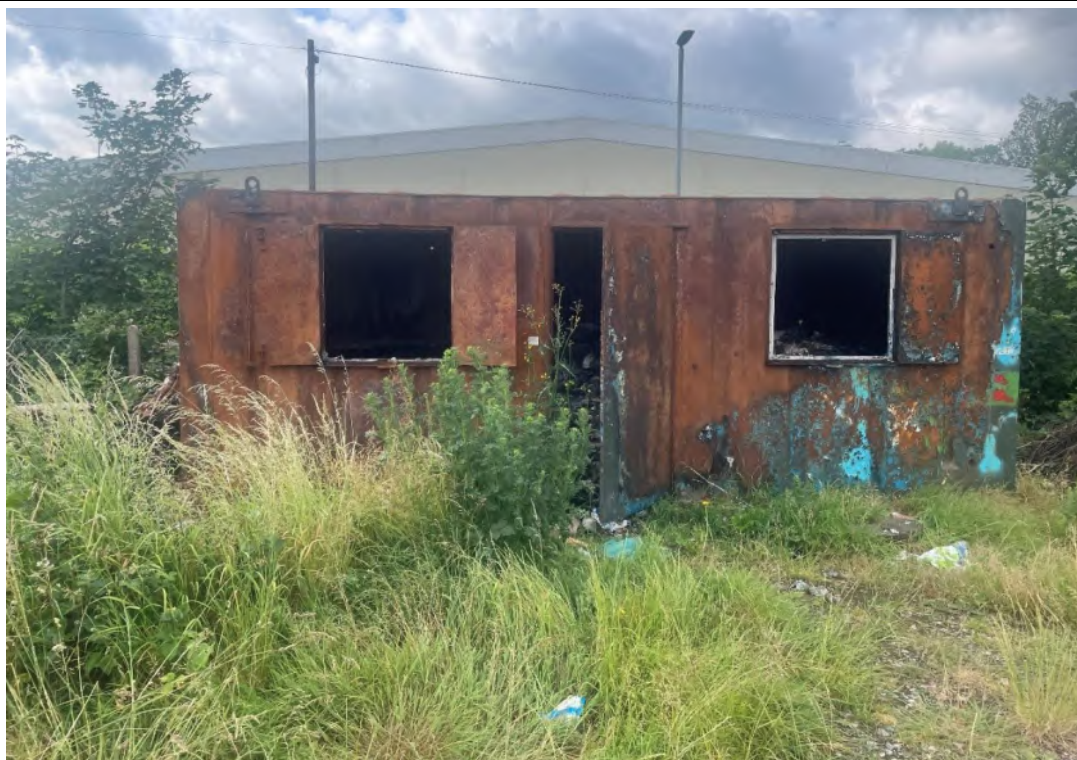
Photo 14 – Old container present along southern boundary. Evidence of fire damage. Burnt ash material present inside container. No evidence of any impact outside the container.

| <b>Existing Buildings&amp; Structures</b> | No permanent structures present on site. There is disused site office / steel container, which shows evidence of fire damage inside. |
| <b>Waste Disposal/<br/>Materials Storage</b> | No significant areas of waste storage or fly tipping present on site. There is some evidence of fire damage and burnt material present within the container located on the southern boundary.<br><br>There are two relatively small stockpiles of vegetation present which is understood to originate from recent vegetation clearance. |

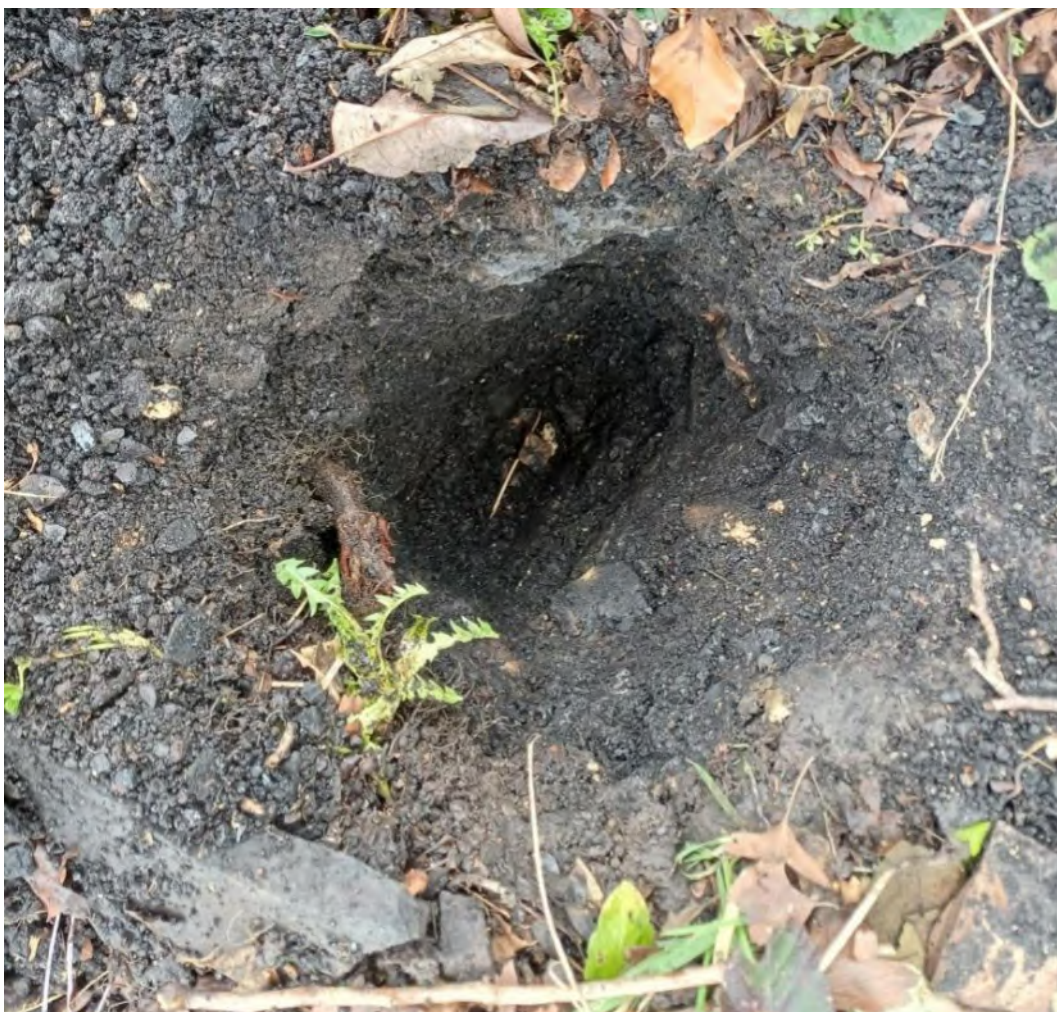
HP1 – 0.50m bgl

| Well | Water Strikes | Sample and In Situ Testing | | | Depth (m) | Level (m) | Legend | Stratum Description | |
|---|---|---|---|---|---|---|---|---|---|
| | | 0.50 | ES | | 0.50 | 126.50 | | Loose dark grey fine to coarse sub angular GRAVEL of clinker, red brick and mudstone with ash. (MADE GROUND) | |

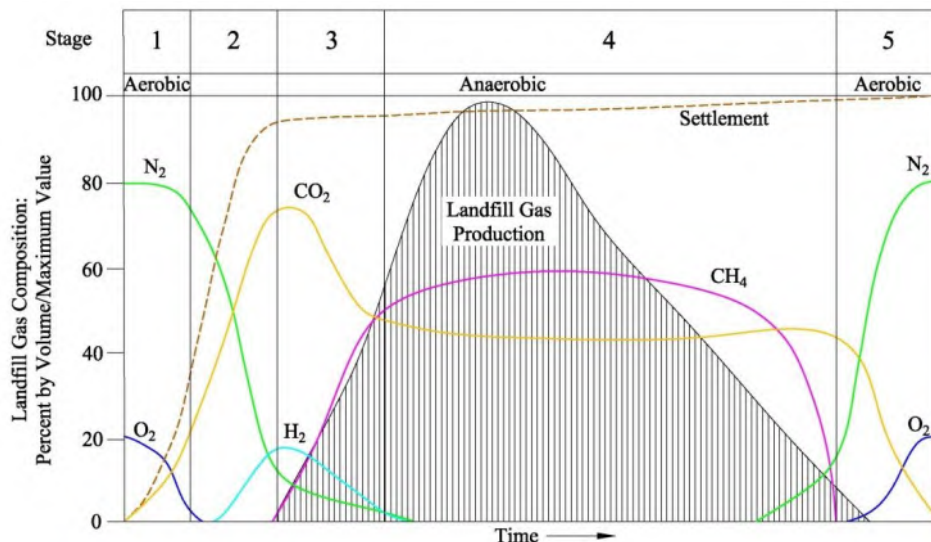
**Figure G2. Idealised Representation of Landfill Gas Generation.**

Figure G2 is taken from EA guidance document LFTGN 03 illustrates typical ground gas generation curves from biodegradable materials:

The production of methane and carbon dioxide at a landfill site may be expected to be considerable and ongoing. Concentrations of methane will eventually decrease, followed by concentrations of carbon dioxide, but the duration and rate of gas production can vary markedly between sites. Five distinct phases of gas production occur during the process which are, in order of event (as marked on Figure G2), as follows:
