## Phase I GeoEnvironmental Desk Study

Acrefair

Wrexham

**Report No. A3341/19**

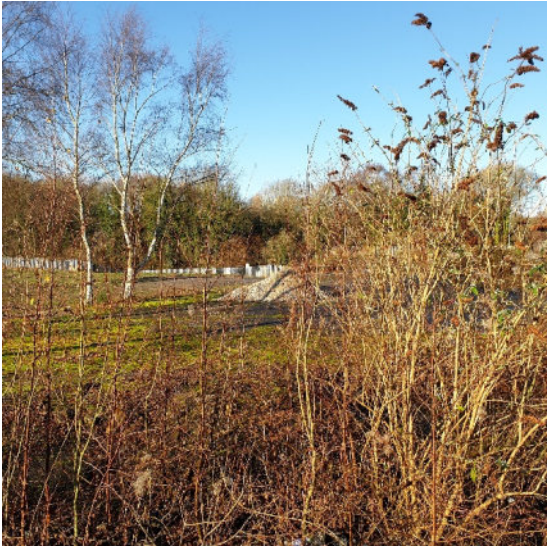
| <p><b>Plate 1 View of site looking north</b></p> | <p><b>Plate 2 View across site looking north along eastern boundary</b></p> |

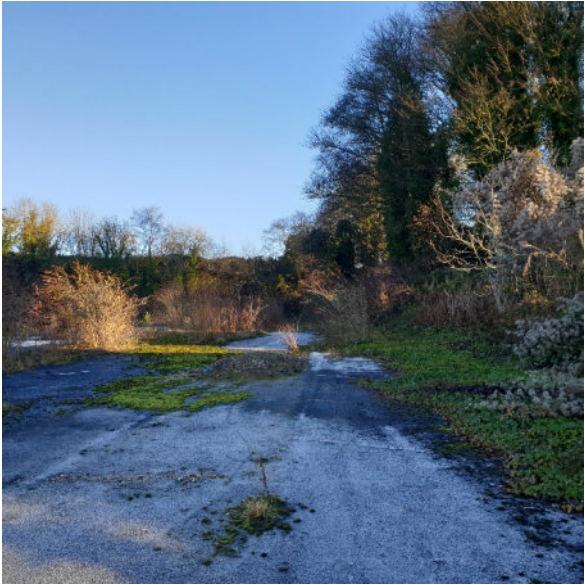
- 3.10 There is a moderate risk of landslides due to the steep slopes on the eastern boundary of the site.

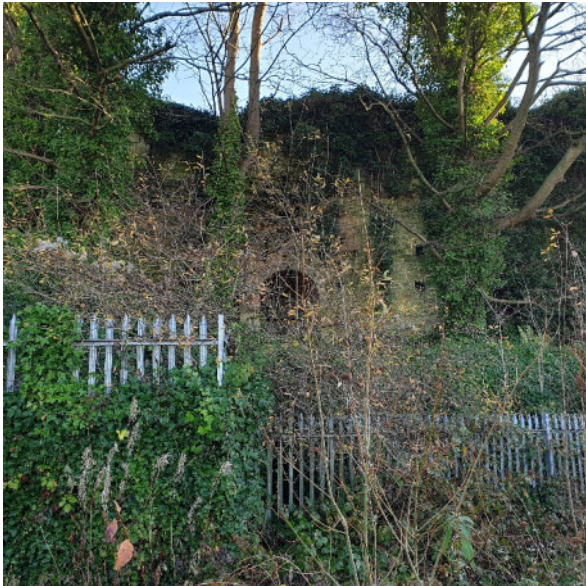
| <p><b>Plate 3 Former kiln on eastern boundary</b></p> | <p><b>Plate 4 Distressed stone retaining wall</b></p> |
