# Phase II Geoenvironmental Site Assessment

Site: Tupa, Penley  
Reference: 17-510-R2  
Date: May 24

| <b>Site Address</b> | Land off Penley Hall Drive, Penley, Wrexham, LL13 0JP |
| <b>Proposed Development</b> | Fisher German LLP intends to construct a low-rise residential development comprising nine dwellings with associated gardens, estate roads and infrastructure. |

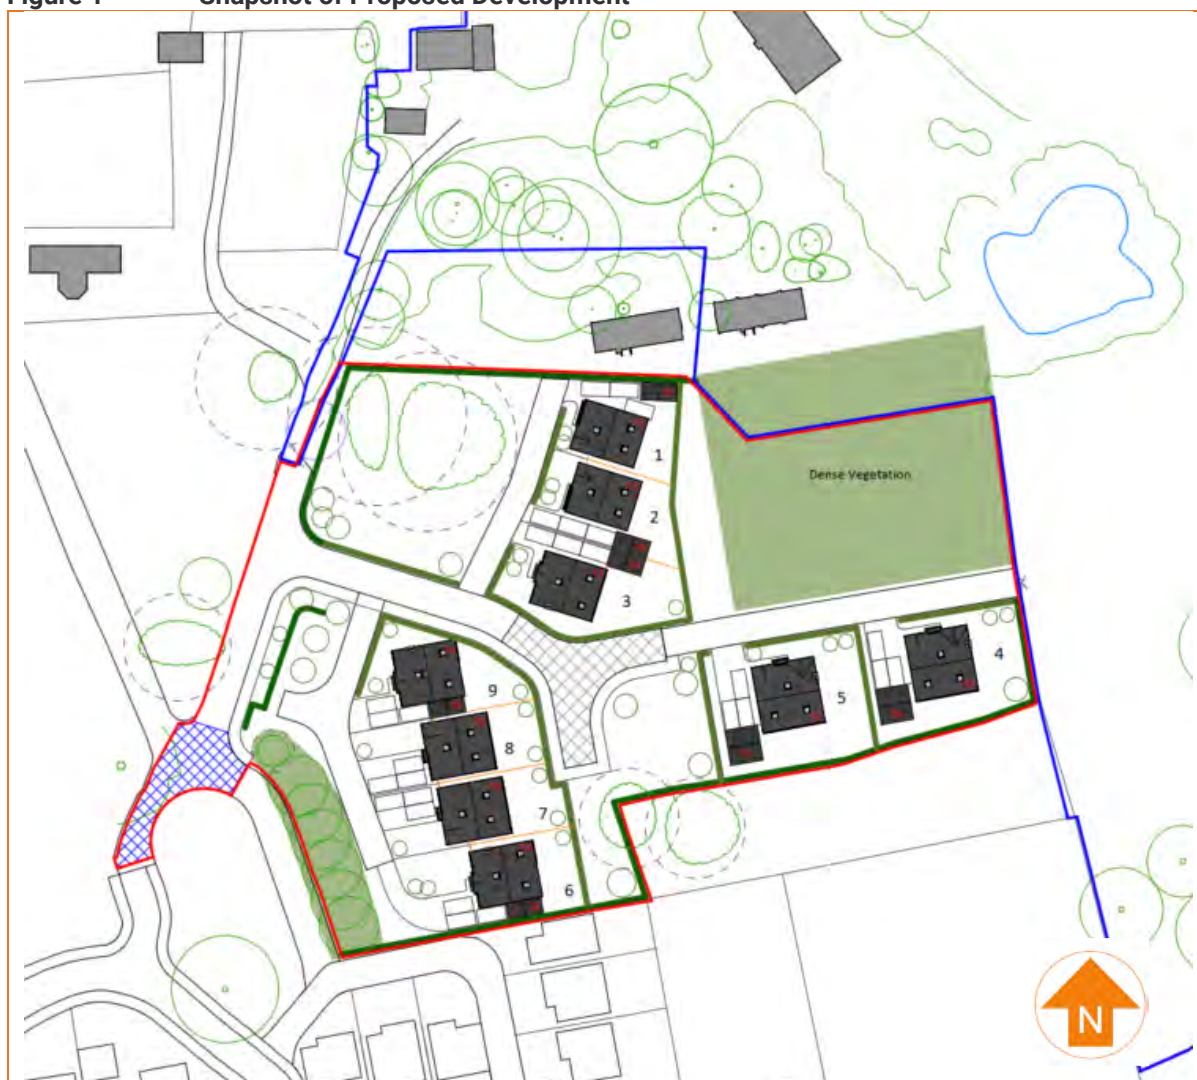
**Figure 1** Snapshot of Proposed Development

A snapshot of the proposed development layout is indicated in Figure 1.

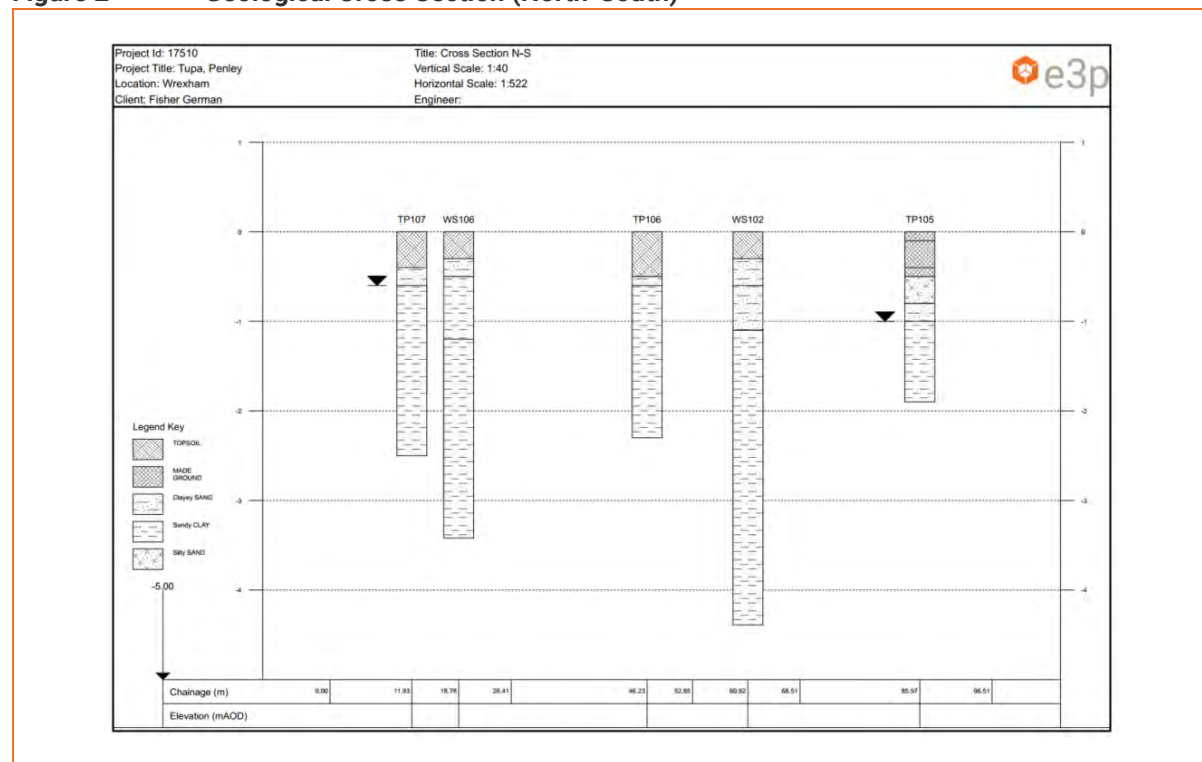
**Figure 2 Geological Cross Section (North-South)**

A geological cross section is included in APPENDIX IV as Drawing 17-510-016a/b, and a snapshot is shown below in Figure 2 and Figure 3.

Deposits within TP105 are believed to be in the position of the former pond feature and comprise reworked silty, sandy clay topsoil above brown sandy gravel of sandstone and brick with cobbles of whole brick identified within the matrix. Between 0.40–0.50 m bgl an organic odour has been noted within the Made Ground deposits.

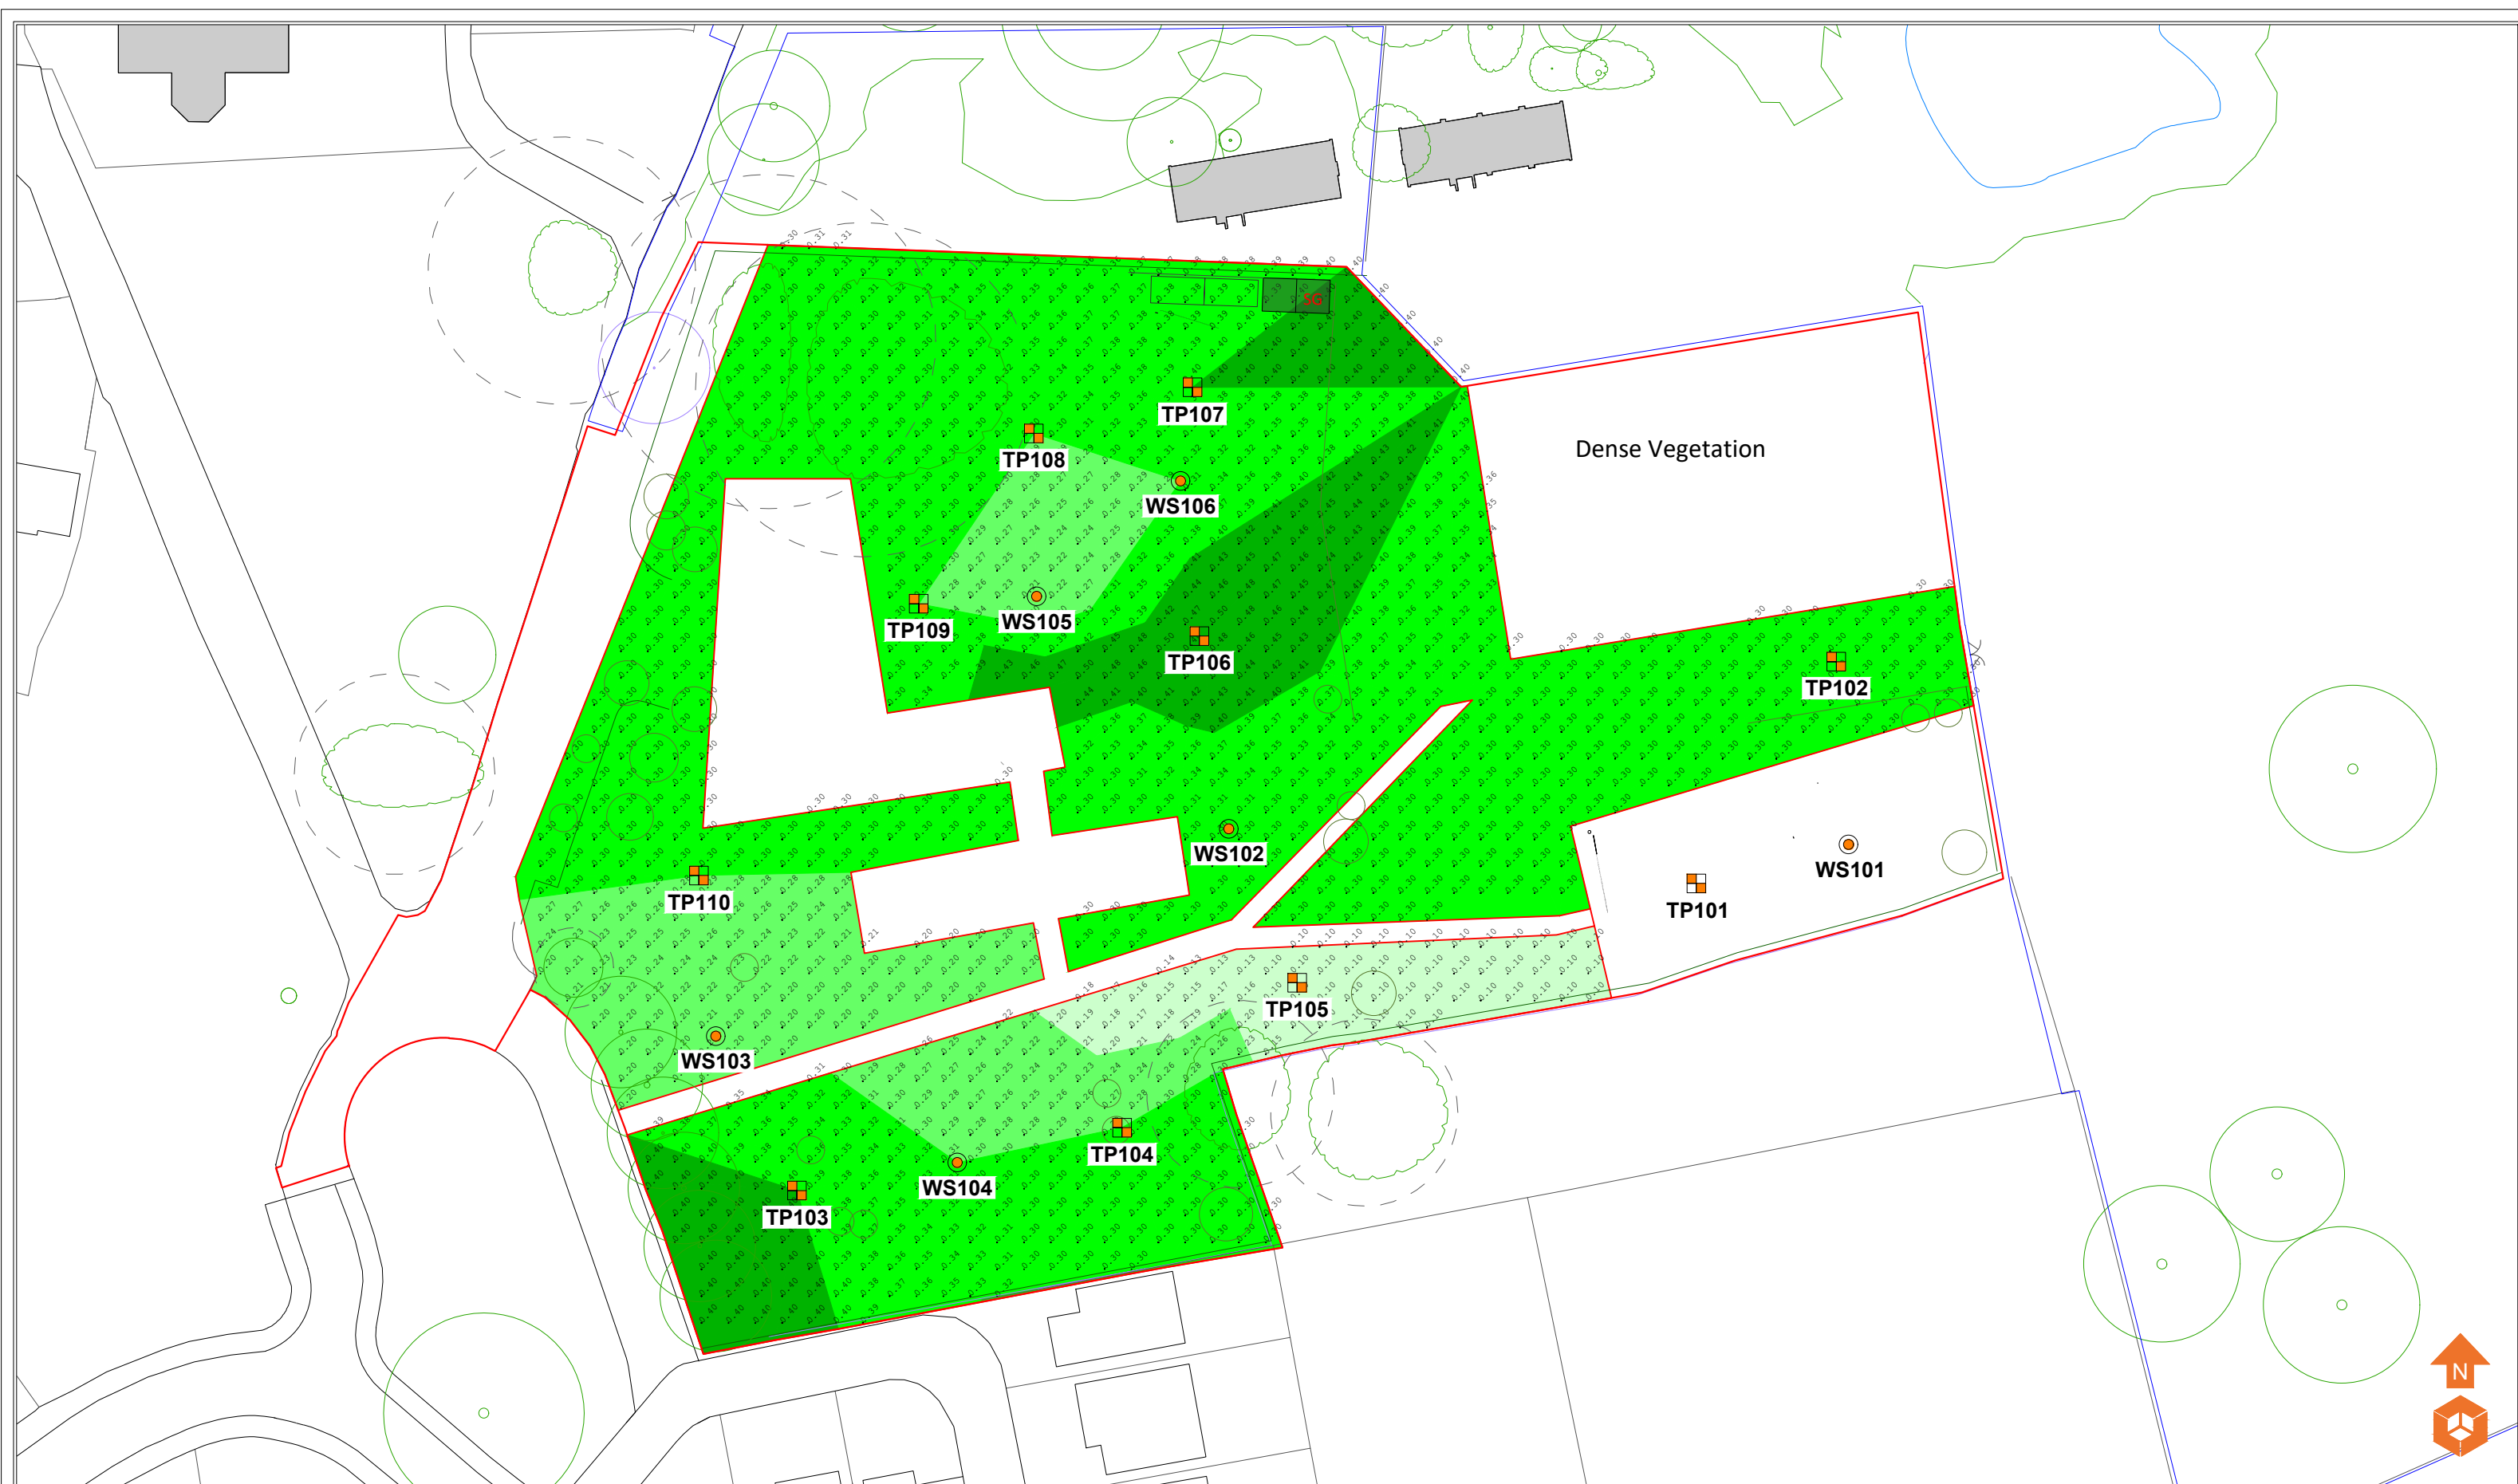
Exploratory Hole Location  
Plan

WS101 Approximate Window Sample Probehole Location (E3P March 2024)

The sampling locations are illustrated in Drawing 17-510-R2-005 (APPENDIX IV). The ground conditions encountered are indicated on the logs, which are provided in APPENDIX VII.

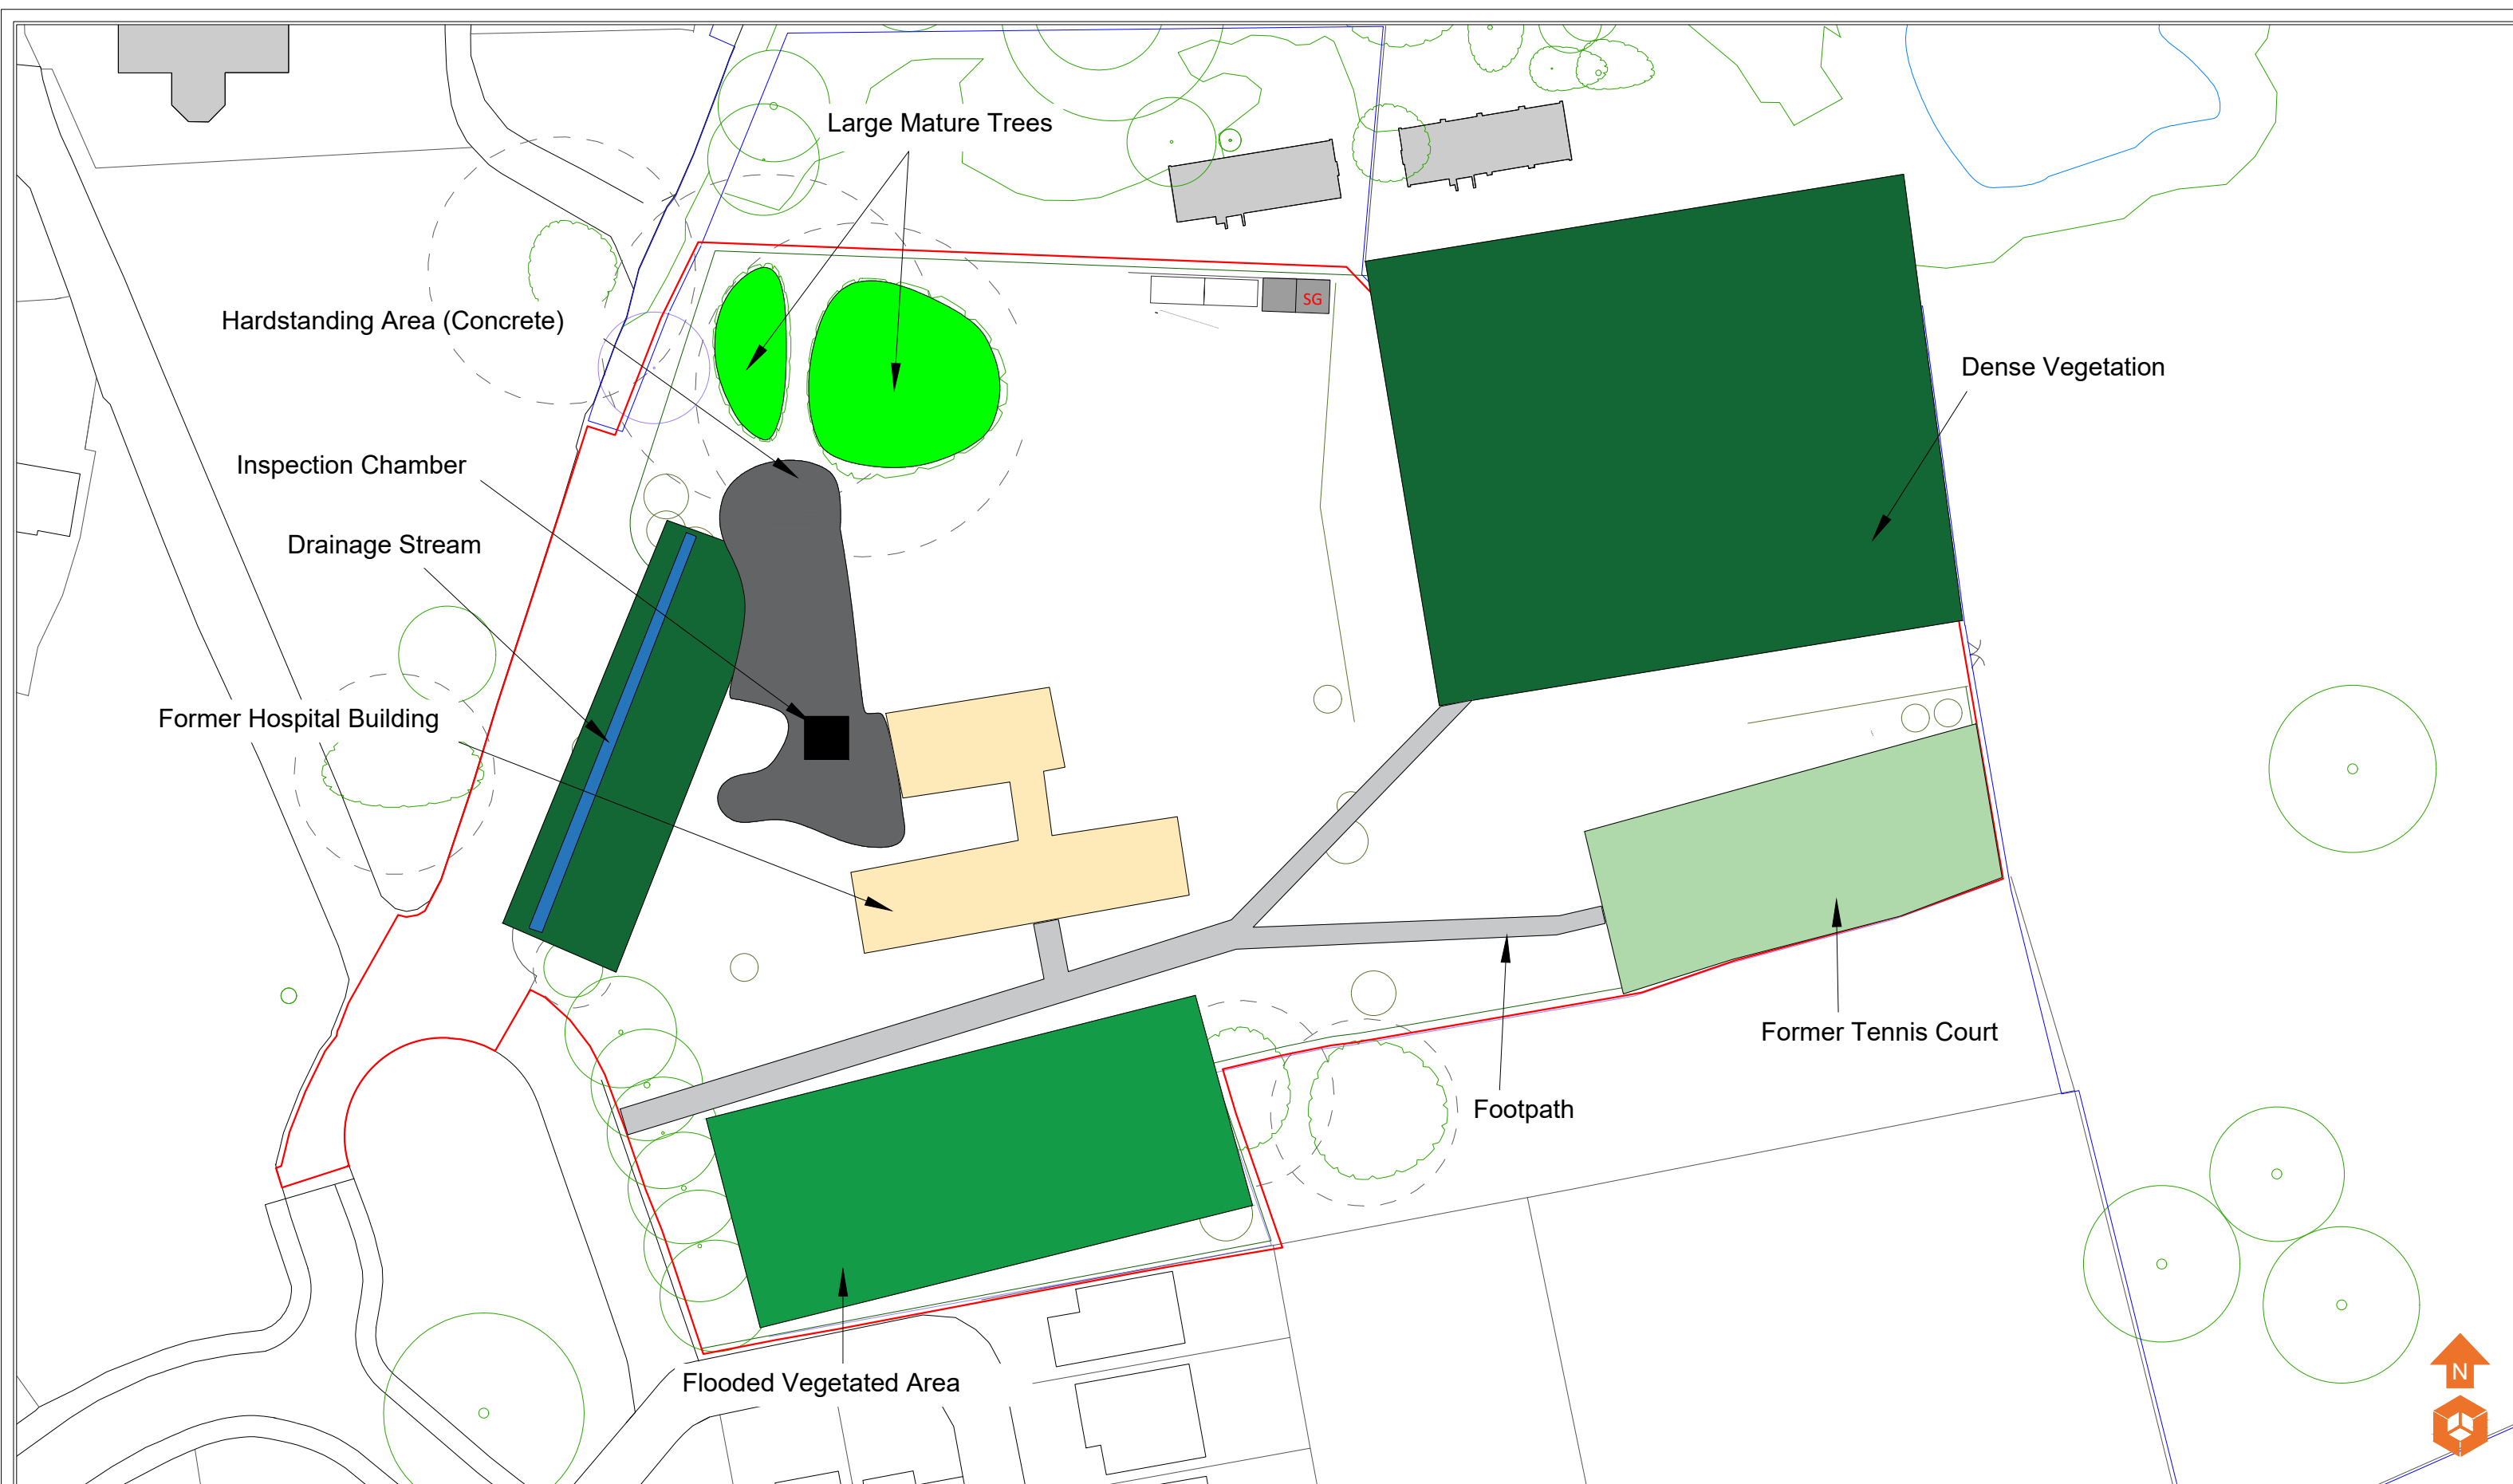
Site Features

- Dense Vegetation
- Former Tennis Court
- Former Hospital Building
- Inspection Chamber
- Flooded Vegetated Area
- Footpath
- Hardstanding Area (Concrete)
- Large Mature Trees

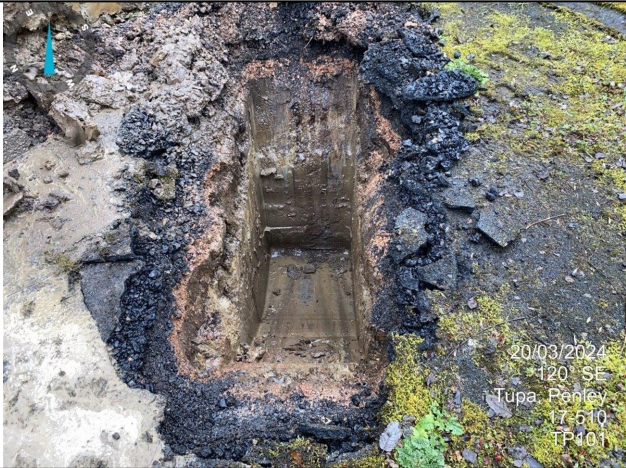
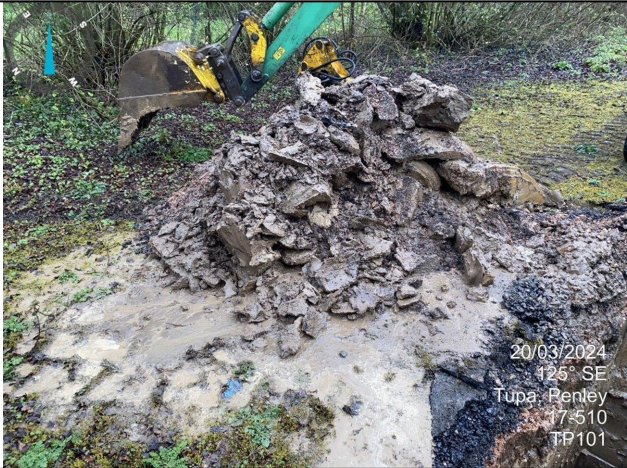
| Remarks: 1. Complete. 2. Water strike noted as moderate ingress at 0.30 m bgl. 3. W3W: bonnet.severe.ensemble | | | | | | | | | |

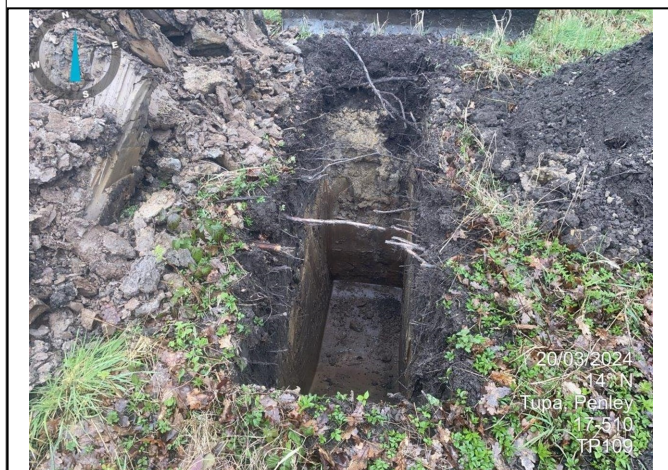
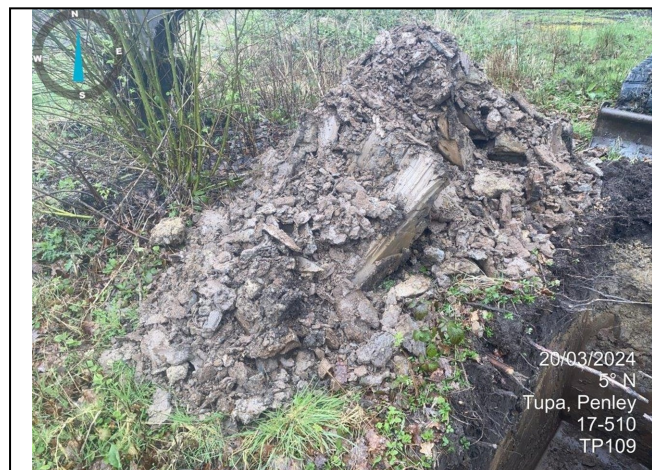
TP109 - Excavation

Remarks: 1. Complete. 2. Water strike noted as slow ingress at 0.30 m bgl. 3. W3W: mysteries.rising.beaks
