## GEOENVIRONMENTAL ASSESSMENT AND GROUND INVESTIGATION

**PROPOSED COMMUNITY HUB, THE GREEN, ROSSETT LL12 0EY**

**6<sup>TH</sup> MARCH 2023**

**C. Eccles - Brownfield Engineering Consultancy**

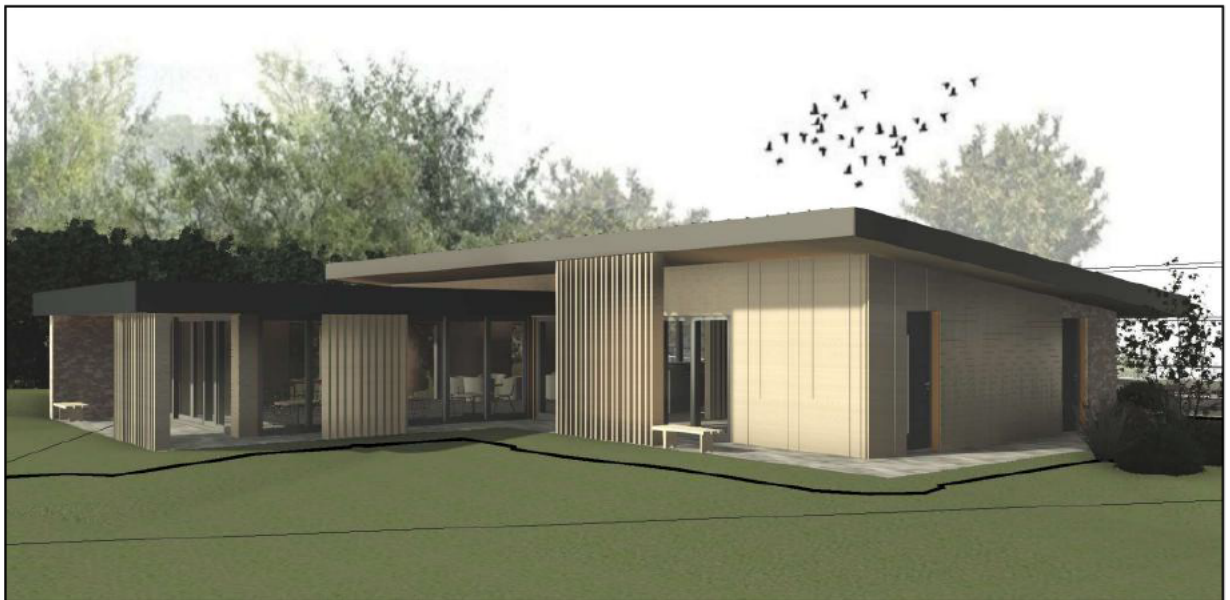
It is understood that the proposed development comprises the construction of a single storey lightly loaded building for use as a community space. The building will have a “green roof” system and requires a “rain garden” /soakaway drainage.

development (Taken from JAR Architecture drawings provided by Engineering Assist Ltd)

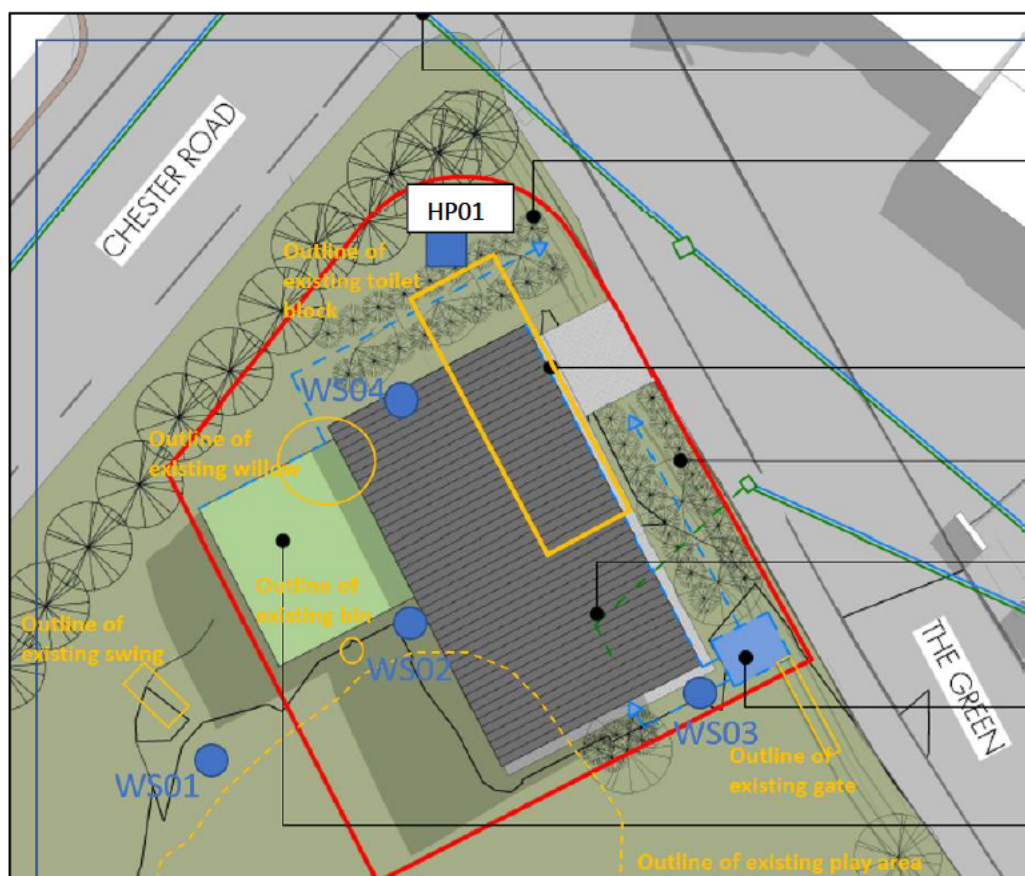
Figure 4: Exploratory Hole Location Plan

The location of the exploratory holes was decided on site by C Eccles Brownfield Engineering Consultancy to give a spread of positions around the new building in areas clear of current underground services, and to investigate the areas proposed for soakaway drainage. The purpose of the holes was to prove the thickness of the made ground, describe the underlying natural strata, collect samples for contamination testing and undertake infiltration tests at approximate soakaway formation depths.

The depths of exploratory holes, descriptions of strata encountered and comments on groundwater conditions are described in Section 4. The trial pit logs are presented in Appendix II. The borehole positions together with existing and proposed site features are shown in Figure 4.

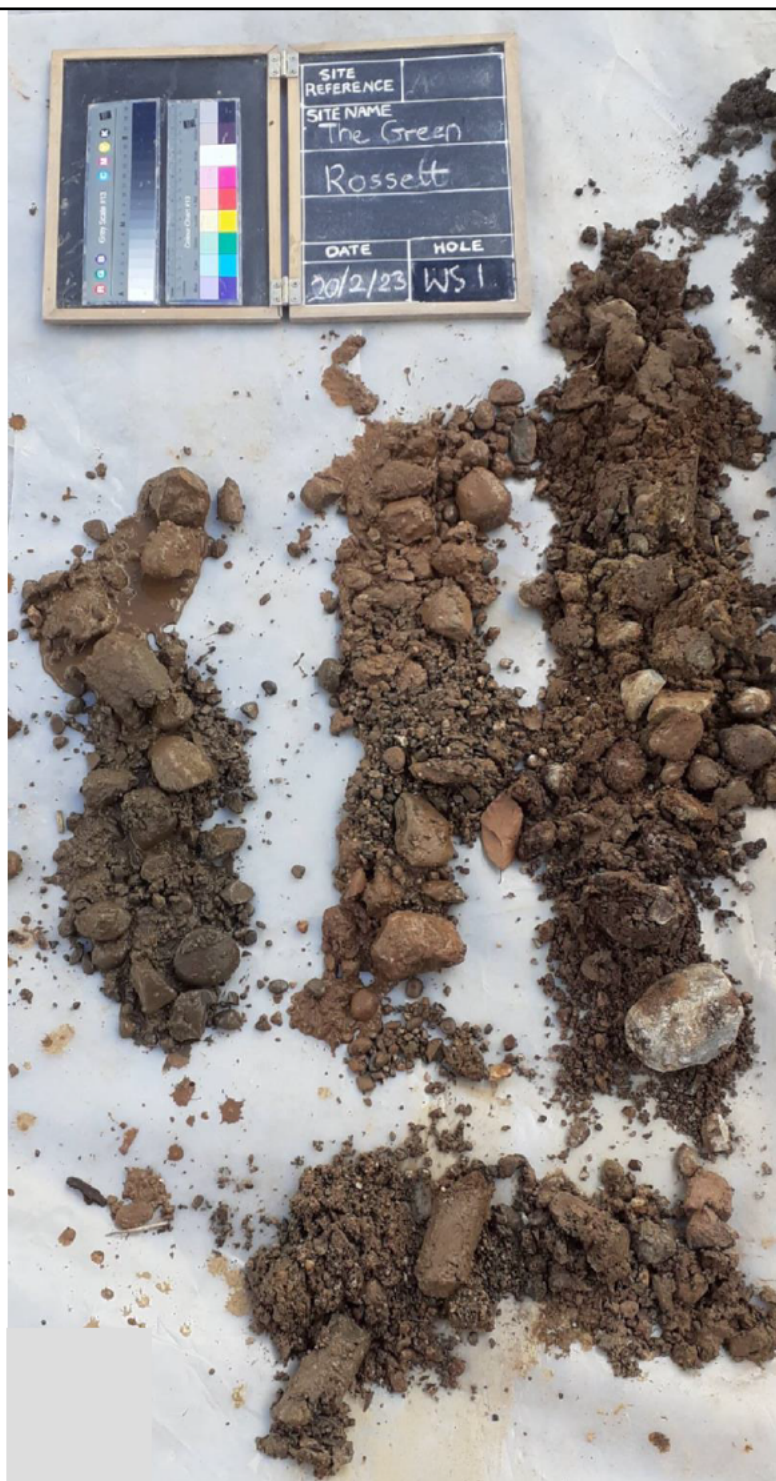
Photograph

| Description of Strata | Depth (m) | Samples | Water | Legend | Run /Recovery N Value |
|---|---|---|---|---|---|
| MADE GROUND: Grass onto dark brown slightly gravelly fine to coarse SAND. Gravel is rounded quartz and sandstone and angular brick. Occasional rootlets. (TOPSOIL) | 0.30 | | | | Hand Excavated Pit<br>GL to 1.0m |
| Loose becoming dense orangish brown and brown sandy fine to coarse GRAVEL with low cobble content. Gravel and cobbles are rounded sandstone and quartz with rare dolerite. | | | | | SPT 1.00-1.45m: 1,2,1,2,1,2<br>N=6 |
| ....From 0.80m: slightly clayey | | | | | Run 1<br>1.0m to 2.0m<br>100% REC |

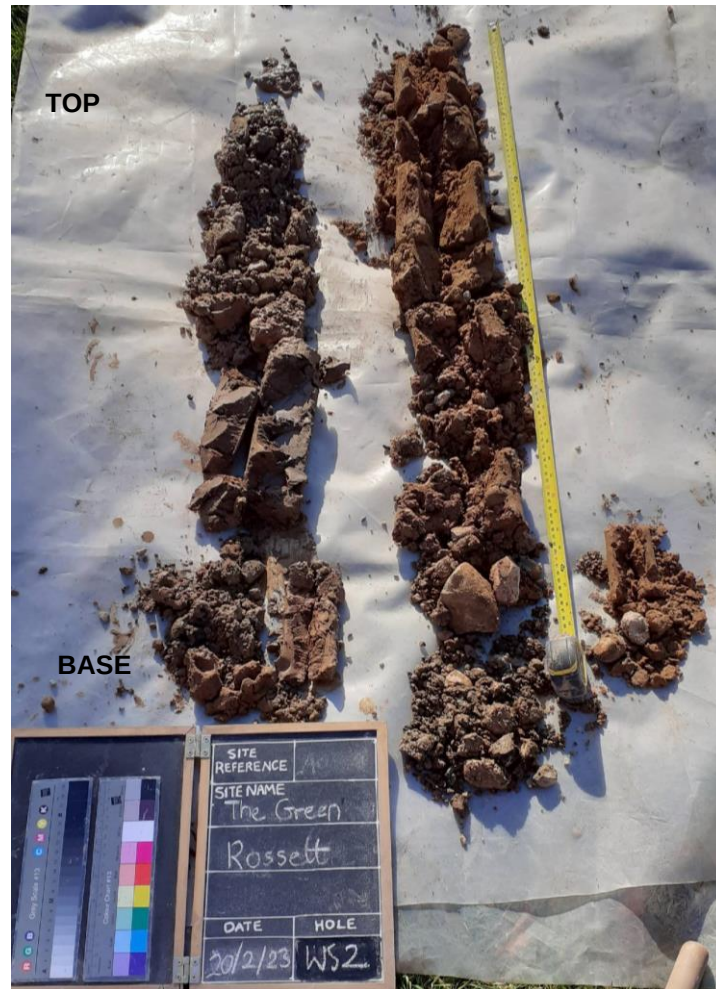
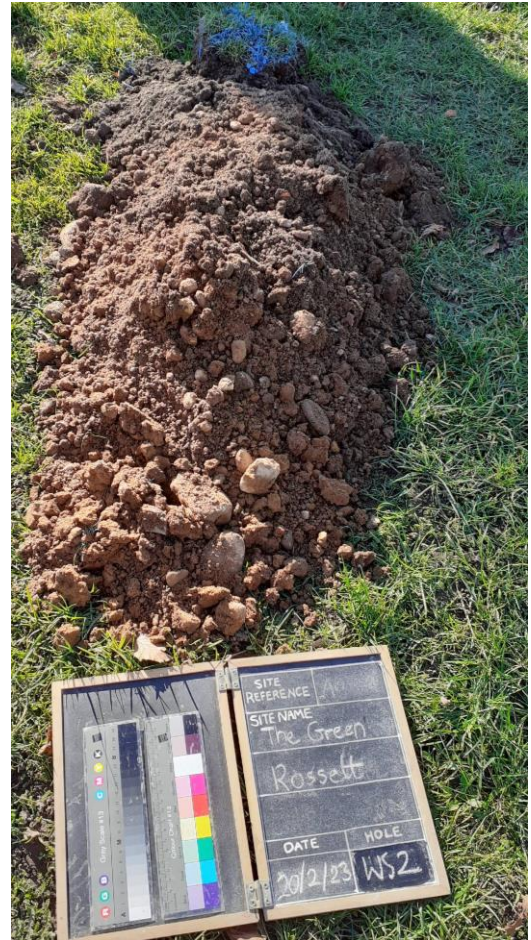
Photograph

| Description of Strata | Depth (m) | Samples | Water | Legend | Run /Recovery N Value | | | | |
|---|---|---|---|---|---|---|---|---|---|
| Loose orangish brown and brown slightly clayey silty gravelly SAND. Gravel is rounded sandstone and quartz.<br><br>....From 0.80m: clayey | 1.60 | | | | | | | | |

| | Run 2<br>2.00-3.00<br>SPT<br>3.00-3.45 | Run 1<br>1.00to 2.00<br>SPT<br>2.00-2.45 | SPT<br>1.00-1.45 | Hand Dug Pit<br>0.00-1.00 |

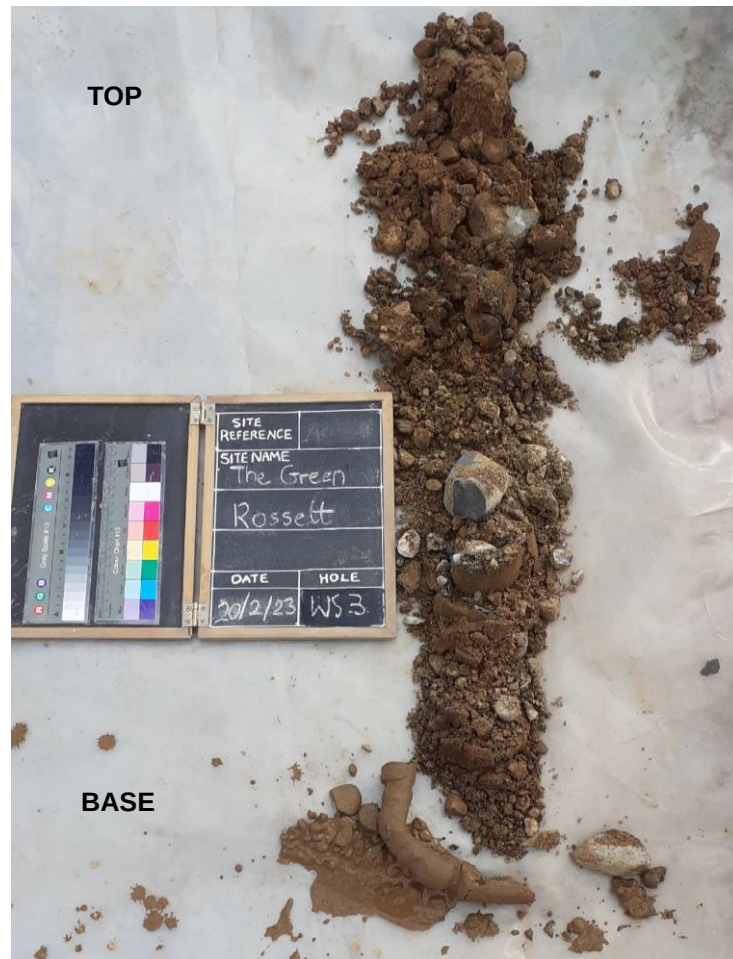
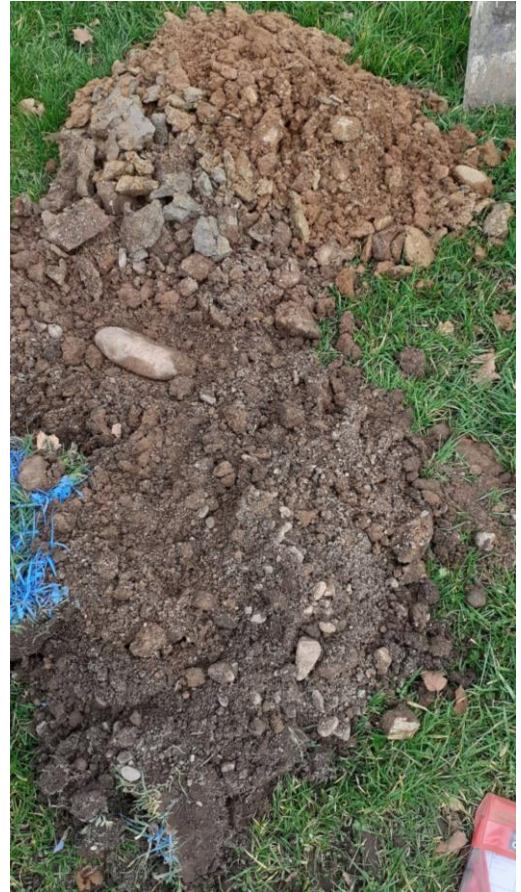
Photograph

| | Run 2<br>No Recovery<br>SPT<br>3.00-3.45 | Run 1<br>1.00to 2.00<br>SPT<br>2.00-2.45 No Recovery | SPT<br>1.00-1.45 | Hand Dug Pit<br>0.00-1.00 |

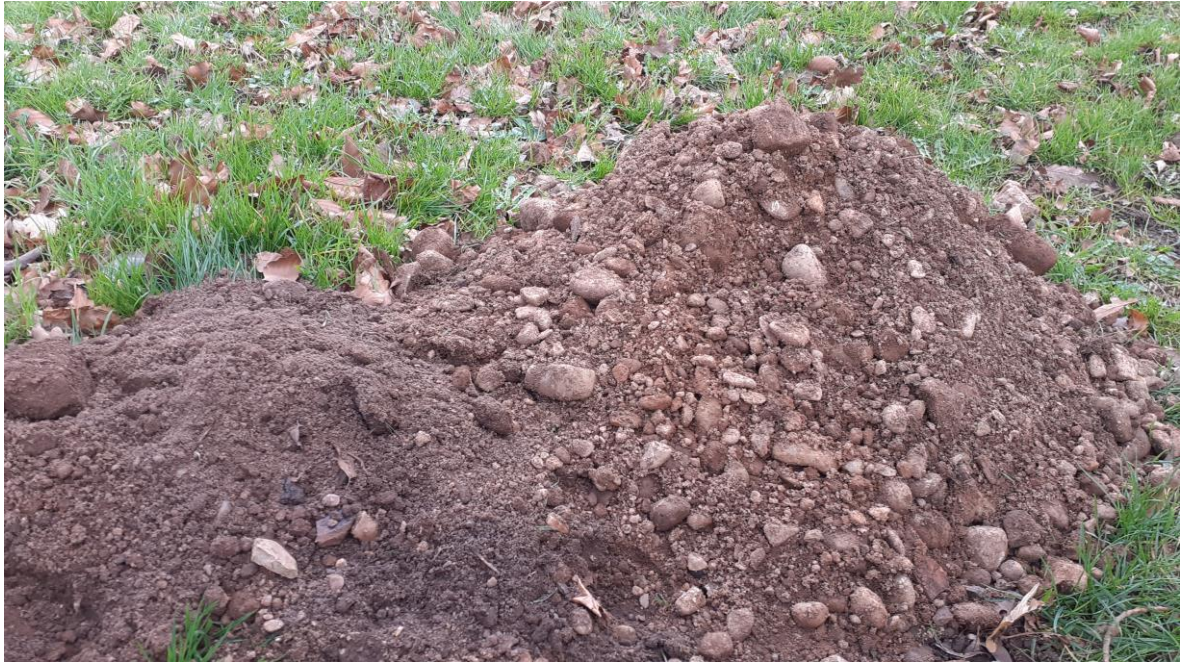
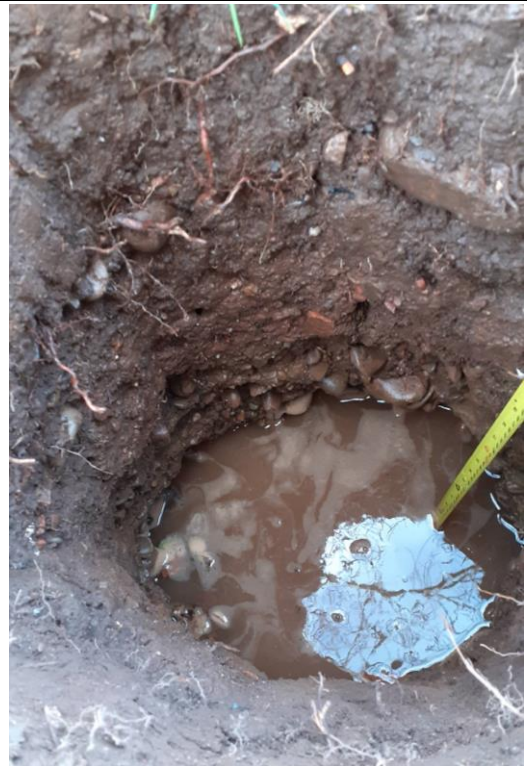
## Photograph

Infiltration test undertaken in hand dug pit 0.30m x 0.30m x 1.00m deep. 20L of water added x 3 tests.

**0.00-0.40m**

**0.40m – 1.00m**

Orangish brown and brown very sandy fine to coarse GRAVEL with low cobble content. Gravel and cobbles are rounded sandstone and quartz.
