# LIFEDeeRiver

LIFE18 NAT/UK/000743

## Erbistock Weir

Final Report

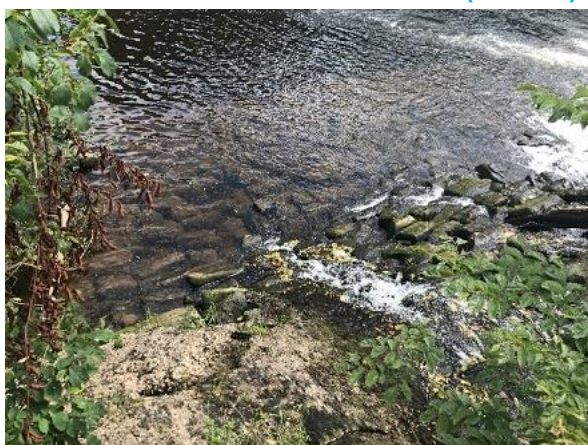
Plate 8-11. LHB side and bottom end of weir, showing dilapidation

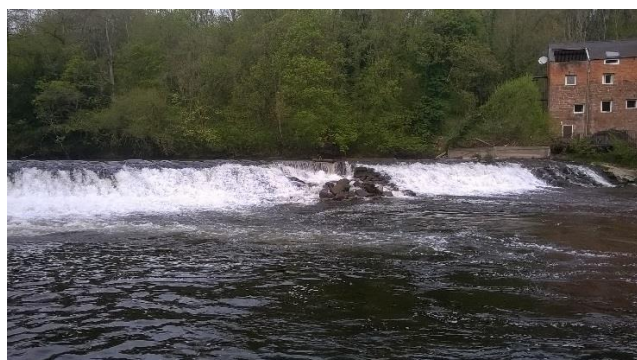
Plate 8-28. Poor condition of the weir including the collapsed section, looking from the RHB downstream of the weir

Following the site visit some photos of the weir were provided to us by NRW, taken when the flow was diverted away from the right-hand bank side of the structure. Some of these are provided in Plates 8-26 to 8-29, and show that much of the weir and existing fish pass are in a poor condition.

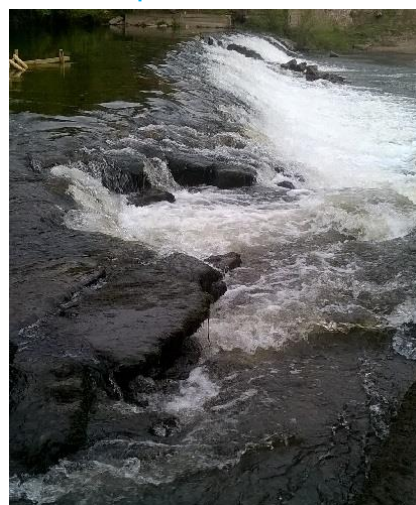
Plate 8-29. Poor condition of the structure, looking across the weir from RHB concrete apron

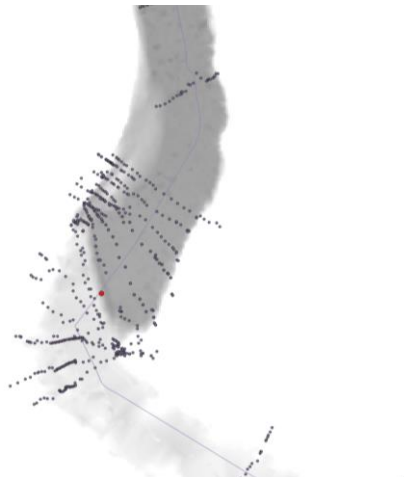
**Figure 4-1. Topographic data xyz locations for Erbistock weir (true locations)**

Surveyed points around the weir itself are indicated in Figure 4-1 below, which shows a reasonable coverage with some gaps in the central weir, which could not be surveyed safely. All surveyed river points are shown in Figure 4-2 below along with an indication of the difference between the measured levels and that in LiDAR data. This shows quite stark differences, particularly upstream of the weir showing the survey depths to be 2m or more deeper than represented in the LiDAR (ultimately showing the benefit of undertaking topographic surveys).
