# **Reasonable Avoidance Measures in relation to Great Crested Newts (GCN)**

DMH TYRES LTD

Unit 1, Miners Road, Llay Industrial Estate, LL12 0PJ

**Planning Permission Reference no: P/2023/0292**

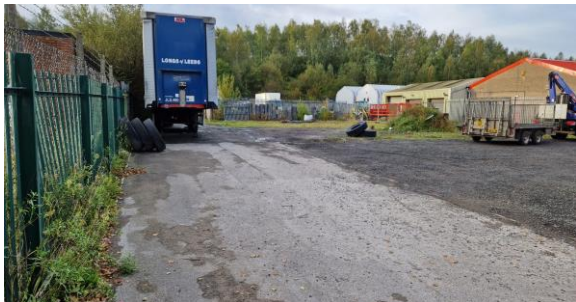
1. Looking due South from existing entrance

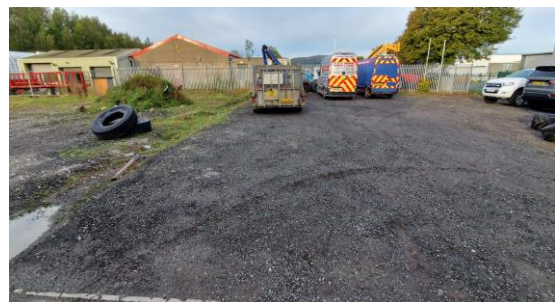
2. Looking west from existing entrance

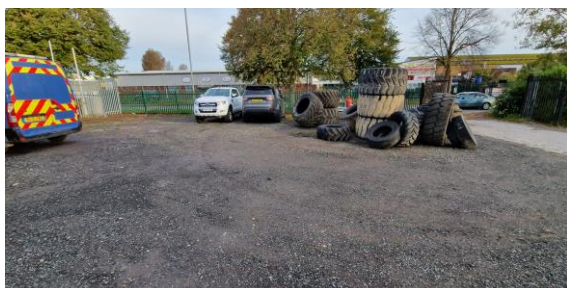
3. Looking at N'thern boundary & existing access  
Onto Miners Rd

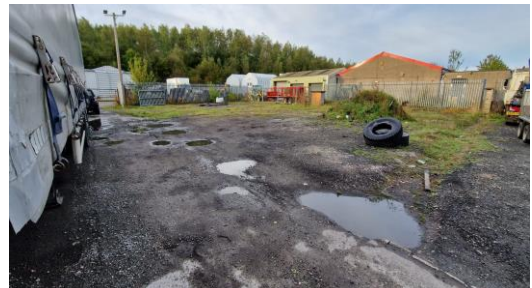
4. Looking South from within site

As very recent photographs show above, the site is all existing hard-standing but in various formats and conditions. Vegetation is established along the edges and un-used areas but other than parked vehicles, pallets with tyres on and one pile of vegetated spoil which can just be seen in the 4<sup>th</sup> photograph, there are no other features or structures within the proposed development area.

The vegetation around the boundary will be manually searched by a licenced ecologist prior to any work taking place, this also applies to the removal of the pallets and tyres. The vegetated spoil heap is very compacted and compressed and does not represent refuge or hibernation potential. Any animals found during searches can be dealt with by the ecologist who will take them to safety.

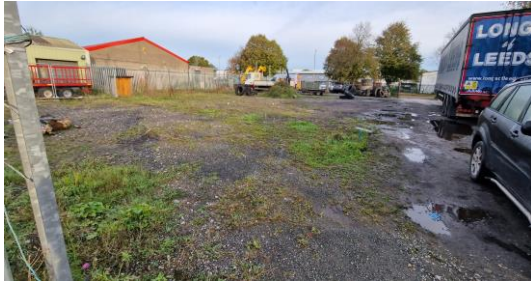
5. Looking North from Southern boundary

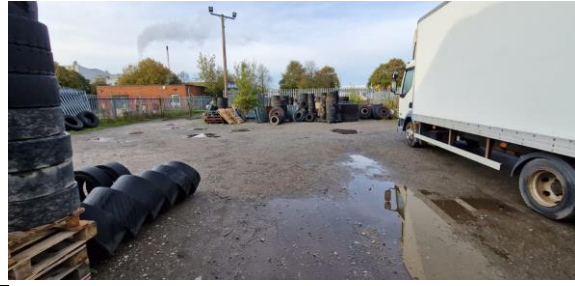
6. Southern yard looking North showing barren ground between good habitat & development plot.

To the south of the development area is an area of land owned by DMH Tyres but leased to another business. This land is not going to be developed and is currently bare hardcore as shown in picture 6.

With the neighbouring area of barren yard to the south of the development providing a barrier between the good habitat and the development plot, it is unlikely that GCN will traverse this to reach the development area. This land will not be used to store construction materials on, unless they are on pallets. Loose spoil and stone will not be stored in this area.

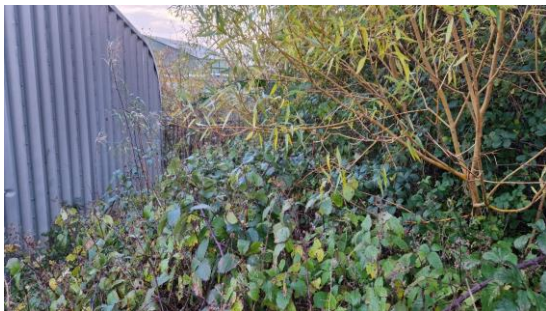
7. Scrub encroaching on to grassland in Proposed mitigation area.

Area of scrub  
shown in photo 7

- The grassy bank which is north-facing, would benefit from some bare earth patches to encourage insect use and prevent uniform succession.
- Along the southern edge of the leased site it is recommended that a purpose-built hibernacula be constructed at a mutually agreeable location so it will not be disturbed by industrial operations, but still allow DMH to utilise some of this area for its existing use. (leased to third party)
- It is recommended that 50% of the grassland be cut and raked annually from the bank to maintain the species rich grassland, thus providing a wider range of habitat options for a range of wildlife, not just GCN.

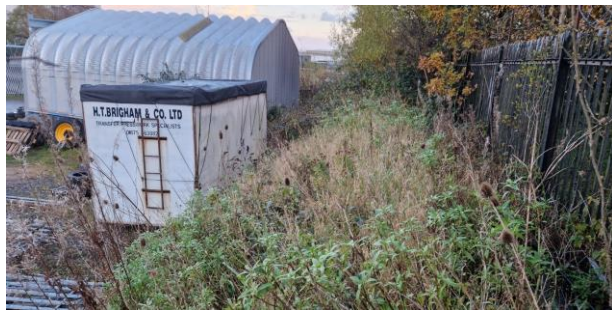
8. Vegetated bank on Southern boundary of leased Yard, to be used as mitigation area.

Existing grassy bank shown  
in photo 8

To adhere to the Planning Policies listed above in section 1, the developer must show that there is an element of biodiversity net-gain or biodiversity benefit as a result of undertaking the development. The already vegetated bank at the south end of the site, in ownership of DMH Tyres Ltd, which is likely to already be used by GCN and other wildlife as a corridor for dispersal, will be developed further to provide this net-gain.

- No evidence of Skipper butterflies was identified during the survey but one of their food sources – Bird's foot trefoil, was found to be growing. It is recommended that some of this plant be translocated to the proposed mitigation area to create Skipper habitat along the base of the bank.
