*Client – Shirley Hughes*

*Site – Pines*

*Reference – 20230091-PRA*

## ***Preliminary Roost Assessment (PRA)***

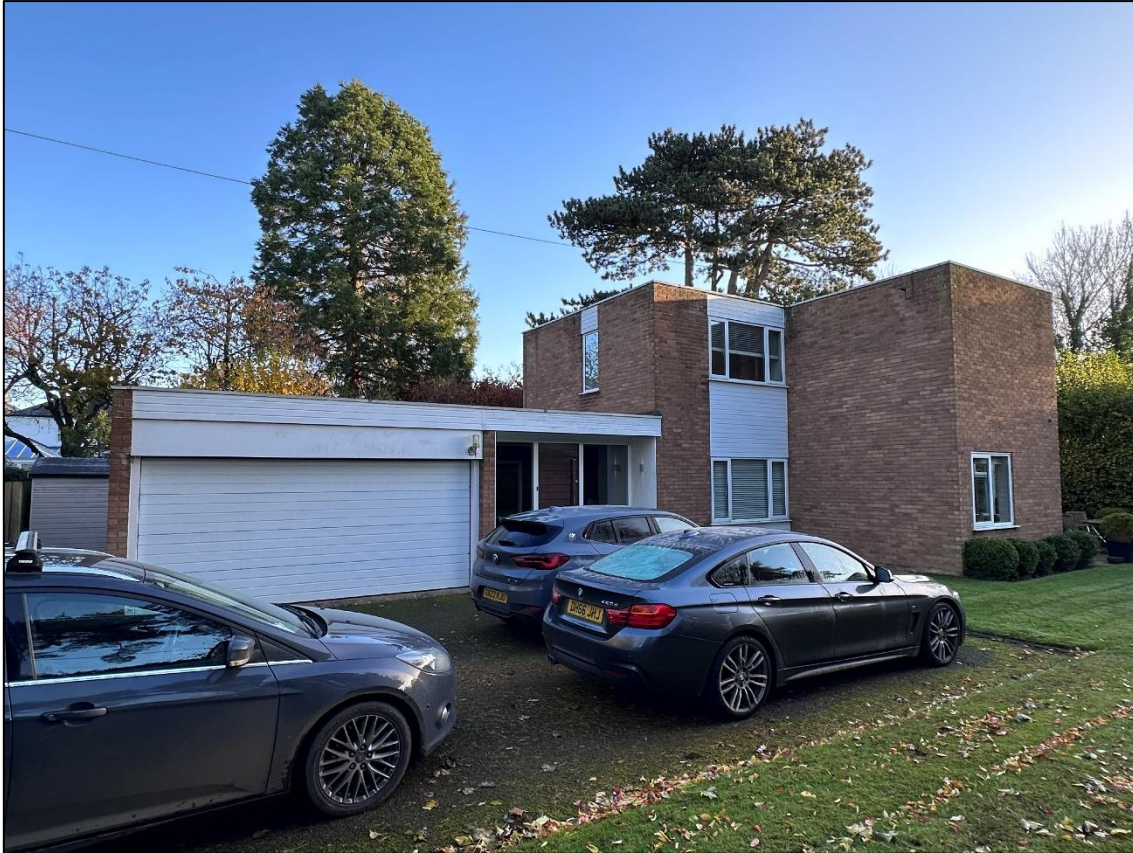
2.2.2. The building comprises a predominantly two-storey residential dwelling with a single storey area and uPVC conservatory on its southeast elevation and a single storey garage on its northwest elevation.

2.2.3. The walls of the building comprise brick cavity walls with uPVC windows and doors throughout and areas of decorative uPVC cladding.

*Figure 2: The building viewed from the west.*

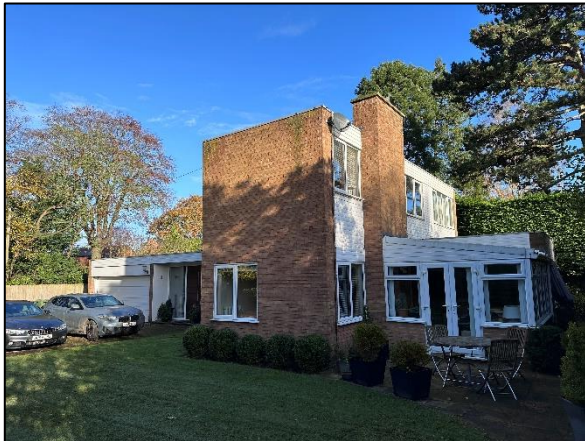
*Figure 3: The building viewed from the southwest.*

4.2.1. The walls of the building were generally found to be in a good condition with no major cracks or voids in the brickwork and the windows and doors intact and sealed.

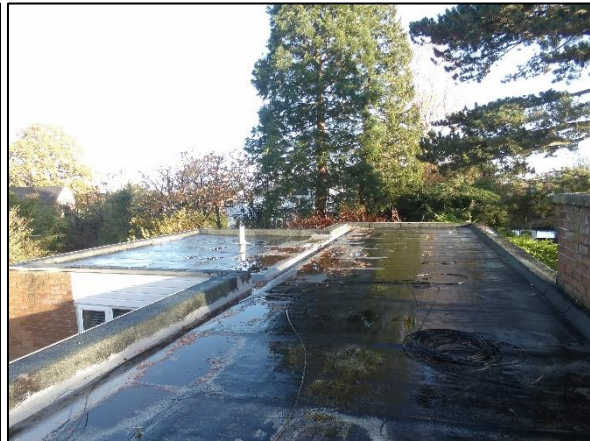
2.2.4. The roof of the building comprises flat felt covered roofs over the main property and garage and a sloping polycarbonate roof over the conservatory.

*Figure 4: The roof of the building.*

4.2.7. The roof of the building was found to be completely unsuitable for roosting bats with the only voids present being voids underneath the metal edging of the roof. These voids were inspected and found to be shallow, providing negligible potential for roosting bats.

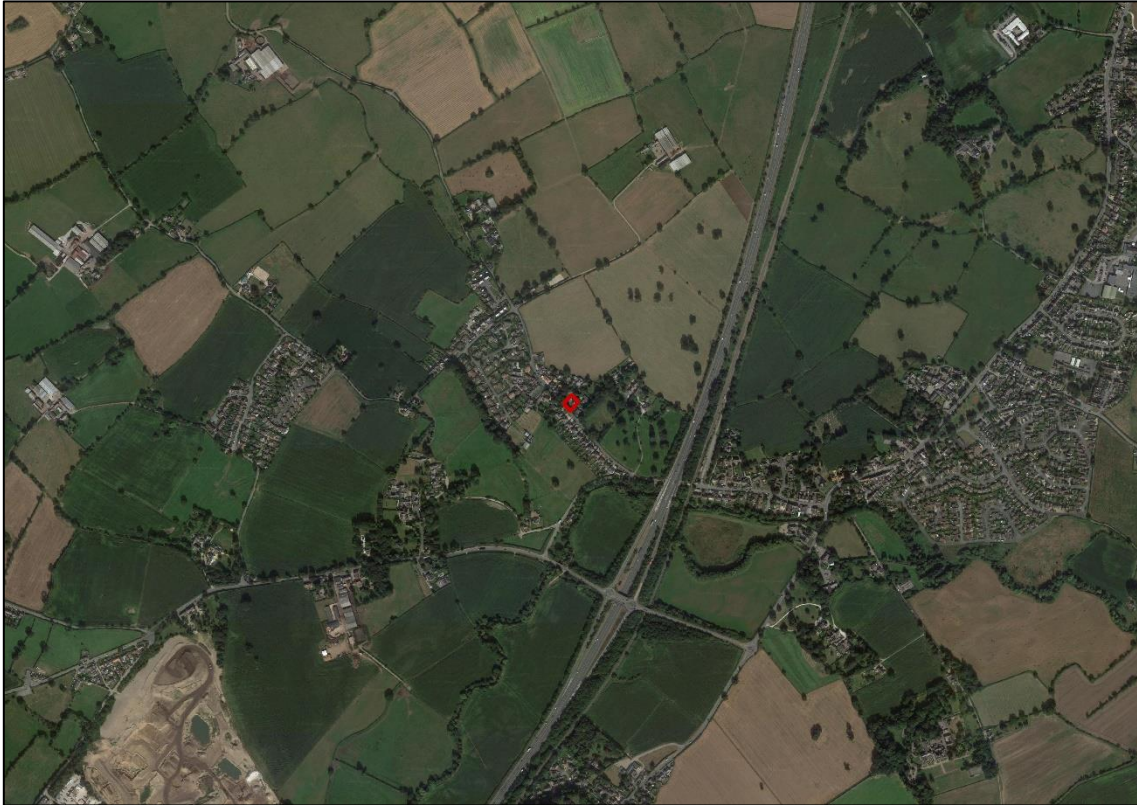
2.2.6. The land immediately surrounding the property comprises further residential properties surrounded by established gardens and tree lines to the north, east and south with Burton Road to the west, with further residential properties beyond.

2.2.7. The wider surrounding area comprises a mixture of open farmland and small pockets of urban land with the A483 running north to south through the area. The village of Rossett is located 750m to the east, on the opposite side of the A483.

*Figure 5: Showing the building in context with the wider surrounding area.*

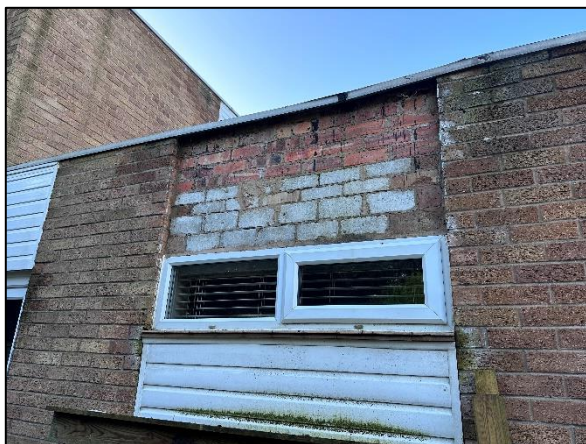
4.2.2. To the rear of the garage an area of missing uPVC cladding was identified, exposing the brickwork behind. The area was inspected and no significant cracks or voids that would provide opportunities for bats were present.

Figure 6: Missing uPVC cladding to the rear of the garage.

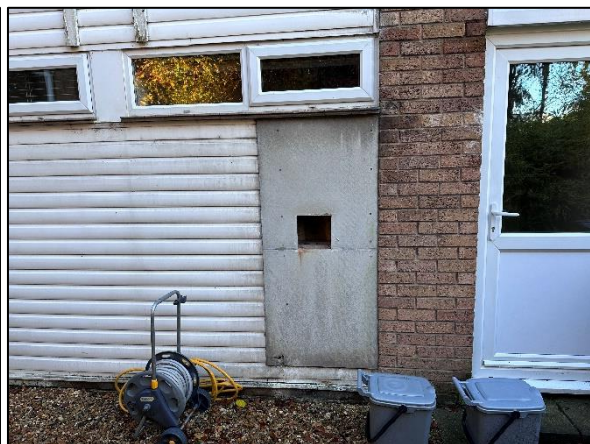
4.2.3. Two further holes were identified in areas of uPVC cladding to the rear of the building. One comprised a square hole adjacent to the rear door of the property located at a height of approximately 1m. The hole extended through the wall due to something, potentially an old vent, having previously been fitted in the location.

Figure 7: Holes adjacent to the rear door.

4.2.4. The hole was thoroughly inspected with an endoscope and was identified to comprise a hole through the concrete blocks of the wall with no significant voids or direct access to the cavity present. No field signs were identified within the void to imply use by bats.

5.1.2. It is recommended that works on the building commence with care, particularly in the area of the voids to the rear of the building. In the event that any bats or bat field signs are encountered it is recommended that all works on the building cease and further advice is sought.

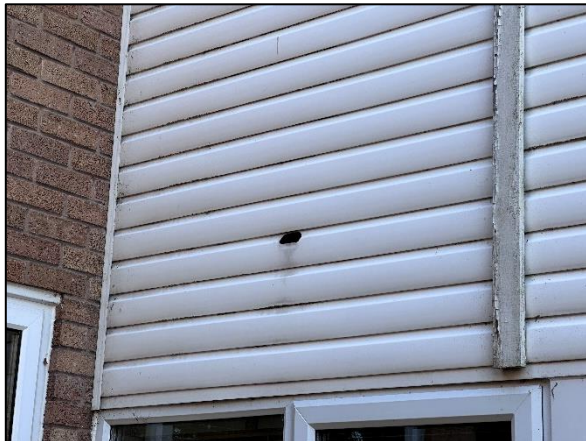
4.2.5. The other hole comprised a small hole in the uPVC cladding. The hole opened into a void in the brickwork with an old nest, anecdotally reported by the owner as a robin (*Erithacus rubecula*) nest, present in the void. A thorough inspection of the void was carried out and no bats or other bat field signs were identified.

Figure 8: The holes in the uPVC cladding.

4.2.13. An old nest, anecdotally reported to be a robin nest, was identified in one of the voids on the rear of the building, showing that birds have previously nested in the building. The nest showed no signs of fresh material to imply nesting in the recent season, which fits with the owners reports that the nest was occupied several years ago.

4.2.14. The voids in the building provide nesting opportunities for several species of bird. Therefore, if the renovation works commence during the nesting season, which extends from March to September each year, the works may have an impact on nesting birds, if they are present in the building at that time.

5.1.5. It is recommended that any works that commence on the building during the nesting season, which extends from March to September each year, are immediately preceded by a thorough nesting bird survey, carried out by a suitably experienced surveyor. Any nests identified must remain undisturbed until the young have fledged from the nest.

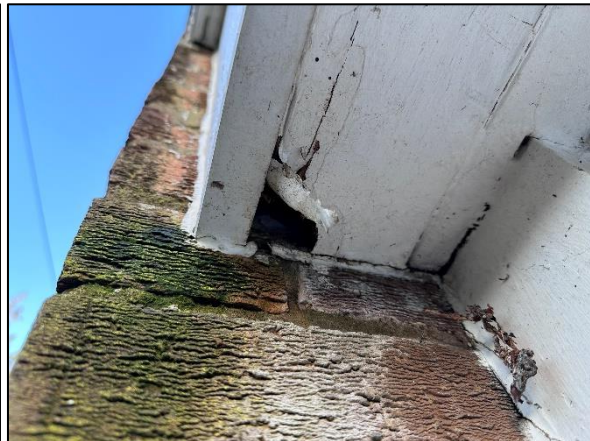
Figure 9: The hole in the soffit over the garage door.

4.2.6. A further small void was identified in the corner of the boxed soffit over the garage door. The void was inspected and the cavity was found to be densely covered with cobwebs, implying nothing had entered the hole, with no bat field signs identified.
