**BAT SCOPING & BAT PRESENCE / ABSENCE SURVEY**

**Bridgeway Centre**

Bridge Road  
Wrexham  
LL13 9QS

Date: 23<sup>rd</sup> November 2023  
UES reference: UES03012/12

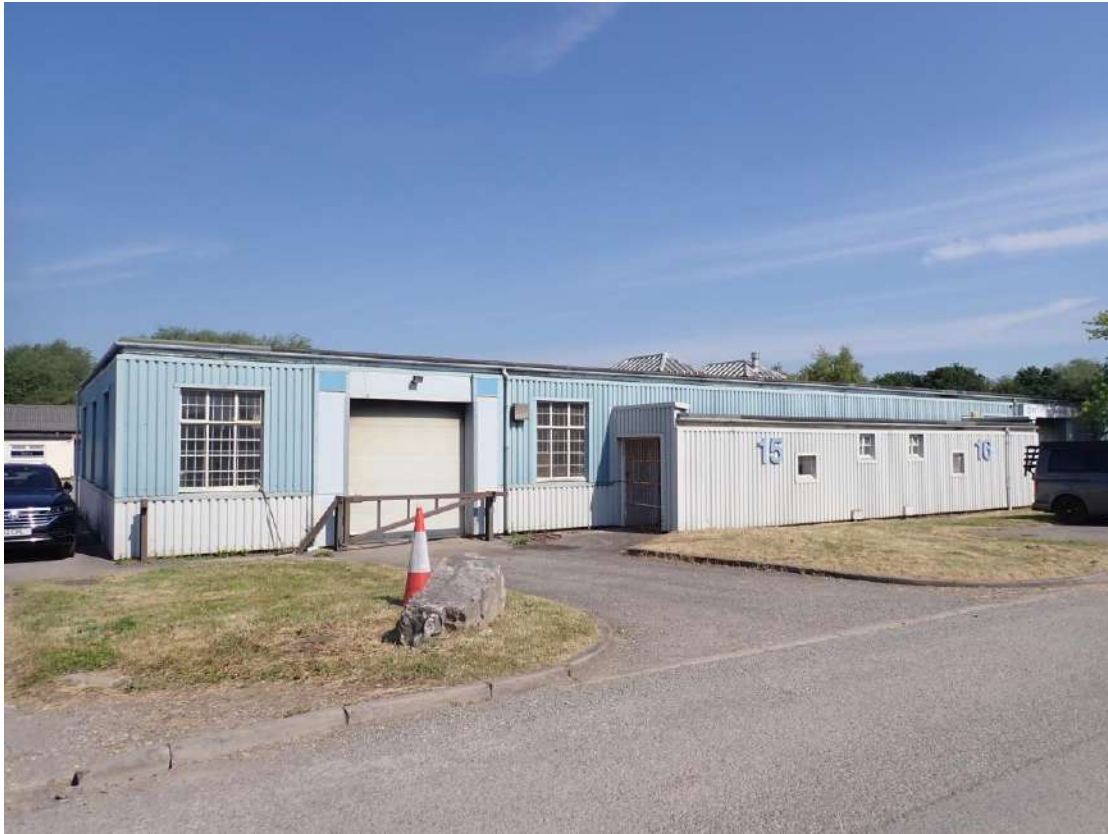
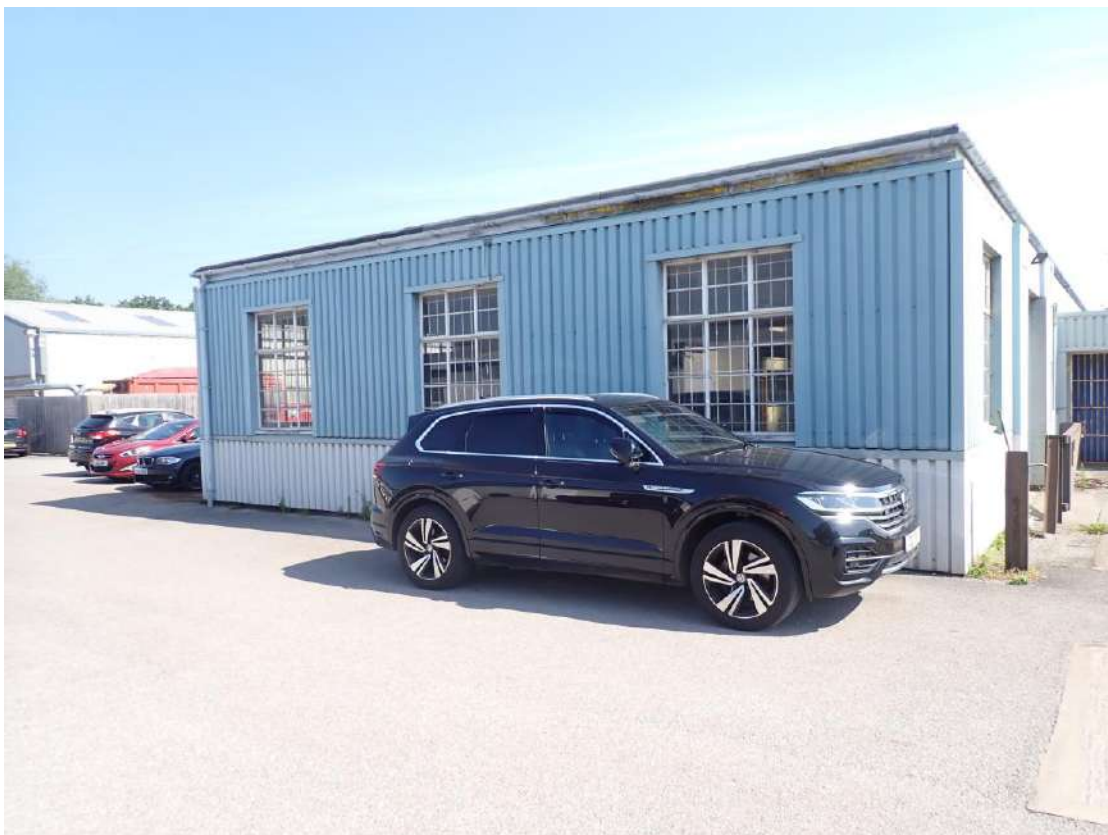
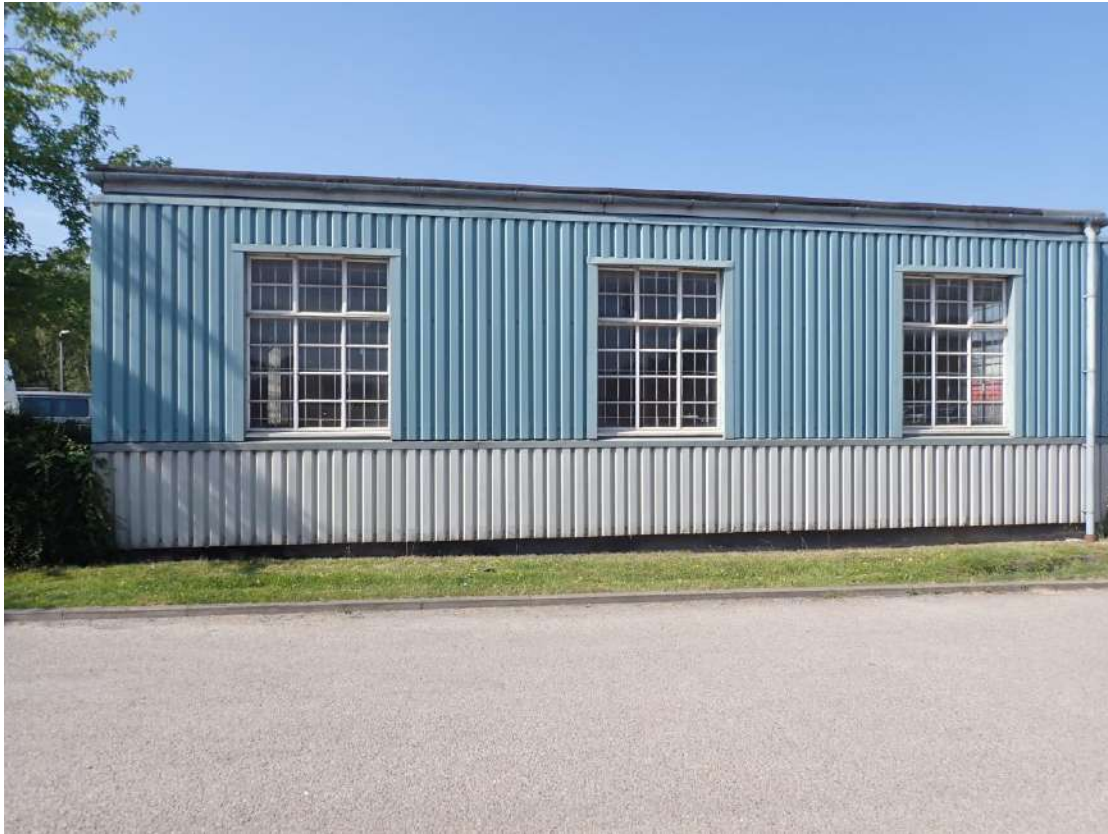
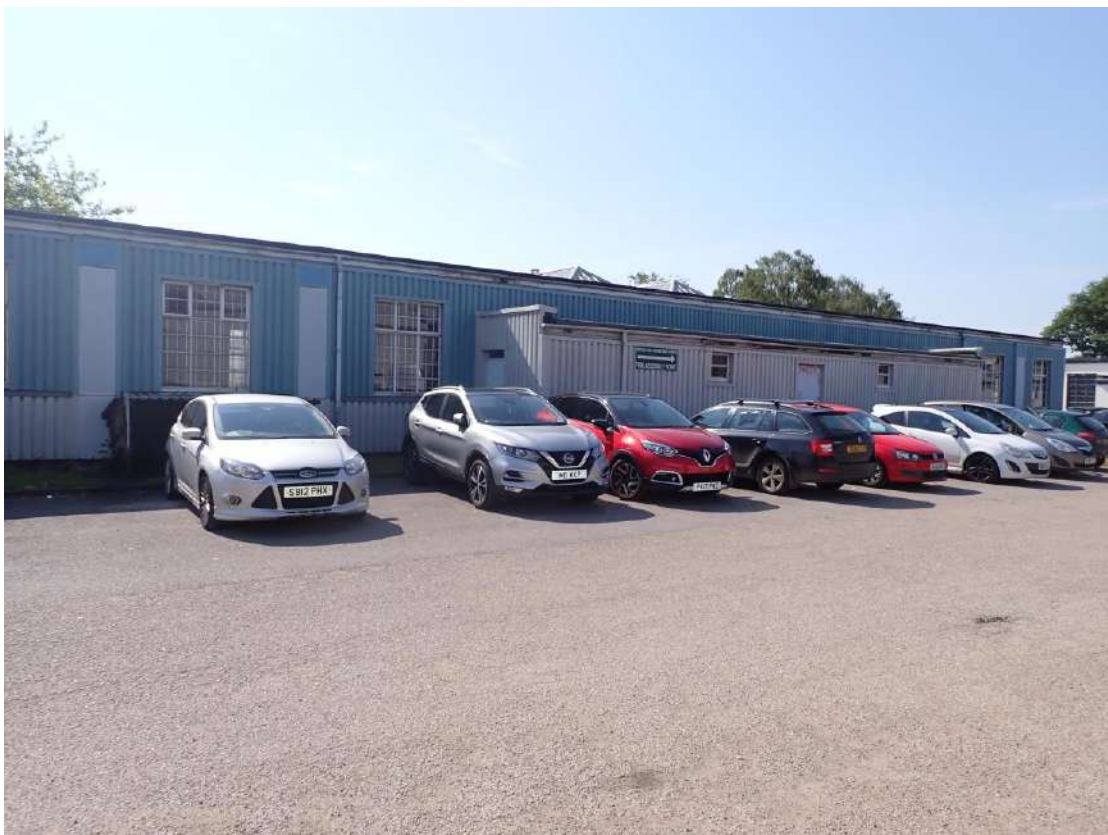
**Building 1** is a single storey rectangular building used as both offices and a workshop (See Appendix 3 – Photographs, Photographs 1-4). The walls are constructed of breeze block with corrugated metal cladding. There is a small extension on the eastern aspect which is a similar design. The roofs are lined with bitumen roofing felt that is in excellent condition and tightly sealed. There are two metal roof lanterns present in the centre of the building. There is lead flashing present around the lanterns which is tightly sealed. The window frames are wooden, and windows are single glazed. The windows are in poor condition but no suitable cracks or crevices for bats were recorded.

Photograph 1 – Southeastern aspect of Building 1.

Photograph 2 – Southwestern aspect of Building 1.

Photograph 3 – Northeastern aspect of Building 1.

Photograph 4 – Northwestern aspect of Building 1.

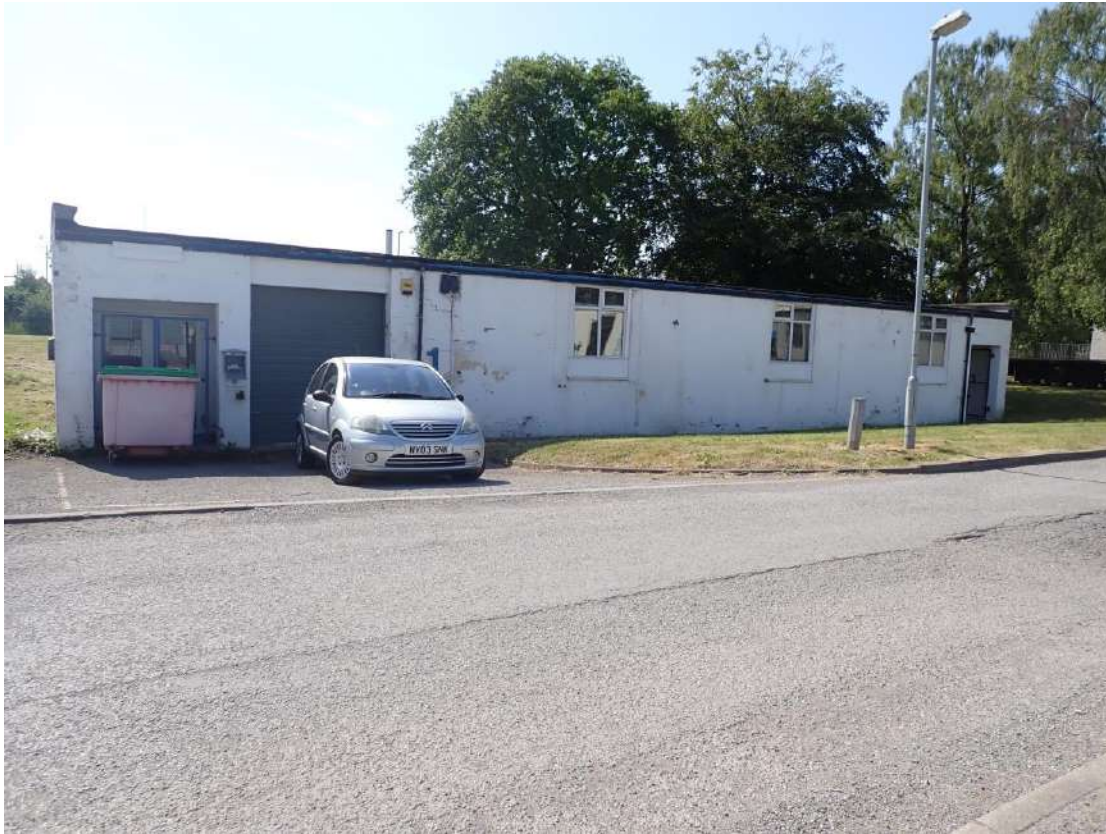
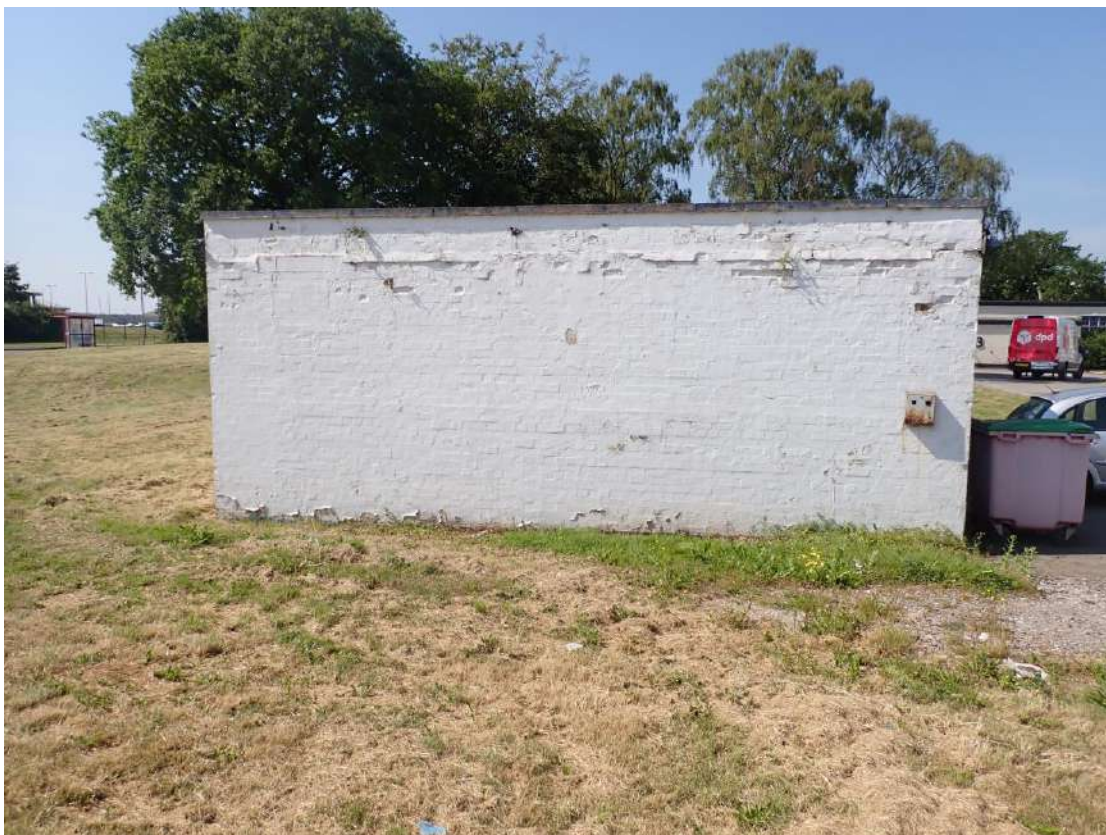
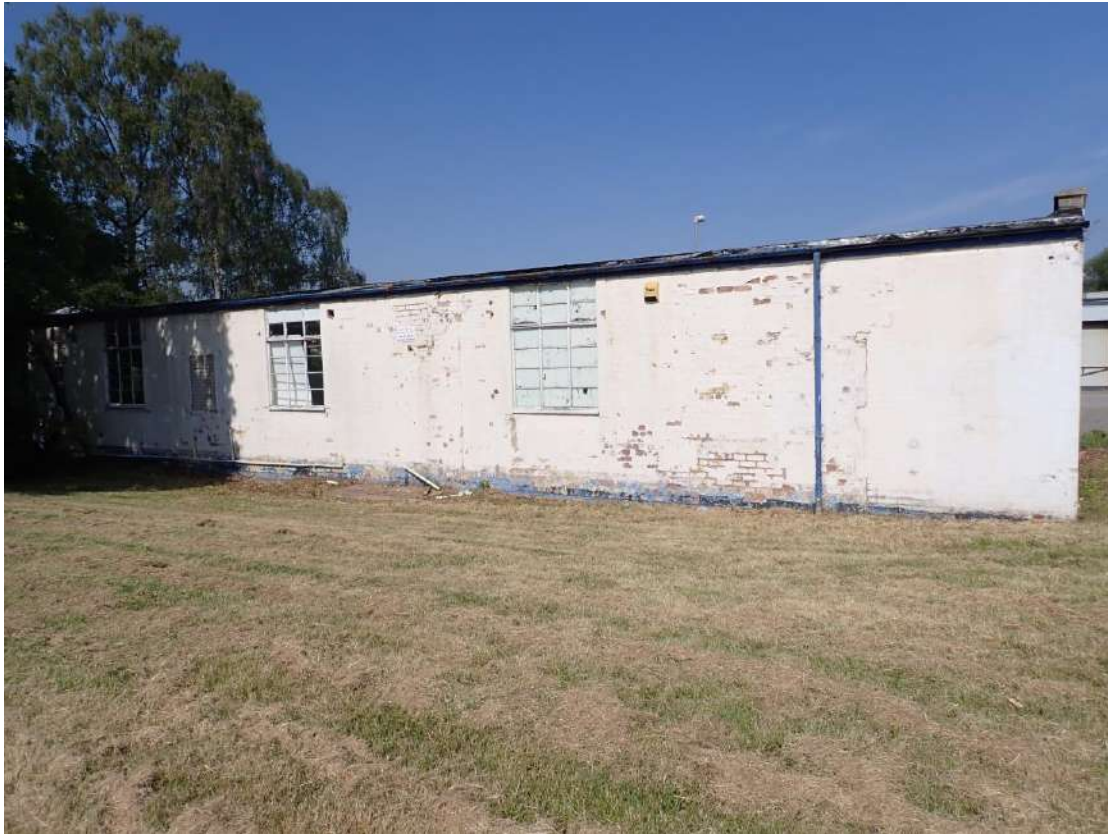
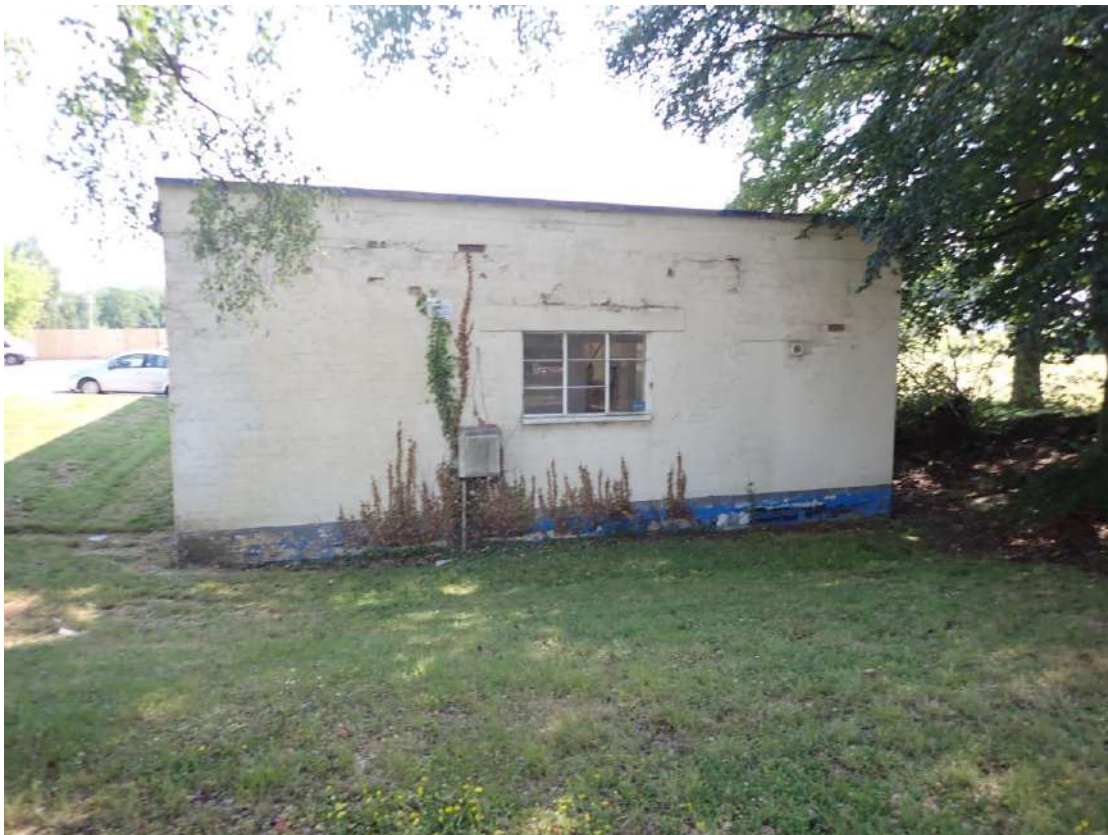
**Building 2** is a brick built rectangular building with a flat roof lined with bitumen roofing felt (Photographs 5-8). The windows have wooden frames in good condition. The building is currently unoccupied. The roof, fascia boards and brick work are in excellent condition with no PRFs identified.

Photograph 5 – Northwestern aspect of Building 2.

Photograph 6 – Northeastern aspect of Building 2.

Photograph 7 – Southeastern aspect of Building 2.

Photograph 8 – Southwestern aspect of Building 2.

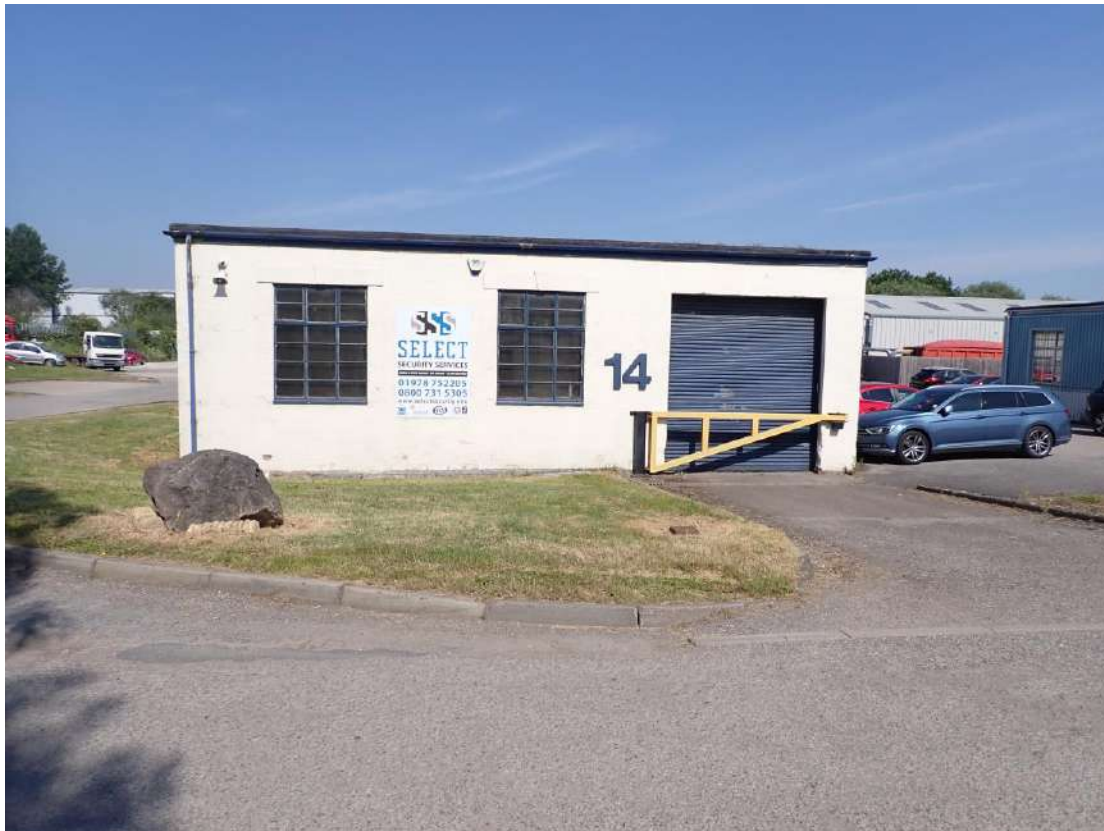
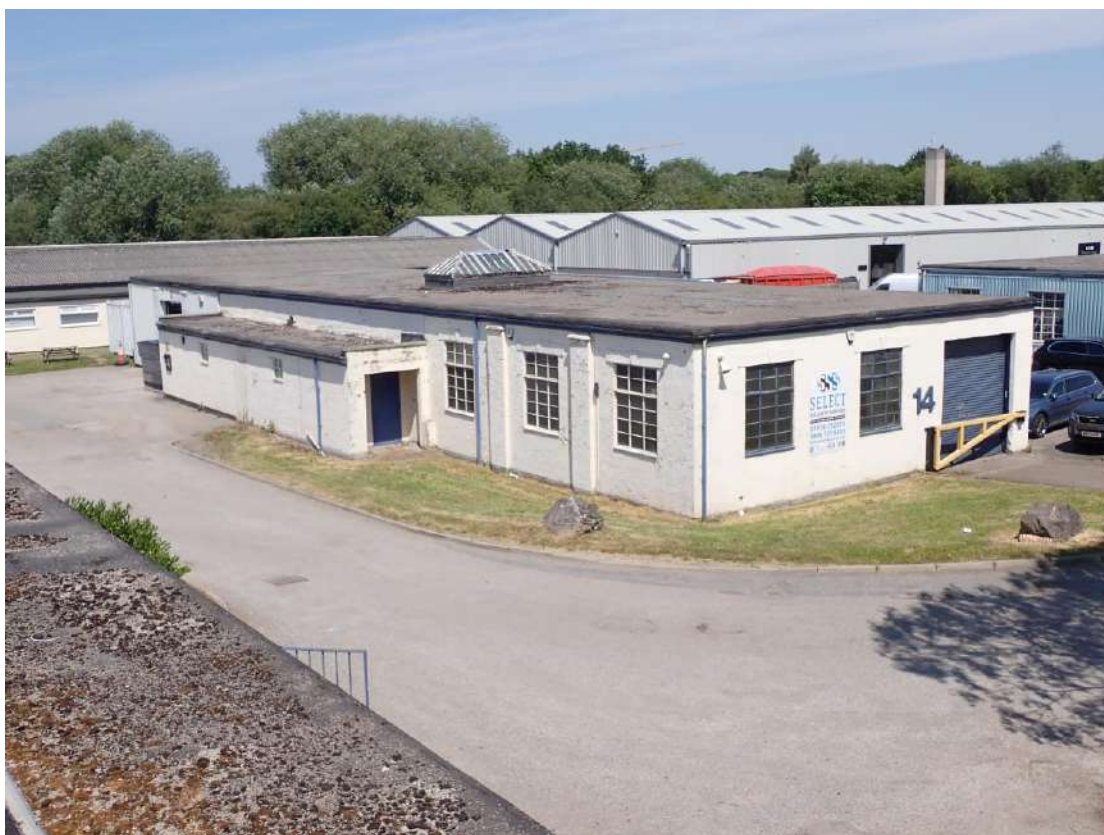
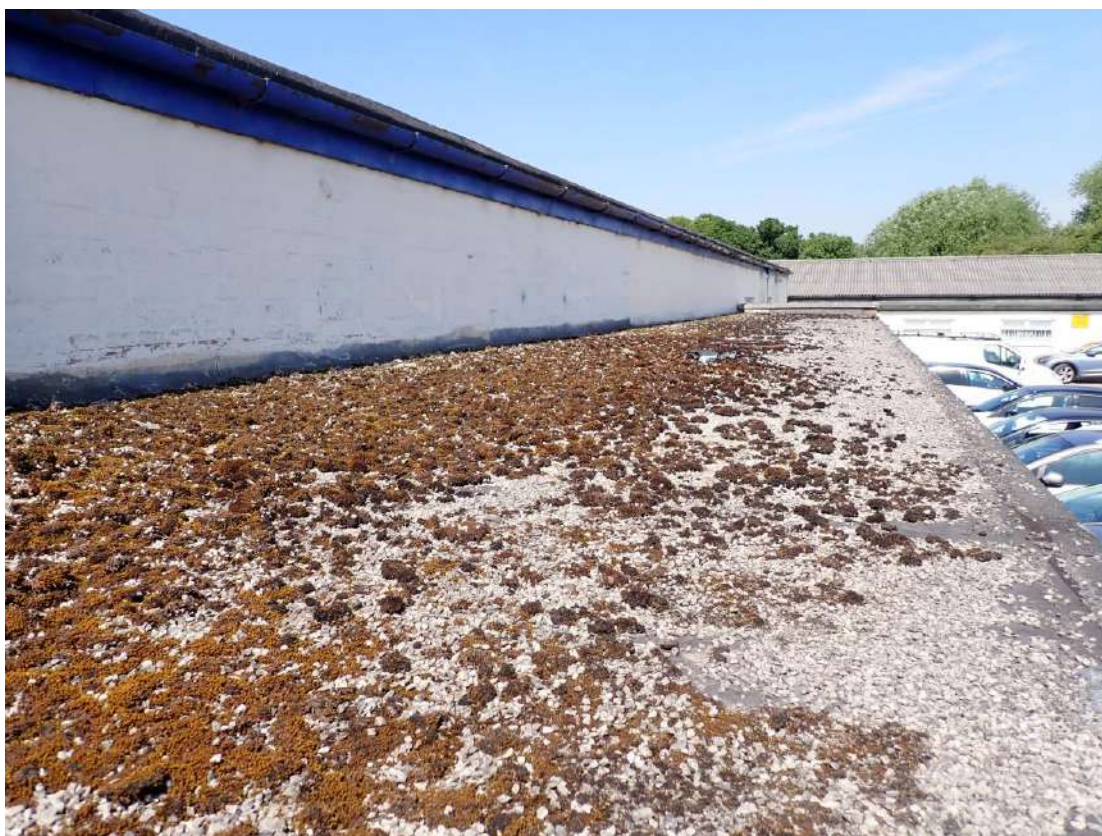
**Building 3** is a brick built rectangular building that has a similar construction to Building 2 (Photographs 9, 10, 13). There is a small extension on the northwestern aspect which is constructed of corrugated metal. The roof and walls are in excellent condition. The wooden fascia board on the southeastern aspect is slightly lifted (Photograph 11) and there is a gap at the end of the guttering on the same aspect, with raised bitumen felt (Photograph 12). These PRFs were inspected with an endoscope revealing no evidence of bats although a sheltered feature still remains.

Photograph 9 – Southeastern aspect of Building 3.

Photograph 10 – Southern aspect of Building 3.

Photograph 13 – Northeastern aspect of Building 3.

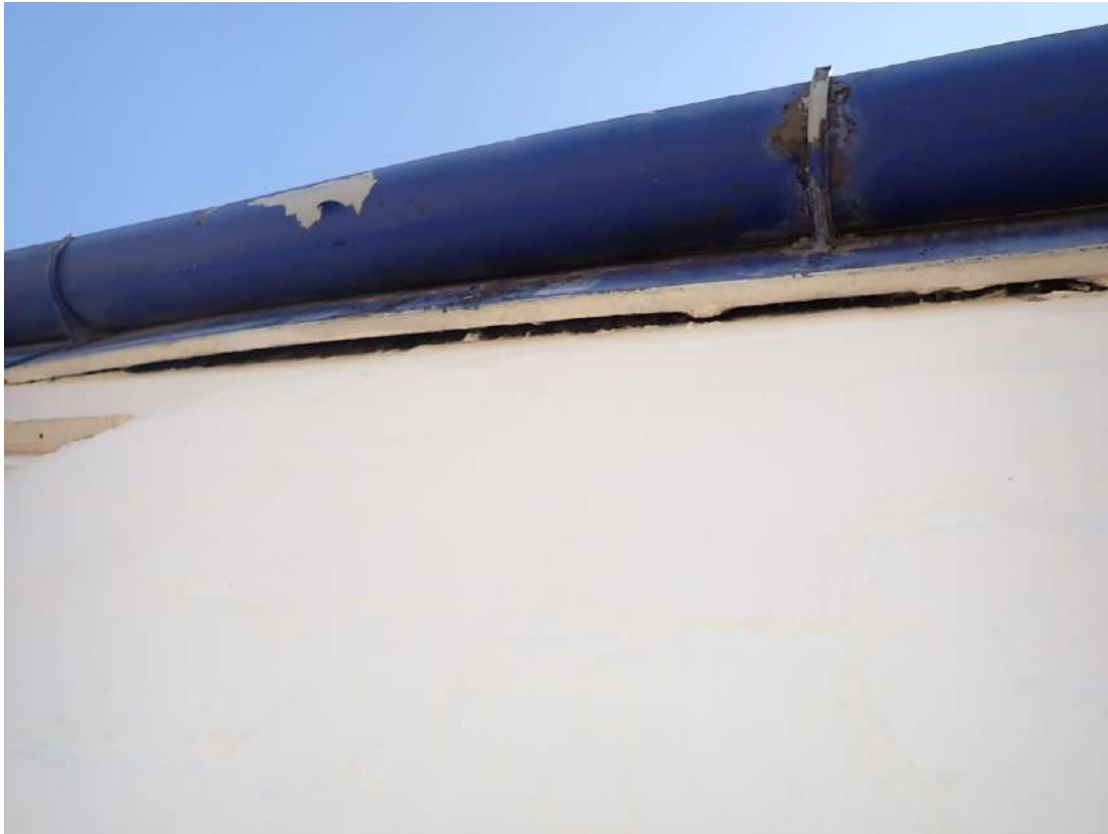
Photograph 11 – Gap under fascia board on Southeastern aspect of Building 3.

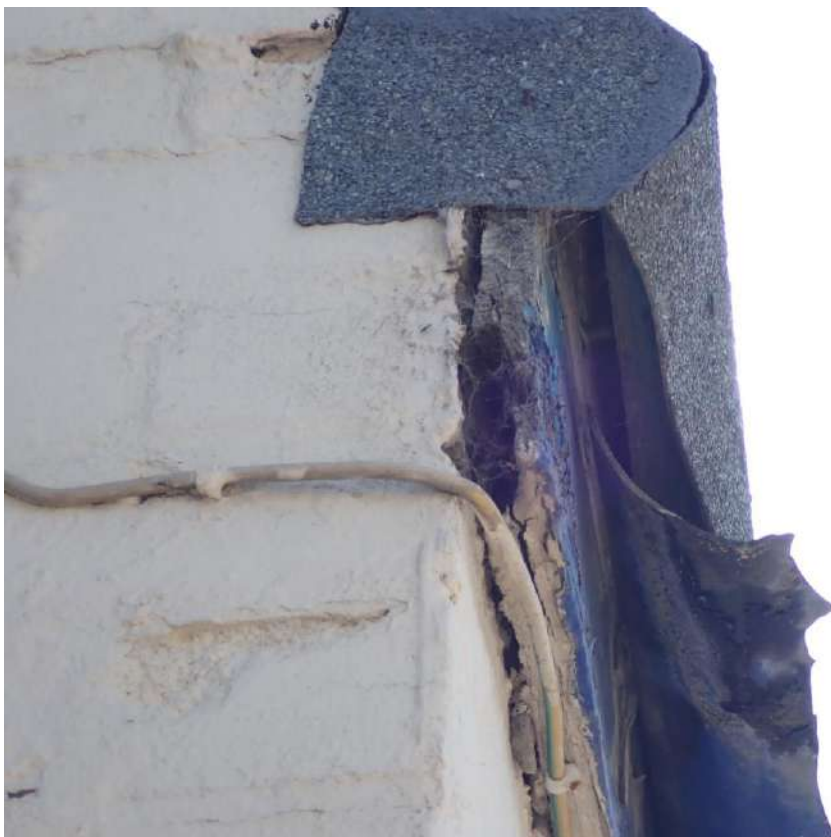
Photograph 12 – Gap towards end of guttering on Southwestern aspect of Building 3 with raised bitumen felt.

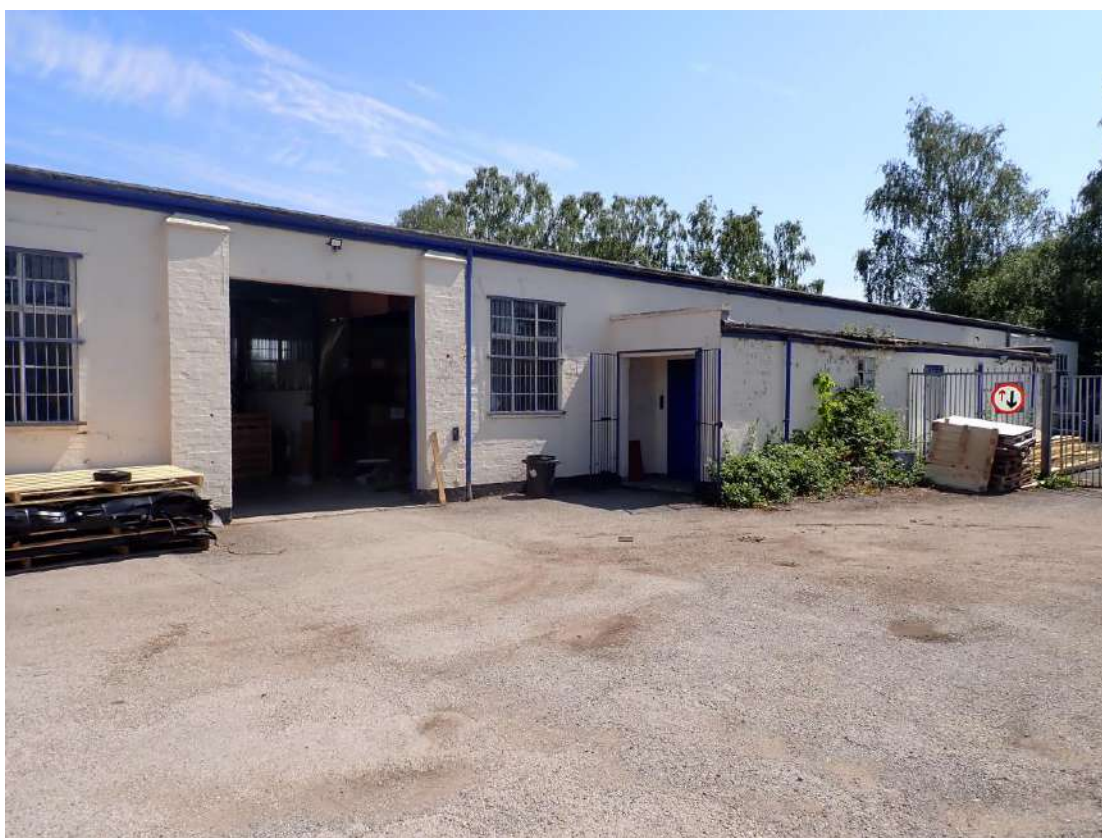
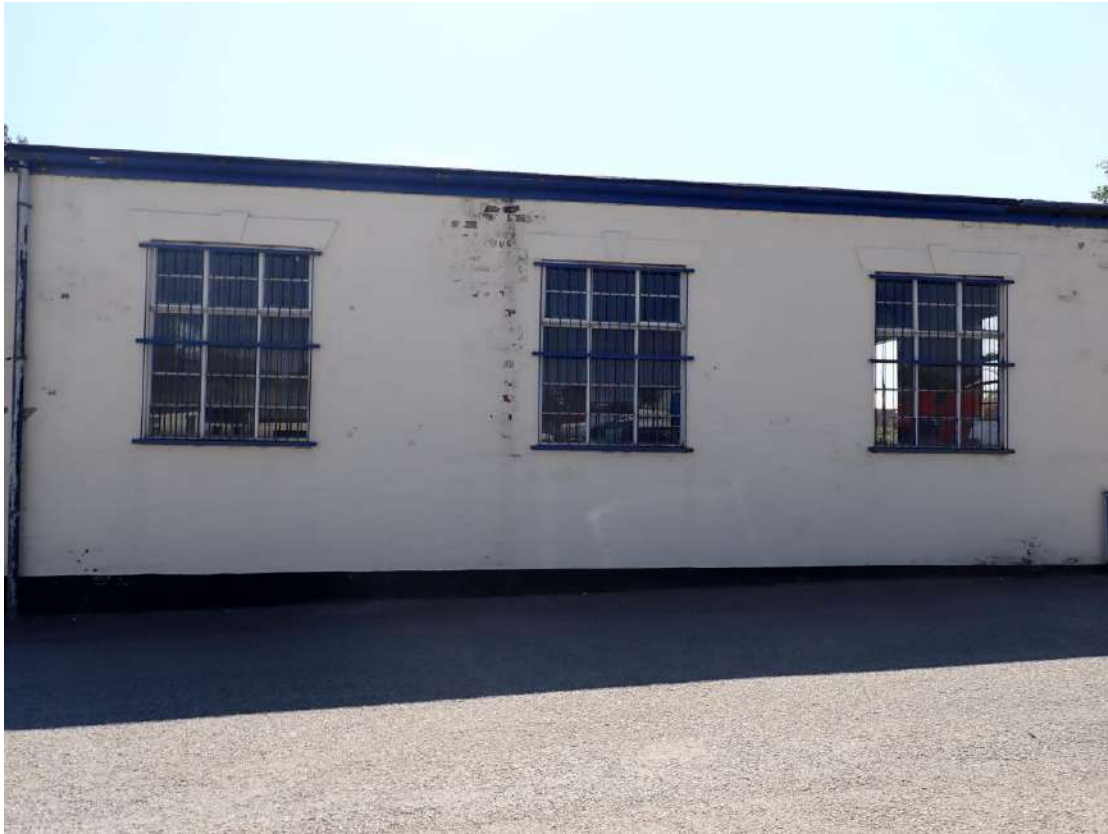
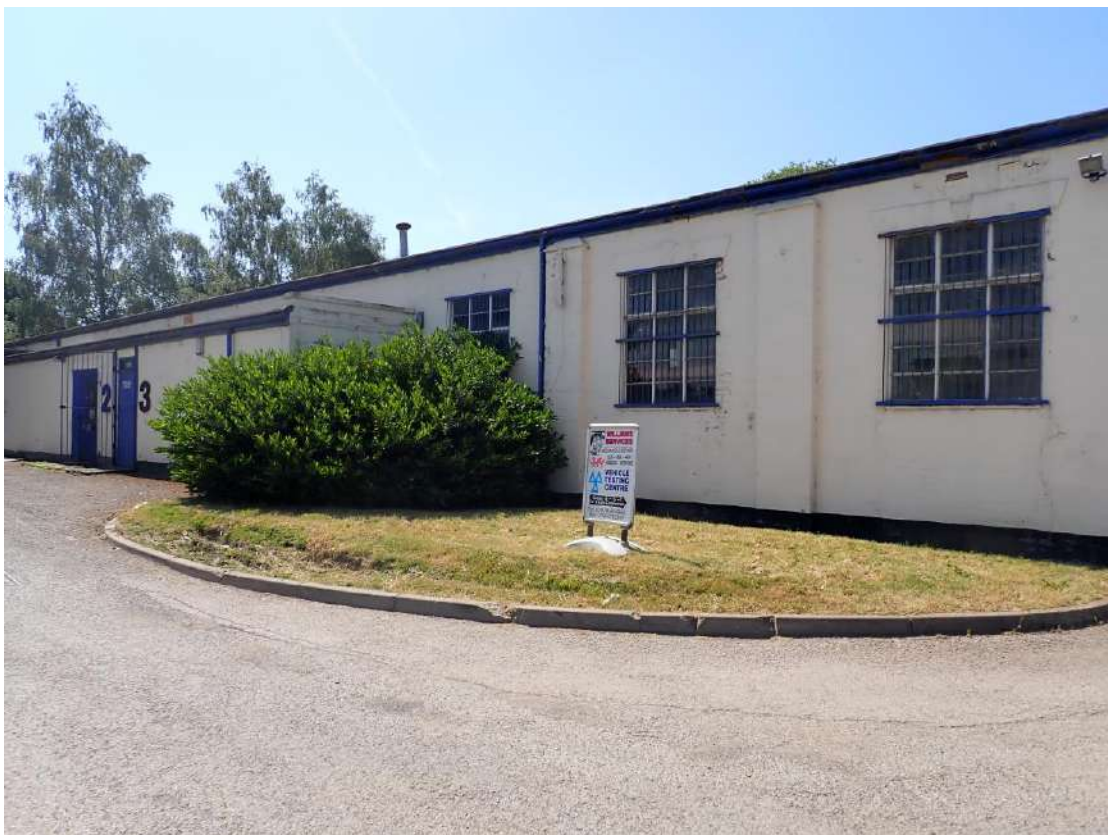
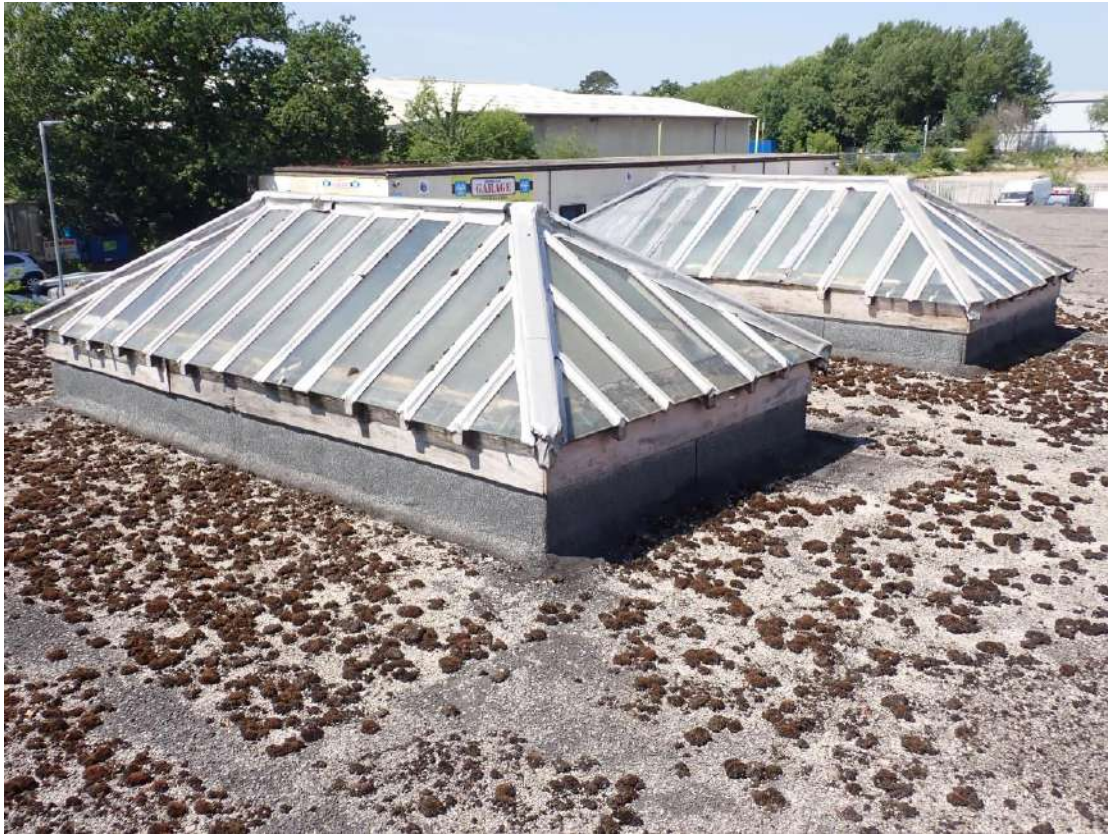
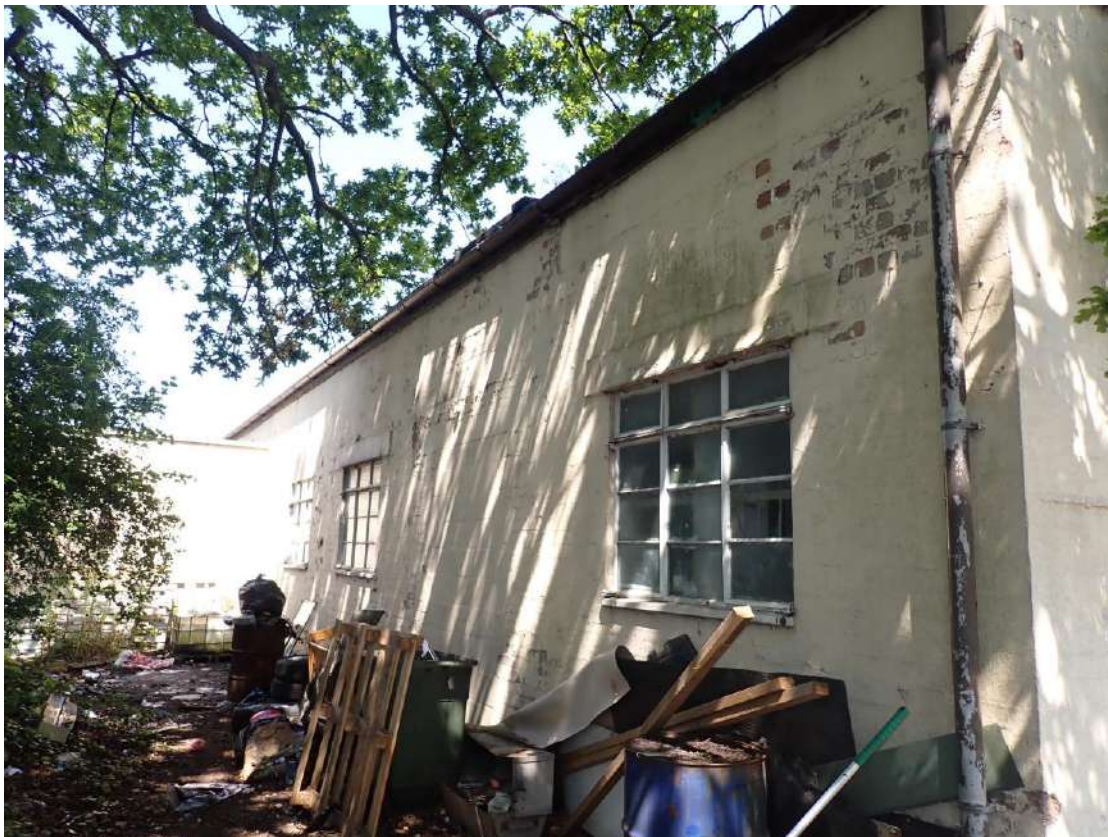
**Building 4** is a brick built rectangular building that is a similar design to Building 2 (Photographs 14, 17, 18, 19). The fascia boards are well fitted with the exception of a gap above the roller shutters on the southwestern aspect (Photograph 15), and further along on the same aspect there's a hold in the brickwork at the top of a brick pillar (Photograph 16). These PRFs were inspected with an endoscope and no evidence of bats were found.

Photograph 14 – Southwestern aspect of Building 4.

Photograph 17 – Northwestern aspect of Building 4.

Photograph 18 – Northeastern aspect of Building 4.

Photograph 19 - Roof of Building 4.

Photograph 20 – Southwestern aspect of Building 4.

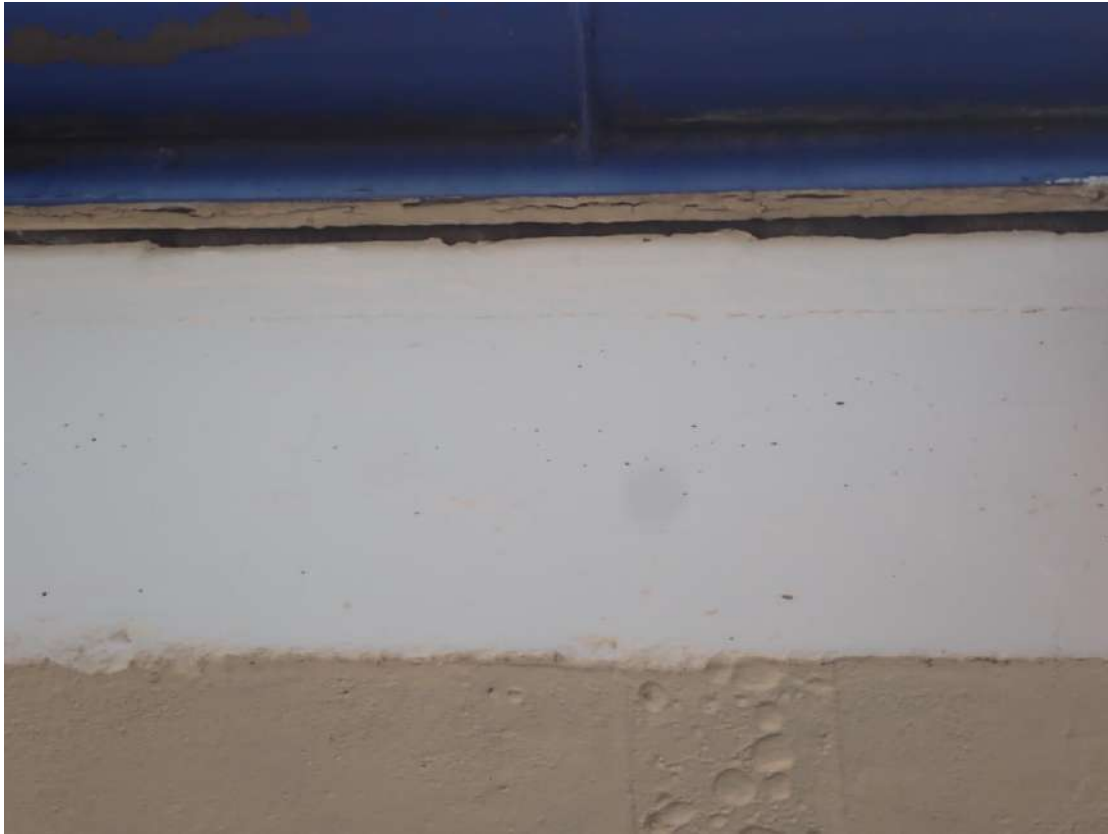
Photograph 15 – gap under fascia board on Southwestern aspect of Building 4, above the roller shutters.

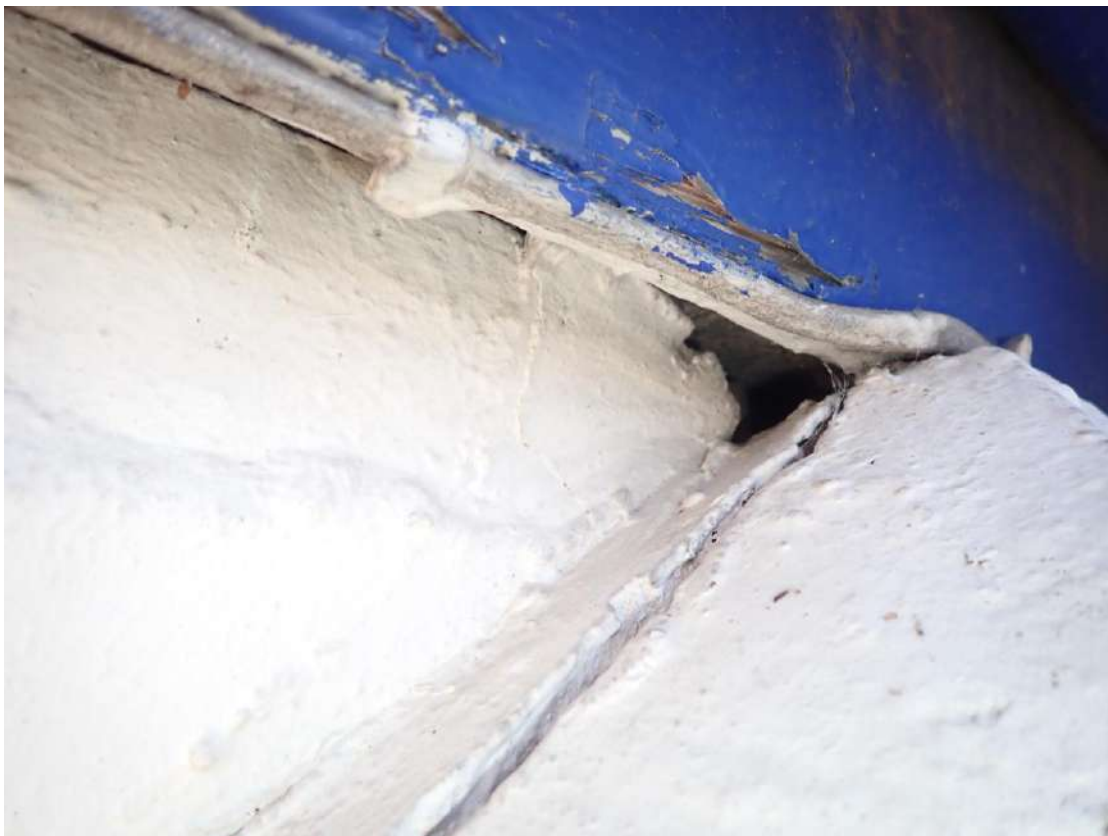
Photograph 16 – Hole under fascia over brick pillar on Southwestern aspect of Building 4.
