**BAT SCOPING & BAT PRESENCE / ABSENCE SURVEY**

**Bridgeway Centre**

Bridge Road  
Wrexham  
LL13 9QS

Date: 23<sup>rd</sup> November 2023  
UES reference: UES03012/12

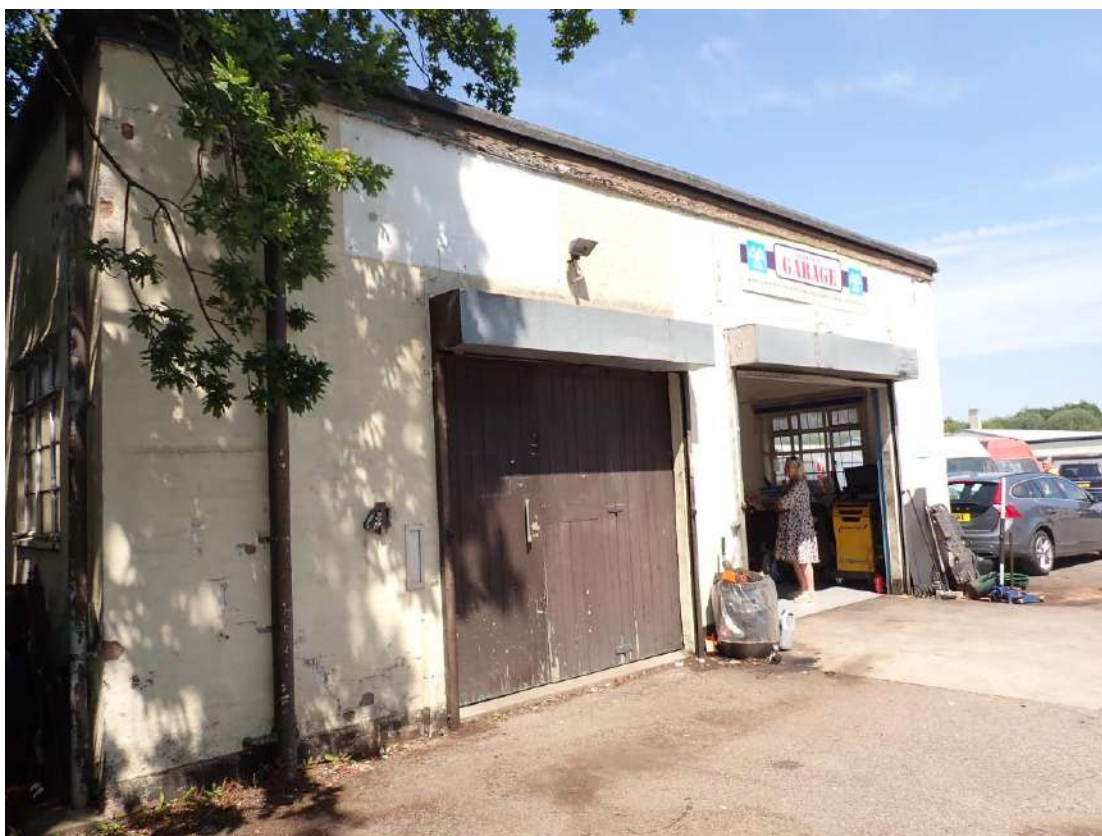
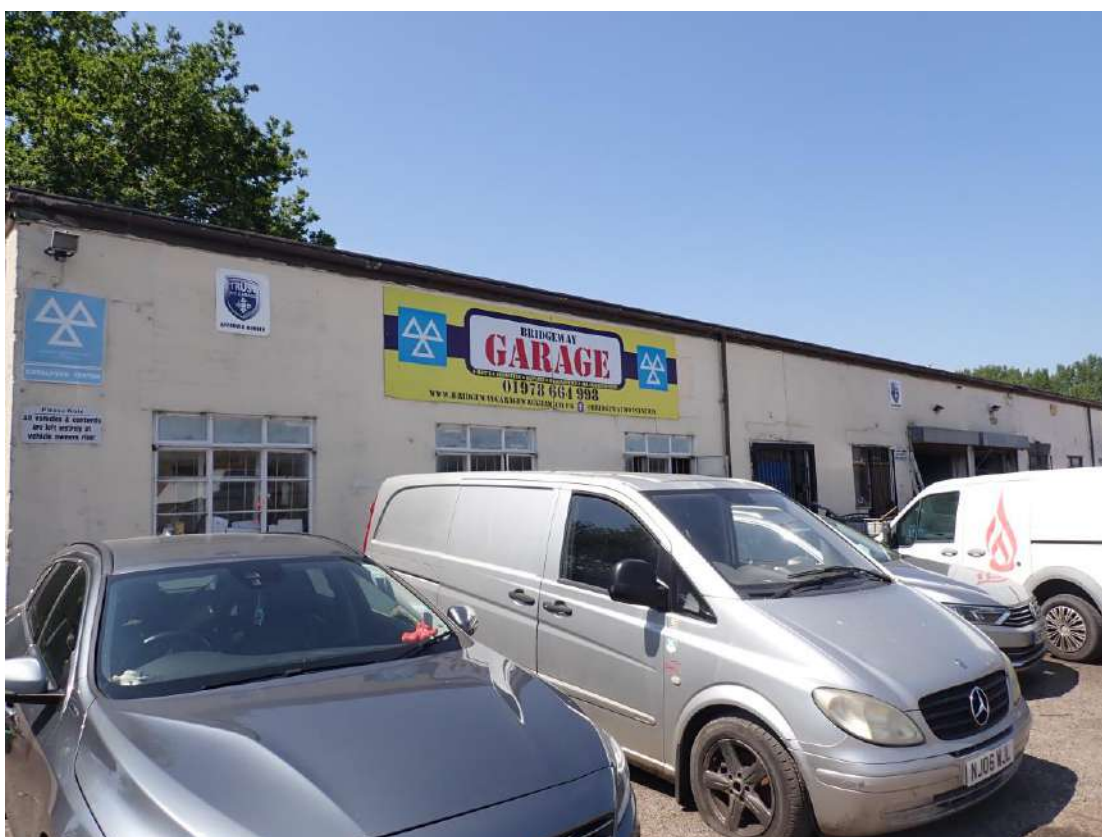
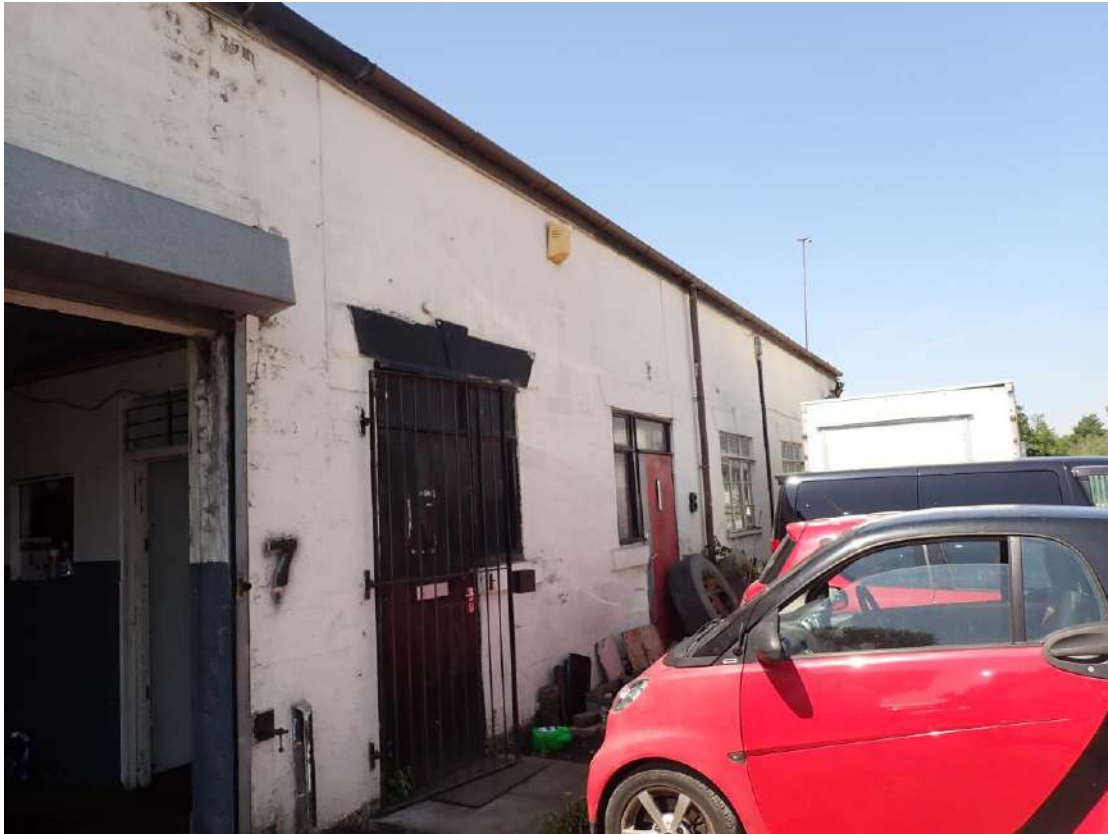
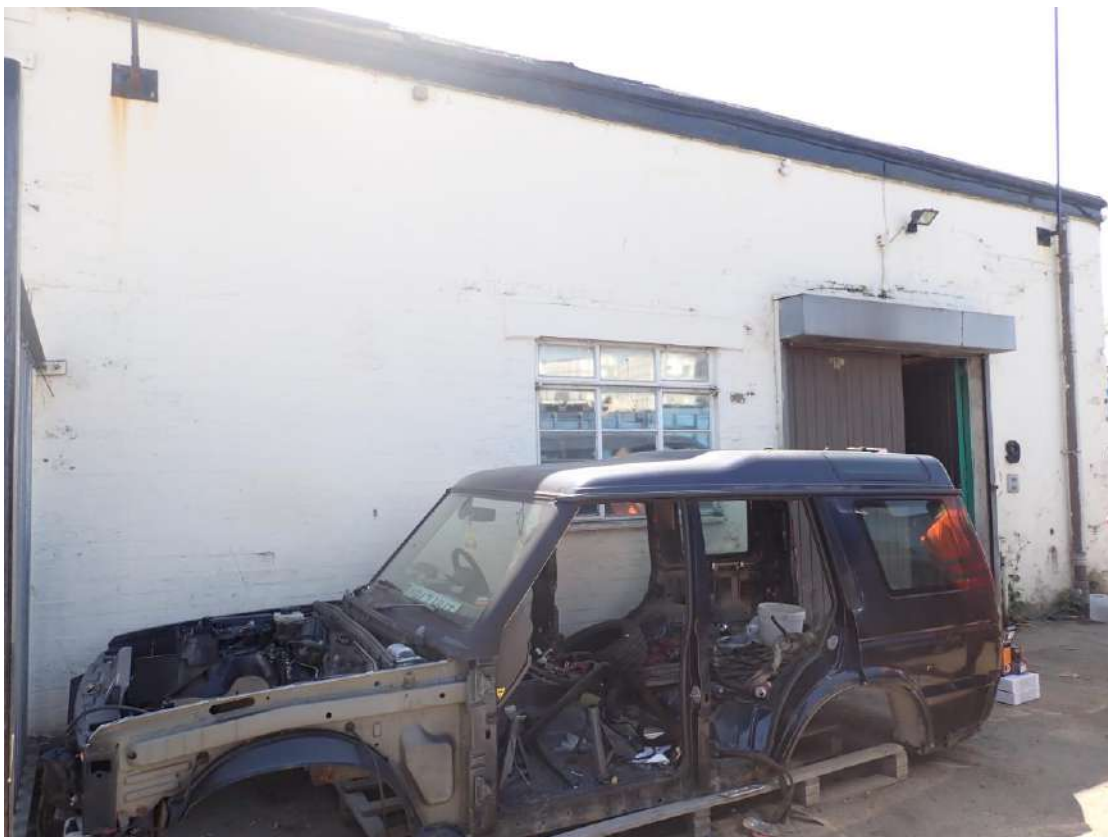
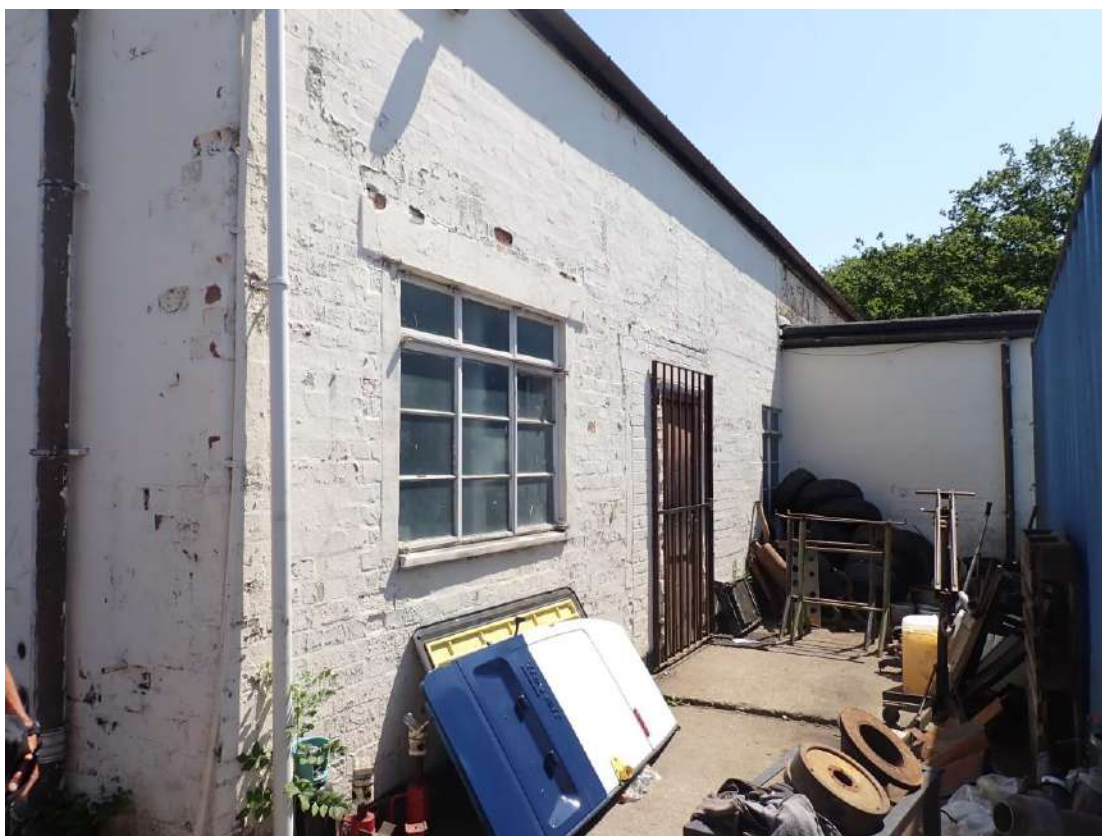
**Building 5** is a similar design to Building 3 and is currently used as a garage for repairing cars. The roof, wooden fascia boards and brick work are all in excellent condition with no PRFs identified.

Photograph 21 – Southeastern aspect of Building 5.

Photograph 22 – Northeastern aspect of Building 5.

Photograph 23 – Northeastern aspect of Building 5 (further north than Photograph 18).

Photograph 24 – Northwestern aspect of Building 5.

Photograph 25 – Southwestern aspect of Building 5 (further West than Photograph 16).
