# Sesswick Eel Screen Preliminary Ecological Assessment

RammSanderson were commissioned by Severn Trent Water to undertake an ecological survey at Sesswick for the construction of eels screens on the bank of the River Dee. The purpose of eels screening is to exclude eels from the river inlet through the installation of a mesh screen. The installation of a screen will require construction of supporting structure into the riverbed, and a hydrolox or wire mesh screen being installed upon it. This will impact the banks of the river and will have impacts upon species within the river course. The survey area formed a terrestrial area on the north-western bank of the River Dee, as shown within the red line boundary in Figure 1. The site mainly comprised of a building and areas of hardstanding, with poor semi-improved grassland surrounding the building, an area of broadleaved woodland within the east of the site, and flowing ditches surrounding it. Works will take place mostly upon the river bank, however some vegetation clearance may be required for access or machinery. This report discusses impacts upon the terrestrial habitats and species within the red line boundary. Impacts upon the

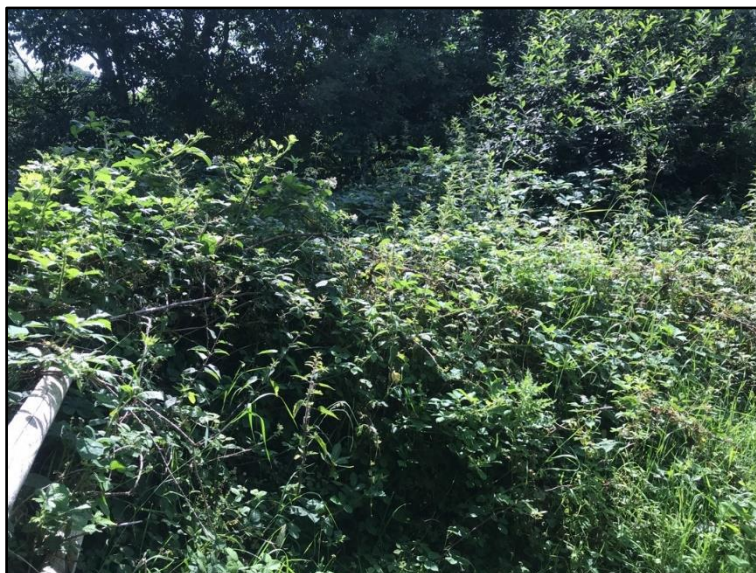
**Figure 3: Dense Continuous Scrub**

Two areas of scrub were located in the north-east of the site, dominated by bramble, with abundant creeping thistle (*Cirsium arvense*), and spear thistle (*Cirsium vulgare*). There was also frequent Himalayan balsam and hoary willowherb (*Epilobium parviflorum*), and occasional cow parsley (*Anthriscus sylvestris*) and red dead nettle (*Lamium purpureum*), as well as rarely occurring ragwort (*Jacobaea vulgaris*), hogweed (*Heracleum sphondylium*) and yarrow (*Achillea millefolium*).

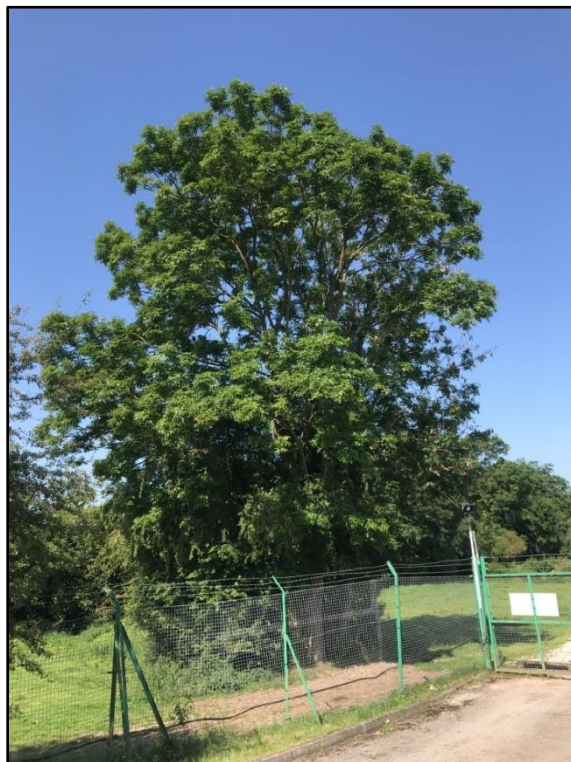
**Figure 4: Scattered Broadleaved Trees**

There were scattered trees along the riverbank comprising ash, willow and alder, with one mature ash near the gate. There were also two single stands of hawthorn.

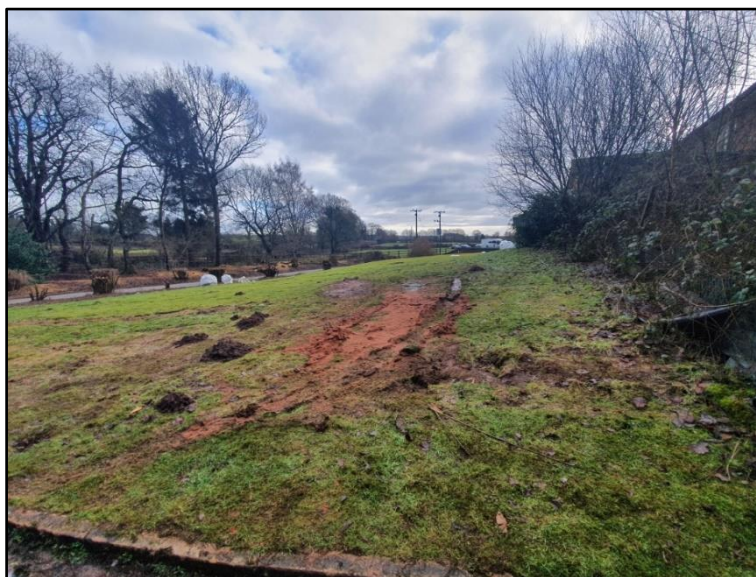
**Figure 5: Improved Grassland**

Poor semi-improved grassland was located around the site forming grass verges surrounding the building. This habitat was similar in assemblage to fields surrounding the site and was dominated by perennial rye grass (*Lolium perenne*), with abundant cock's foot (*Dactylis glomerata*), Yorkshire fog (*Holcus lanatus*), frequent meadow buttercup (*Ranunculus acris*), creeping buttercup (*Ranunculus repens*), creeping thistle and white clover (*Trifolium repens*). There was also occasional dandelion (*Taraxacum sp.*), mayweed (*Tripleurospermum*), plantain (*Plantago sp.*) and rarely occurring chickweed (*Stellaria media*).

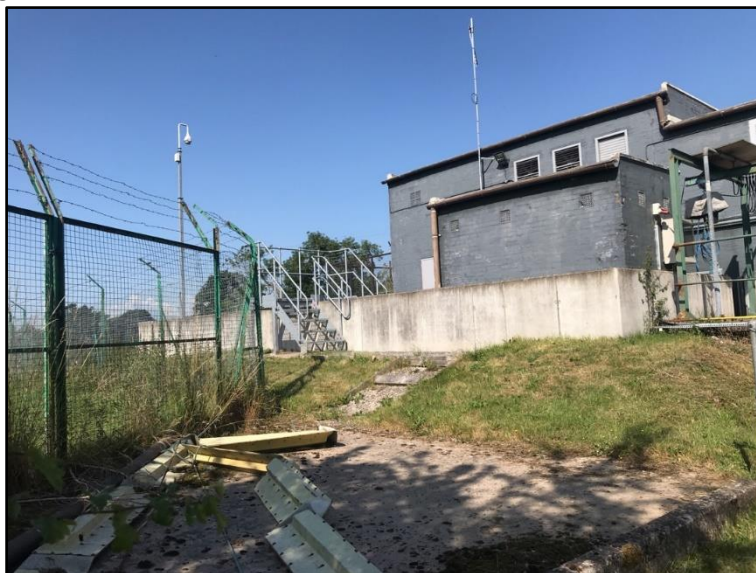
**Figure 7: Building 1**

One building was present on site. This was a solid brick single storey pumping station and associated infrastructure works. This building is not to be impacted by the works.

The buildings on site were had limited suitability for roosting bats. Furthermore, the buildings are not to be impacted by the works and as such bat roosts in buildings are removed from further discussion within this report.

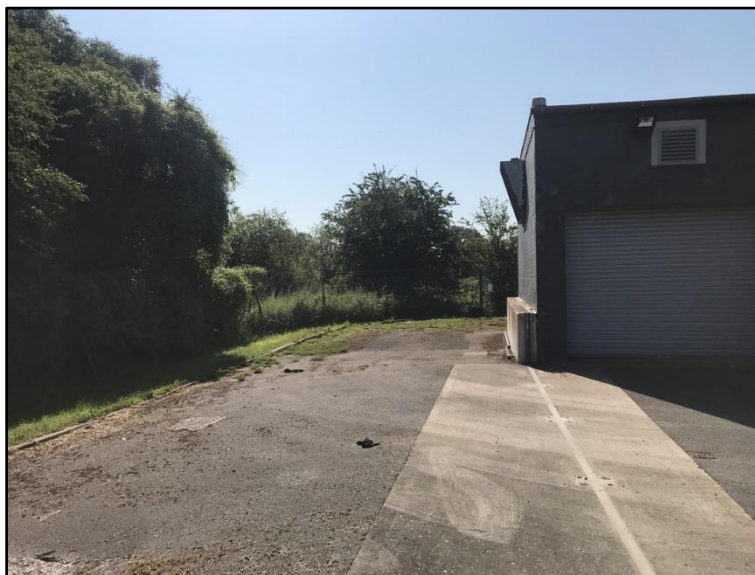
**Figure 8: Hardstanding**

There were areas of hardstanding surrounding the building for access of vehicles and pedestrians.
