## **APPENDIX C: PREVIOUS REPORTS**

Wynnstay Technology Park  
New Housing Development  
Geo-Environmental Report  
Gratton Oakes Ltd

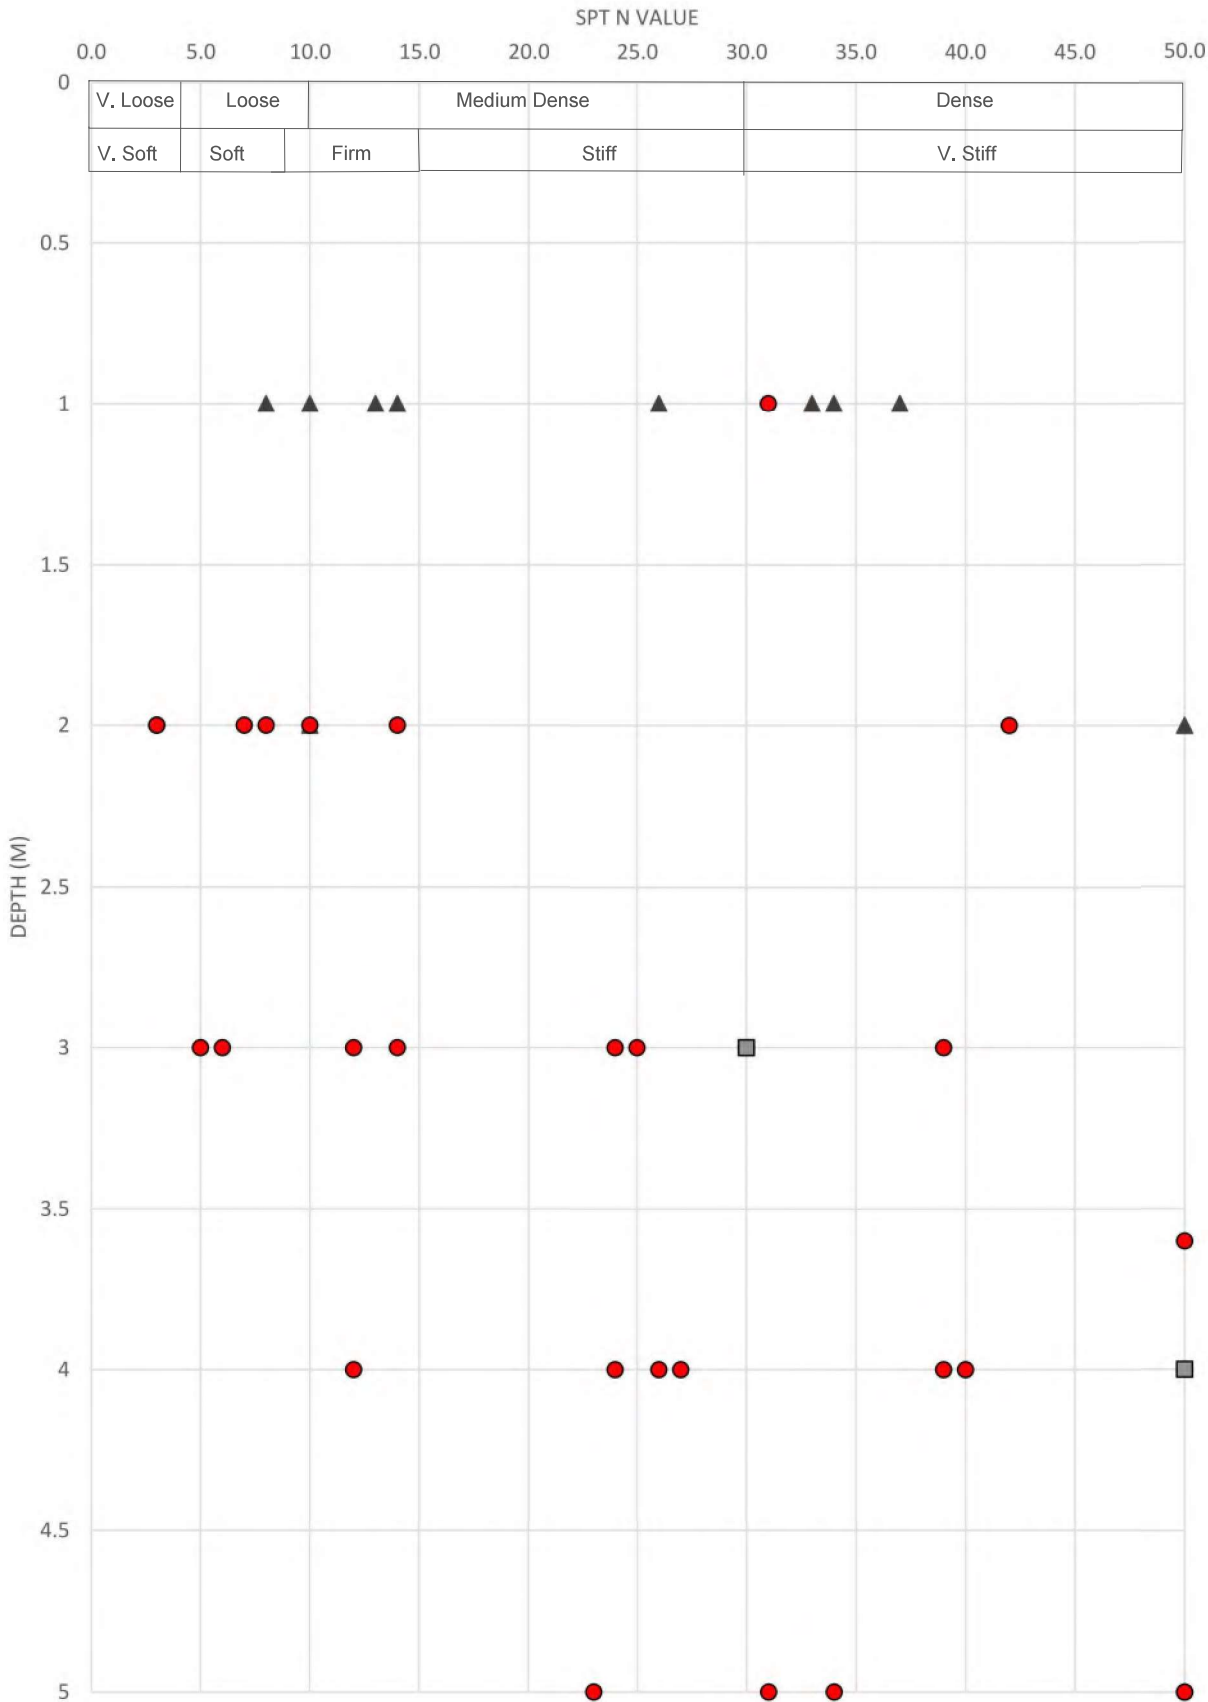
Figure Title  
SPT 'N' VALUE VS DEPTH

# RECORDED SPT N VS DEPTH

▲ Made Ground ● Glacial Till ■ Glacial Deposits

Standard Penetration Tests (SPT) recorded SPT “N” values between 8 and greater than 50, confirming the loose to very dense consistency, see Figure 5. However, values were generally between 10 and 26 (medium dense), with the higher values probably influenced by coarse fragments (cobbles) within the colliery spoil.

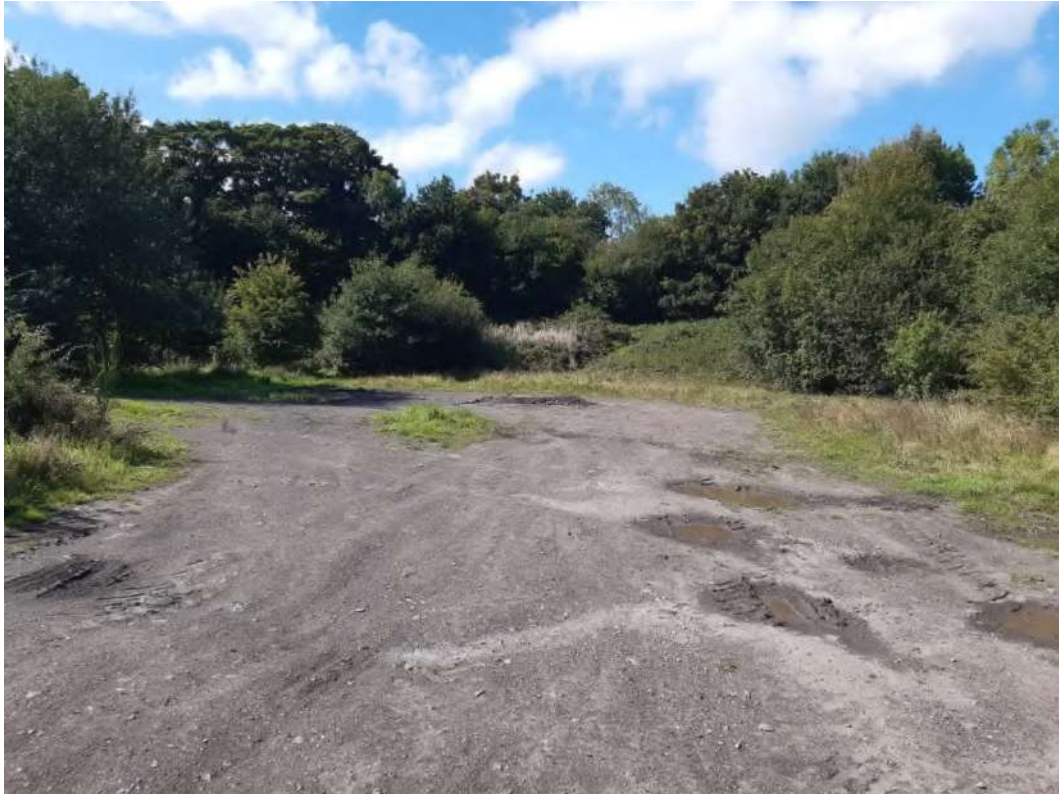
Photograph 7 Central section of site showing colliery spoil at surface

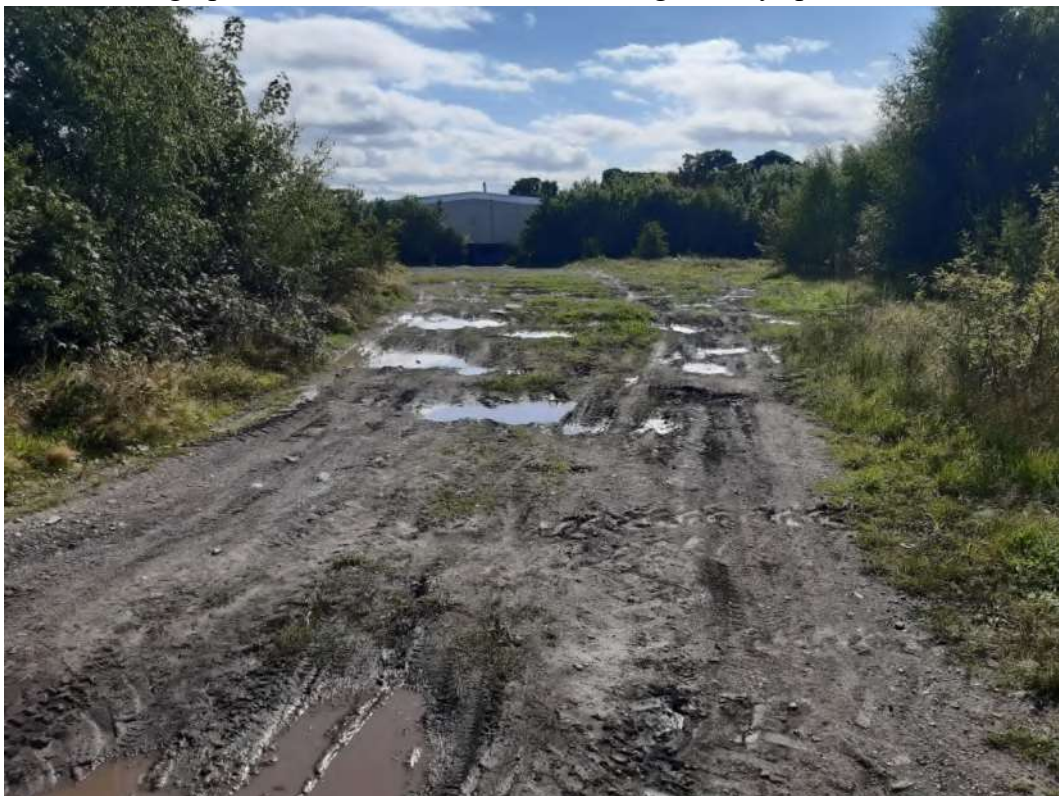
Photograph 8 Showing water ponding on site
