## Appendix 3- Soil Logs

| | | Project: Maes Y Capel | Trial Pit:<br><b>TP01</b> |

**Drawing 4937-CAU-MYC-XX-DR-C-5603\_S2.P03**  
**Proposed Drainage Construction Details Sheet 4**

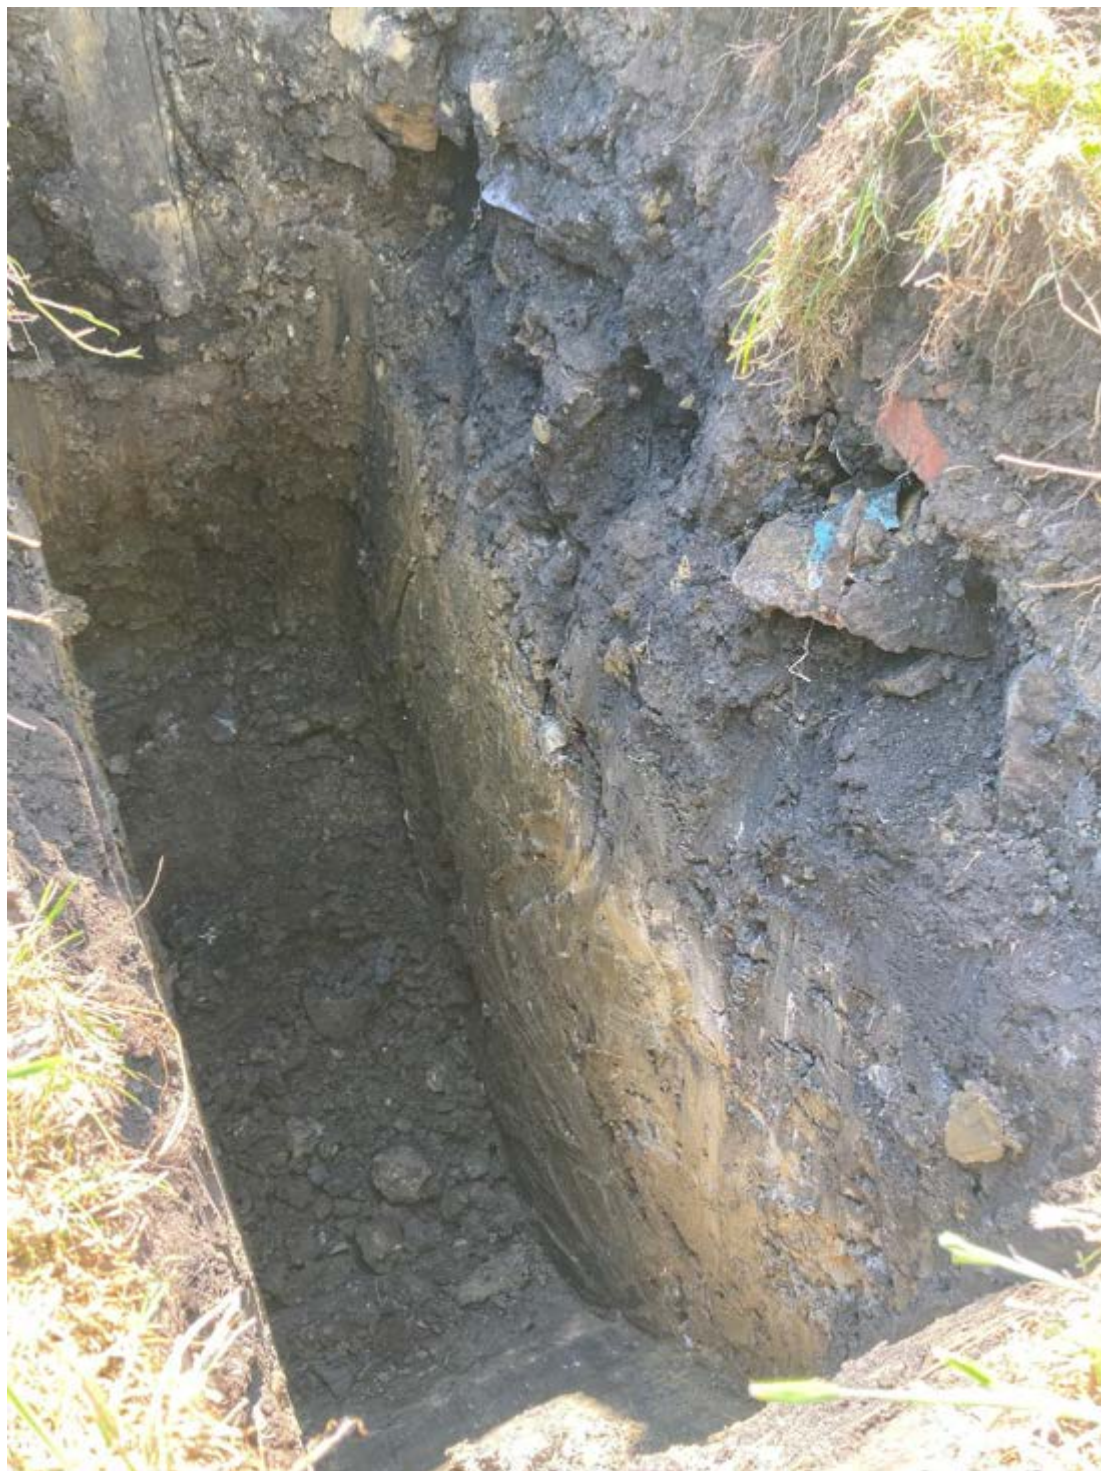
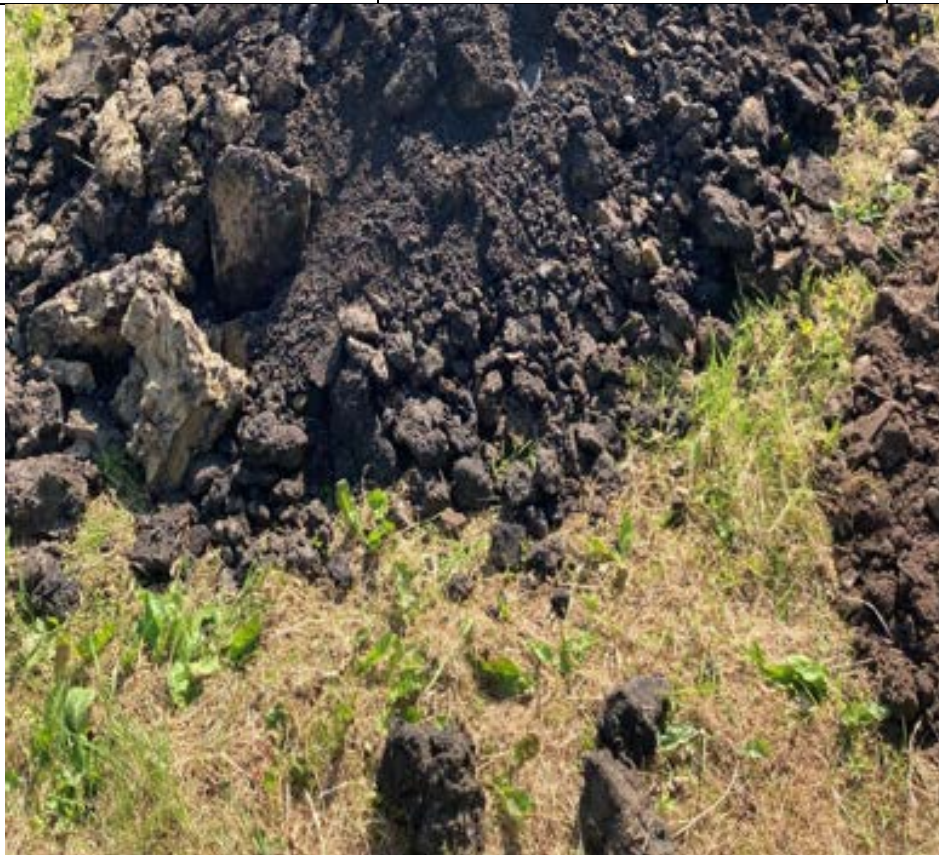
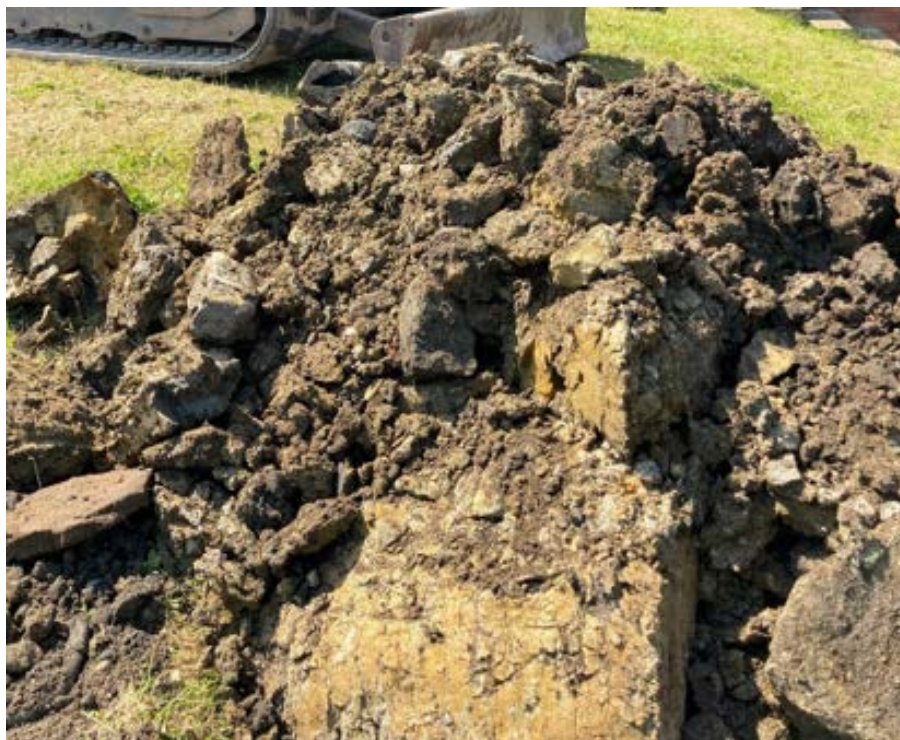
**Trial Pit Photographs:**

| | | Project: Maes Y Capel | Trial Pit:<br><b>TP01</b> |
|---|---|---|---|
| 0 | 0.25 | Dark brown sandy silt with grass/rootlets contains occasional piece of clay pipe, metal and plastic.<br>TOPSOIL. | |
| 0.25 | 1.1 | Greyish brown very sandy slightly clayey gravelly silt. Gravel fine to coarse subangular of siltstone, sandstone and occasional piece of glass brick and metal. | Env: 0.4-0.45 |
| 1.1 | 1.2 | Firm grey mottled orange slightly sandy gravelly CLAY. Gravel fine to coarse rounded to sub-rounded of siltstone. Becomes sandy at 1.5m. Becomes stiff at c. 2.1m (excavator advancement slows). | Env: 1.1m<br>Geo: 1-1.15m (tub),<br>1.5m (tub), 2m (tub). |
| 2.2 | 2.5 | Dark grey stiff slightly gravelly CLAY. Gravel fine to coarse rounded to subrounded of siltstone.<br><br><b>End 2.5m excavator could not reach further due to angle of trial hole on embankment.</b> | Geo: 2.5m (tub) |
| <b>Excavated by</b> – 5 tonne tracked excavator<br><b>Plan Dimensions of Pit</b> – 0.7m x 1.8m<br><b>Groundwater</b> - Dry<br><b>Stability</b> – Stable, sides remained vertical when excavated,<br><b>Contamination</b> – No visual or olfactory evidence of contamination | | | |

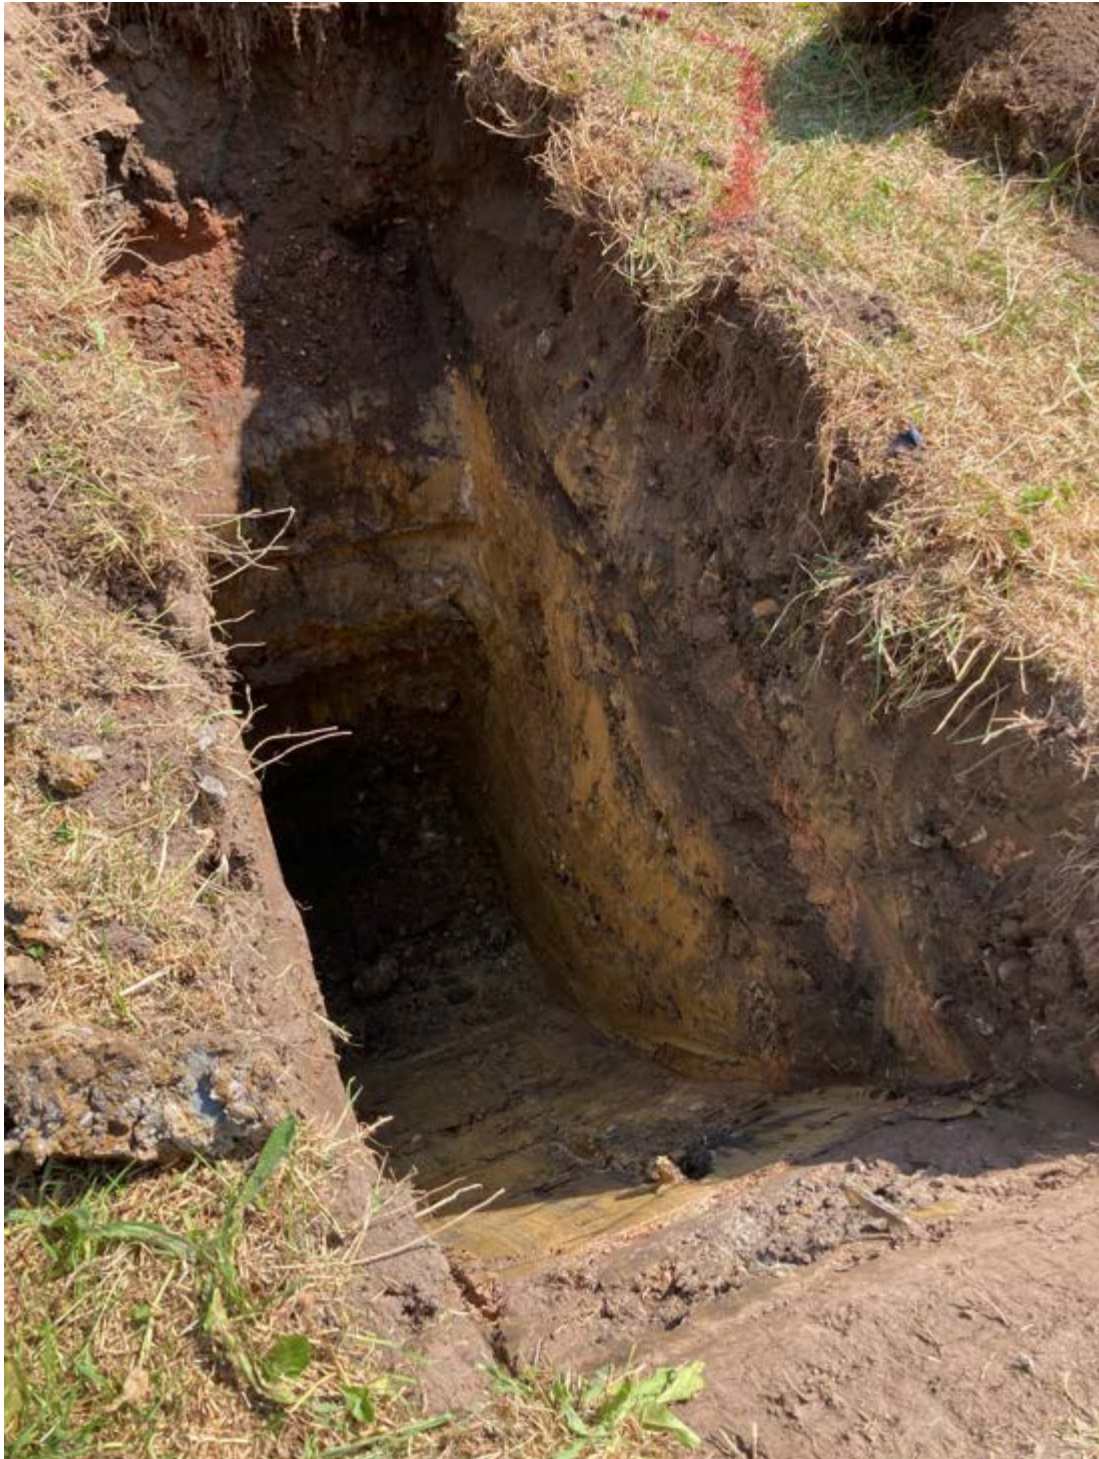
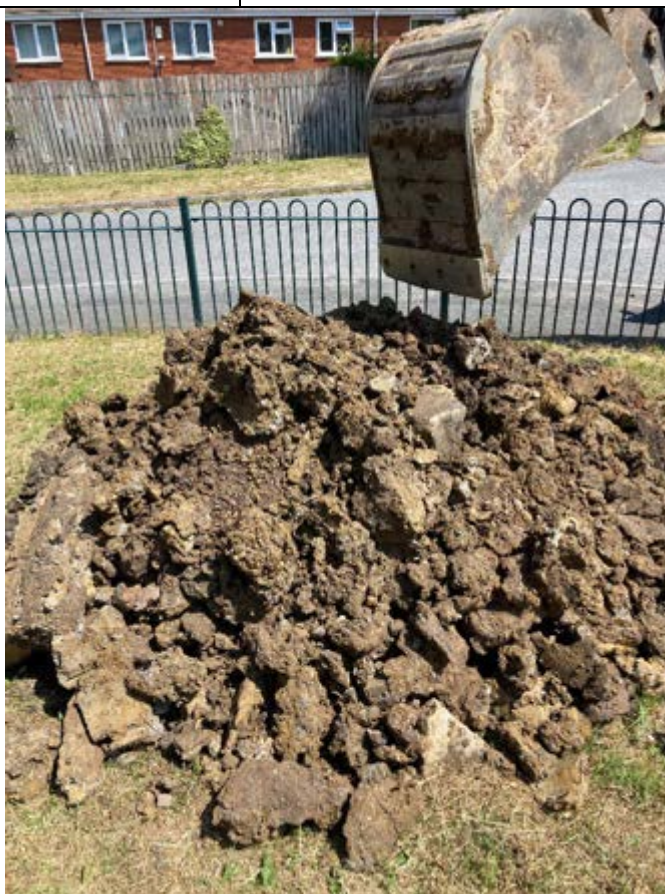
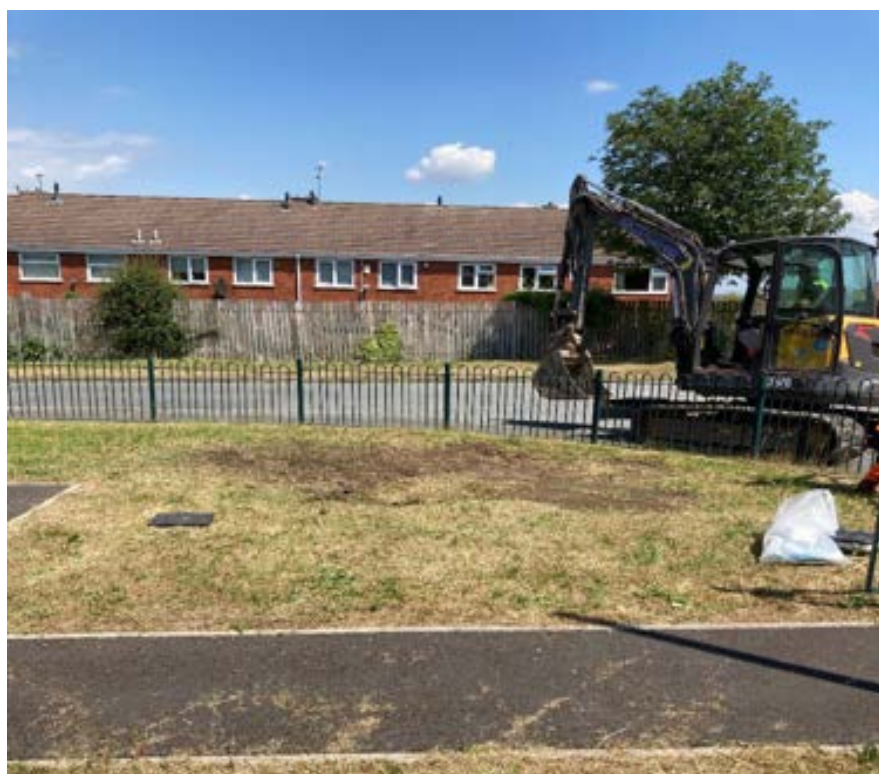
**Trial Pit Photographs:**

| | | Project: Maes Y Capel | Trial Pit:<br><b>TP02</b> |
|---|---|---|---|
| 0 | 0.3 | Dark brown sandy silt with grass/rootlets contains occasional brick cobble and plastic TOPSOIL. | Env: 0-0.05m |
| 0.3 | 0.6 | Brown very gravelly sand. Gravel fine coarse angular to subangular of sandstone and occasional brick fragment. Occasional cobble of brick (REWORKED GROUND/MADE GROUND). | |
| 0.6 | 0.8 | Black slightly sandy organic SILT. Potentially relic topsoil. | |
| 0.8 | 2 | <p>Stiff grey mottled orange slightly sandy gravelly CLAY. Gravel fine to coarse rounded to sub-rounded of siltstone.</p> <p>Hand shear vane average reading= 104kPa at 0.8m.</p> <p><b>End 2m. Could not advance further due to having to reach over metal fence.</b></p> | Geotech: 1m (bulk), 1.5m (bulk), 2m (bulk) |
| <p><b>Excavated by</b> – 5 tonne tracked excavator</p> <p><b>Plan Dimensions of Pit</b> – 0.7m x 1.8m</p> <p><b>Groundwater</b> - Dry</p> <p><b>Stability</b> – Stable, sides remained vertical when excavated,</p> <p><b>Contamination</b> – No visual or olfactory evidence of contamination</p> | | | |

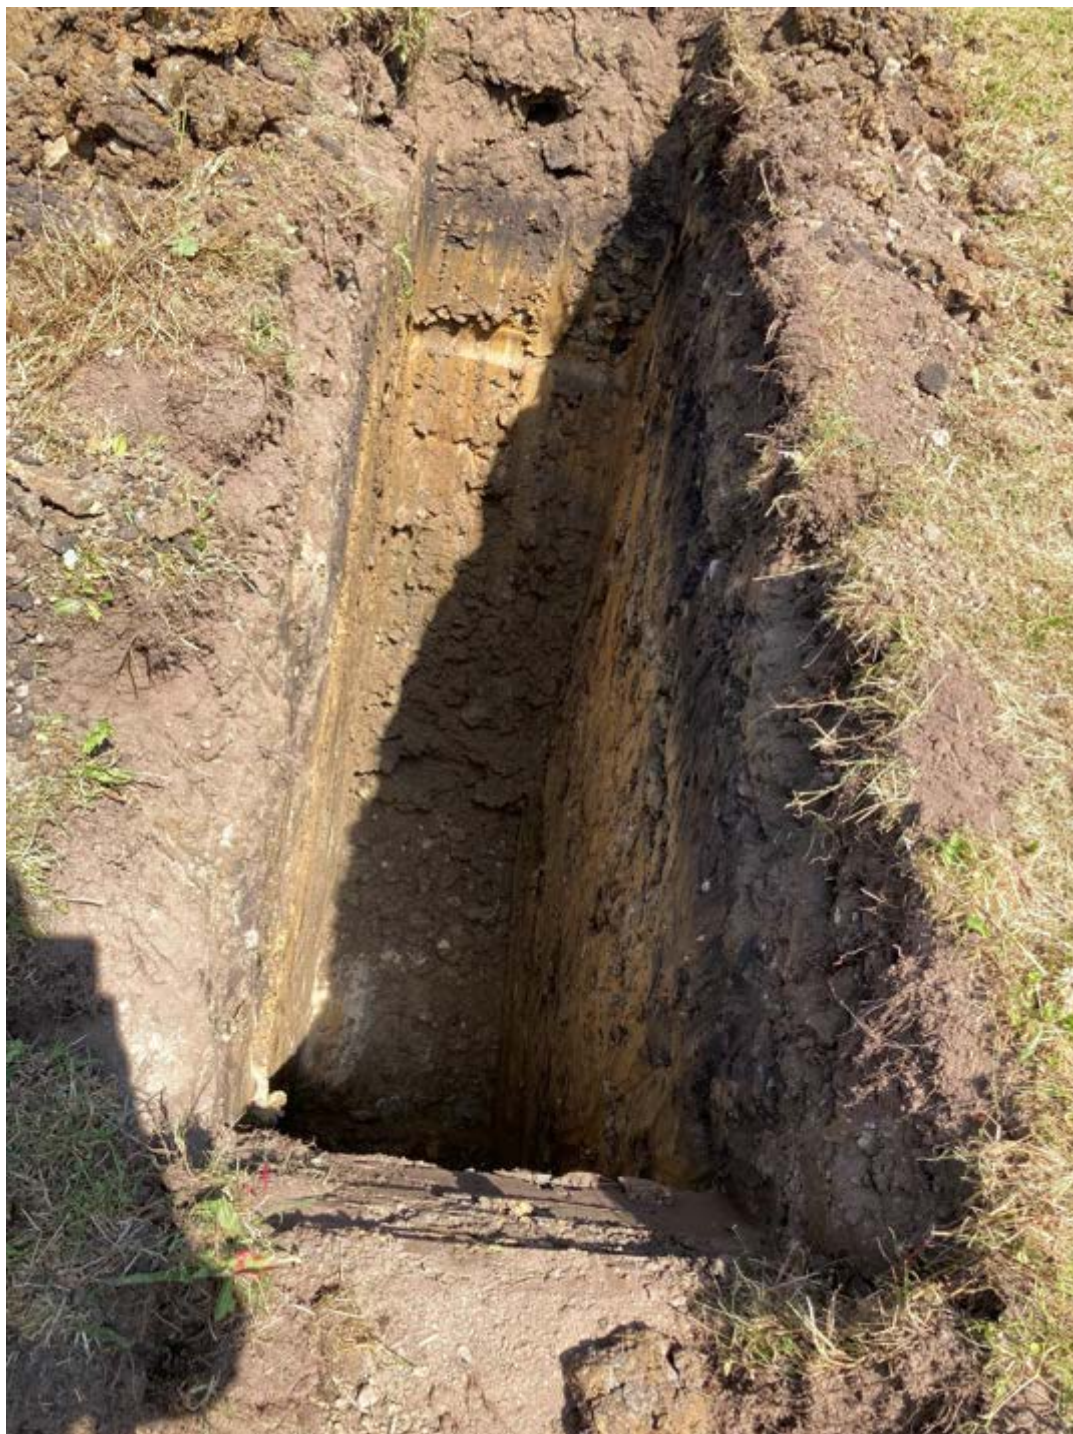
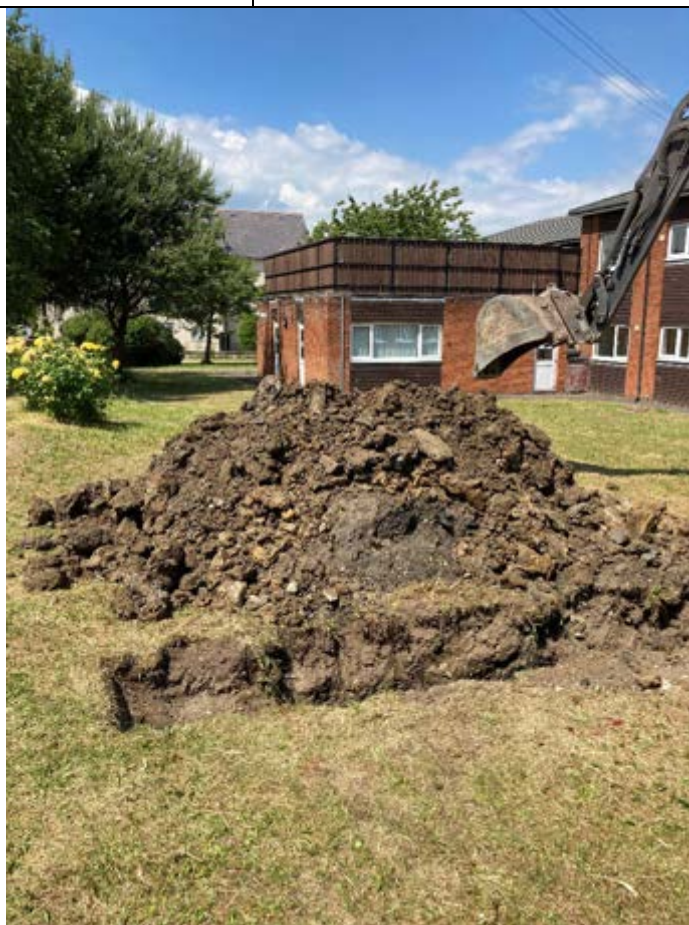
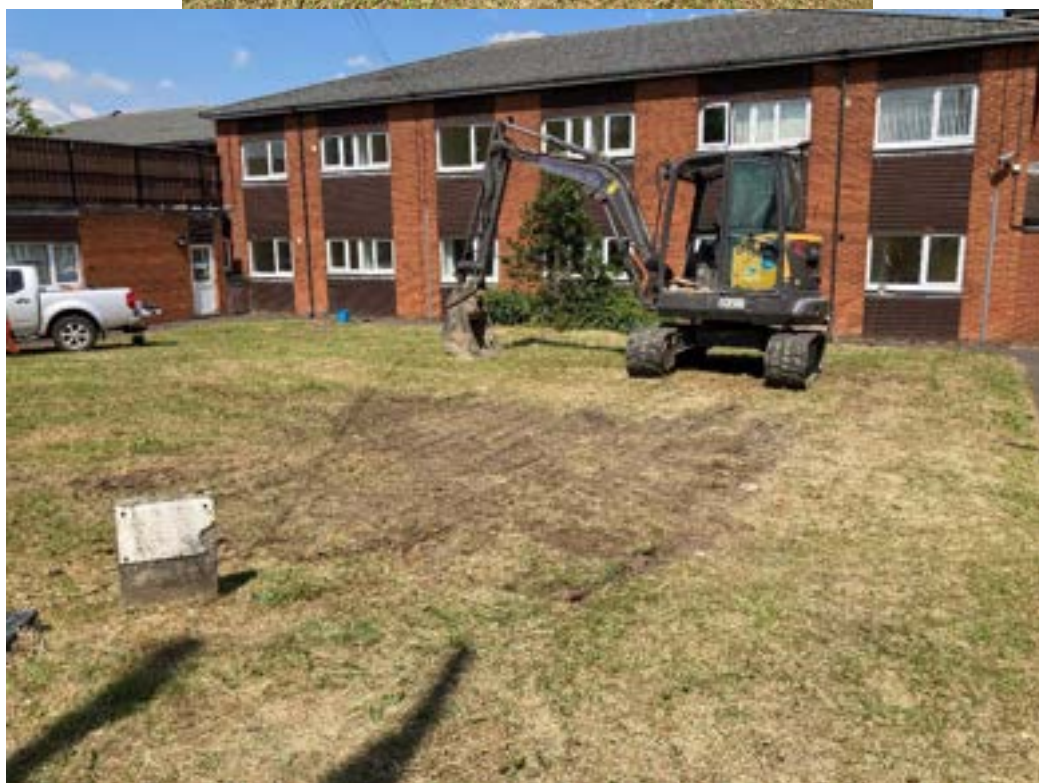
**Trial Pit Photographs:**

| | | Project: Maes Y Capel | Trial Pit:<br><b>TP03</b> |
|---|---|---|---|
| 0 | 0.2 | Dark brown sandy silt with grass/rootlets contains occasional brick cobble and plastic TOPSOIL. | Env: 0.2-0.25m |
| 0.2 | 0.4 | Very gravelly slightly silty sand. Gravel fine to coarse angular to subangular of sandstone and occasion piece of brick and pottery. Occasional cobble of brick. | |
| 0.4 | 0.6 | Black slightly sandy organic SILT. Potentially relic topsoil. | |
| 0.6 | 2.7 | <p>Firm grey mottled orange slightly sandy gravelly CLAY. Gravel fine to coarse rounded to sub-rounded of siltstone. Occasional subrounded cobble and boulder of sandstone.</p> <p>Excavator struggles at 2.2m interpreted as stiff to very stiff.</p> <p>Bucket scrapes at 2.6m very slow advancement.</p> <p><b>2.7m end, excavator could not advance either due large boulder or bedrock.</b></p> | Geotech: 0.7-0.75m (bulk), 1.5-1.66m (bulk), 2.2-2.3m (bulk). |
| <p><b>Excavated by</b> – 5 tonne tracked excavator</p> <p><b>Plan Dimensions of Pit</b> – 0.8m x 2m</p> <p><b>Groundwater</b> - Dry</p> <p><b>Stability</b> – Stable, sides remained vertical when excavated,</p> <p><b>Contamination</b> – No visual or olfactory evidence of contamination</p> | | | |

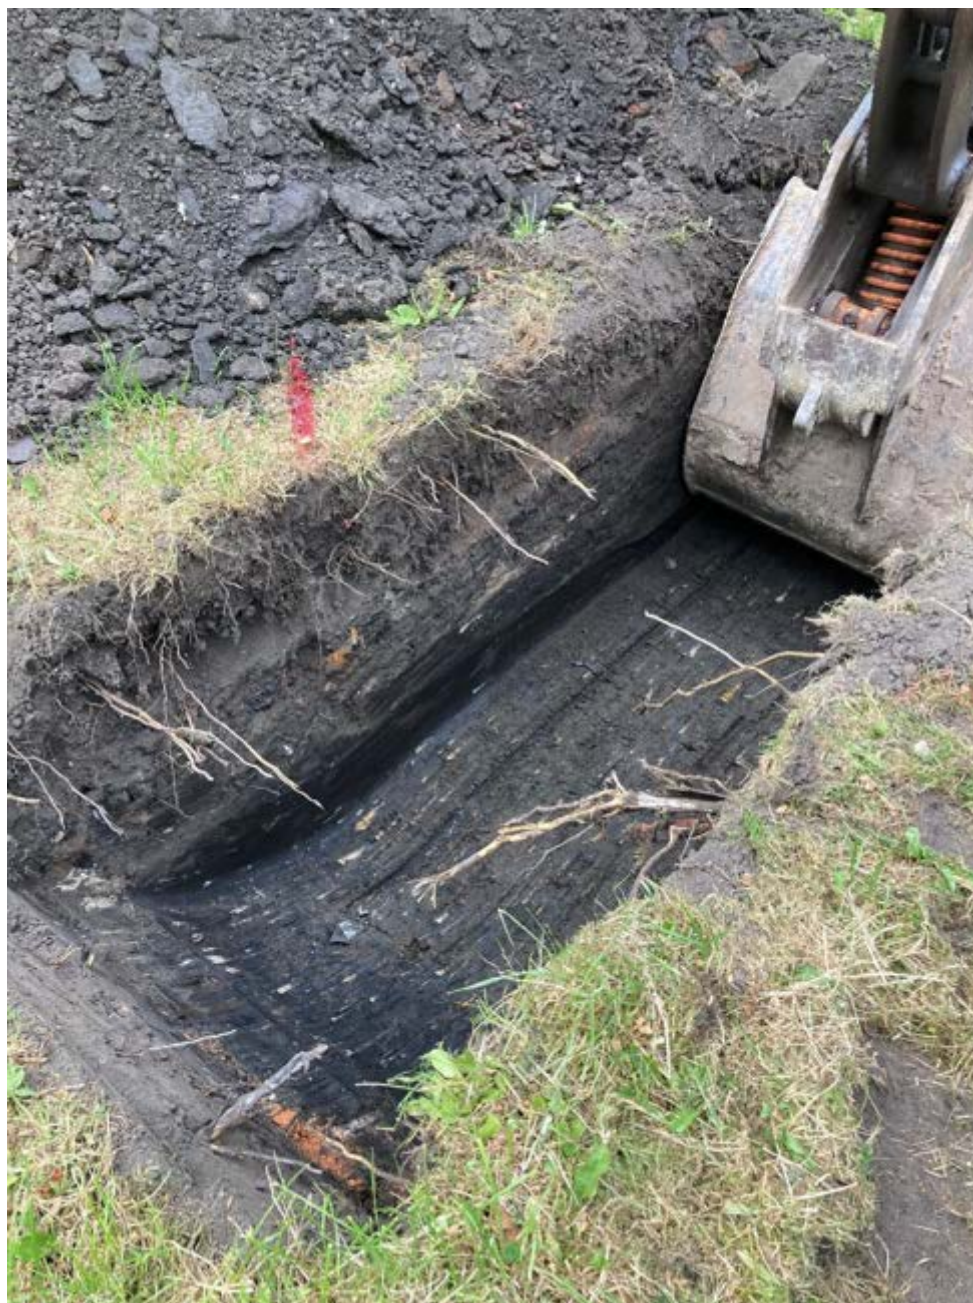
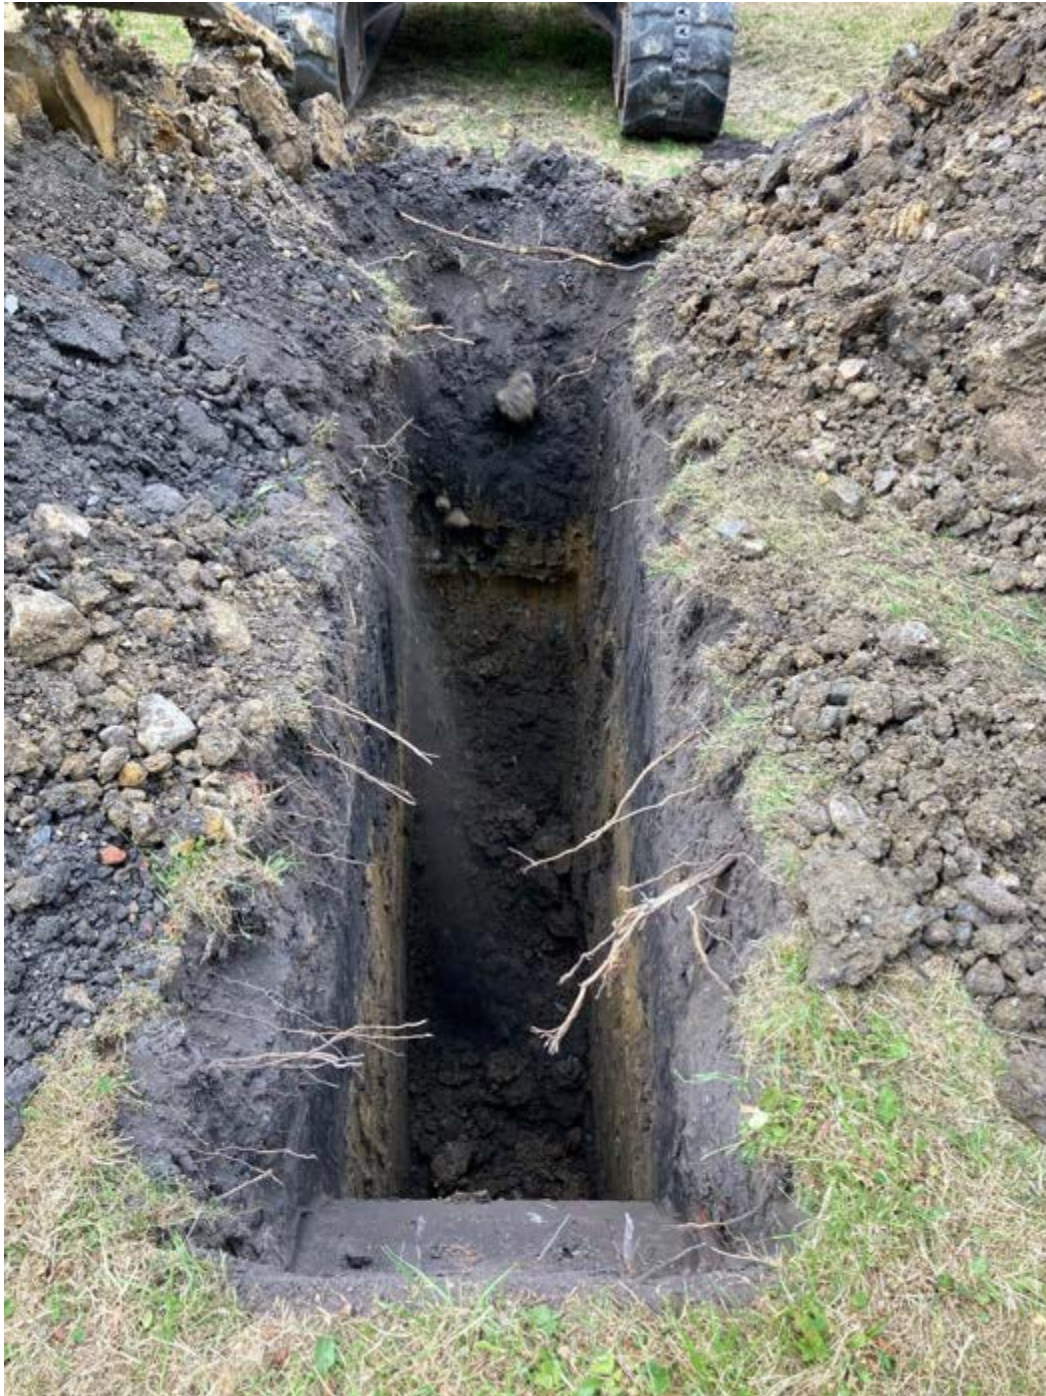
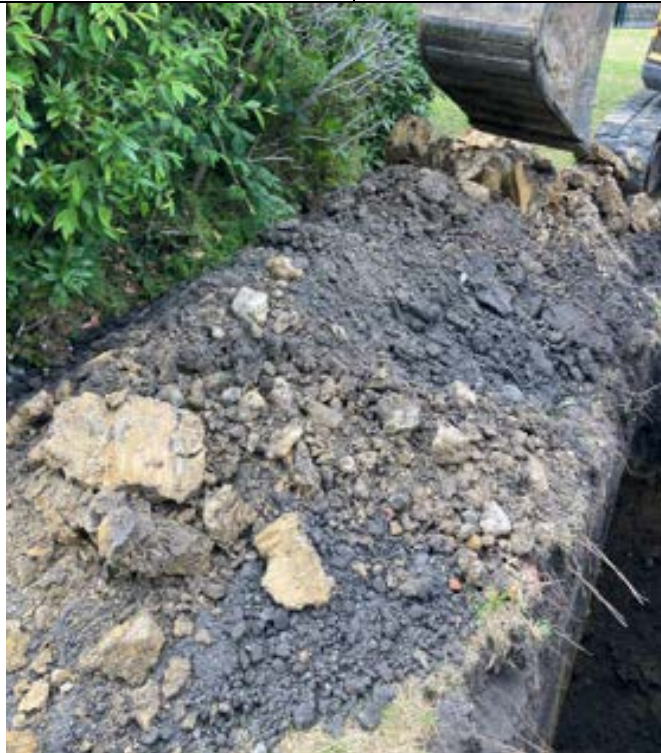
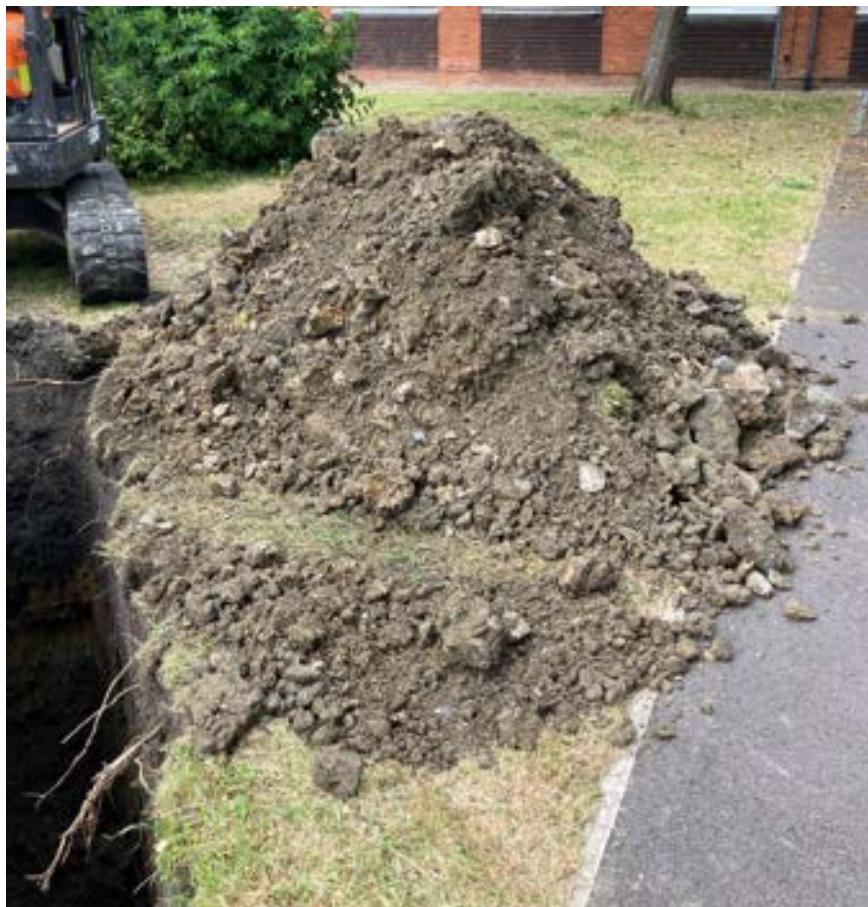
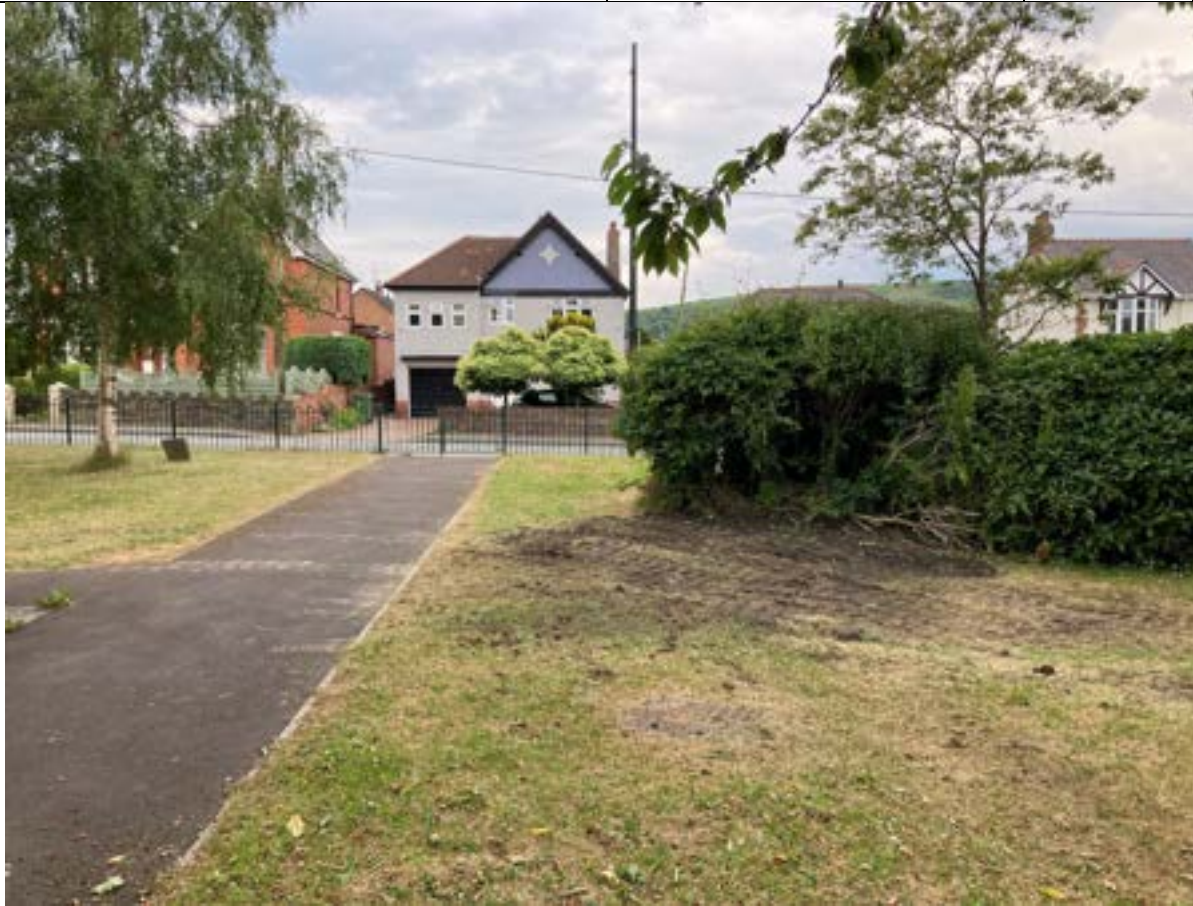
**Trial Pit Photographs:**

| 0 | 0.4 | Dark brown sandy silt with grass/rootlets contains roots, occasional brick cobble, plastic, and wood TOPSOIL. | | |
| 0.4 | 0.85 | Black gravelly slightly silty sand. Gravel fine to coarse subrounded to angular of sandstone, glass milk bottle, plastic. ASH/MADE GROUND. | | |
| 0.85 | 1.5 | Firm grey mottled orange slightly sandy gravelly CLAY. Gravel fine to coarse rounded to sub-rounded of siltstone. Occasional subrounded cobble and boulder of sandstone. Average hand shear vane reading=52kPa. | | |
| 1.5 | 3 | Stiff dark grey mottled brown sandy gravelly CLAY with occasional cobbles. Gravel fine to coarse and subrounded of mudstone. Cobbles subrounded of mudstone. Excavator struggles to advance (interpreted as stiff).<br><br>Cobbles become more frequent at c.2.5m<br><br>Digging very slow at 2.7m<br><br><b>End 3m.</b> | | |
| <b>Excavated by</b> – 5 tonne tracked excavator<br><b>Plan Dimensions of Pit</b> – 0.8m x 2.2m<br><b>Groundwater</b> - Dry<br><b>Stability</b> – Stable, sides remained vertical when excavated,<br><b>Contamination</b> – No visual or olfactory evidence of contamination | | | | |
