## **PHASE 2 GROUND INVESTIGATION:**

**GSL2949**

Wales and West Housing

GroundSolve Ltd

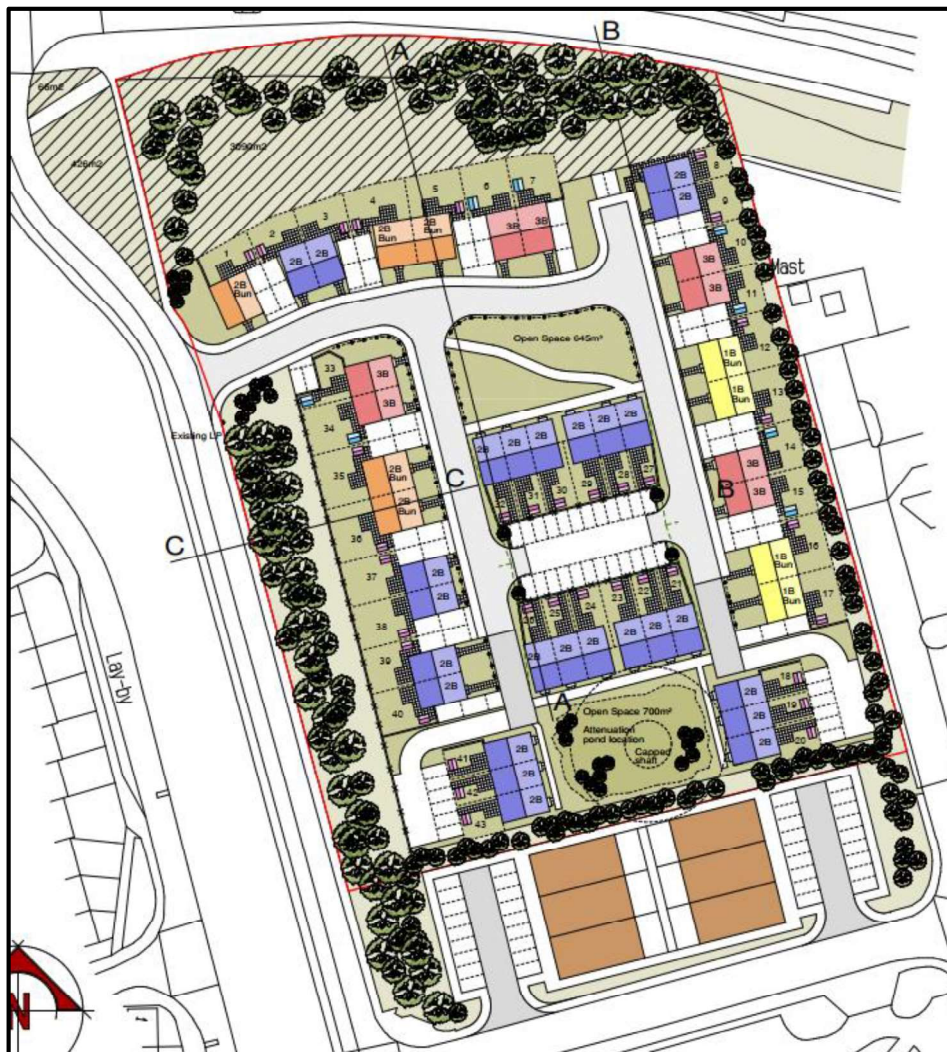
**Figure 1 - Extract from Proposed Development Plan**

The proposed development is comprised of 43 residential properties with associated parking and garden areas as well as access roads and two areas of open recreational space. Also proposed are 6 industrial properties to the south of the site with associated parking and access road. See **Figure 1** below.

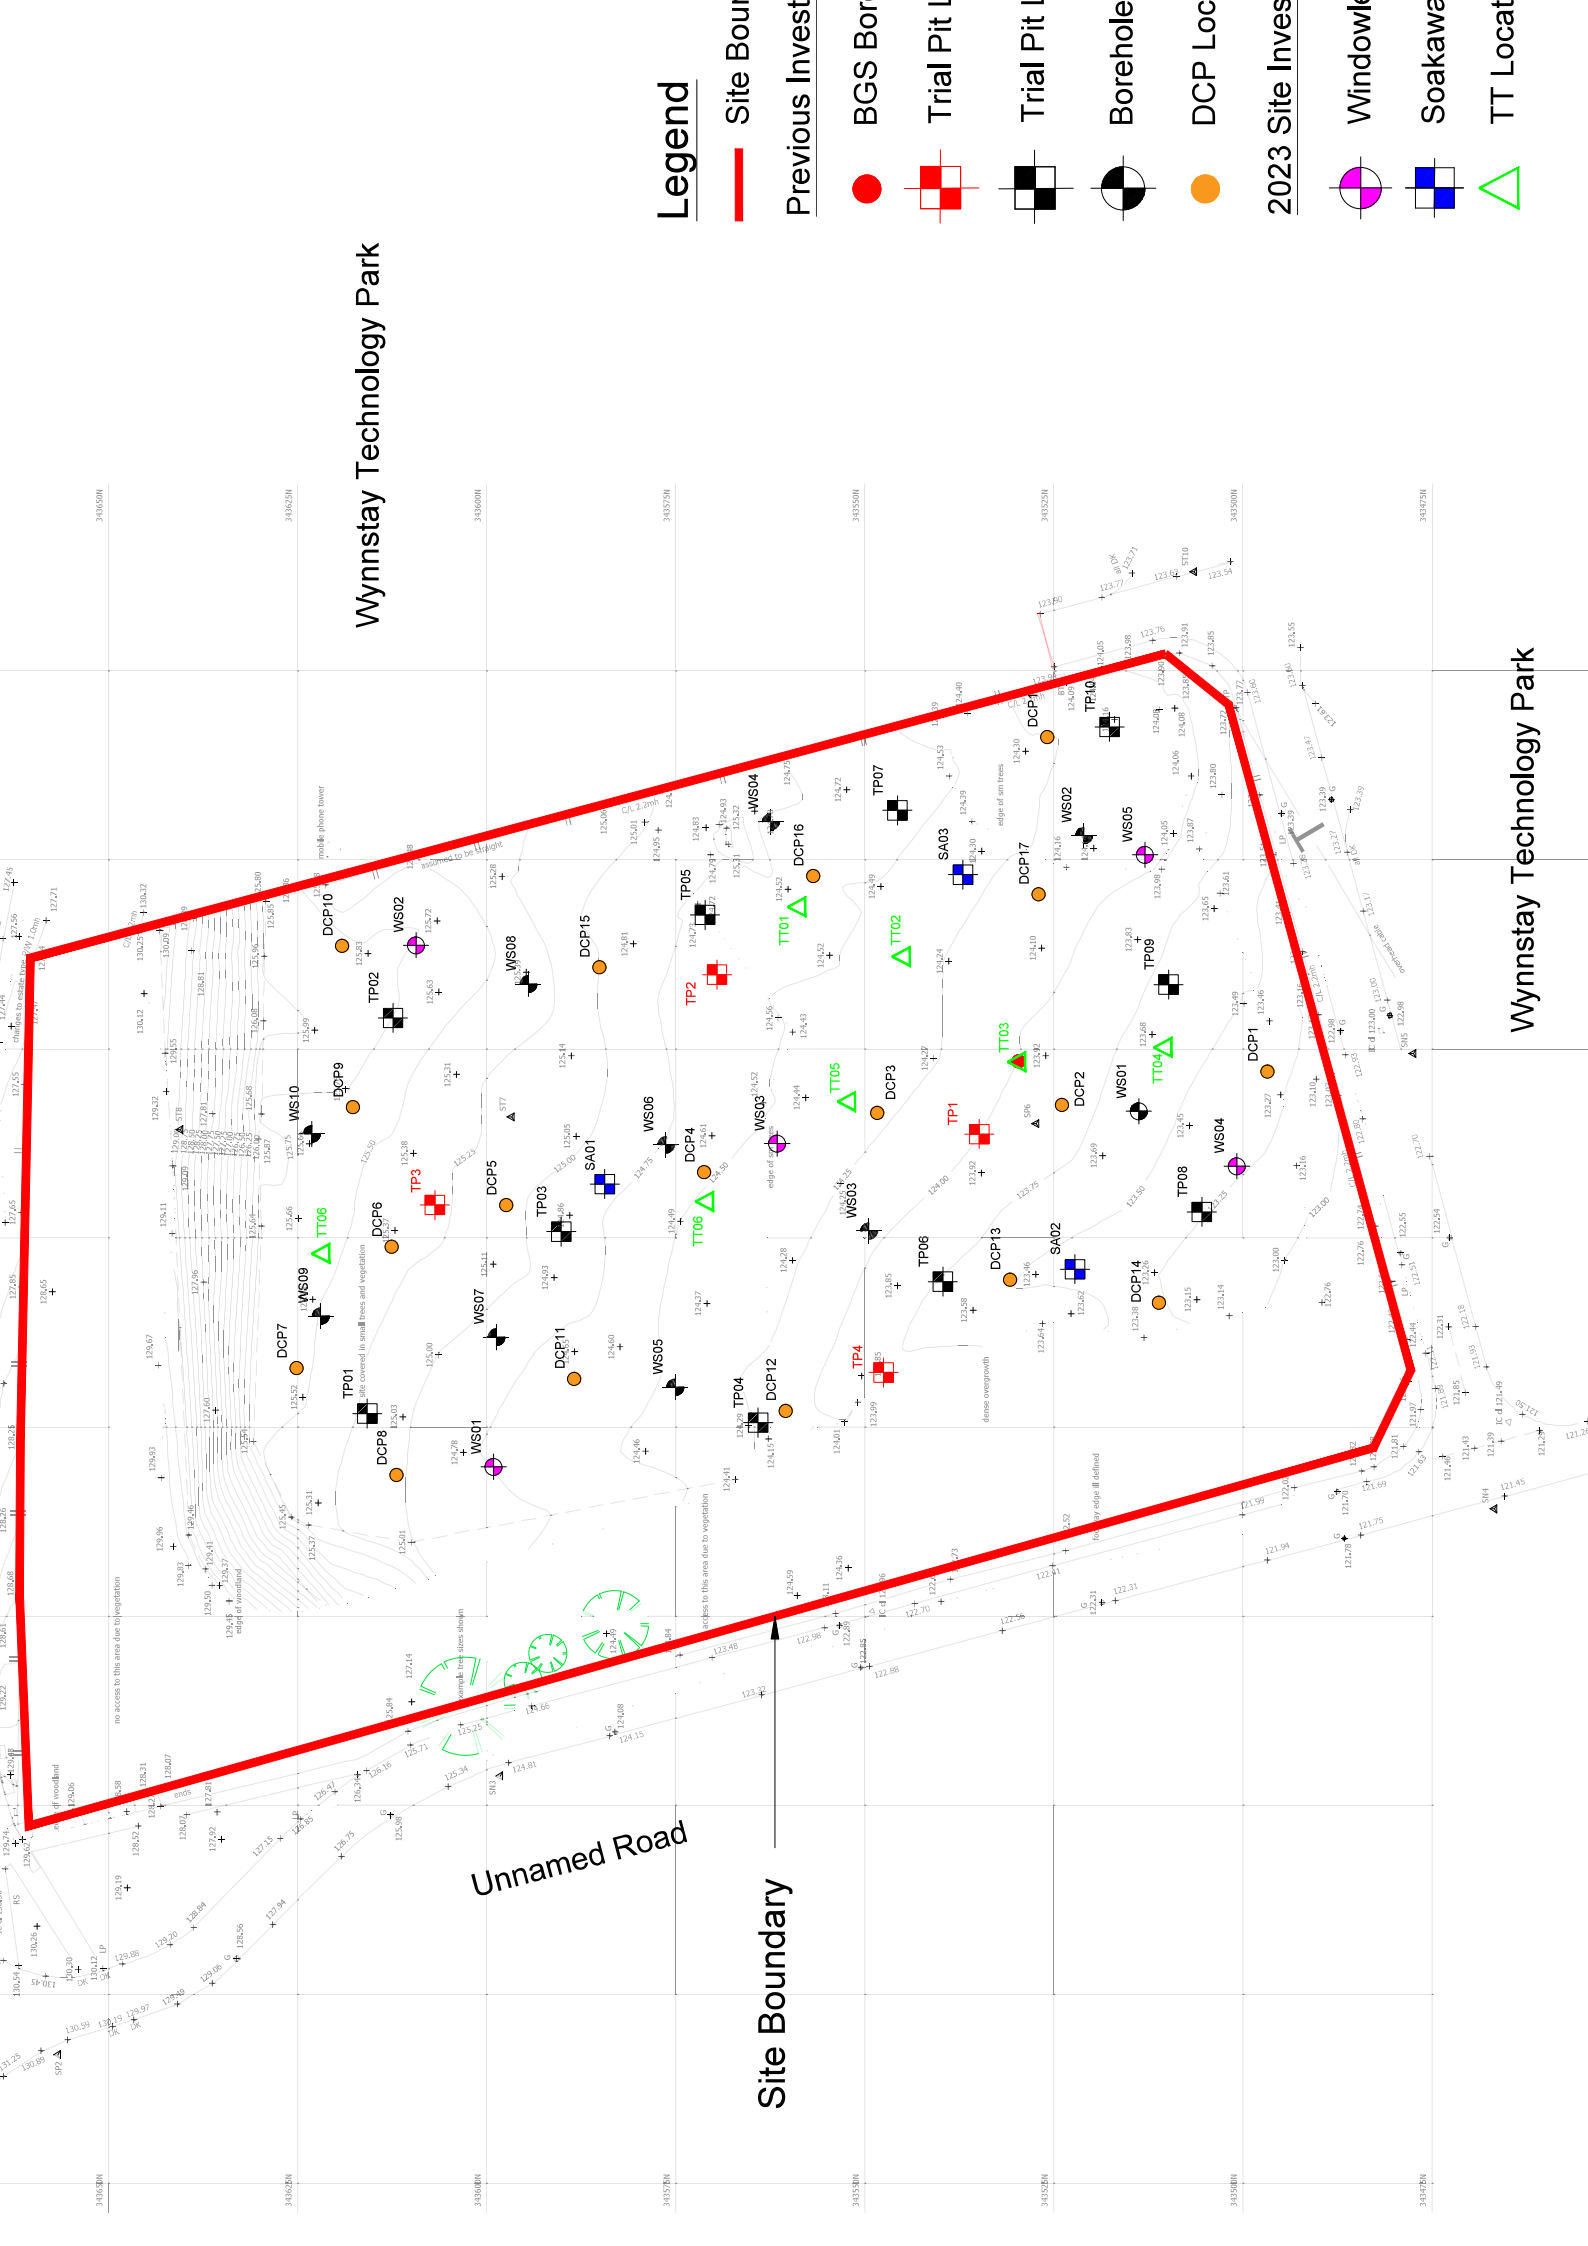
The locations of all exploratory holes can be found in **Figure 2** along with the locations of the previous investigations.
