## **Tyn Y Coed, Chester Road, Rossett, Wrexham**

### **Bat Activity Survey Report**

Report number: ROS/01/22

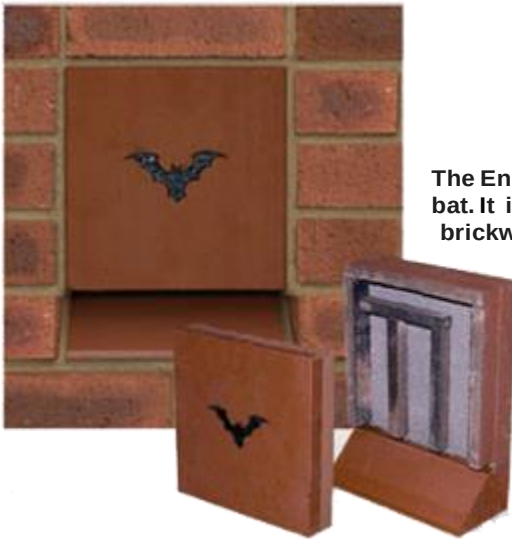
The Enclosed Bat Box 'C' from Ibstock is designed for the pipistrelle bat. It is ideal for new builds as it can be integrated directly into the brickwork to produce a discrete but attractive home for bats.

Therefore, in order to comply with local biodiversity gain policy, it is suggested that three bat boxes/bricks are erected onto the new elevations facing away from the street/local flood lighting.
