| <b>Project Title</b> | "Maes y Rhedyn", Gresford Road, Llay |
| <b>Document Title</b> | Validation Report For Placement of Inert Cover For POS |
| <b>Document Number</b> | 6697val_POS |

# INERT COVER VALIDATION REPORT FOR POS

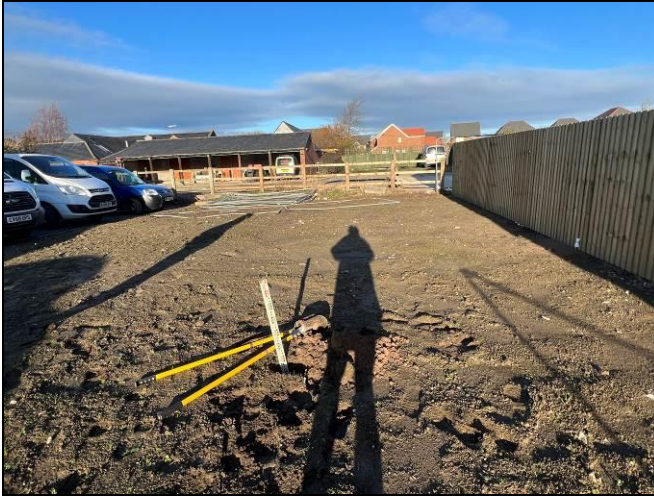
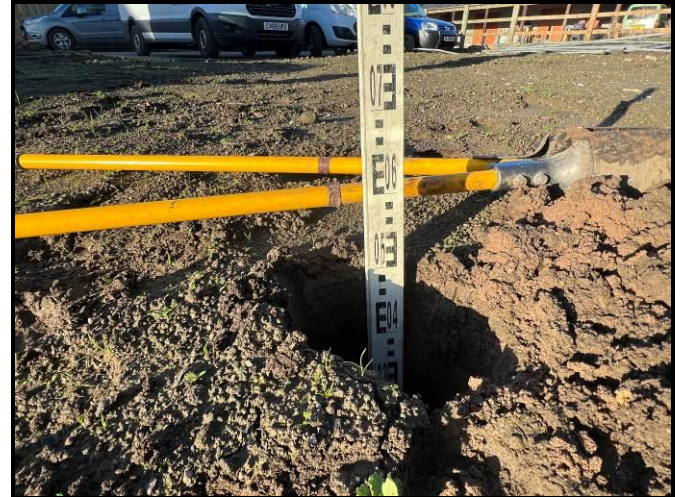
### POS VH1

| Plot Number of validation hole | Plot Range Covered by Validation Hole | Front / Rear / POS | Base of Topsoil | Base of Subsoil | Total Depth of Inert Cover | Description of Topsoil (see photographs) | Description of Subsoil (see photographs) | Source of Topsoil | Source of Subsoil |
|---|---|---|---|---|---|---|---|---|---|
| VH1 | POS | | 200mm | 500mm | 500mm | Dark brown, slightly silty, sandy, clayey TOPSOIL | Light brown, silty SAND | Site Won | Verified greenfield source from Mescar Fisheries, Lydiate L31 4HS |

Photographs 1 & 2: Showing the location of the validation hole within the POS Area and the depth of inert cover achieved. Photographs taken 23<sup>rd</sup> November 2023.

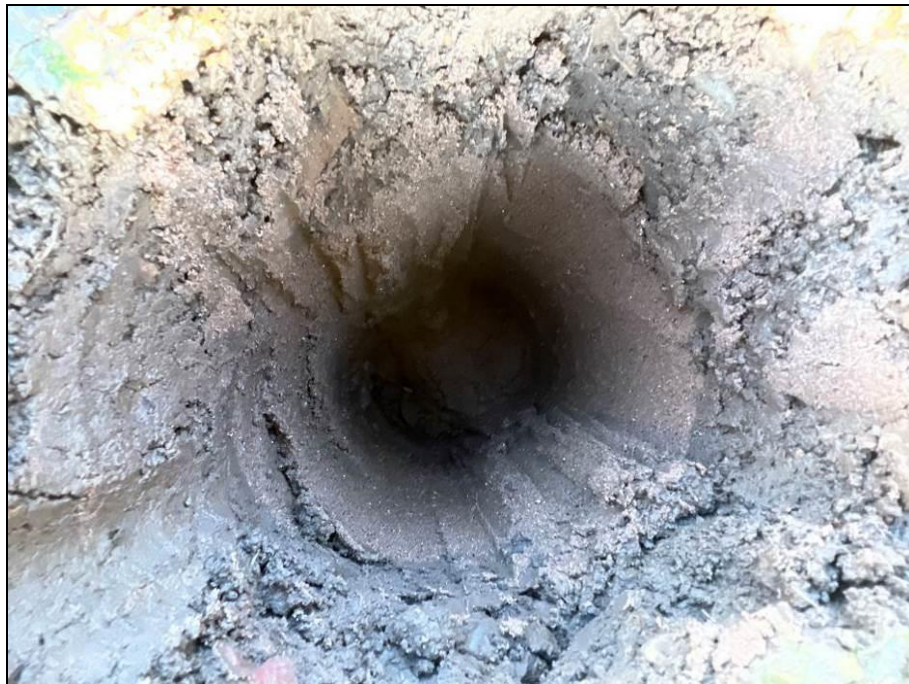
Photograph 3: Shows the composition of the inert cover within the validation hole in the POS Area. Photograph taken 23<sup>rd</sup> November 2023.

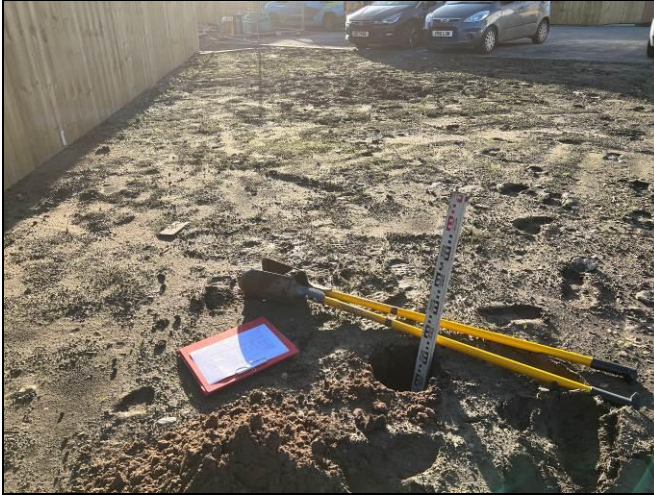
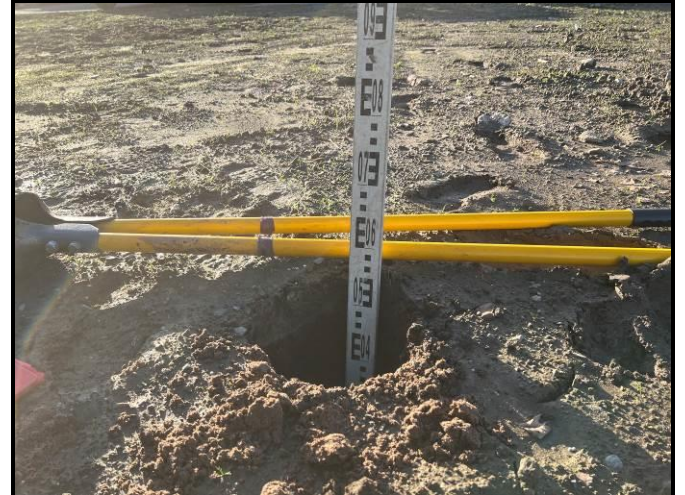
**POS VH2**

| Plot Number of validation hole | Plot Range Covered by Validation Hole | Front / Rear / POS | Base of Topsoil | Base of Subsoil | Total Depth of Inert Cover | Description of Topsoil (see photographs) | Description of Subsoil (see photographs) | Source of Topsoil | Source of Subsoil |
|---|---|---|---|---|---|---|---|---|---|
| VH2 | POS | | 200mm | 600mm | 600mm | Dark brown, slightly silty, sandy, clayey TOPSOIL | Light brown, silty SAND | Site Won | Verified greenfield source from Mescar Fisheries, Lydiate L31 4HS |

Photographs 4 & 5: Showing the location of the validation hole within the POS Area and the depth of inert cover achieved. Photographs taken 23<sup>rd</sup> November 2023.

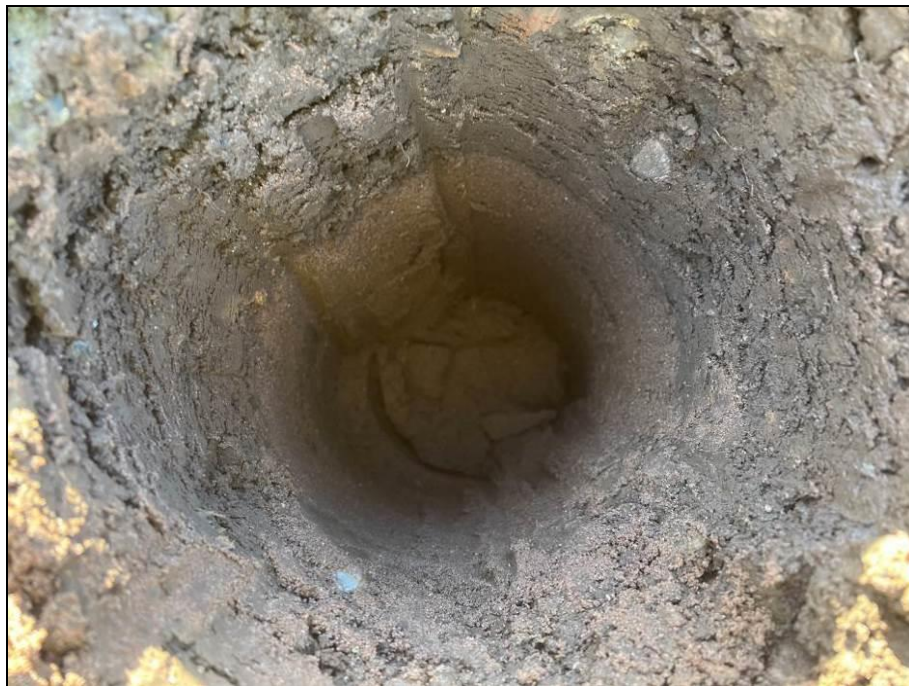
Photograph 6: Shows the composition of the inert cover within the validation hole in the POS Area. Photograph taken 23<sup>rd</sup> November 2023.

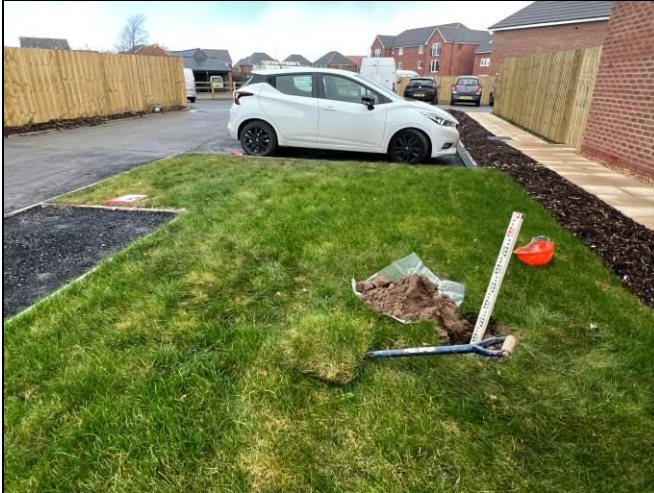
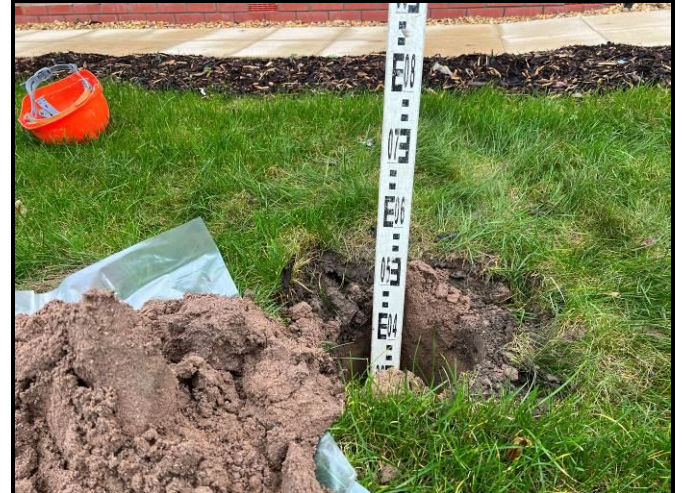
**POS VH3**

| Plot Number of validation hole | Plot Range Covered by Validation Hole | Front / Rear / POS | Base of Topsoil | Base of Subsoil | Total Depth of Inert Cover | Description of Topsoil (see photographs) | Description of Subsoil (see photographs) | Source of Topsoil | Source of Subsoil |
|---|---|---|---|---|---|---|---|---|---|
| VH3 | POS | | 150mm | 500mm | 500mm | Dark brown, slightly silty, sandy, clayey TOPSOIL | Light brown, silty SAND | Site Won | Verified greenfield source from Mescar Fisheries, Lydiate L31 4HS |

Photographs 7 & 8: Showing the location of the validation hole within the POS Area and the depth of inert cover achieved. Photographs taken 24<sup>th</sup> November 2023.

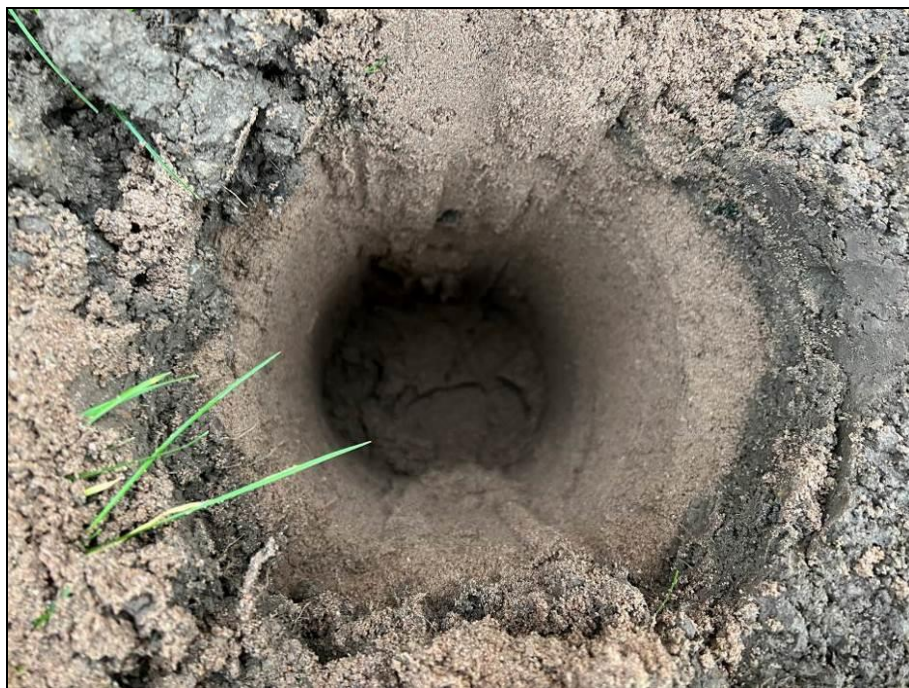
Photograph 9: Shows the composition of the inert cover within the validation hole in the POS Area. Photograph taken 24<sup>th</sup> November 2023.

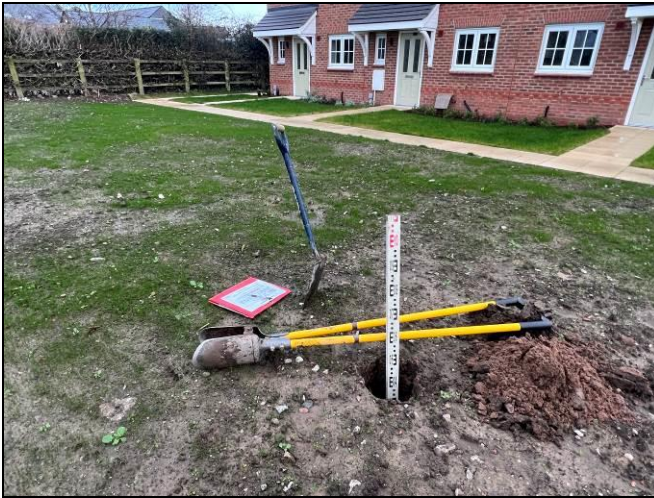
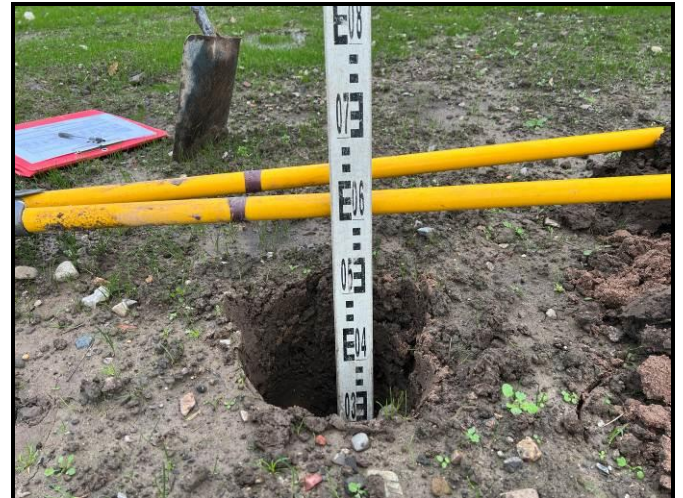
**POS VH4**

| Plot Number of validation hole | Plot Range Covered by Validation Hole | Front / Rear / POS | Base of Topsoil | Base of Subsoil | Total Depth of Inert Cover | Description of Topsoil (see photographs) | Description of Subsoil (see photographs) | Source of Topsoil | Source of Subsoil |
|---|---|---|---|---|---|---|---|---|---|
| VH4 | POS | | 150mm | 500mm | 500mm | Dark brown, slightly silty, sandy, clayey TOPSOIL | Light brown, silty SAND | Site Won | Verified greenfield source from Mescar Fisheries, Lydiate L31 4HS |

Photographs 10 & 11: Showing the location of the validation hole within the POS Area and the depth of inert cover achieved. Photographs taken 24<sup>th</sup> November 2023.

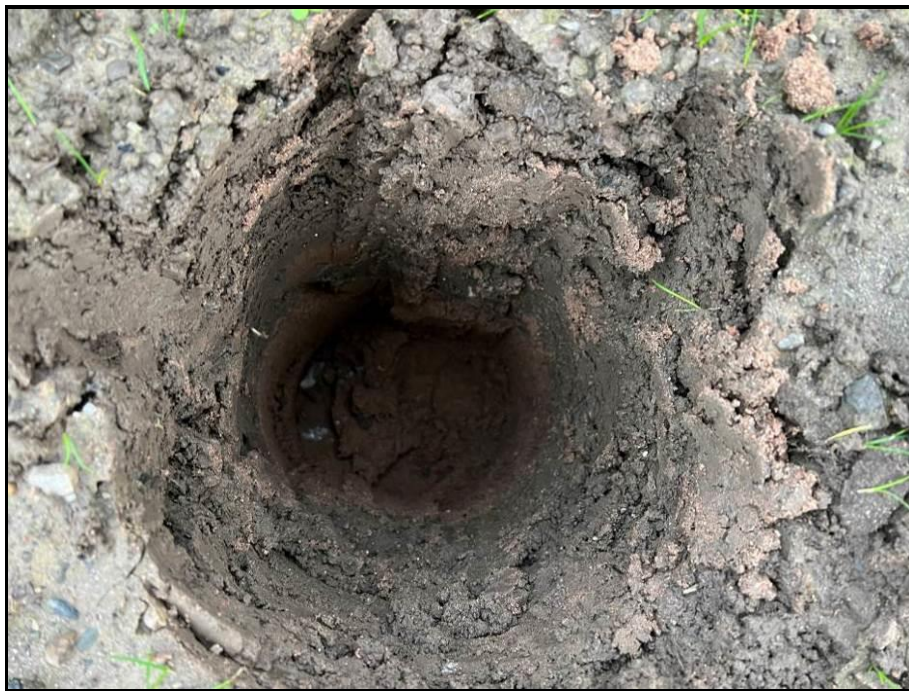
Photograph 12: Shows the composition of the inert cover within the validation hole in the POS Area. Photograph taken 24<sup>th</sup> November 2023.

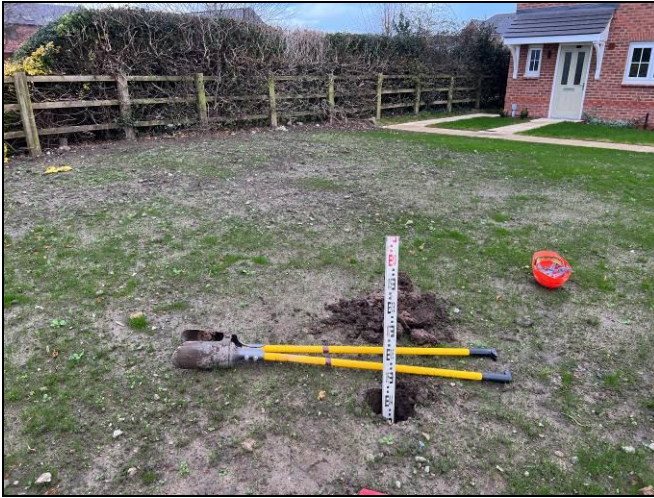
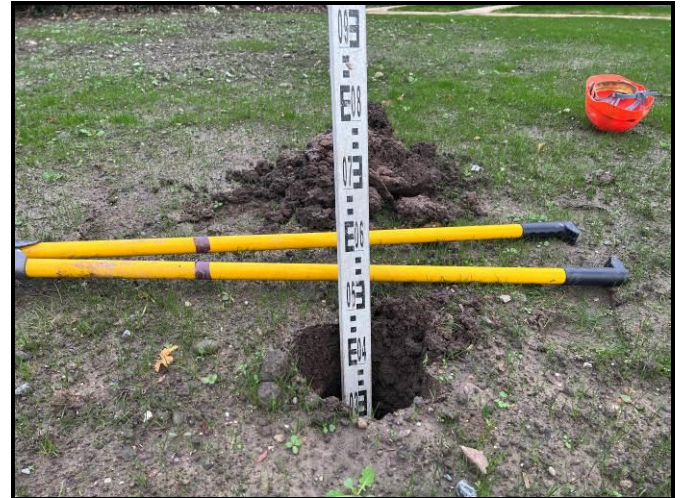
**POS VH5**

| Plot Number of validation hole | Plot Range Covered by Validation Hole | Front / Rear / POS | Base of Topsoil | Base of Subsoil | Total Depth of Inert Cover | Description of Topsoil (see photographs) | Description of Subsoil (see photographs) | Source of Topsoil | Source of Subsoil |
|---|---|---|---|---|---|---|---|---|---|
| VH5 | POS | | 150mm | 500mm | 500mm | Dark brown, slightly silty, sandy, clayey TOPSOIL | Light brown, silty SAND | Site Won | Verified greenfield source from Mescar Fisheries, Lydiate L31 4HS |

Photographs 13 & 14: Showing the location of the validation hole within the POS Area and the depth of inert cover achieved. Photographs taken 24<sup>th</sup> November 2023.

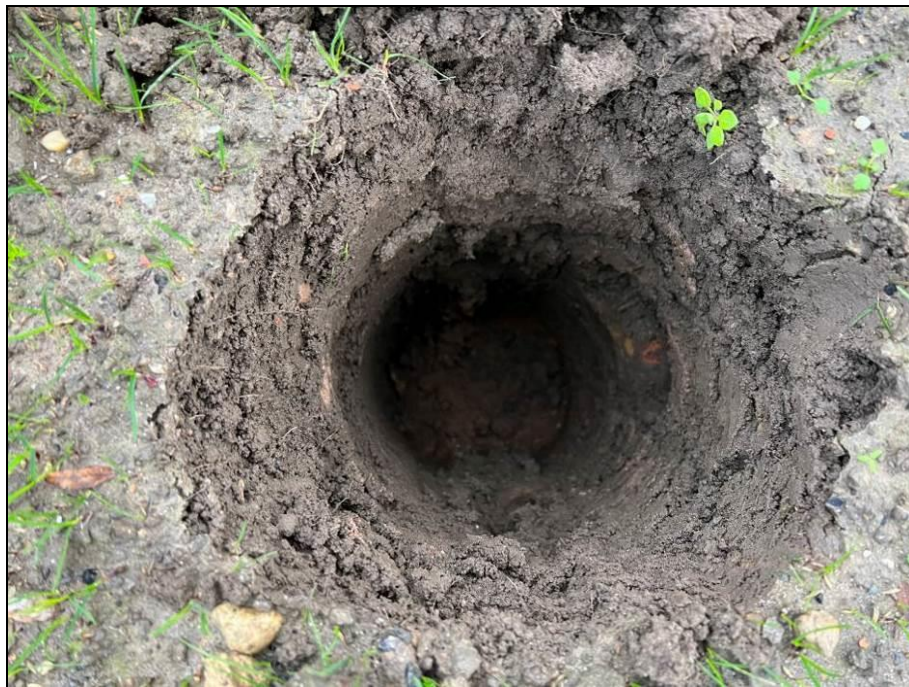
Photograph 15: Shows the composition of the inert cover within the validation hole in the POS Area. Photograph taken 24<sup>th</sup> November 2023.

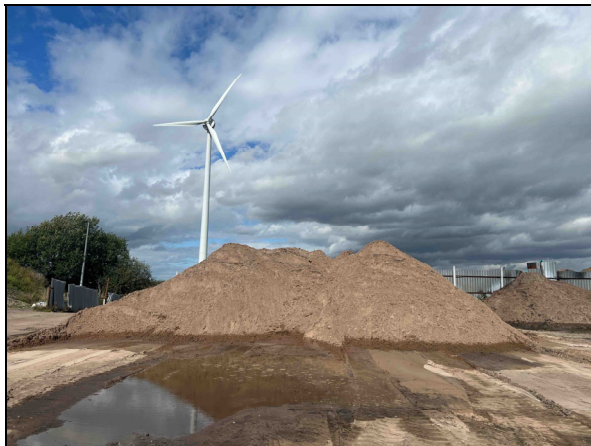
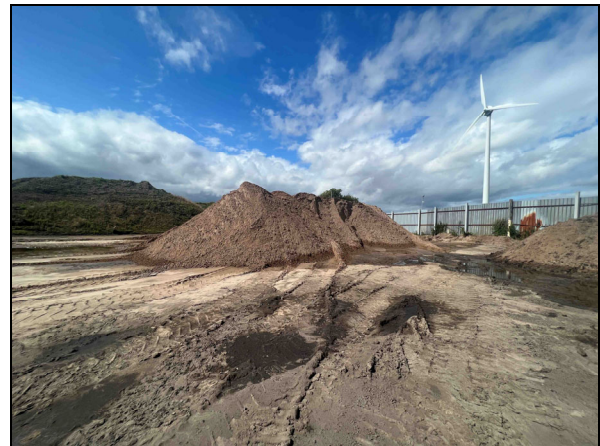
#### **Stockpile Sampling and Inspection – 21<sup>st</sup> August 2023**

*Photographs 1 & 2: Showing the status and nature of the Anwyl Homes subsoil stockpile during sampling and inspection on 21<sup>st</sup> August 2023.*

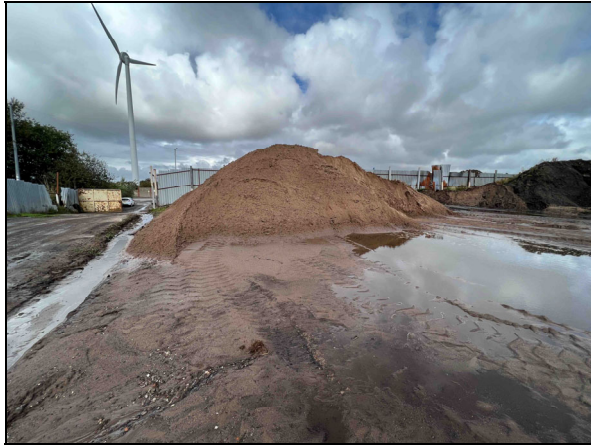
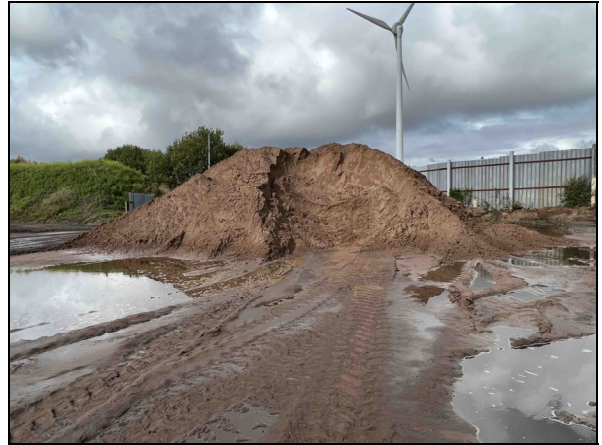
Stockpile Inspection – 22<sup>nd</sup> September 2023

*Photographs 5 & 6: Showing the status and nature of the Anwyl Homes subsoil stockpile during an inspection on 22<sup>nd</sup> September 2023.*

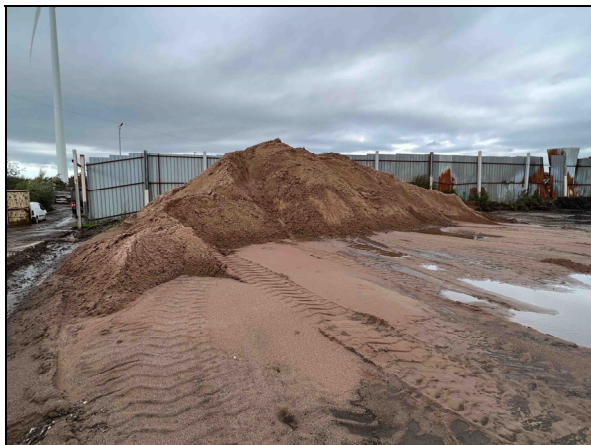
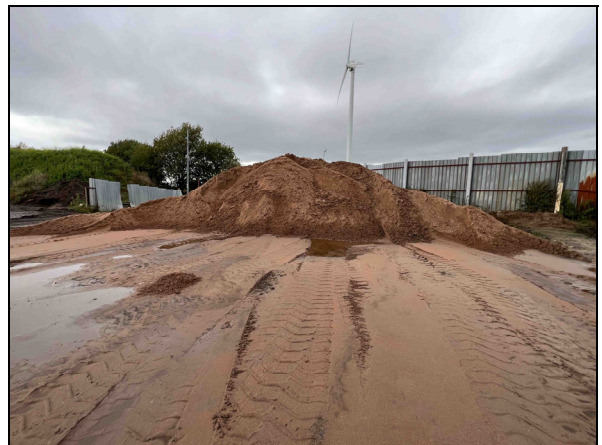
Stockpile Inspection – 6<sup>th</sup> October 2023

*Photographs 7 & 8: Showing the status and nature of the Anwyl Homes subsoil stockpile during an inspection on 6<sup>th</sup> October 2023.*

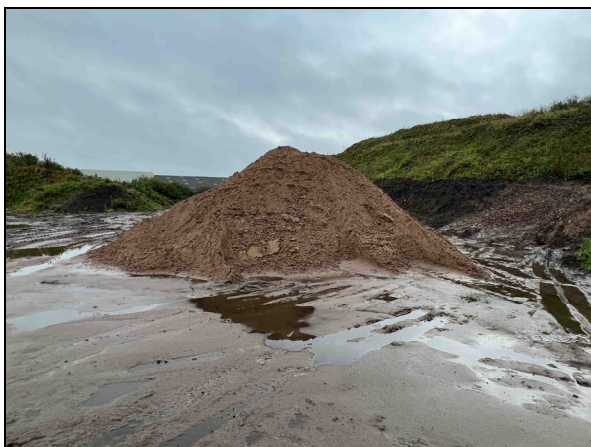
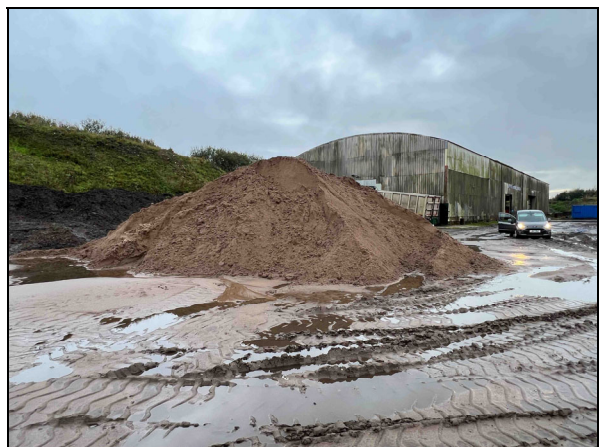
Stockpile Inspection – 19<sup>th</sup> October 2023

*Photographs 9 & 10: Showing the status and nature of the Anwyl Homes subsoil stockpile during an inspection on 19<sup>th</sup> October 2023.*

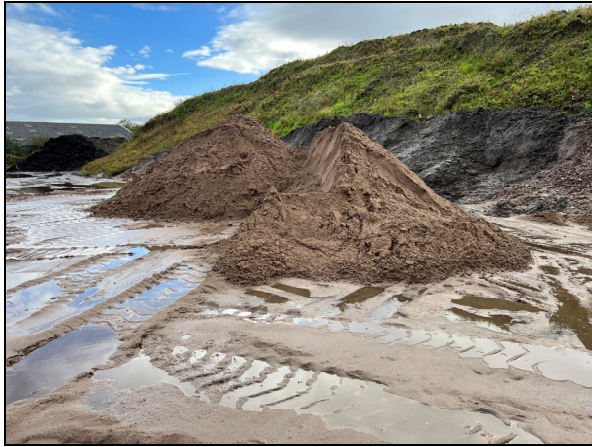
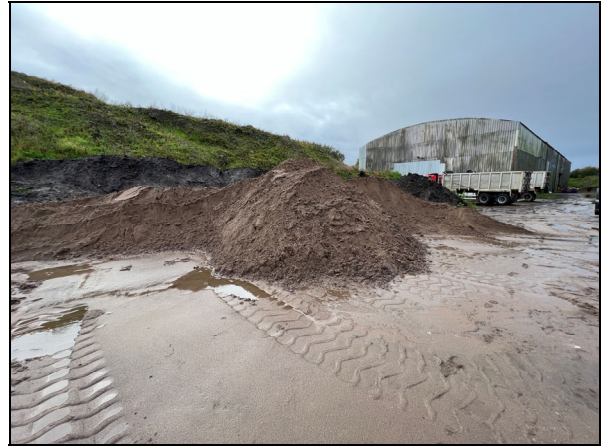
Stockpile Inspection – 2<sup>nd</sup> November 2023

*Photographs 11 & 12: Showing the status and nature of the Anwyl Homes subsoil stockpile during an inspection on 2<sup>nd</sup> November 2023.*

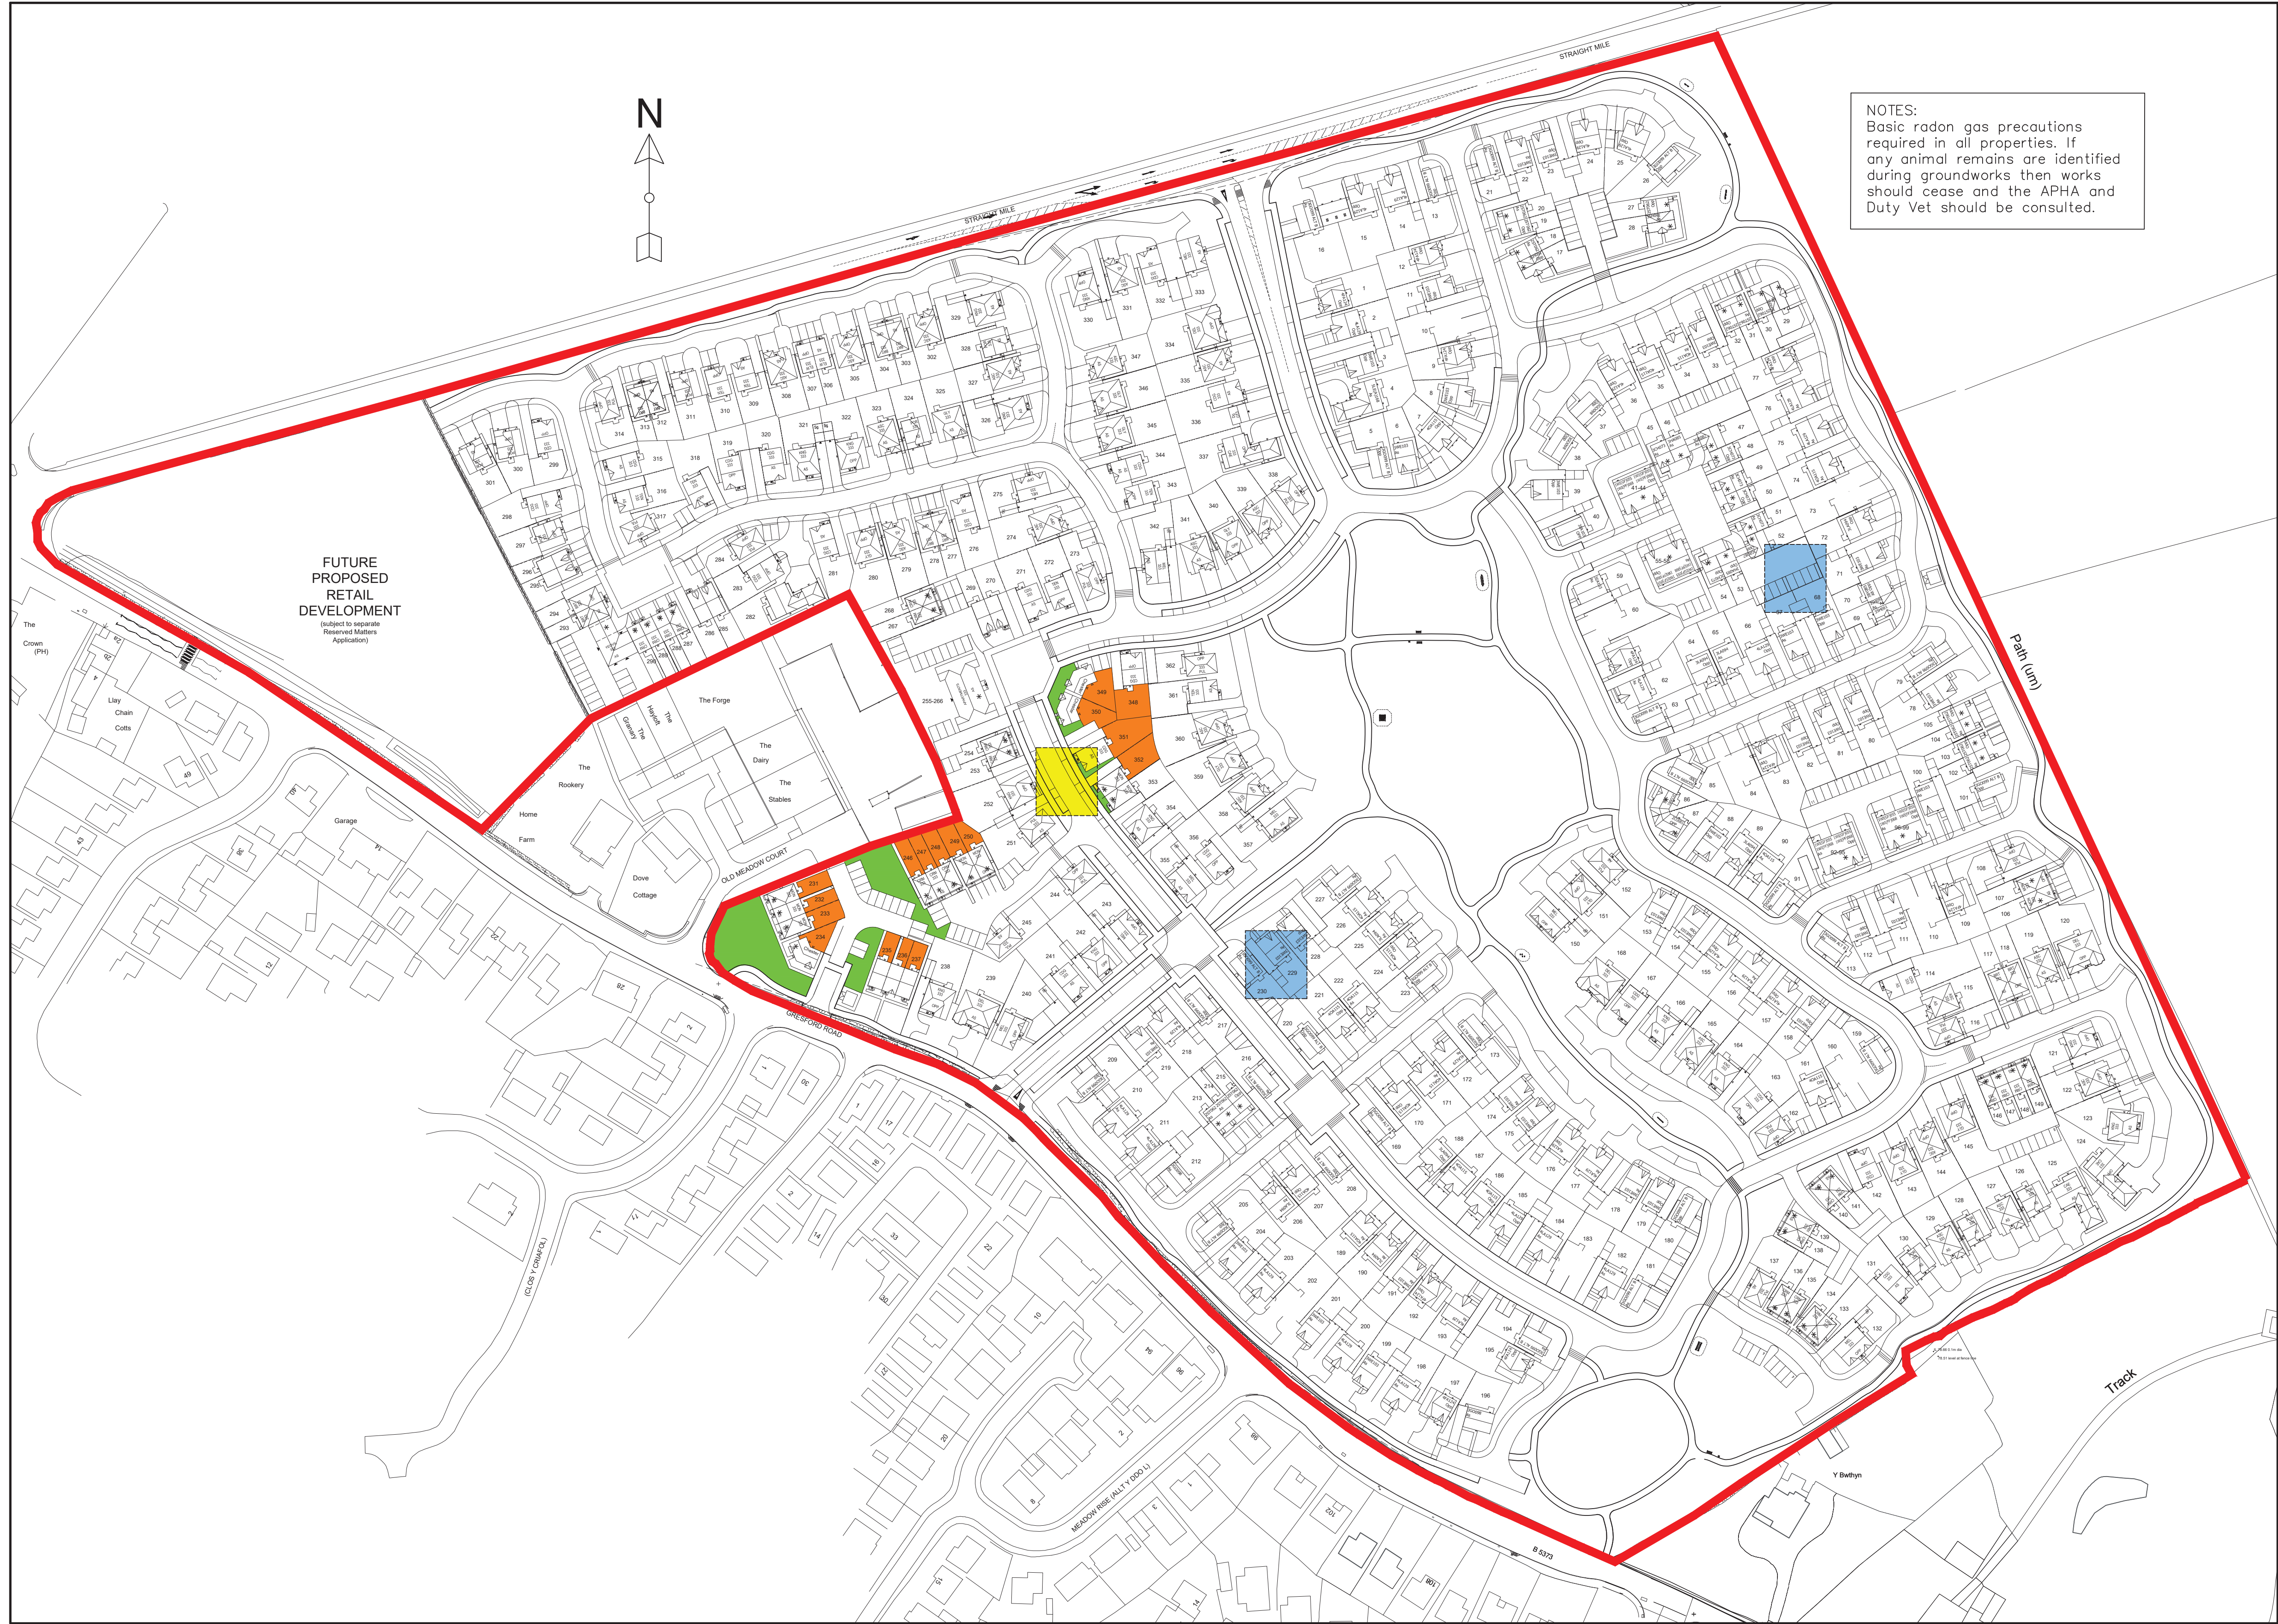
NOTES:  
Basic radon gas precautions  
required in all properties. If  
any animal remains are identified  
during groundworks then works  
should cease and the APHA and  
Duty Vet should be consulted.

- KEY
- Approximate site boundary
  - Front garden landscaped areas where ground levels should be reduced or raised to accommodate 450mm of clean inert capping. Capping should consist of at least 150mm of topsoil.
  - Rear garden areas where ground levels should be raised or reduced to allow for at least 600mm of clean inert capping. Capping should consist of at least 150mm of topsoil.
  - Approximate location where animal remains have been identified and will require appropriate disposal in accordance with APHA and Duty Vet guidance.
  - Approximate areas where landowner has indicated where animal remains may be present but not identified during the site investigation.

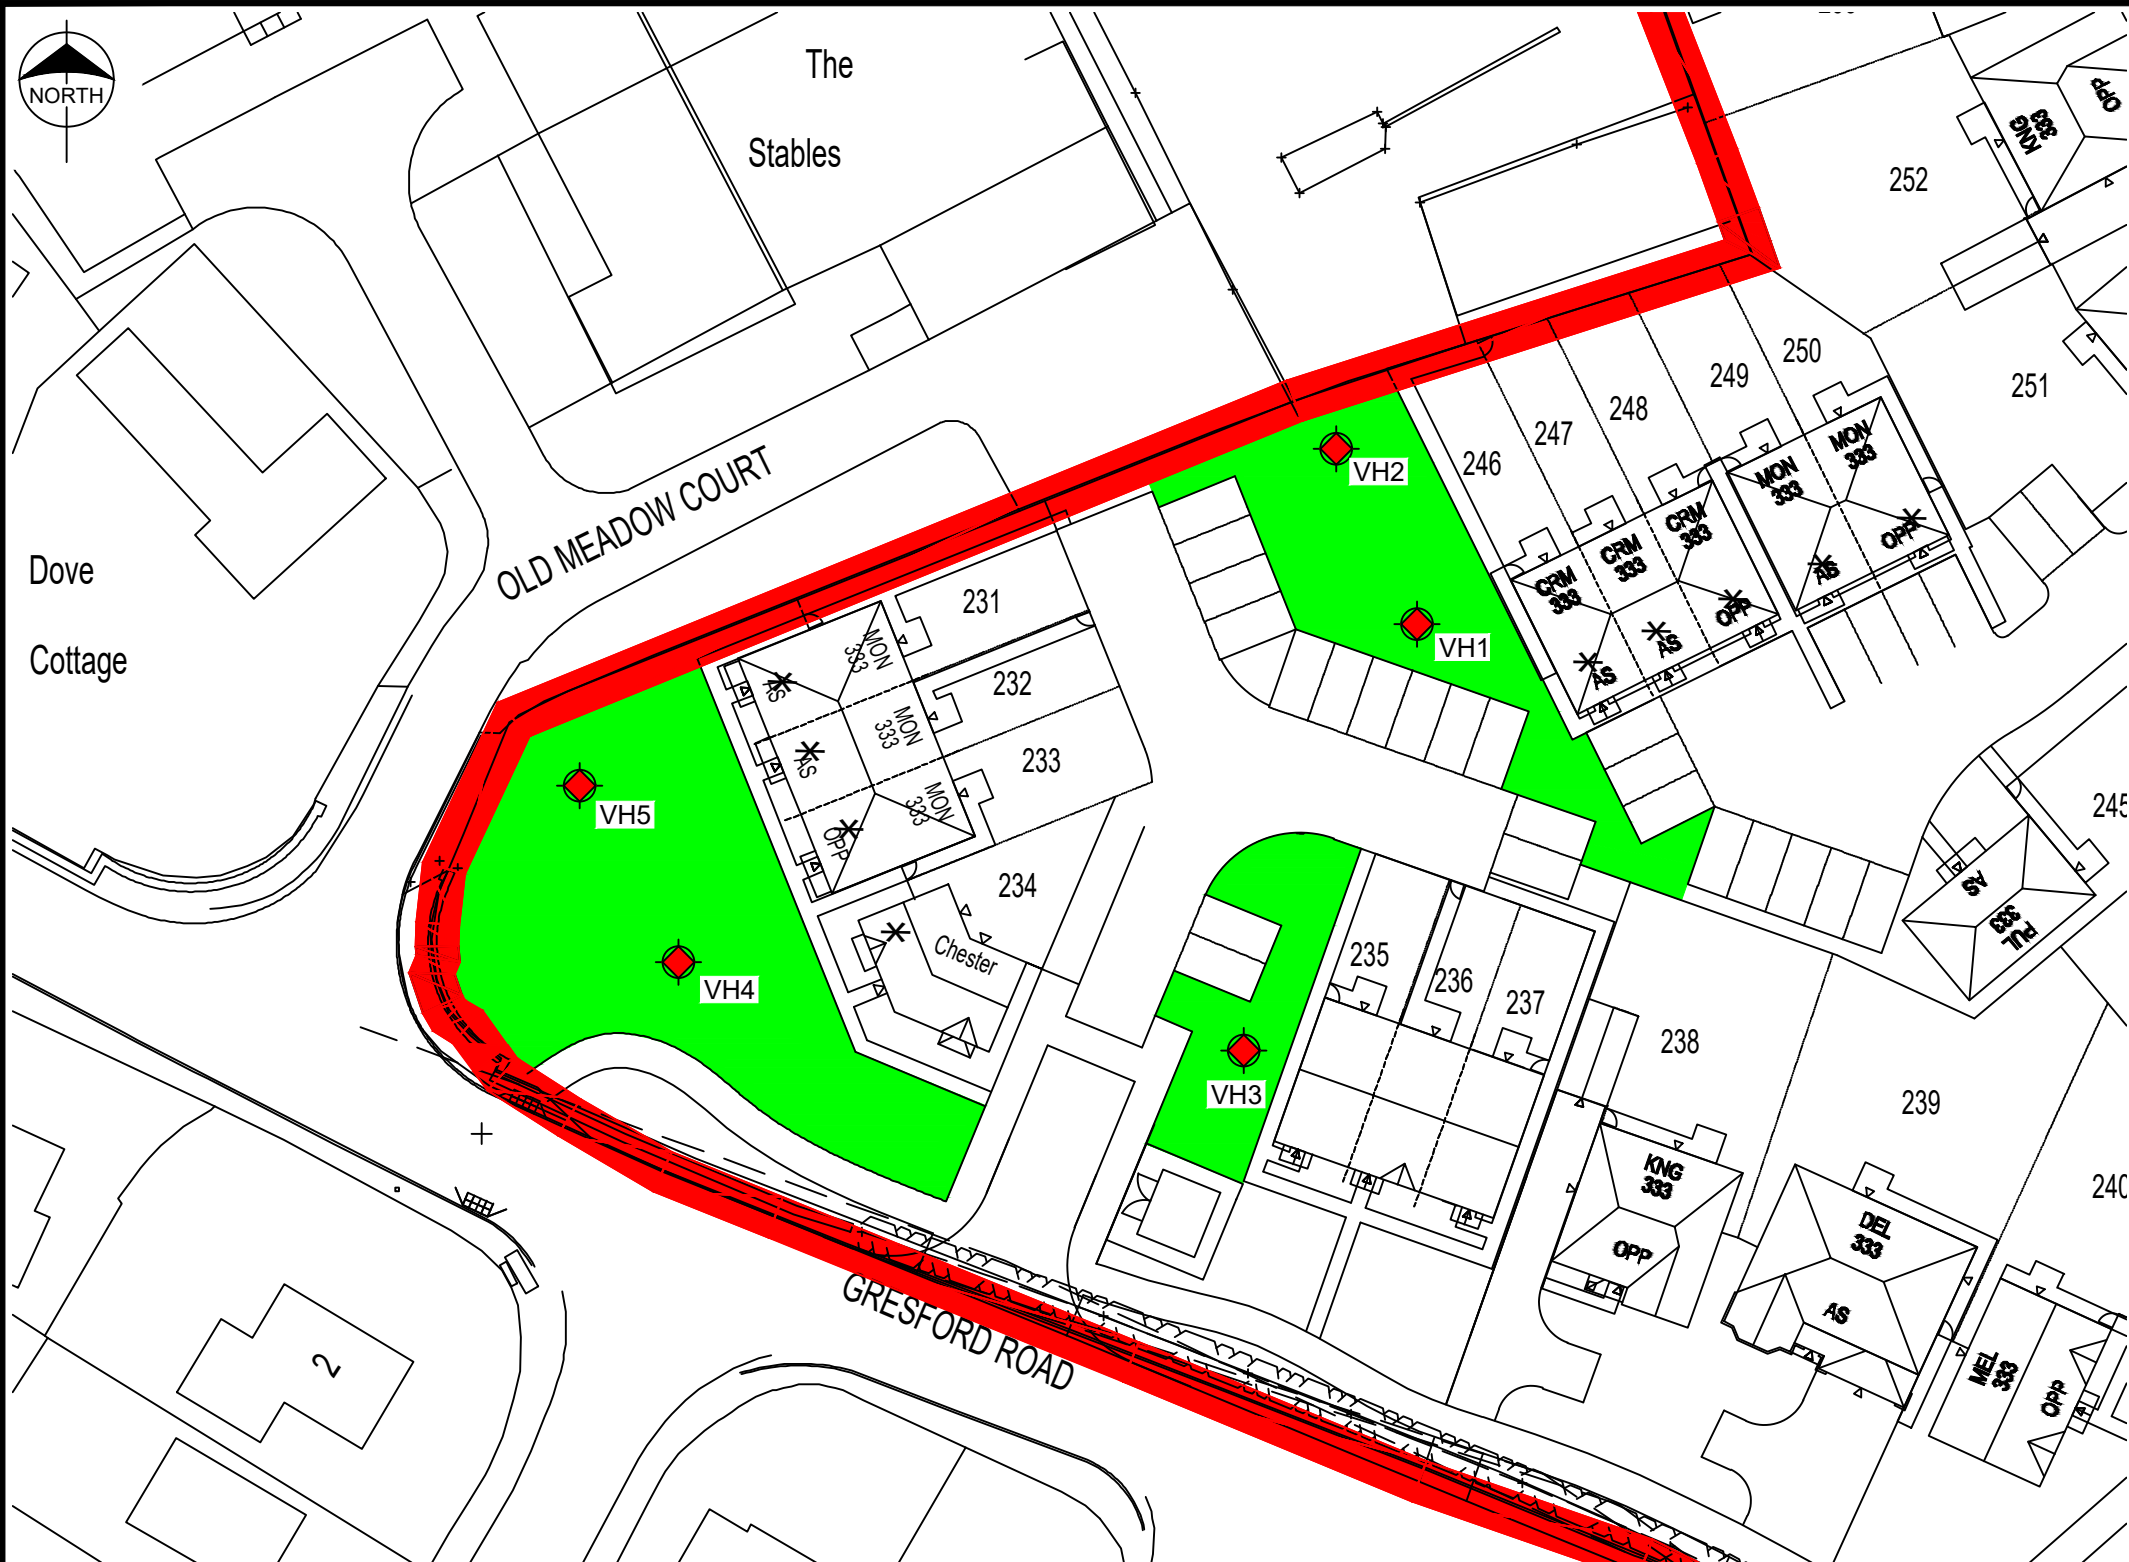
**KEY TO VALIDATION HOLES**  
(All positions are approximate unless otherwise stated)

Validation holes VH1 - VH5 completed by Coopers between 23 - 24 November 2023
