Erbistock Mill,  
Erbistock, Wrexham

Protected Species Scoping Report  
Report KE22/0250

23<sup>rd</sup> December 2022

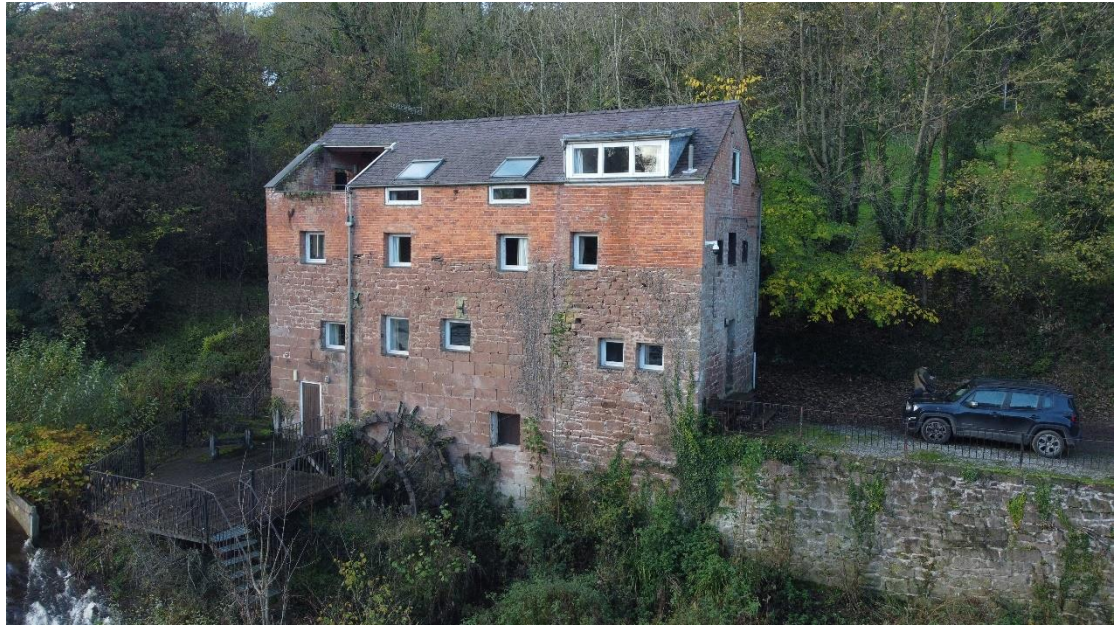
*Photograph 1- East face of Building*

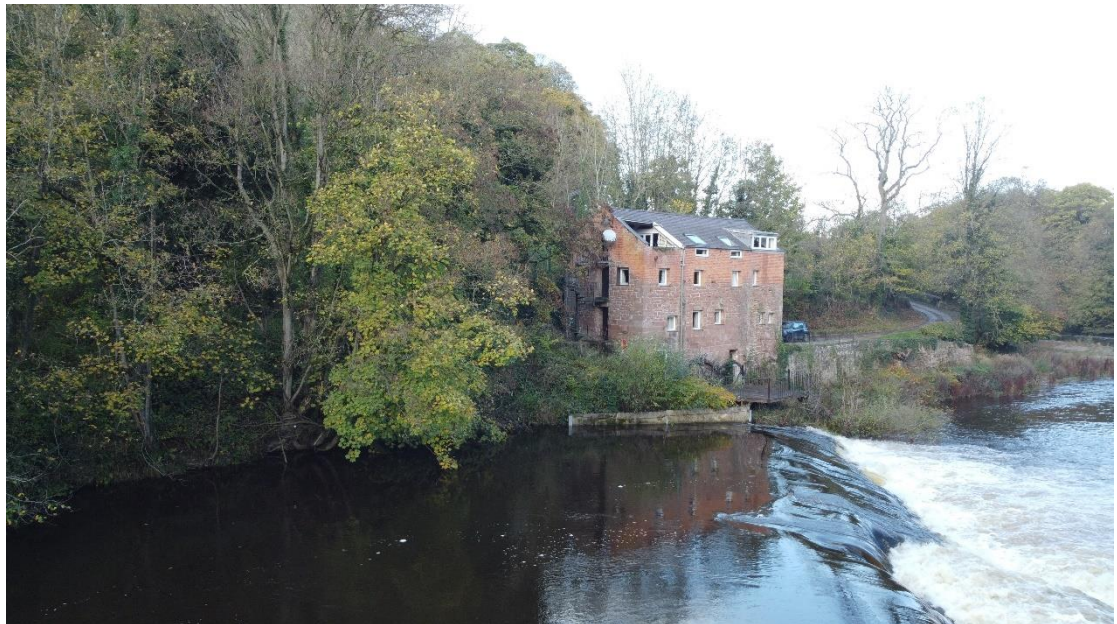
*Photograph 2- East face of building viewed from weir*

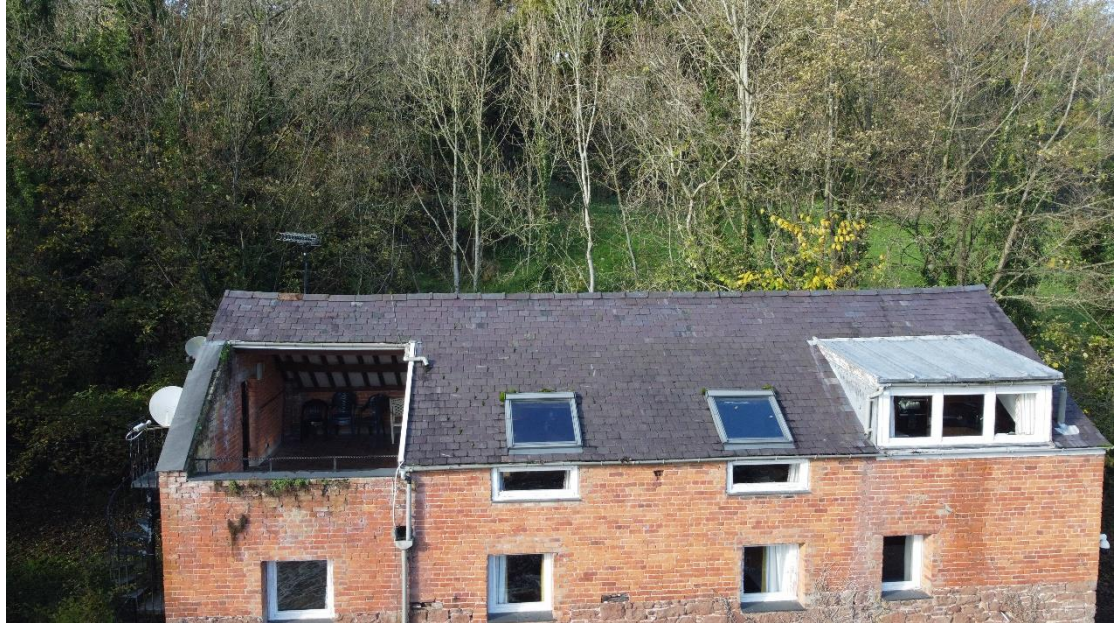
The roof of the building appears to be intact and in good condition with no missing slates or areas of raised ridge. Verge mortar at each gable end is intact and well pointed. It is likely that the roof has been restored in the relatively recent past, possibly when the dormer windows and skylights were installed.

*Photograph 3- View of roof showing Terrace area and dormers*

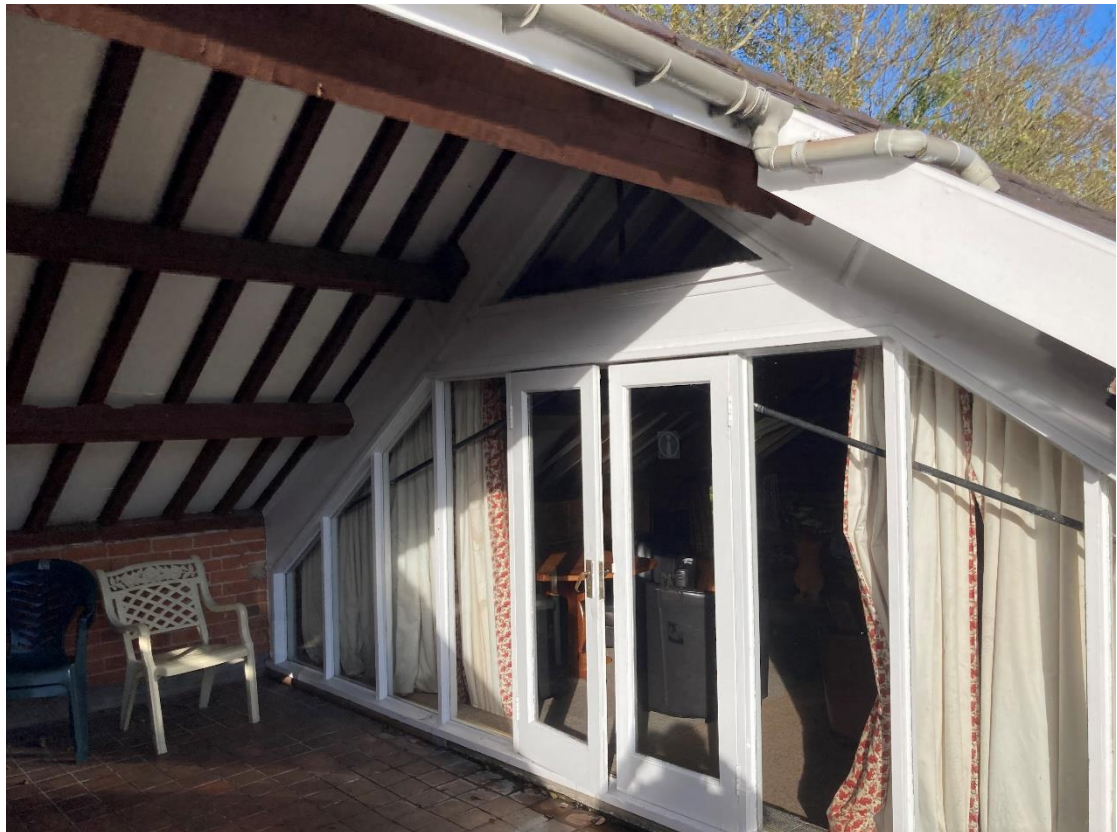
The building has an open terrace area at the southern end of the top floor (Bat Target Note 1 on Figure 2). In this location a section of the east facing roof pitch has been removed in order to create the open terrace space. The roof ridge line has been retained across the full length of the building. The terrace area measures approximately 3 m x 6 m in area and is 3 m in height.

The upper floor terrace area was observed to be intact and well sealed with no obvious potential bat roosting features. The external brickwork within the terraced area is well pointed with no obvious potential roosting crevices and the internal face of the roof is well plastered and tightly sealed. No bat droppings or other bat field signs were identified within the building interior or the terrace area.

*Photograph 4- Existing terrace area*

Development proposals would include the restoration of the roof and the conversion of the terrace area into living accommodation.

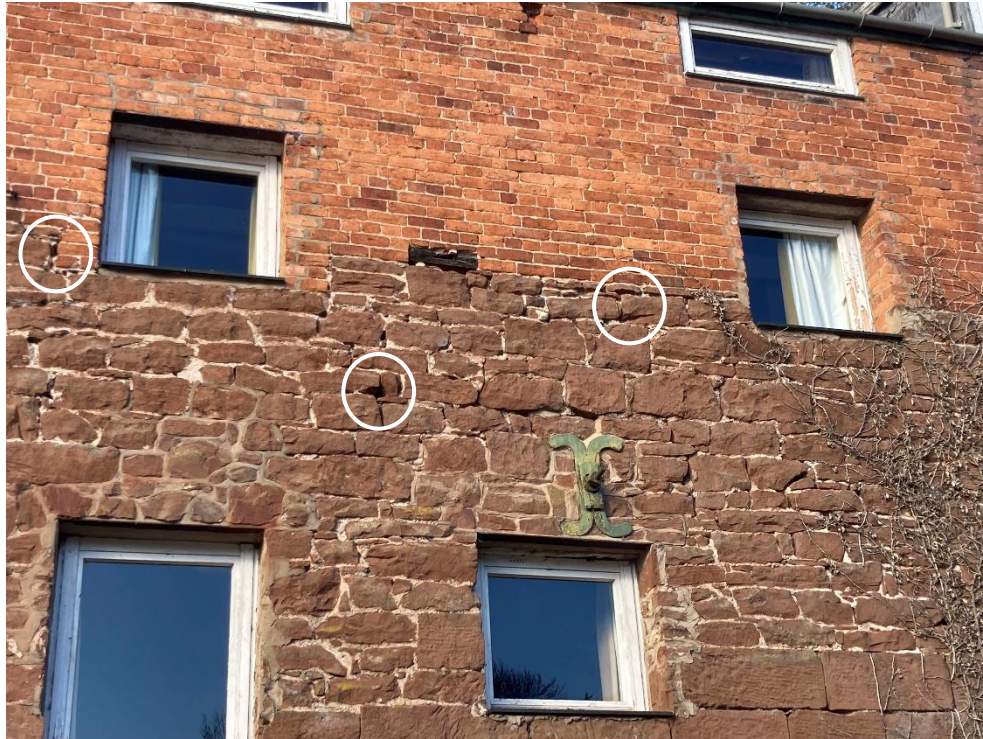
However, there are intermittent deep crevices between the areas of sandstone blockwork located at the building's east and west faces (Bat Target Notes 2 on Figure 2). The crevices are located within the sandstone blockwork between the ground floor and first floor windows of the building. The crevices in the block work only offer suitable roosting habitat for individual or low numbers of non-breeding bats.

*Photograph 5- East base of mill building showing crevices in blockwork*

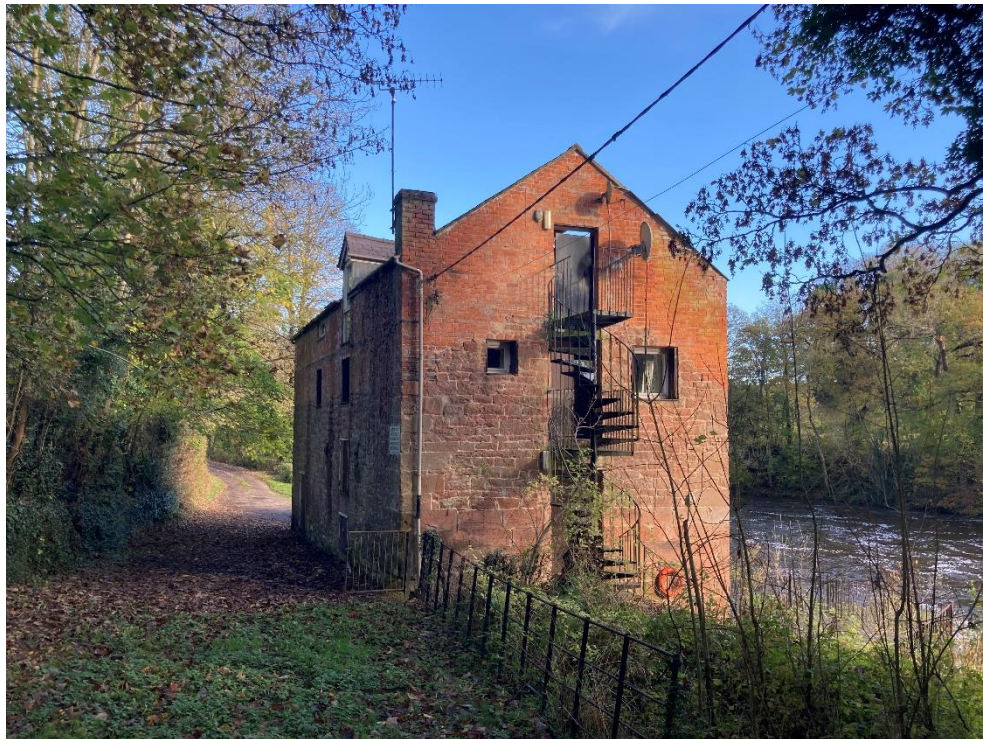
*Photograph 6- South and west face of the mill building*

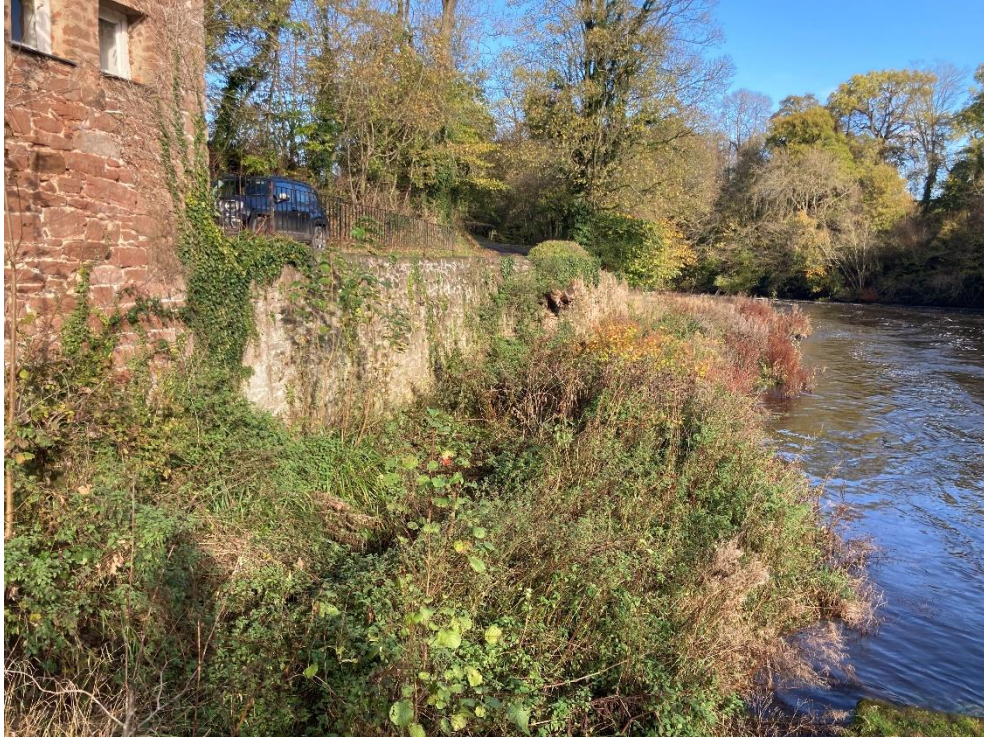
There is a sandstone retaining wall running along the western bank of the river. A vegetated sand bar has developed within the river channel in front of the retaining wall and the mill building. Vegetation on the bank comprises principally of nettle, with bramble, great willow herb, pendulous sedge, greater burdock, dog rose, creeping thistle and small teasel. Scattered young trees/saplings are present including willow, sycamore and alder. There are patches of fern growing on the side of the mill and beneath the area of decking including male fern, lady fern and hart's tongue fern.

There are patches of non-native invasive plant species present along the sand bar including stands of Himalayan balsam (Target Note 4) and the also three small stands of Japanese knotweed. The knotweed is located both upstream and downstream of the area of raised decking (Target Notes 2 and 5).

*Photograph 7- Habitats on sandbar*

It is therefore recommended that a Himalayan Balsam management plan is produced and adhered to works.

Control measures for Himalayan balsam should aim to prevent seeding (generally August-October). It is recommended that plants are removed by hand-pulling or cutting around the works areas. This should be carried out May-July to be the most effective. Cutting should be carried out at ground level and below the first node to achieve the best results.

Appropriate no works zones should be marked out around the stands of Japanese knotweed. Alternatively, the stands could be removed in advance of works. If this option is pursued, then it is recommended that a Japanese knotweed method statement is produced, providing methods by which this invasive species will be treated and controlled.

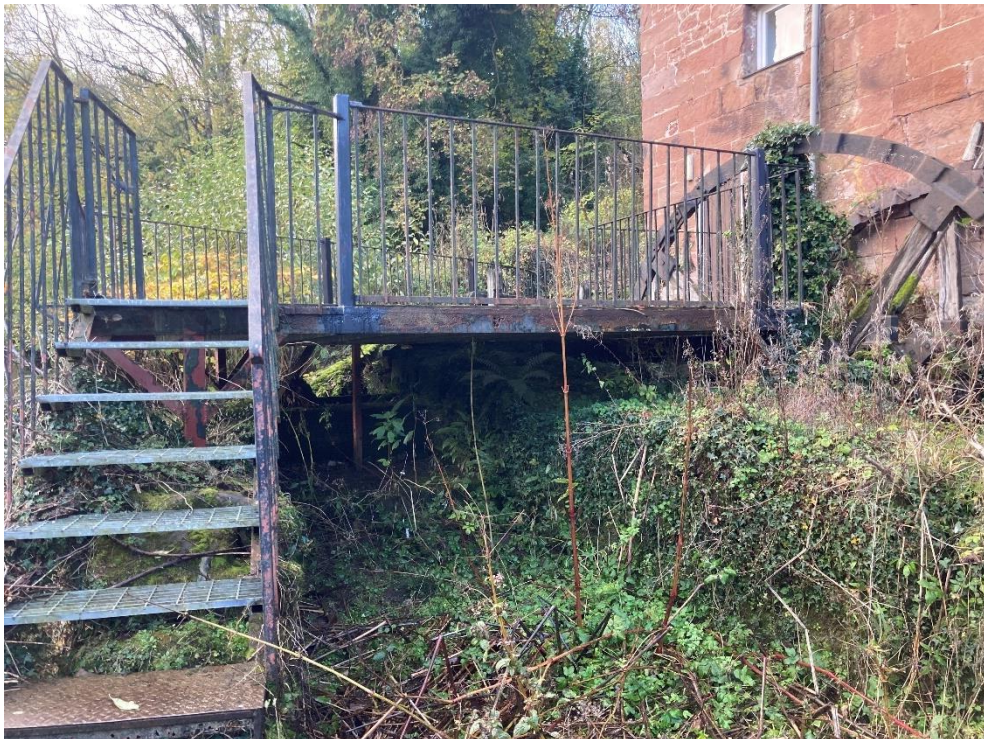
The area of decking (Building 2 on Figure 2) extends out into the river channel immediately adjacent to the weir. The decking is raised from the riverbank by approximately 1.2 m.

*Photograph 8- Decking area*

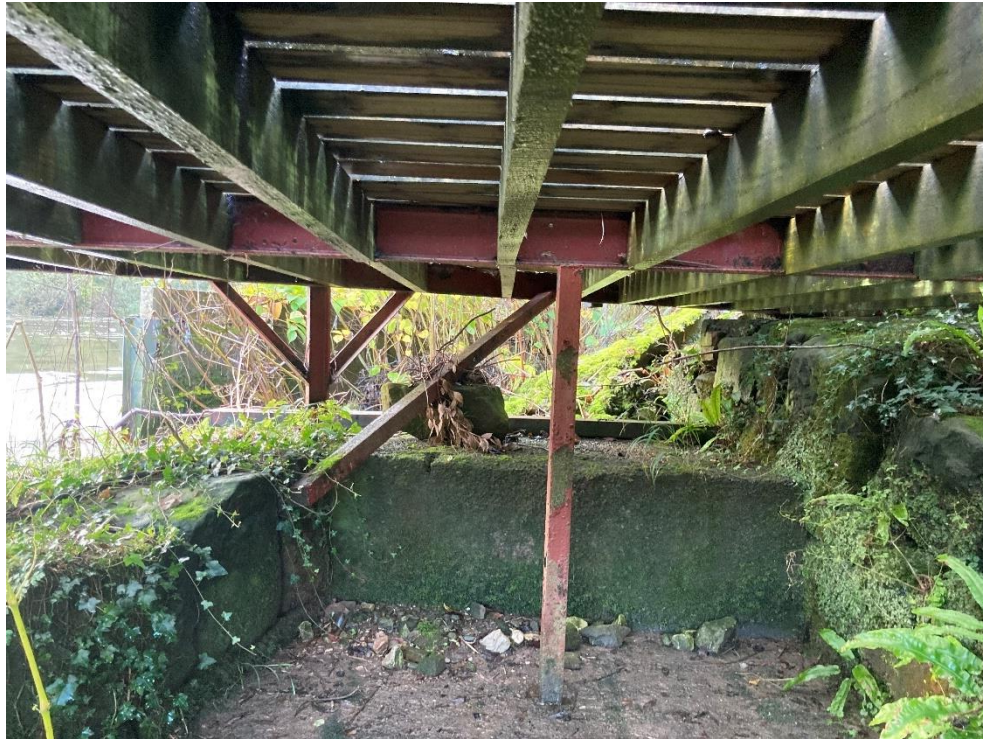
The area underneath the decking may also offer a temporary resting area for otter. However, the area is relatively exposed and open with no suitable secure, holt sites to allow use during the daytime or for prolonged resting periods.

*Photograph 9- Habitats beneath decking*

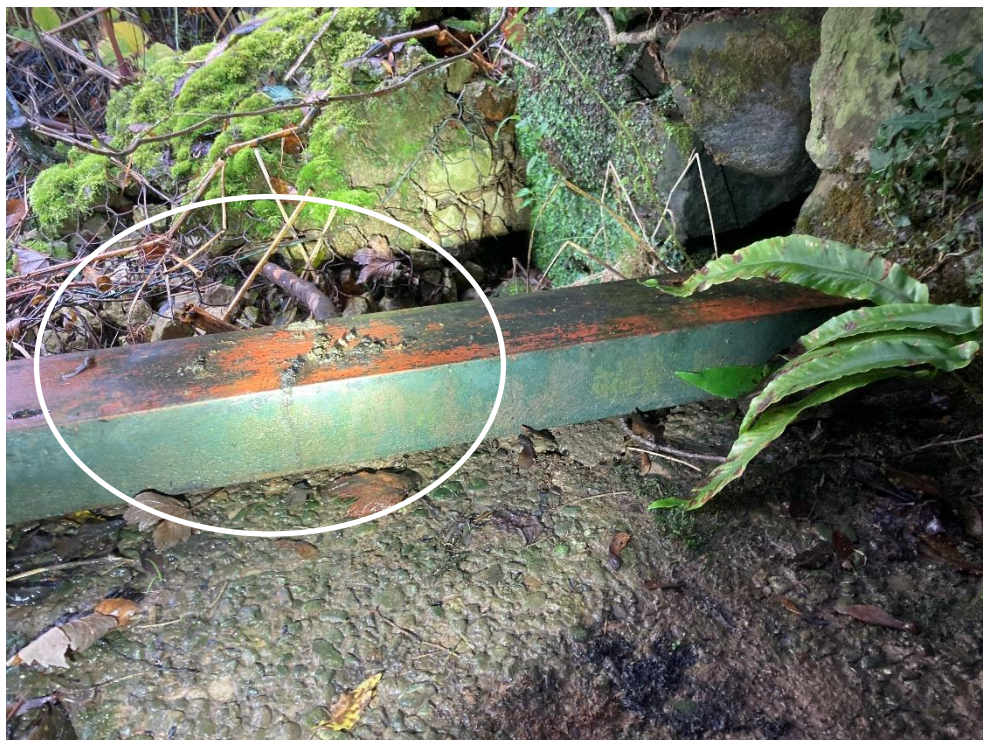
The area beneath the decking was searched for otter field signs. Moderately fresh and old otter spraint was identified on a steel beam beneath the decking. This confirms that otter pass beneath the decking area relatively frequently. It is likely that otter travel under the decking in order to pass around the adjacent weir.

*Photograph 10- Otter spraint under decking area*

In order to limit the risk of these potential negative impacts, it is recommended that an appropriate works method statement is produced detailing best practices methods and pollution control measures to be followed during the construction phase. Further measures to limit the risk of disturbance or harm to otters should include:

- No works should be carried out at the site between sunset and sunrise.
- No overnight lighting should be used.
- A tidy works area should be maintained during construction and any hazardous substances should be fenced off to remove any otter hazards from the site.
