**Acton Park Community Primary School,  
Acton, Wrexham**

**Bat – Potential Roost Assessment**

October 6<sup>th</sup> 2023

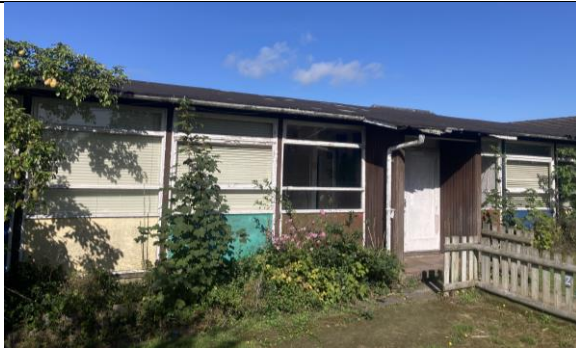
**Plate 1:** The south-eastern aspect of the building showing roofing felt and wood cladding structure with external garden.

- 3.2.2 The building is a disused, timber chalet classroom, with wood cladding and roofing felt on a shallow pitched roof (plates 1-5). The external gardens of the classroom were laid to lawn with some shrubs and flower beds.

- 3.2.3 The building is generally well sealed to bats. The roof structure is made up of solid plywood timber sheets upon open timber rafters (plate 8). The roofing felt is glued to the plywood with no visible gaps, cracks or areas that are lifted (plate 1). No PRFs are present within the walls or surrounding windows or doors (plate 3).

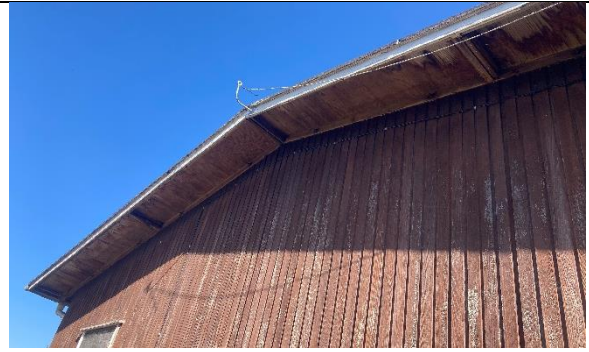
**Plate 2:** The well-sealed gable ends of the building. No PRF's present.

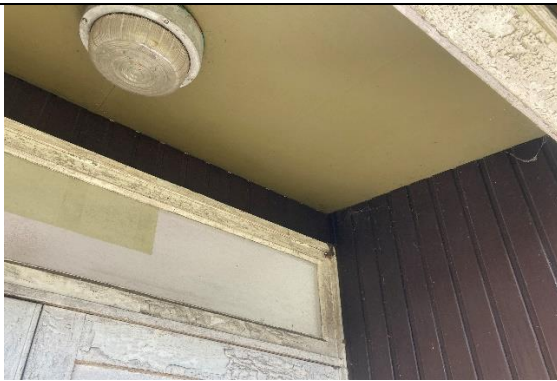
**Plate 3:** Areas around window and ends of timber sarking well sealed

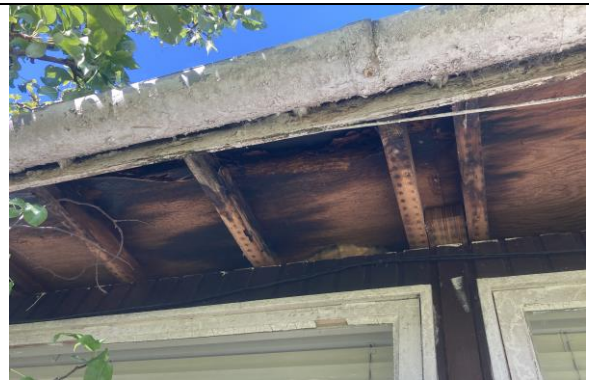
**Plate 4:** The gaps between the open rafters allowing direct flight access into the loft space across the front of the building.

- 3.2.4 The soffit timber is not present along the entire front and back elevations and gaps between each rafter is open. These gaps are 75mm x 400mm and provide a large amount of direct flight access to the loft space (plate 4-5).

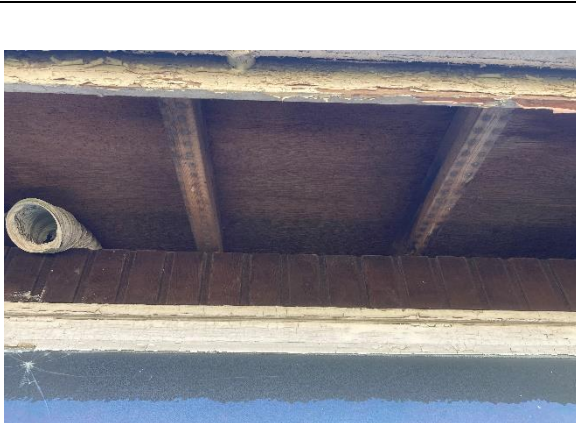
**Plate 5:** The gaps between the open rafters allowing direct flight access into the loft space across the front of the building

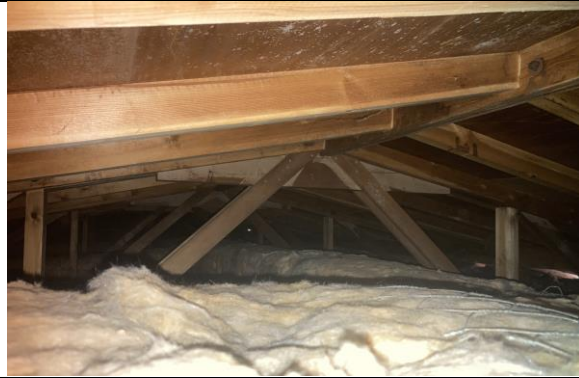
**Plate 6:** loft space, 750mm height 'clean' timber framing

- 3.2.5 The loft space spans the full footprint of the building, (plate 7-8). The loft space has a height of approximately 750mm. Internal access for survey work throughout the loft space was not possible due to the roof construction. Access through a loft hatch allowed a survey of the immediate area surrounding it and to ascertain the thermal and light conditions present within the loft. Light levels within the loft are significant due to the open gaps between each rafter. In addition a notable draught was present within the loft at the time of the survey.

- 3.2.6 Potential Roost Features within the loft were not present. The ceiling of the loft was the underside of plywood boards, this was then nailed to modern timber rafters, no gaps or crevices within the wooden framework exist. Roosting points were limited to the open outside of timbers.

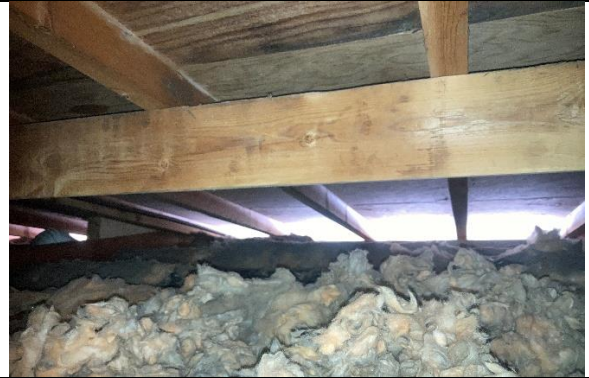
**Plate 8:** view from the loft looking out of the gaps between the rafters. Note significant light spillage into loft
