## Ph 1 Desk Study & Ph2 Geo-environmental Site Investigation

PLAS COCH ROAD  
WREXHAM  
LL11 2BA

Report Ref. 1928-19 / Final  
/ Revision 1 – 31<sup>st</sup> July 2019

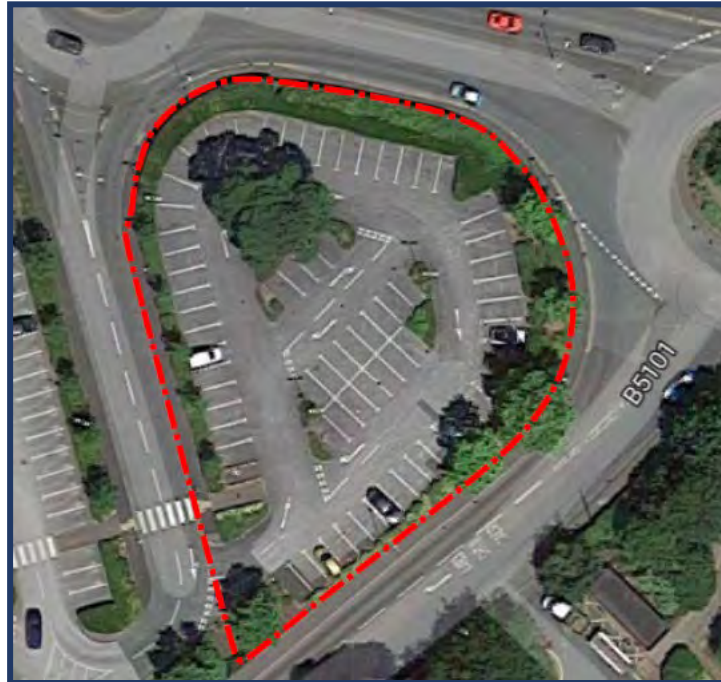
The approximate National Grid reference for the site is 332572E, 351333N. An aerial photograph of the site is presented below with the site boundary marked in red.

The site covers an area of approximately 0.24ha and is irregular in shape. The site comprises part of the car park, with associated trees and soft landscaping features along the perimeter.

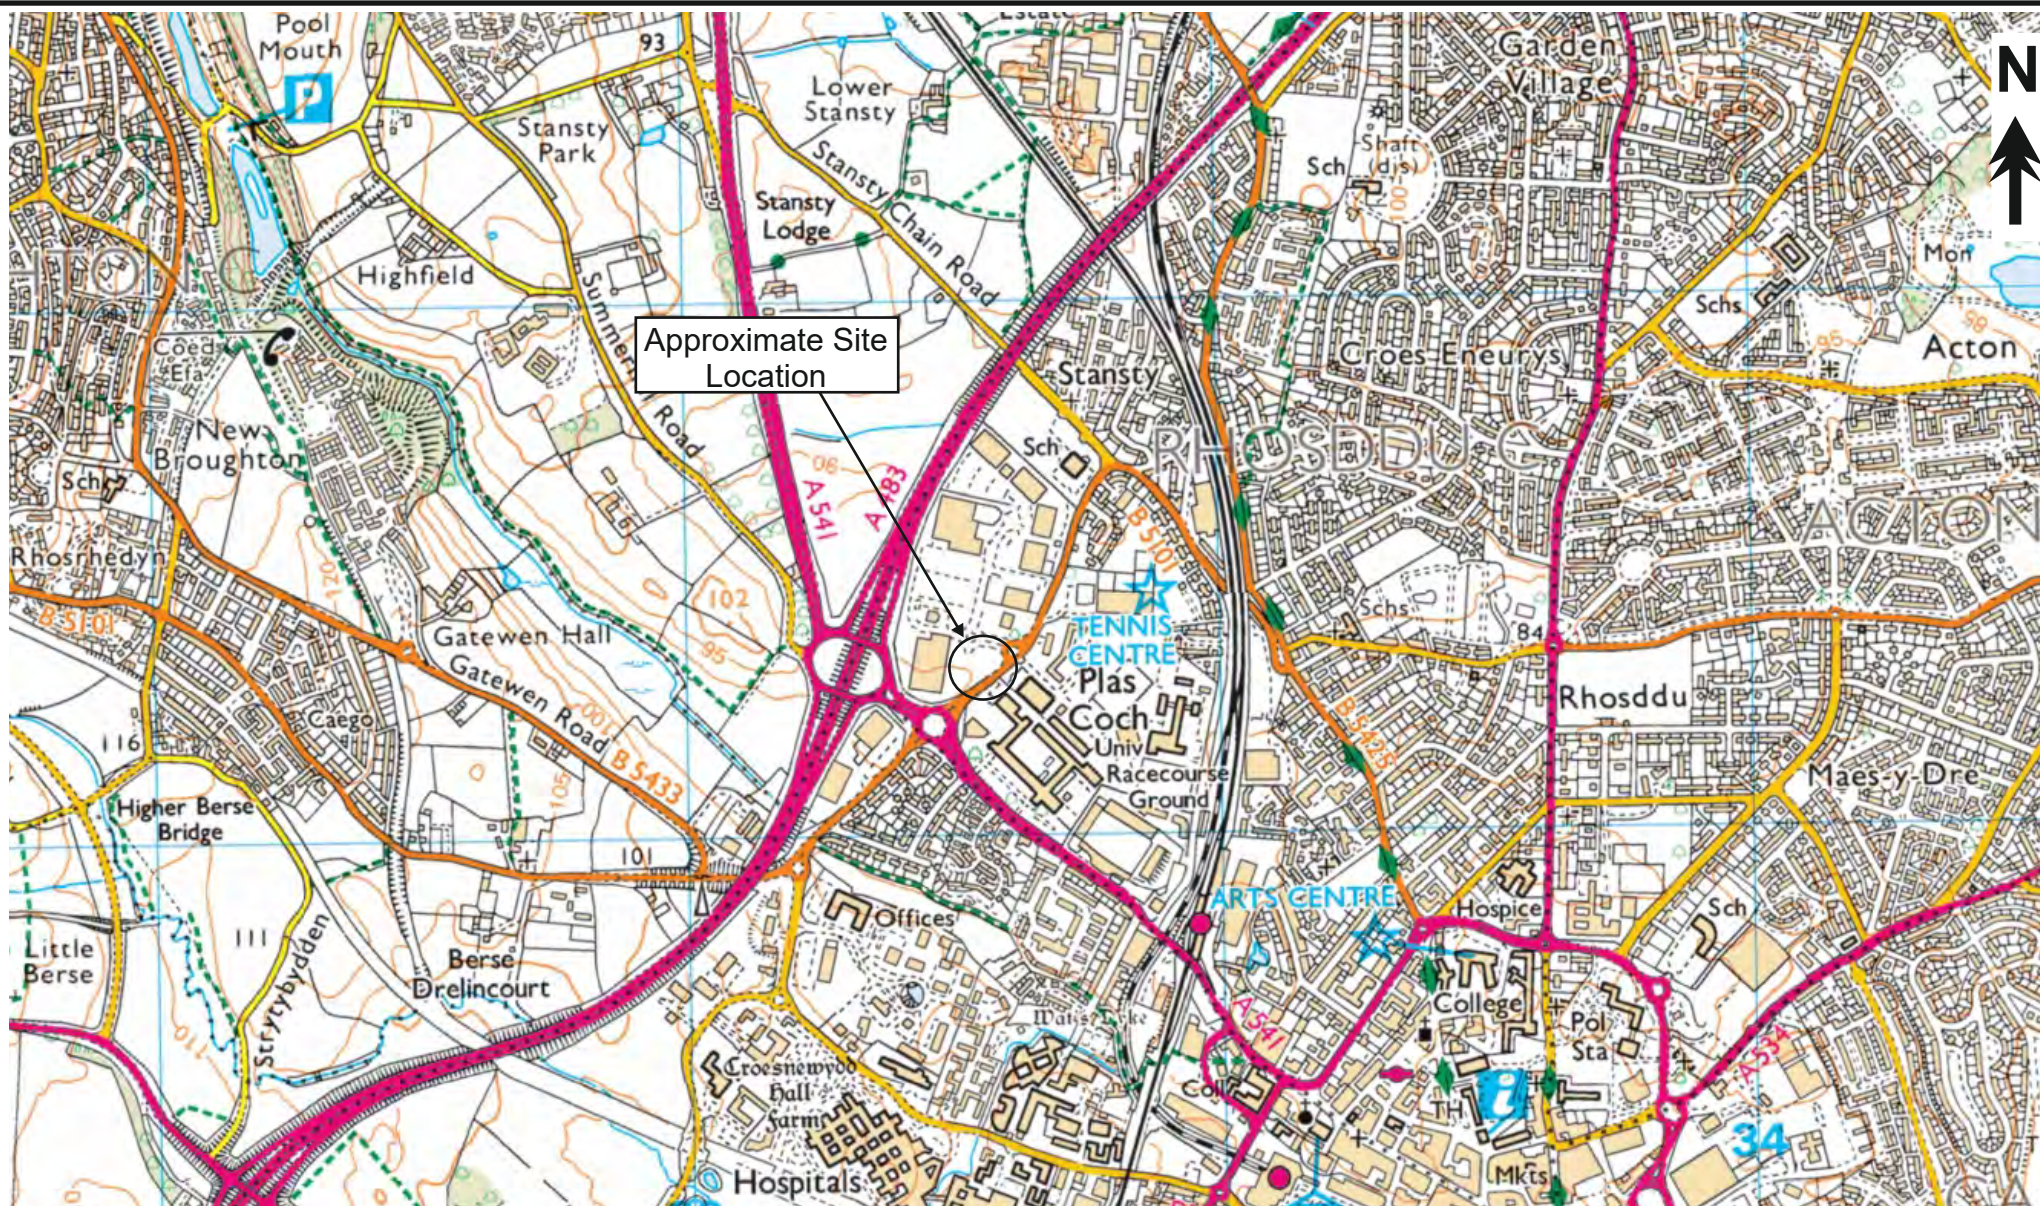
Figure 1

The site is located off Plas Coch Road, Wrexham approximately 1.12km northeast of Wrexham Central Train Station. An extract of the 1:50,000 Ordnance Survey map showing the general location of the site is included as Figure 1.
