## PHASE 2 GROUND INVESTIGATION FOR PROPOSED CRICKET PAVILION

**GWERSYLLT PARK CRICKET CLUB, GWERSYLLT LL11 4DA**

**30<sup>TH</sup> MARCH 2023**

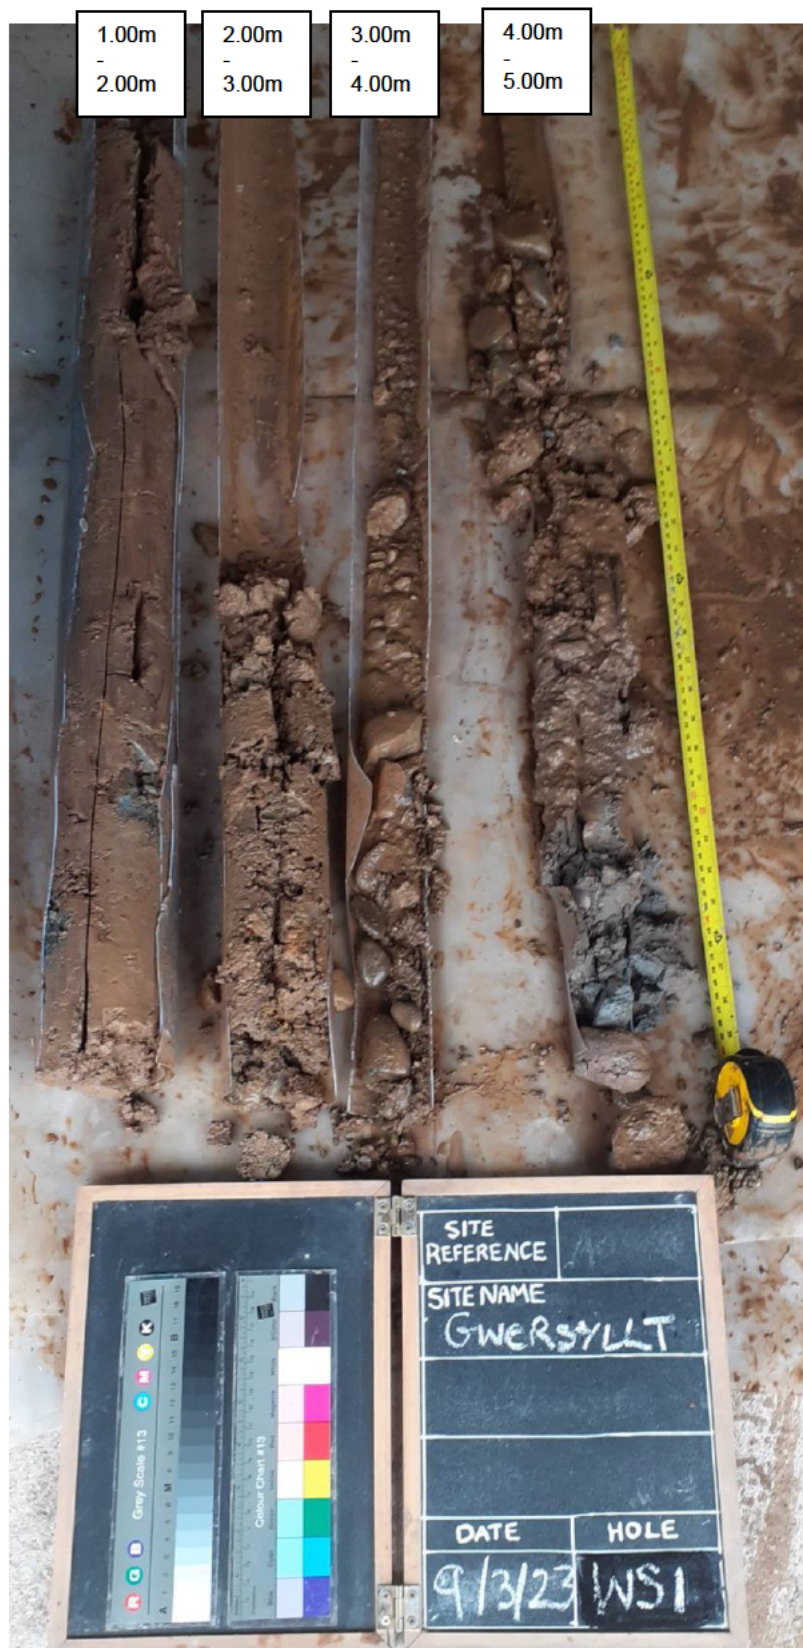
# DYNAMIC SAMPLING PHOTOGRAPHS

**TOP**

**BASE**

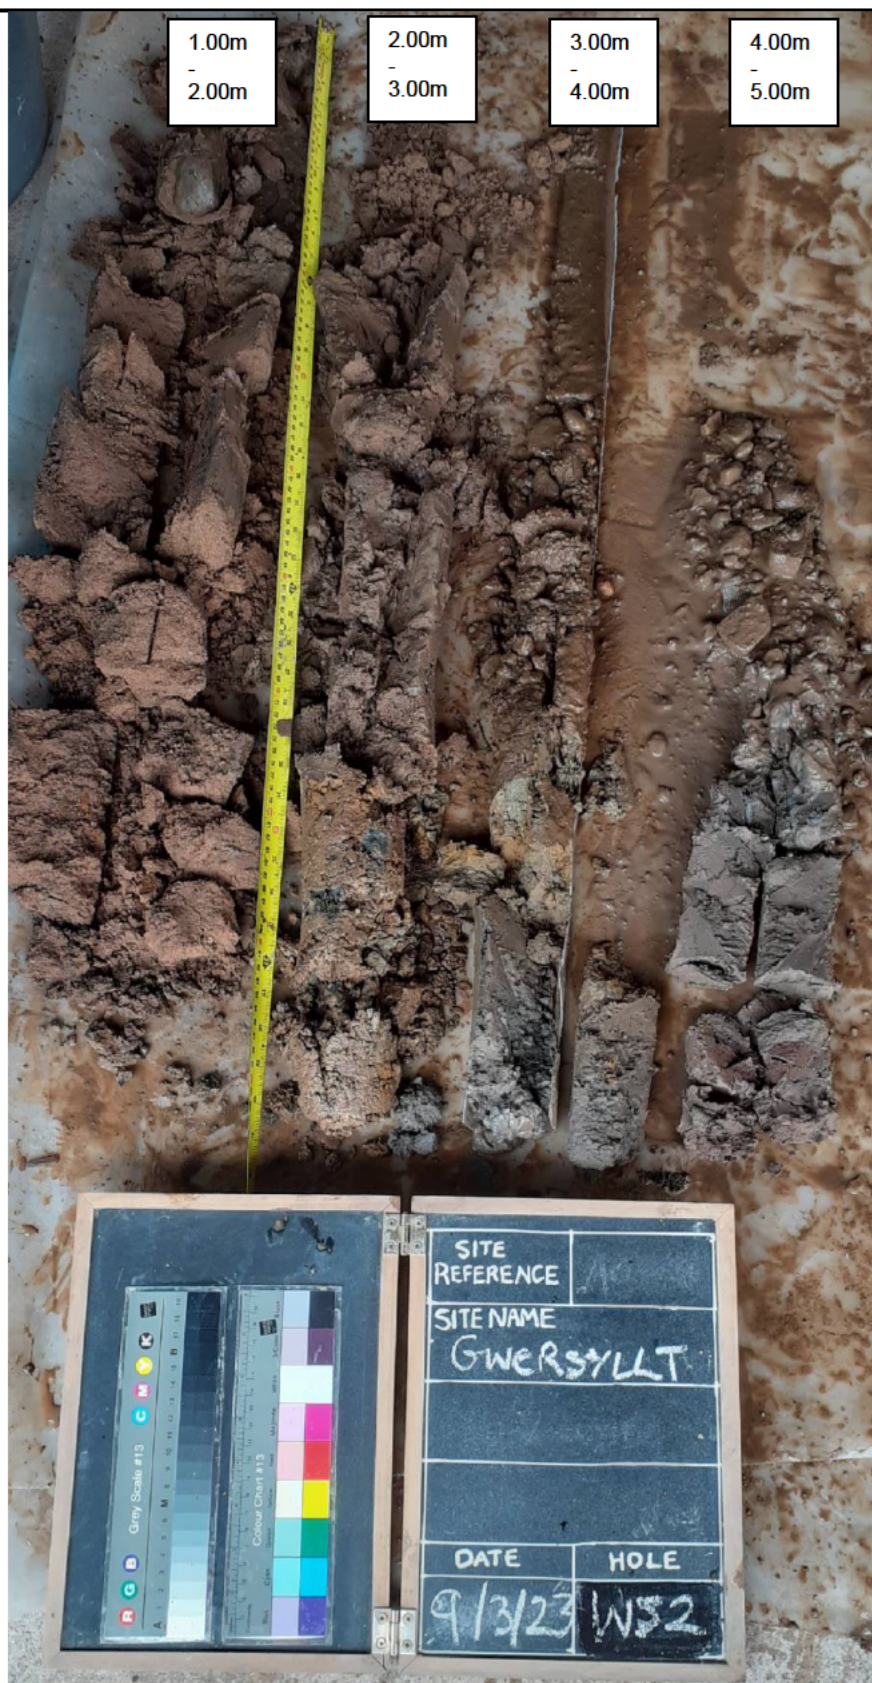
**HP03**

## TRIAL HOLE PHOTOGRAPHS

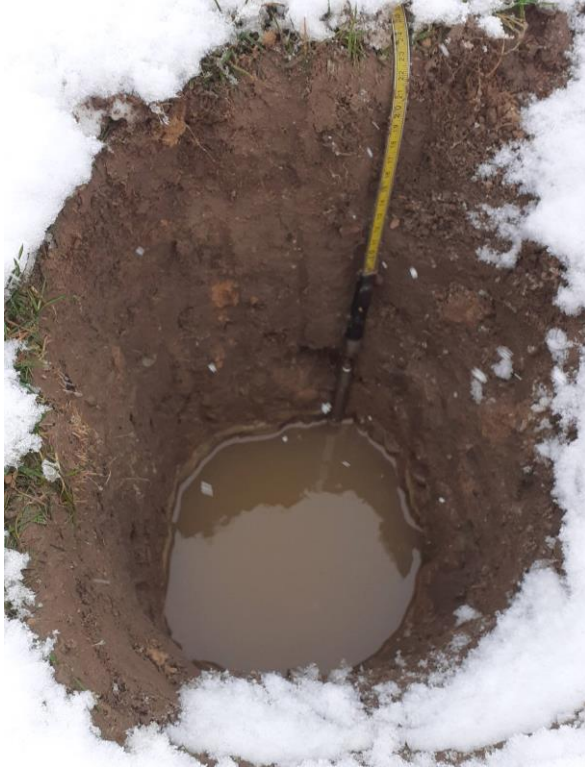
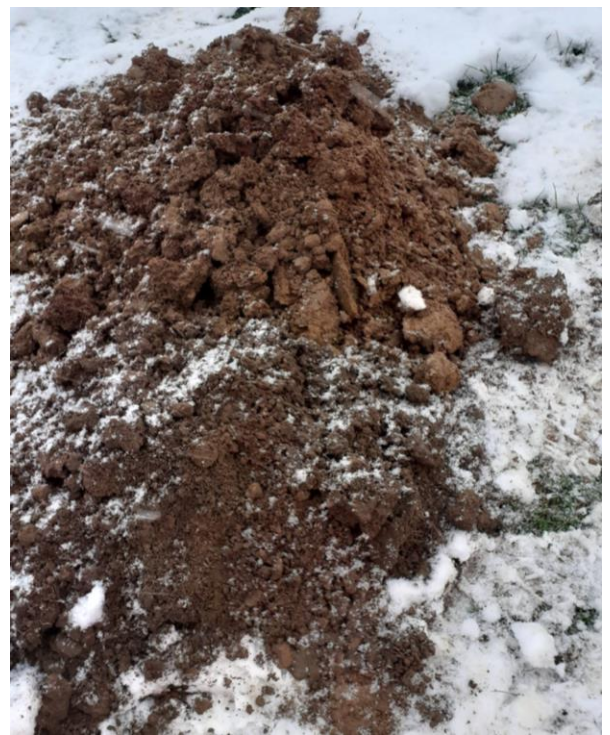
Photograph

An infiltration test was attempted in the shallow clayey strata above the water table but no fall in water level was recorded over the test period of 80 minutes.

Trial Hole during soakage test

Spoil Mound
